**US Army Corps
of Engineers®**
Engineer Research and
Development Center

Modeling of Nearshore-Placed Dredged Material

July 2015

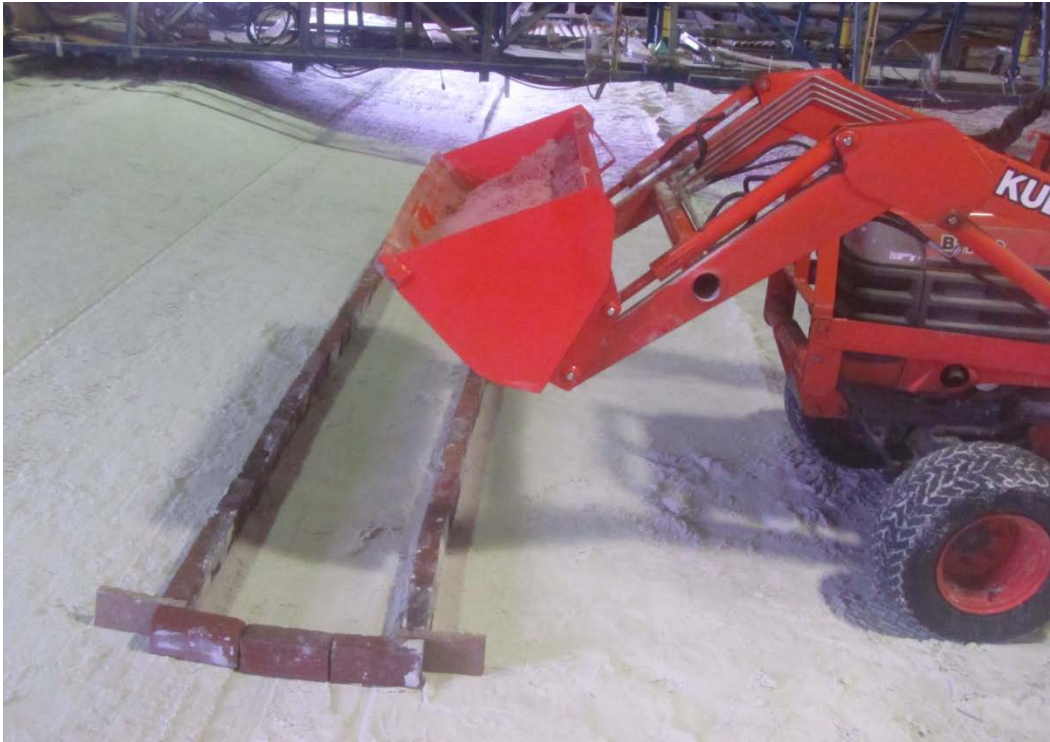
Figure 5. Construction of Mound 2.

Figure 6. Construction of Mound 2.

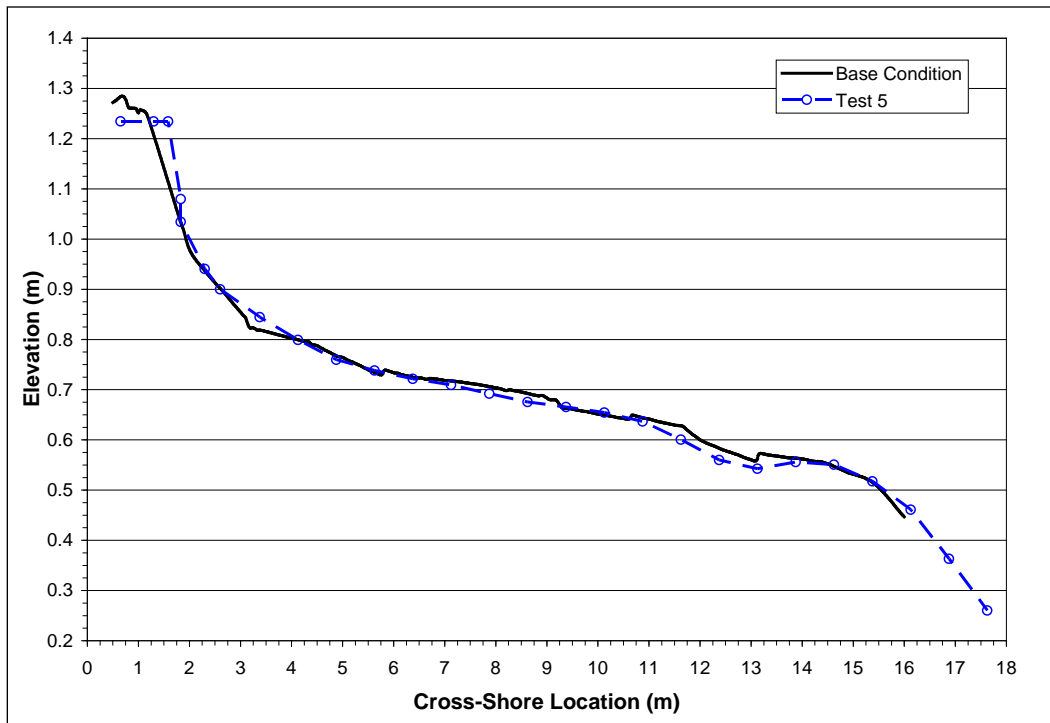
The average cross-shore profile of the Base Condition is plotted in Figure 10 with the equilibrium profile of LSTF Test 5 (Smith et al. 2009). Although the profiles are similar, there are discrepancies between profiles. A scarp formed with the Test 5 profile, and it was not desired to reconstruct a scarp face in the present study. Therefore, a milder foreshore slope was constructed for the present study. The Test 5 shoreline was located at

$Y \approx 2.6$ m, and it was preferred to match the shoreline and foreshore slope of the equilibrium profile. As a result of the construction method, the Base Condition beach was 2 cm lower near the 3 m cross-shore location. Two areas were built higher than the Test 5 beach. The Base Condition beach was constructed approximately 1 cm higher between 6 and 9 m, and 2 cm higher between 11 and 14 m. The Base Condition survey extended to 16 m but indicates that the offshore slope is steeper than the Test 5 slope.

Figure 10. Average beach profile of Base Condition initial beach and Test 5 beach.

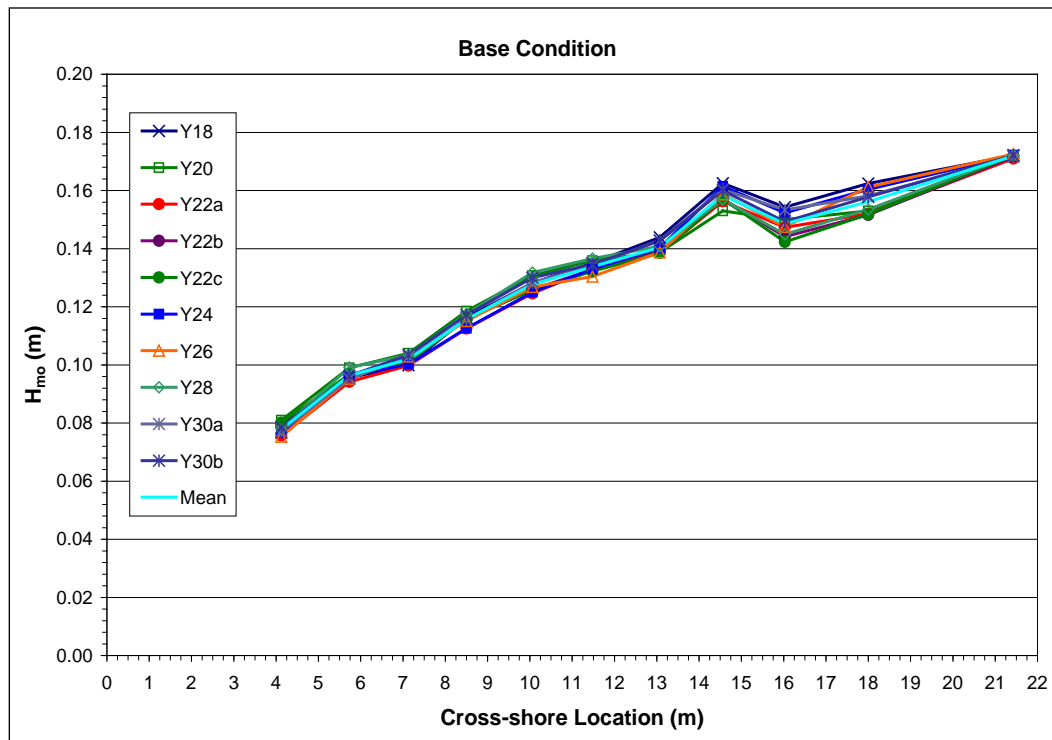
Figure 14 shows the cross-shore distribution of wave heights at all measured transects for the Base Condition. The figure shows wave heights decrease between the generator and beach, with some variability, and shoal prior to breaking at $X = 14.5$ m. A sharp decrease in height occurs immediately shoreward of the breakpoint followed by milder dissipation. The alongshore distribution of wave heights is nearly uniform in the surf zone.

Figure 14. Cross-shore distribution of wave height for the Base Condition.

Figure 29 shows the cross-shore distribution of wave heights with Mound 1 and the mean heights with the Base Condition. Waves propagating over Mound 1 have more longshore variability than observed with the Base Condition (Figure 14), and breaking occurs farther offshore. Additionally, dissipation in the surf zone is not as uniform as with the base condition; dissipation is milder between $X = 11.5$ to 10 m, at which heights decay more sharply, which may indicate a secondary break point. Wave heights at the innermost gauge are lower at the two longshore locations nearest and downdrift of the mound, Y26 and Y28.

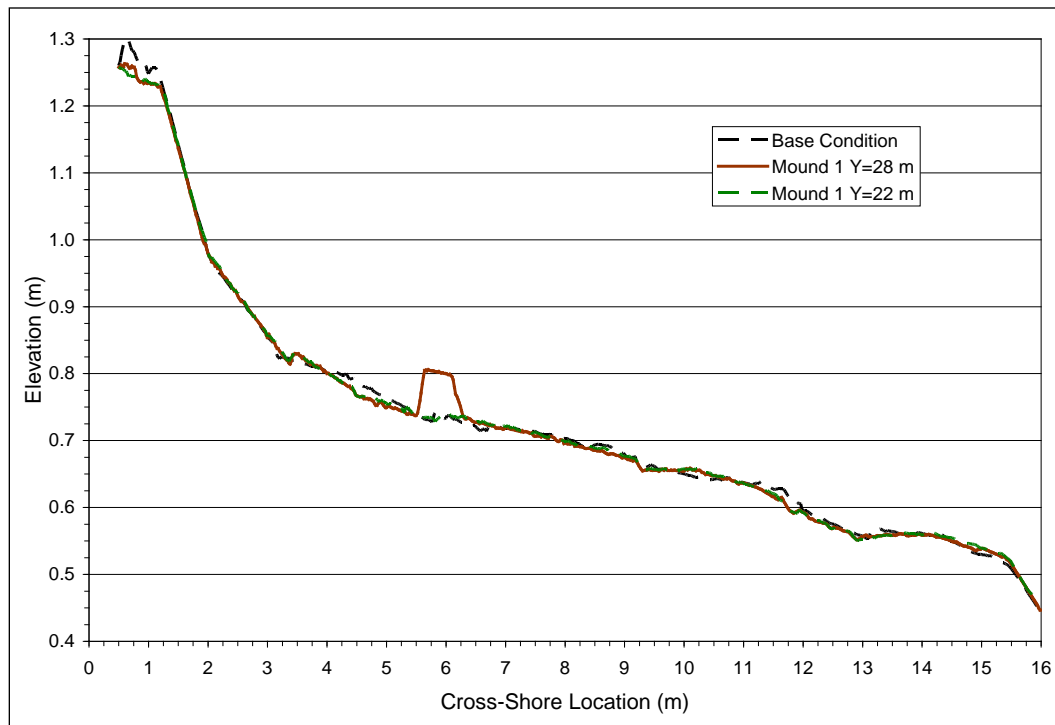
Mound 1 was constructed between $Y = 26$ m and $Y = 29$ m at a model scale depth of 0.17 m below still water level (swl) with 0.10 m^3 (3.4 ft^3) of sand dyed brown. Prototype values at a 1:20 scale represent a 3.4 m depth and 800 m^3 ($28,300 \text{ ft}^3$) volume. The cross-sectional profile of Mound 1 at $Y = 28$ m, the mound centerline, is shown in Figure 15. Also shown is the profile of the Base Condition and the Mound 1 profile at $Y = 22$ m. The Mound 1 profile matches the Base Condition well but is slightly lower shoreward of the mound. Mound 1 initial bathymetry is plotted in Figure 16. The profile at $Y = 22$ m (Figure 15) and parallel contours shown in the initial bathymetry plot (Figure 16) illustrates that the beach was

Figure 15. Mound 1 initial beach profile at locations Y=22 and 28 m.

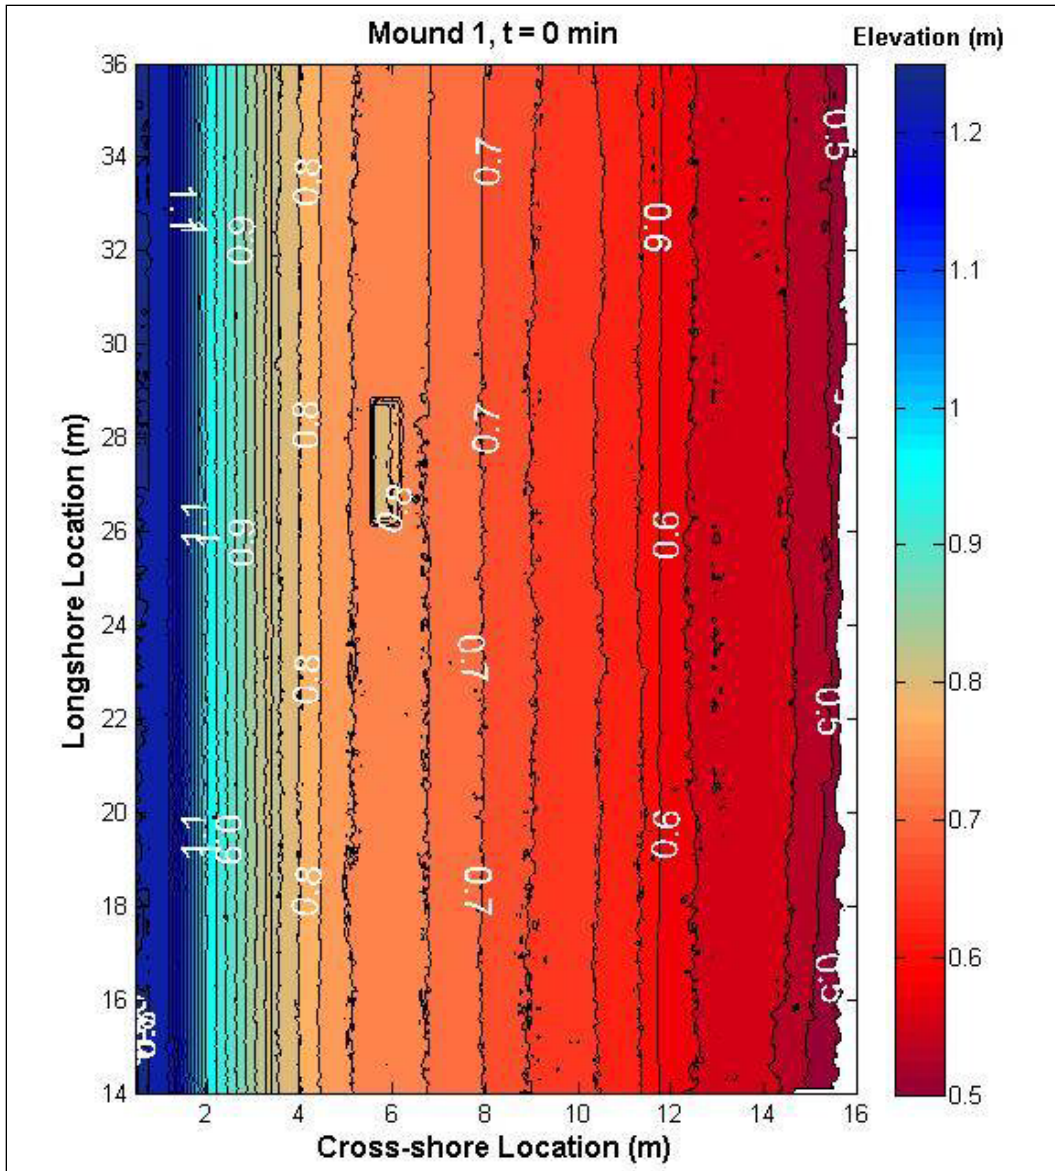
uniformly lower than the Base Condition shoreward of the mound. Panoramic photos of the Mound 1 initial beach are shown in Figures 17 and 18, and a photo of the mound looking offshore is shown in Figure 19.

Figure 16. Mound 1 initial bathymetry.

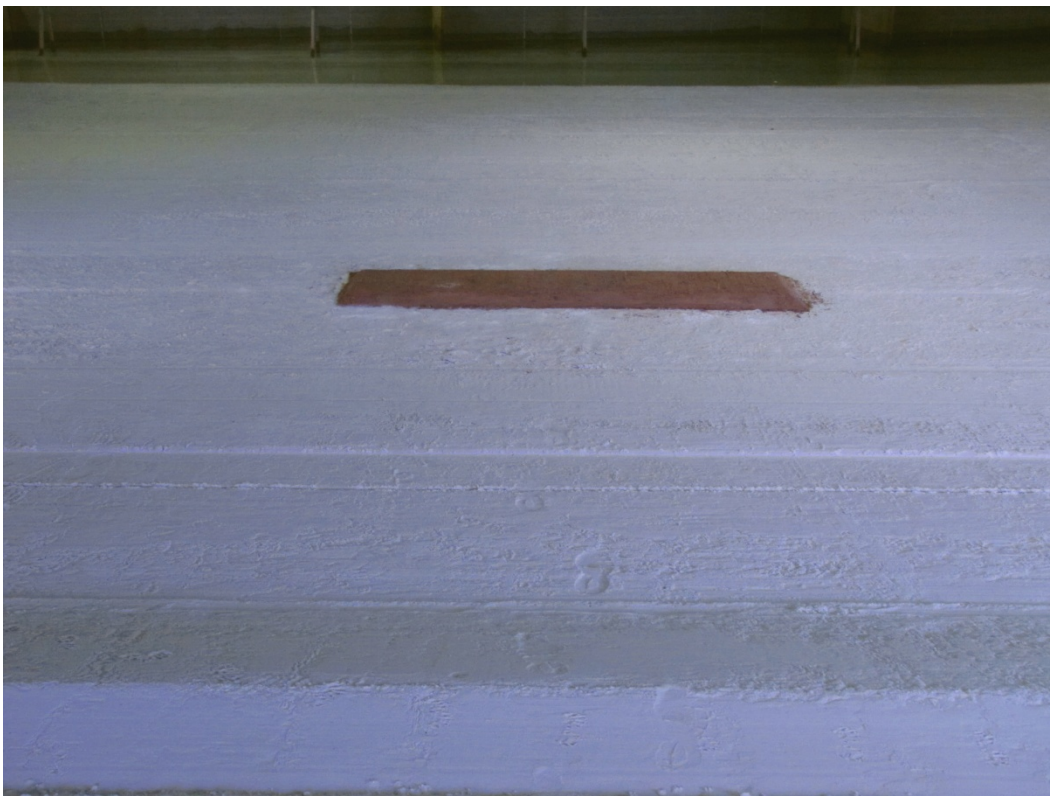
Figure 19. Mound 1 initial beach looking offshore.

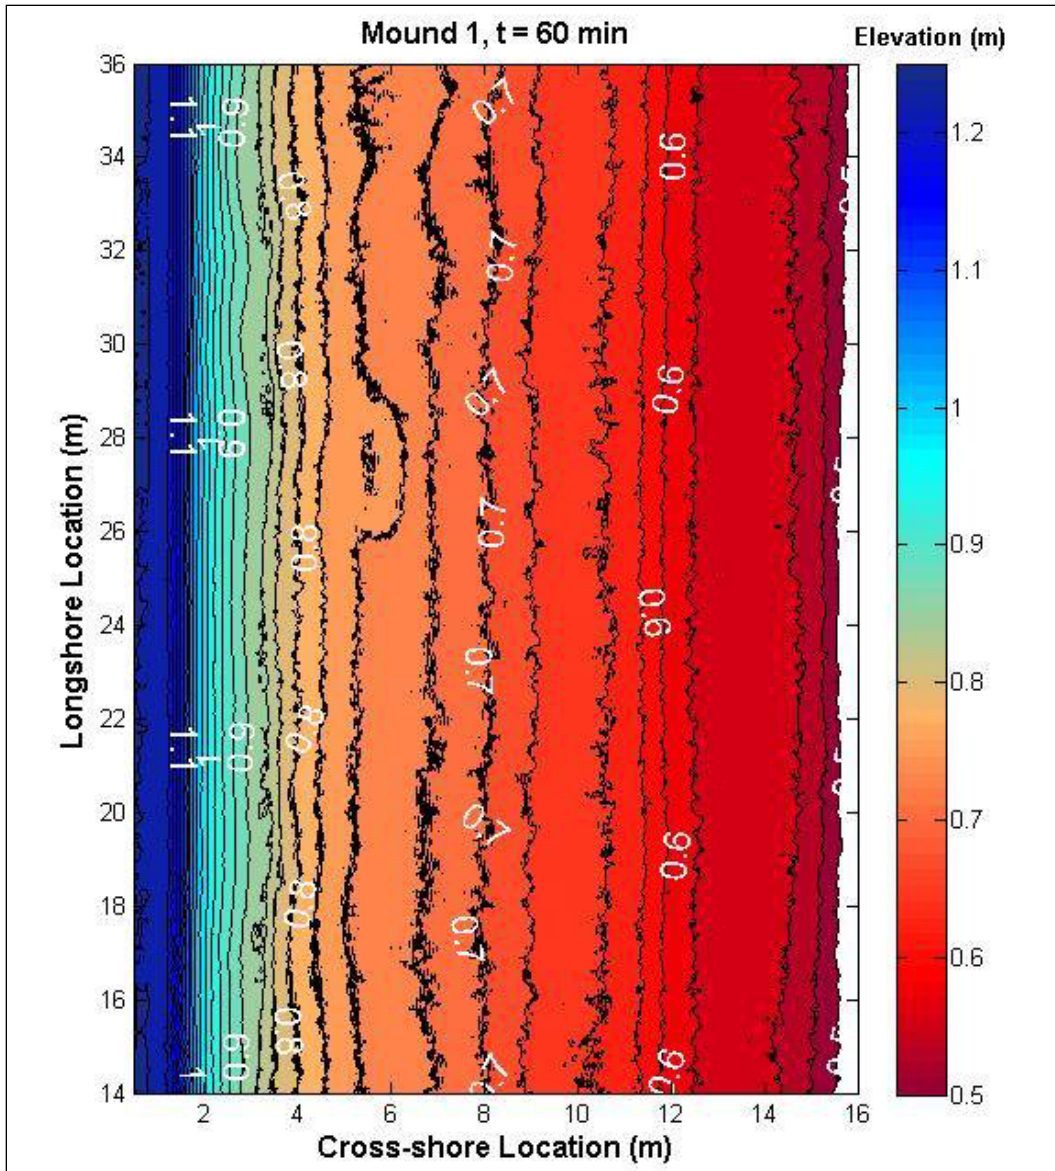
Waves were generated for a total of 120 min. Unfortunately, the hard drive containing the survey data acquired after the final test segment failed. Bathymetry following 60 min of wave action is shown in Figure 20. The figure shows the diminished mound outlines and shows that the mound sand has spread. Contours remain uniform. Photographs of the Mound 1 beach after 60 min are shown in Figures 21 through 23. The photographs show the brown mound sand had dispersed and transported predominantly downdrift. Also, a scarp began to form at the limit of wave uprush (Figure 21). Photographs taken after 120 min (Figures 24 to 26) show the brown sand to be lighter in color and in less area, indicating the mound sand continued to be transported downdrift and mixed with the native sand.

Figure 20. Mound 1 after 60 min of waves.

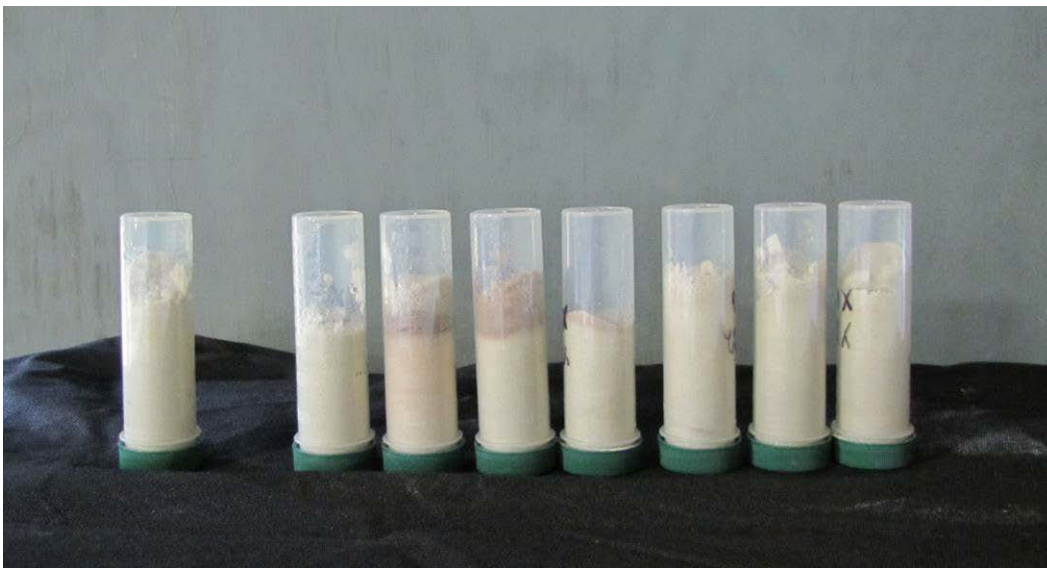
Figure 27 shows sand samples taken with 10.8 cm long tubes at the cross-shore centerline of the mound at alongshore locations of (left to right) $Y = 34, 30, 28, 26, 24, 22, 20,$ and 18 m. As expected, the samples show more mound sand present near the original mound location with lesser amounts evident farther from the original placement. However, the photos show that the mound sand is mixed with the native LSTF sand at $Y = 24$ m to a depth of 0.6 cm. Little mound sand is visible at $Y = 30$ m, directly updrift of the mound, and no mound sand is apparent at $Y = 34$.

Figure 27. Photograph of Mound 1 sand samples collected after 120 min of waves at alongshore locations (from left to right): Y34, Y30, Y28, Y26, Y24, Y22, Y20, and Y18.

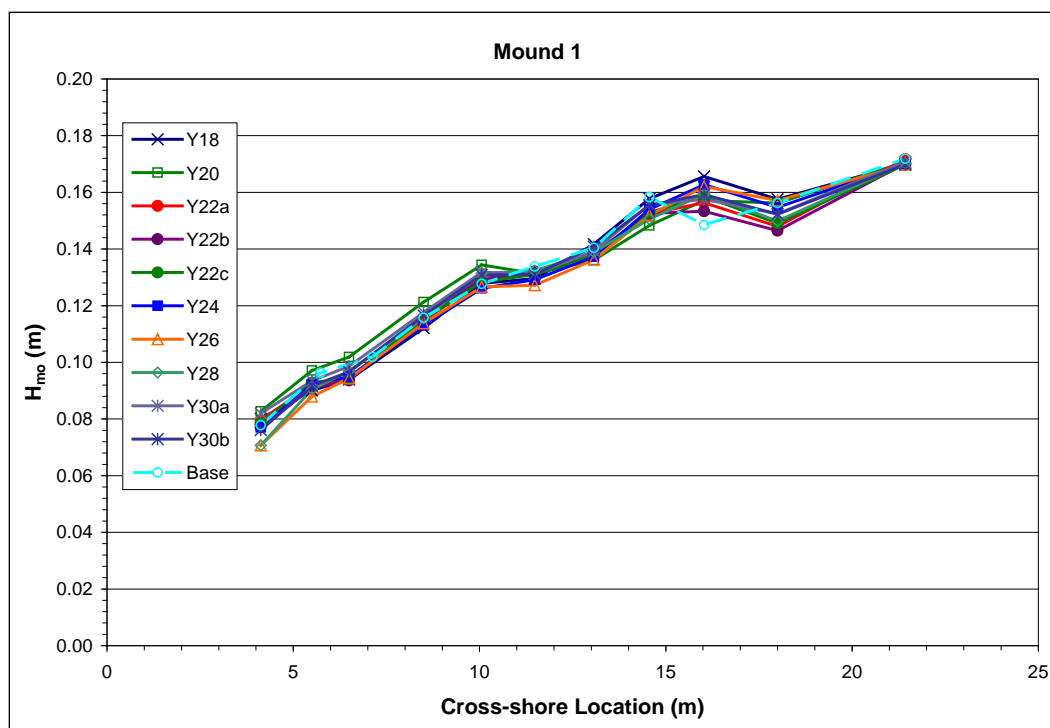
Figure 29. Cross-shore distribution of wave height for Mound 1.

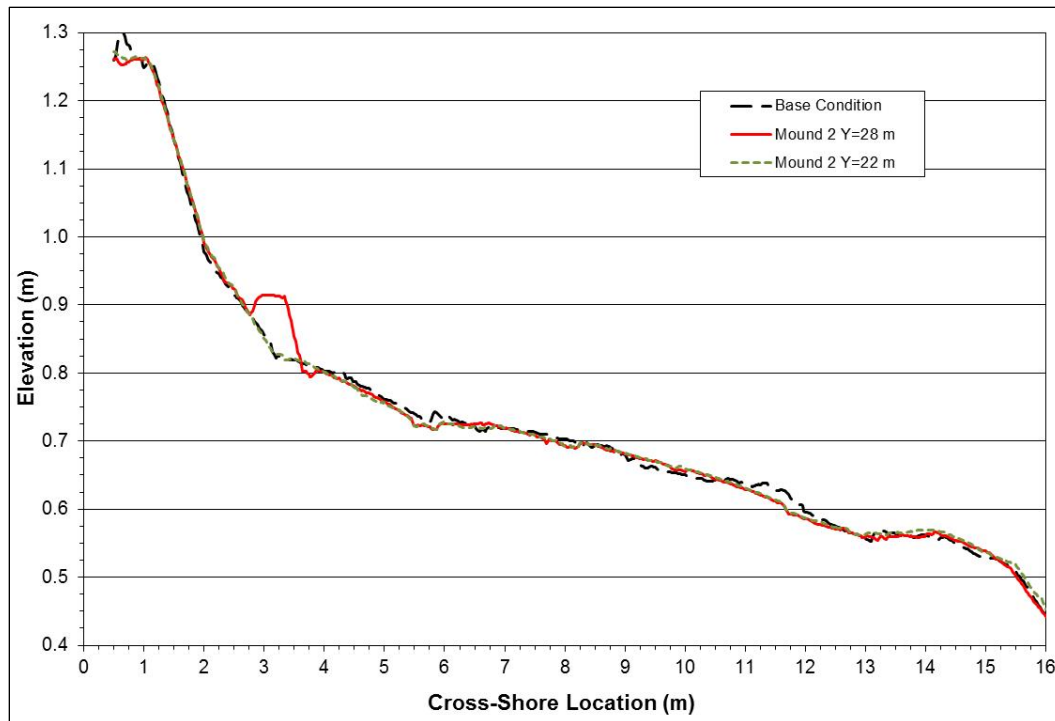
Mound 2 was constructed between $Y = 26$ and $Y = 30$ m at a model scale depth of 0.06 m below swl to represent a prototype depth of 1.2 m. The mound was built 1 m longer than Mound 1 with 0.17 m^3 (5.9 ft^3) of sand (dyed red), which represented $1,330 \text{ m}^3$ ($47,000 \text{ ft}^3$) at a 1:20 scale. The cross-sectional profile of Mound 2 at the mound centerline (Y28) is shown in Figure 30 with the profile of the Base Condition and the Mound 2 profile at $Y = 22$ m. The Mound 2 and Base Condition profiles are similar, but the mound profile deviates from the base profile offshore, particularly between $X = 11$ and approximately 12 m. Mound 2 initial bathymetry is plotted in Figure 31 and photos of the initial beach are shown in Figures 32 to 34.

Figure 30. Mound 2 initial beach profile compared to the Base Condition profile.

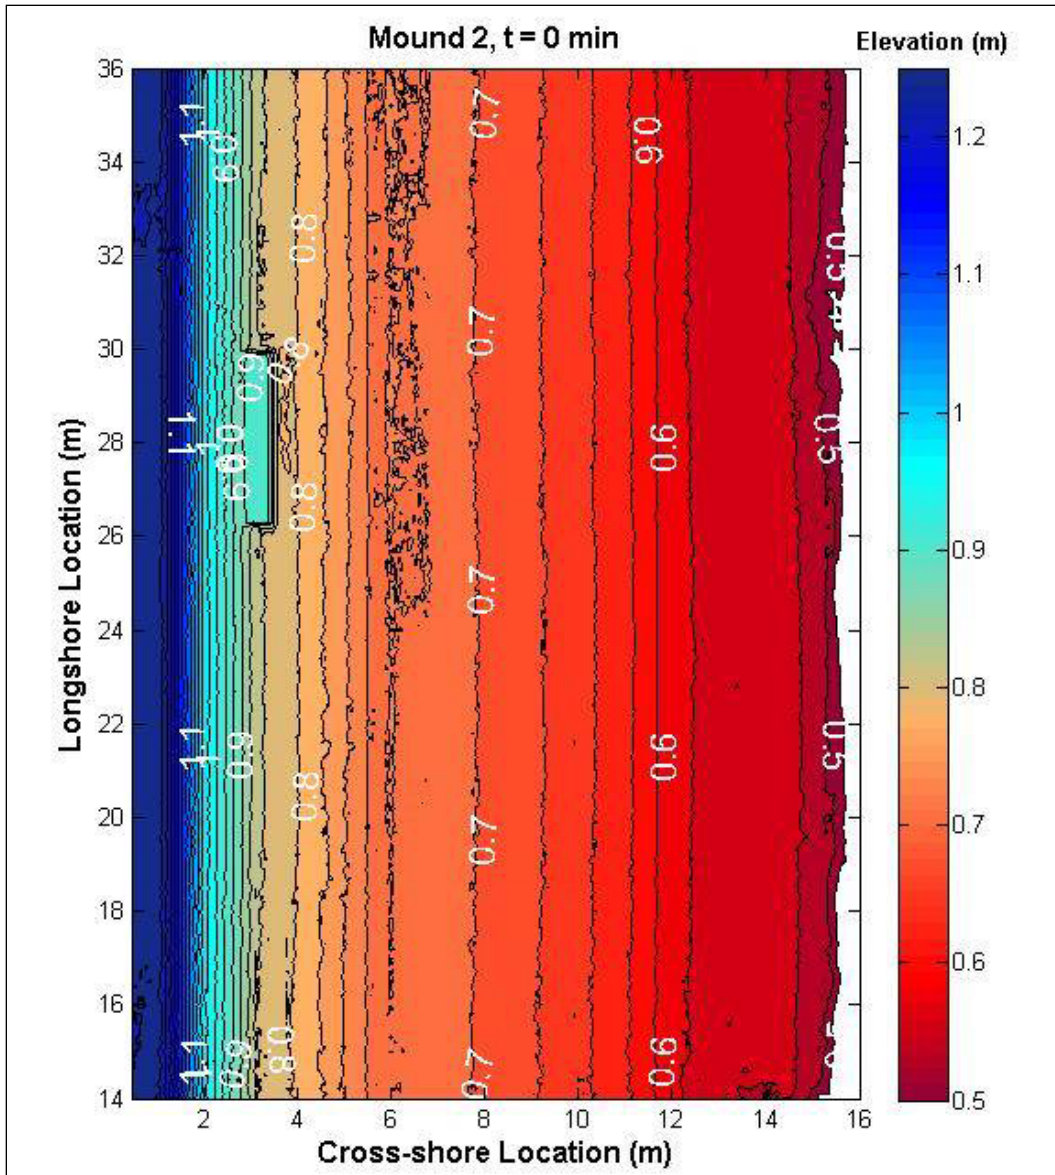
Figure 31. Mound 2 initial bathymetry.

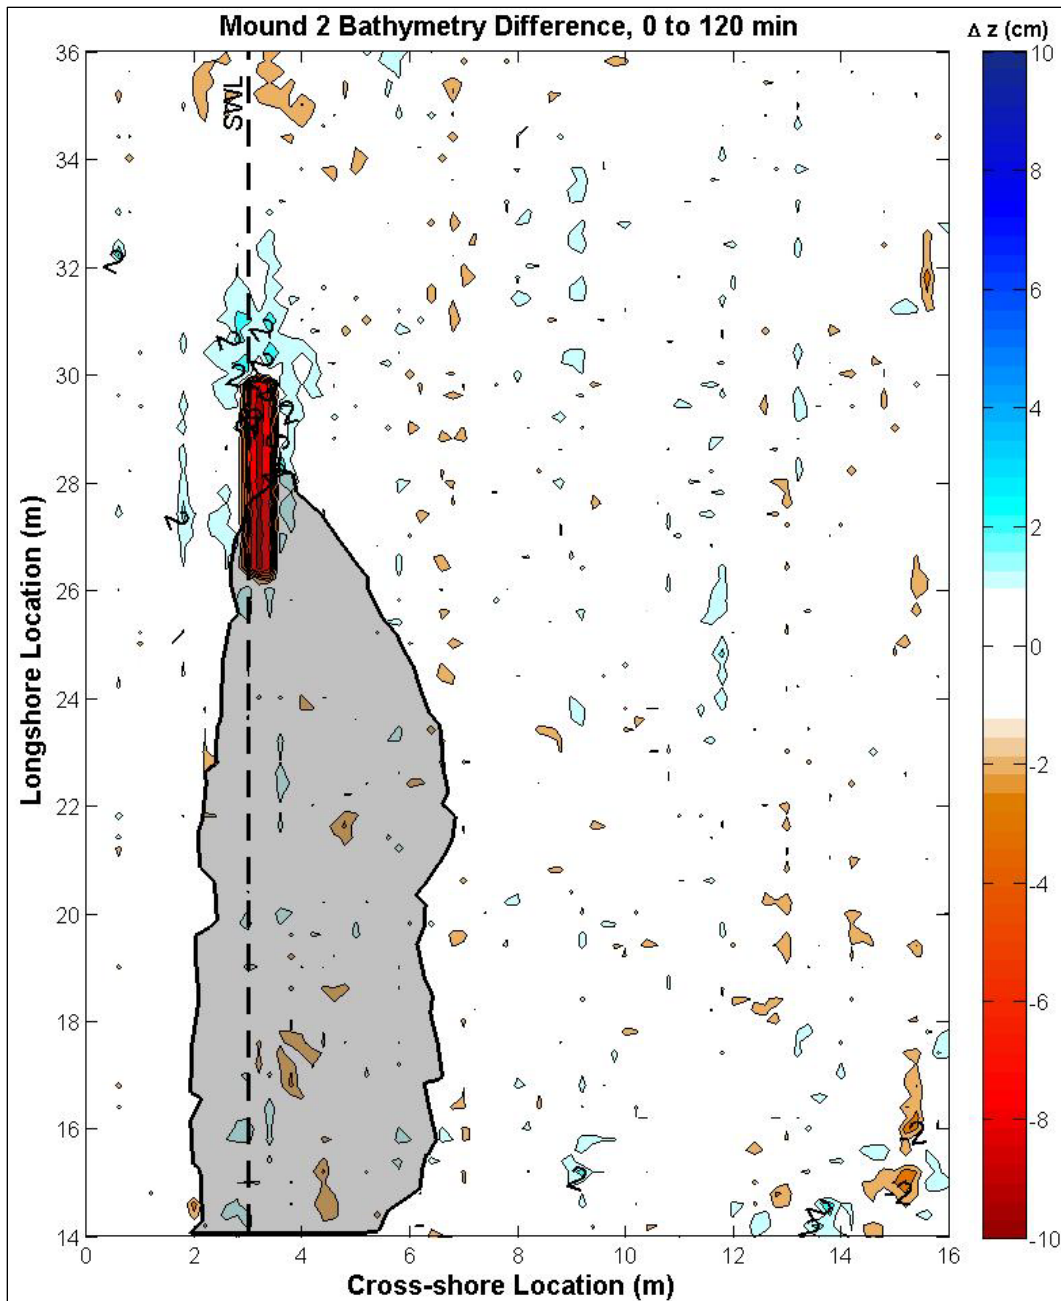
Figure 40. Mound 2 relative bathymetry difference after 120 min of waves.

No significant areas of erosion are present onshore and downdrift of the mound, which may be a result of mound sand feeding the longshore transport. Sand from Mound 2 was transported alongshore farther than sand from Mound 1, which is related to the shallower depth and higher longshore currents at the Mound 2 placement location. The beach behavior also is similar to a detached breakwater in that longshore transport is disrupted, accumulating sand updrift and in the vicinity of the mound placement site.

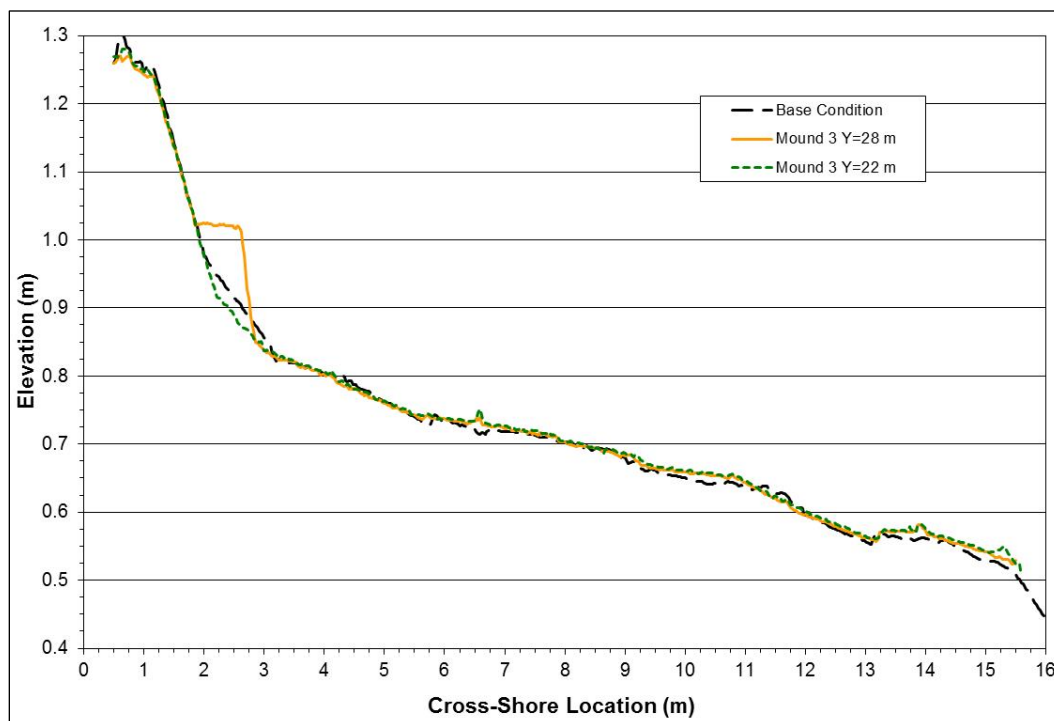
Mound 3 was constructed on the foreshore slope between $Y = 26$ m and $Y = 30$ m at a model scale elevation of 0.12 m above swl to represent an elevation of 2.4 m at a 1:20 scale. The mound was constructed with 0.21 m^3 (7.4 ft^3) of orange-dyed sand to represent $1,680 \text{ m}^3$ ($59,300 \text{ ft}^3$). Figure 42 shows the cross-sectional profile of the Mound 3 beach at the mound centerline ($Y = 28$) and at $Y = 22$ m for Mound 3 and the Base Condition. The Mound 3 profile at $Y = 22$ m agrees with the Base Condition over most of the profile; however, the profile is lower than the Base Condition between $X = 2$ and 3 m. Bathymetry is given in Figure 43, which shows some

Figure 42. Mound 3 initial beach profile compared to the Base Condition profile.

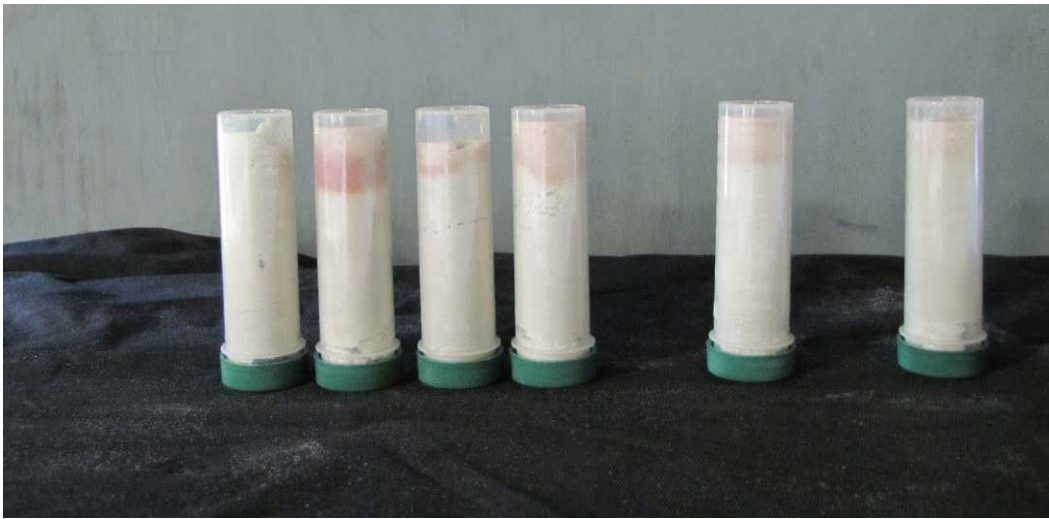
Figure 50. Photograph of Mound 3 sand samples collected after 120 min of waves at alongshore locations (from left to right): Y30, Y28, Y26, Y24, Y20, and Y18.

beach. Although the shaded area indicates the mound sand didn't cause accretion, Figure 50 indicates mound sand mixed with the native sand and contributed to the accretion observed directly downdrift of the initial mound location.
