TECHNICAL REPORT REMR-CO-4

STABILITY OF DOLOS AND TRIBAR OVERLAYS FOR REHABILITATION OF STONE-ARMORED RUBBLE-MOUND BREAKWATER AND JETTY TRUNKS SUBJECTED TO BREAKING WAVES

February 1988
Final Report

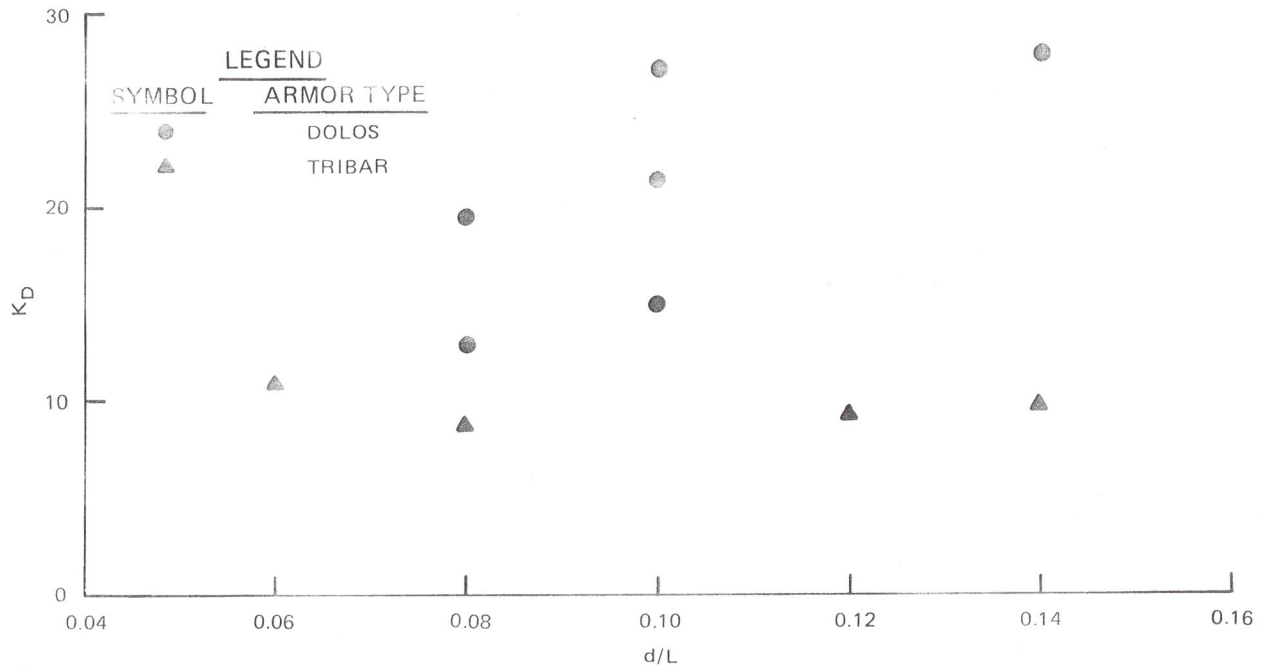
Figure 2. Stability coefficient K_D versus relative depth d/L
 $\cot \alpha = 2.0$

20. Figures 2 and 3 present K_D as a function of d/L and H/d , respectively. These data show dolos stability to be sensitive to both d/L and H/d with minimum stability occurring at the lower values of d/L and higher values of H/d , i.e., longer wave periods in shallower water. These trends are consistent with those observed by Carver (1983) for dolos used in new construction. Influences of H/d and d/L on tribar stability do not appear to be significant in the present data. The minimum K_D observed for tribars is equal to that obtained for new construction and to that observed for dolos is about 15 percent less (12.8 versus 15).

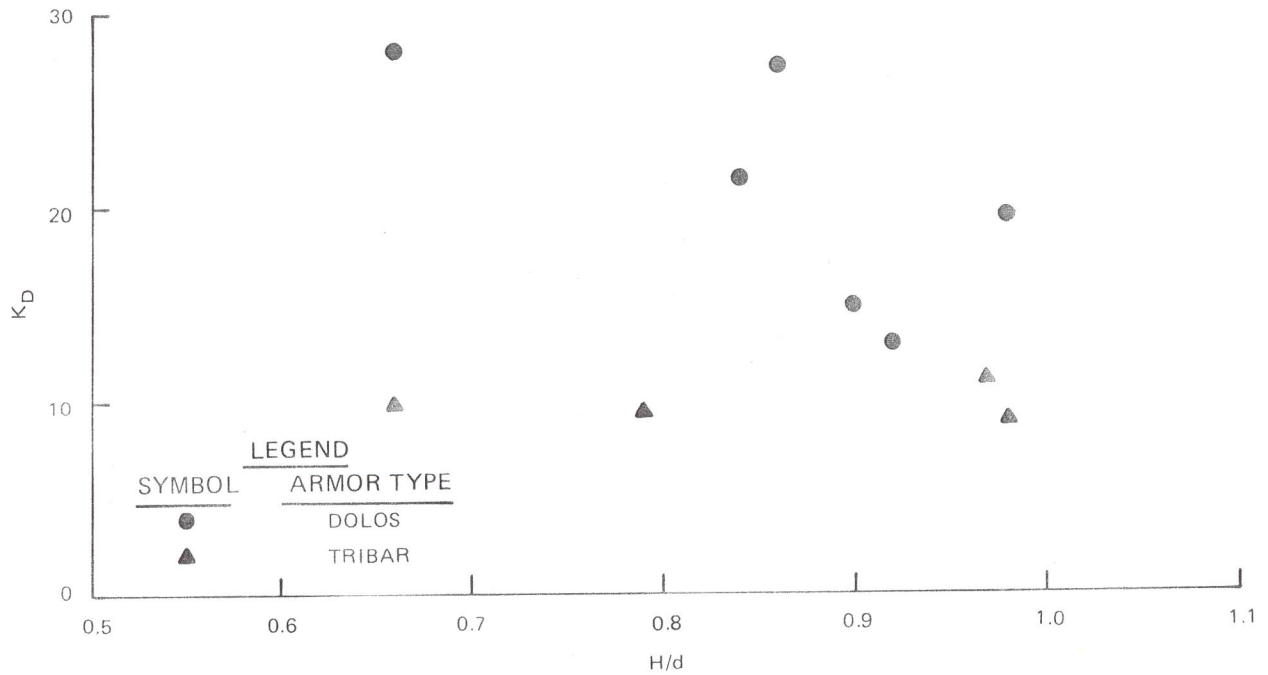
Figure 3. Stability coefficient K_D versus relative wave height H/d
 $\cot \alpha = 2.0$

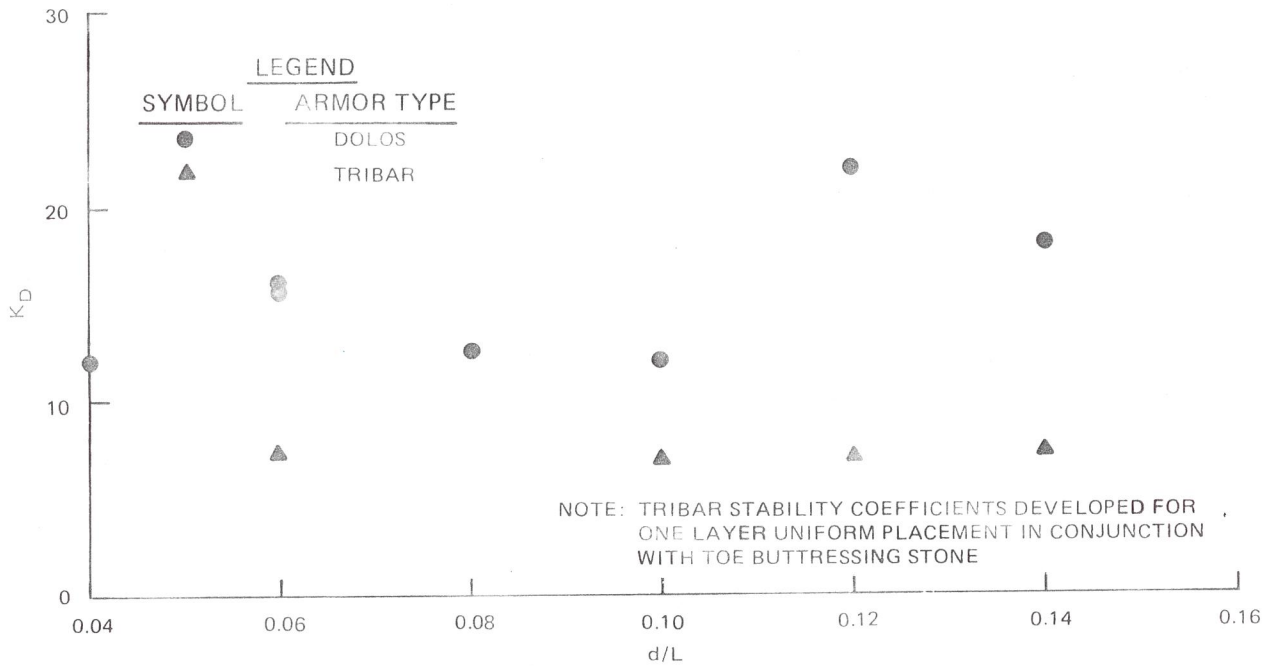
Figure 4. Stability coefficient K_D versus relative depth d/L
 $\cot \alpha = 1.5$

24. Results of stability tests for the uniformly placed tribars are summarized in Table 2 along with the previously discussed dolos test results. These data indicate a minimum stability coefficient of 7.0 for the uniformly placed tribars. Figures 4 and 5 present K_D as a function of d/L and H/d , respectively. Similar to results for the 1V-on-2H slope, dolos stability proved to be sensitive to d/L and H/d with minimum stability occurring at the lower values of d/L and higher values of H/d and tribar stability was not significantly influenced by either d/L or H/d .

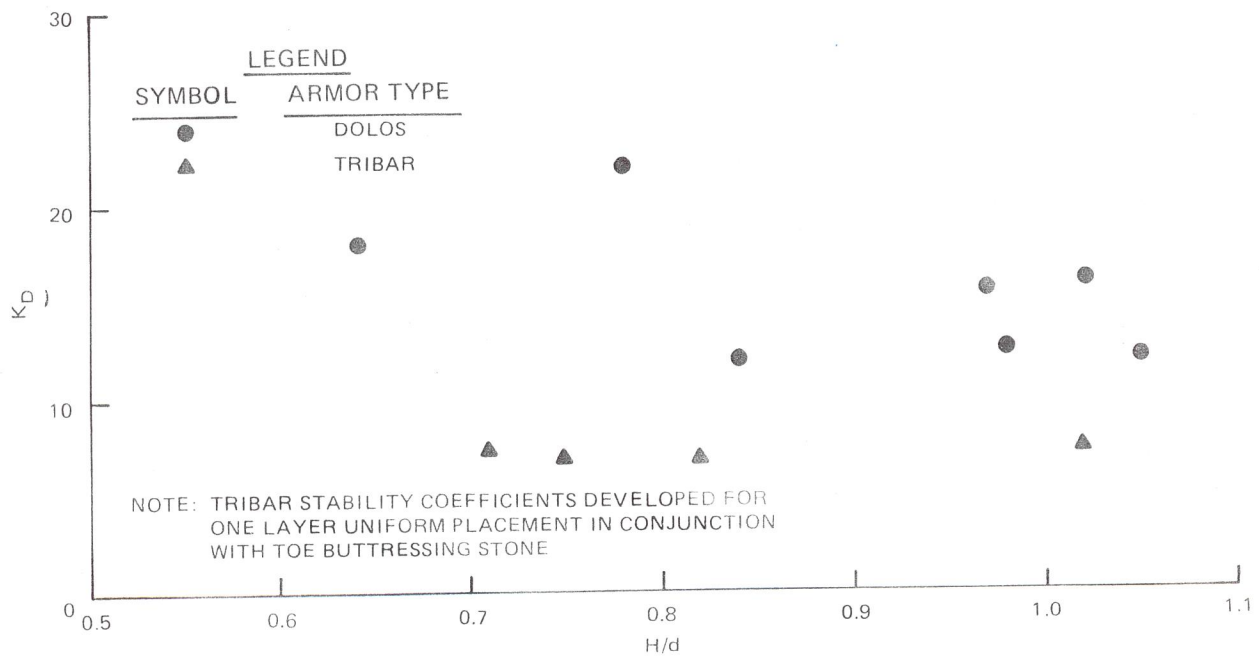
Figure 5. Stability coefficient K_D versus relative wave height H/d
 $\cot \alpha = 1.5$
