# REPAIR, EVALUATION, MAINTENANCE, AND REHABILITATION RESEARCH PROGRAM

TECHNICAL REPORT REMR-CO-6

## STABILITY OF DOLOS OVERLAYS FOR REHABILITATION OF TRIBAR-ARMORED RUBBLE-MOUND BREAKWATER AND JETTY TRUNKS SUBJECTED TO BREAKING WAVES

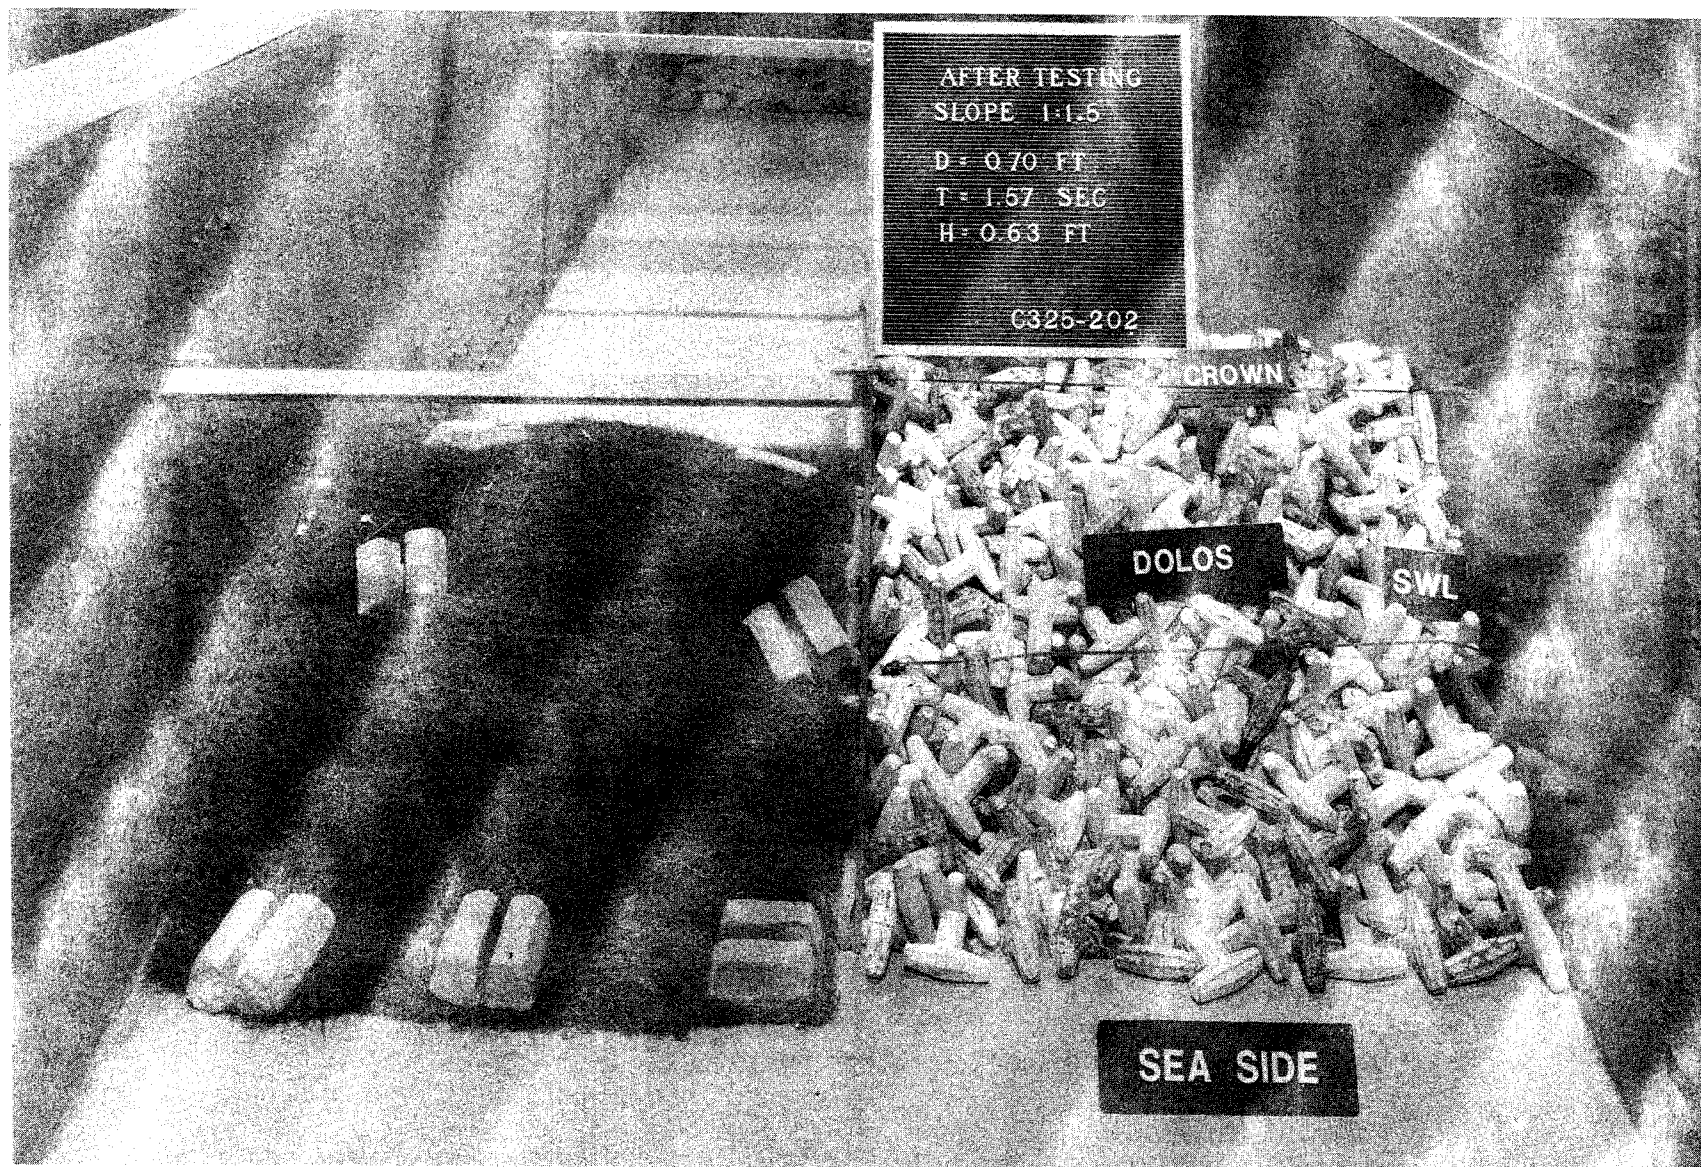
Photo 6. Sea-side view after attack of 1.57-sec, 0.63-ft waves;  $d = 0.70$  ft;  
 $W_a = 0.589$  lb; 1V-on-1.5H structure slope

Armor units were placed randomly in two layers, and the number of armor units per given surface area was equal to that presently recommended for new construction in EM 1110-2-2904 (Headquarters, Department of the Army 1986). Photos 5-11 show typical after-testing conditions of the structures.
