**RQ-21A Blackjack  
Small Tactical Unmanned Aircraft System  
(STUAS)**

**Initial Operational Test and Evaluation Report**

**June 2015**

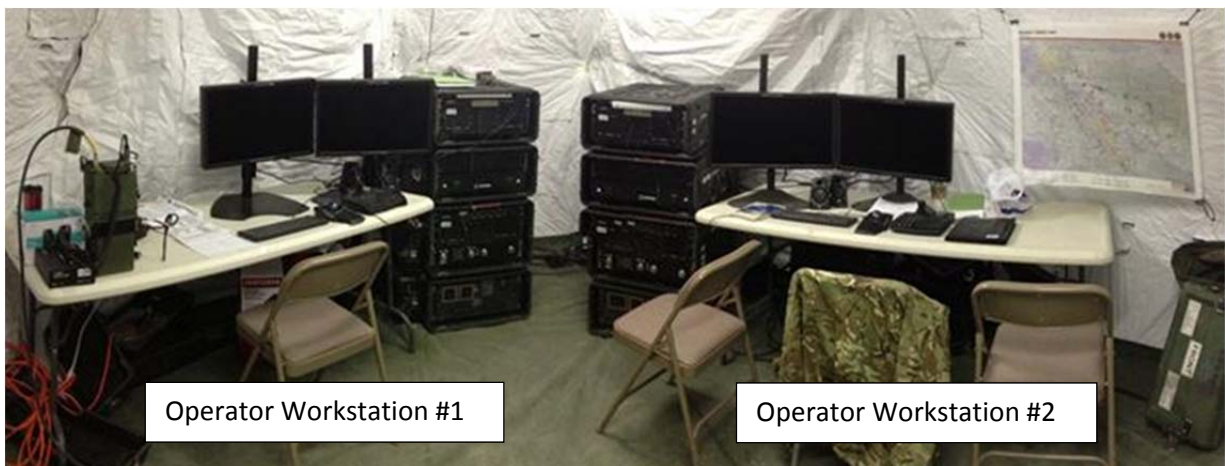
**Figure 1-3. Tabletop Ground Control Station Configuration**

The ground control station (GCS) is used to plan missions, control and monitor the air vehicle, and manage data received from the air vehicle. Figure 1-3 shows the tabletop ground control station configuration used during operations at Marine Corps Air-Ground Combat Center Twentynine Palms. The GCS includes two operator workstations, two ground data terminals for air vehicle command and control and video downlink, and a Global Positioning System (GPS) Electronics Module. Air vehicle operators control the air vehicle and multi-function ball turret through the GCS.

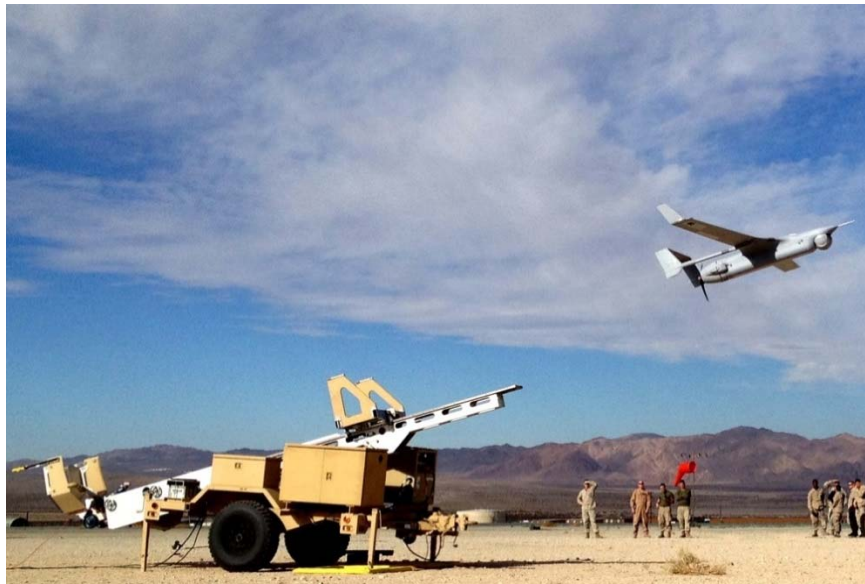
**Figure 1-5. The RQ-21A Launcher**

The RQ-21A launcher is a pneumatically-controlled device that accelerates the air vehicle to flight speed at takeoff and enables expeditionary employment of the RQ-21A in austere conditions without runways (see Figure 1-5). The launcher system is self-powered and designed for transport by air (via CH-53 helicopter, C-130 aircraft, and C-17 aircraft) or by land (towed by HMMWV).

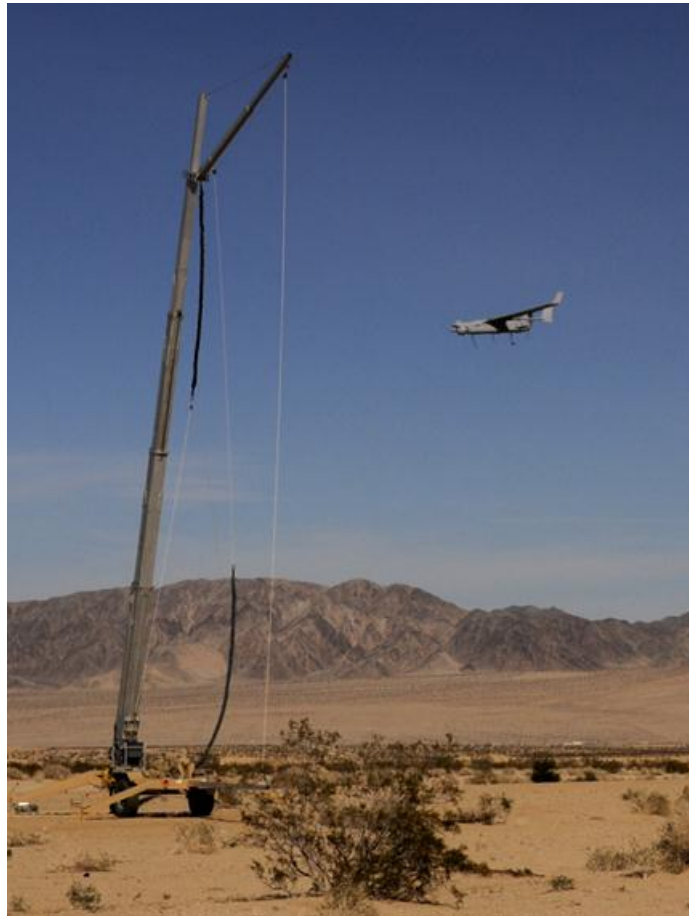
**Figure 1-6. RQ-21A Recovery System**

The RQ-21A recovery system employs a telescoping hydraulic mast and boom system that suspends a rope to capture the air vehicle in mid-flight (see Figure 1-6). After the rope captures the air vehicle, the air vehicle spins about the rope down to the ground. The recovery system mounts on a modified tactical Military Standard (MIL-STD) trailer chassis with an engine-driven hydraulic power unit. External electrical power and fiber optic signal cables are required to support the GPS electronics module onboard the RQ-21A recovery system.

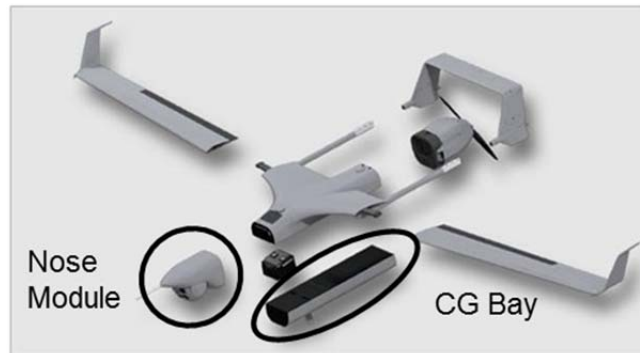
**Figure 3-4. Air Vehicle Payload Modules**

The modular air vehicle design allows for payload changes within the 60-minute Modular/Interchangeable Payload KPP threshold. Build-up of an entire air vehicle takes 20 minutes. As shown in Figure 3-4, the air vehicle carries payloads in one of two modules: the nose module or the Center of Gravity (CG) Bay.

The electro-optical/infrared sensor mounts to the nose module. The CG Bay carries the communications relay payload and the automatic identification system. The CG Bay will carry additional payloads in the future provided they have the appropriate interface connections.

Maintainers are able to remove and replace the nose module or the CG Bay well within the required 60-minute threshold. The nose module connects to the air vehicle fuselage with eight bolts and has a pneumatic tubing connection for the pitot systems and a serial port type connection to the avionics module. The CG bay connects to the air vehicle fuselage with eight bolts and a single power connection to the avionics module.

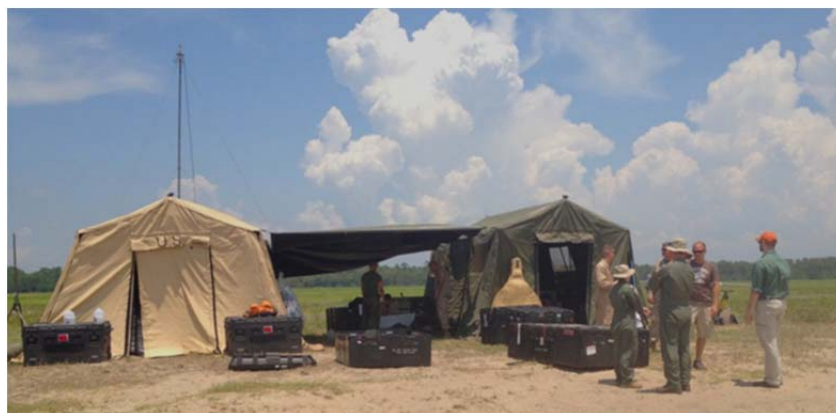
**Figure 4-9. RQ-21A Expeditionary Configuration**

RQ-21A support equipment does not facilitate expeditionary operations. As fielded, each RQ-21A system includes two tents used as shelter for the ground control stations. The system does not provide for inclement weather protection for air vehicles, support equipment, and spare parts. As shown in Figure 4-9, air vehicle module packing cases and spare parts would be stored under a tarpaulin strung between two tents or in the back of High Mobility Multipurpose Wheeled Vehicles (HMMWVs).
