PLANS FOR ELIMINATION OF SHOALING
IN NEW CASTLE-FINNS POINT RANGES
DELAWARE RIVER
MODEL INVESTIGATION

TECHNICAL MEMORANDUM NO. 2-259

WATERWAYS EXPERIMENT STATION

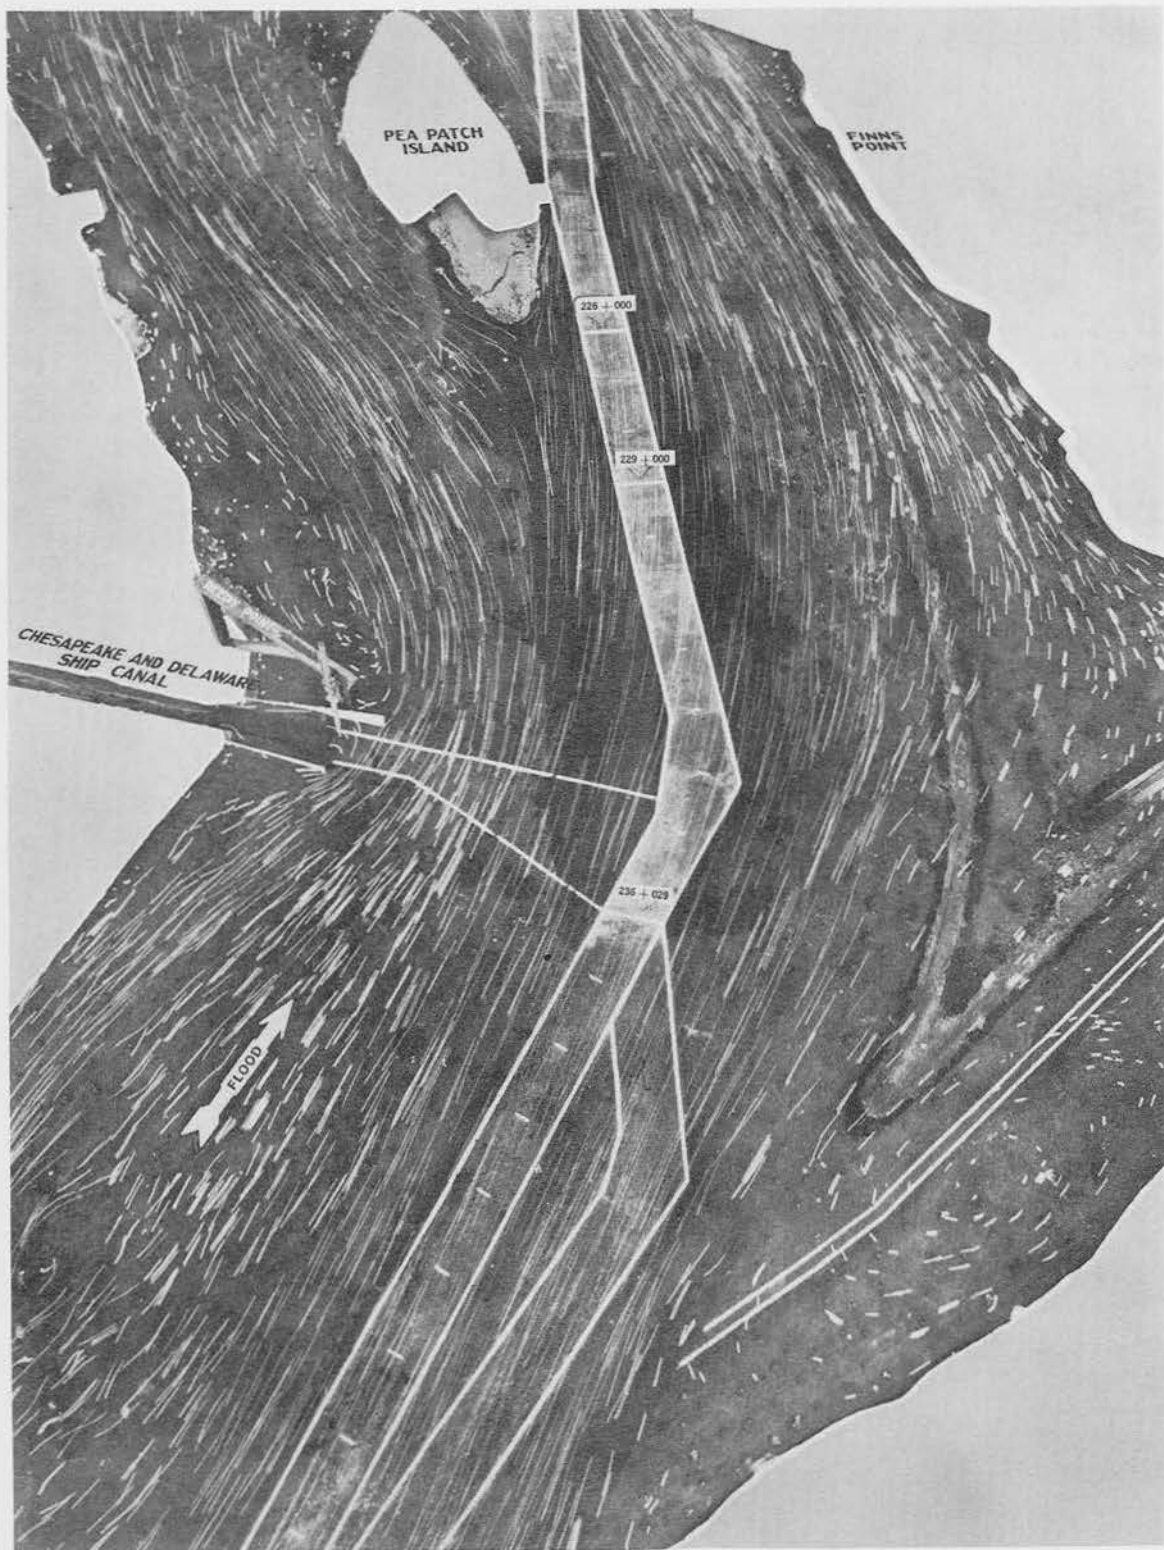
Plan 3, Strength of Ebb

the rate of shoaling within the problem area. It may be noted that the rate of shoaling in section 3 was materially reduced, while that in section 1 was increased by approximately the same amount. There were slight increases in flood velocities at stations 223+500 and 239+000 with no appreciable change in ebb velocities. (See plate 12 for tide and velocity measurements.) The directions of flood and ebb currents were not appreciably affected by the change in channel alignment (photographs 9 and 10).

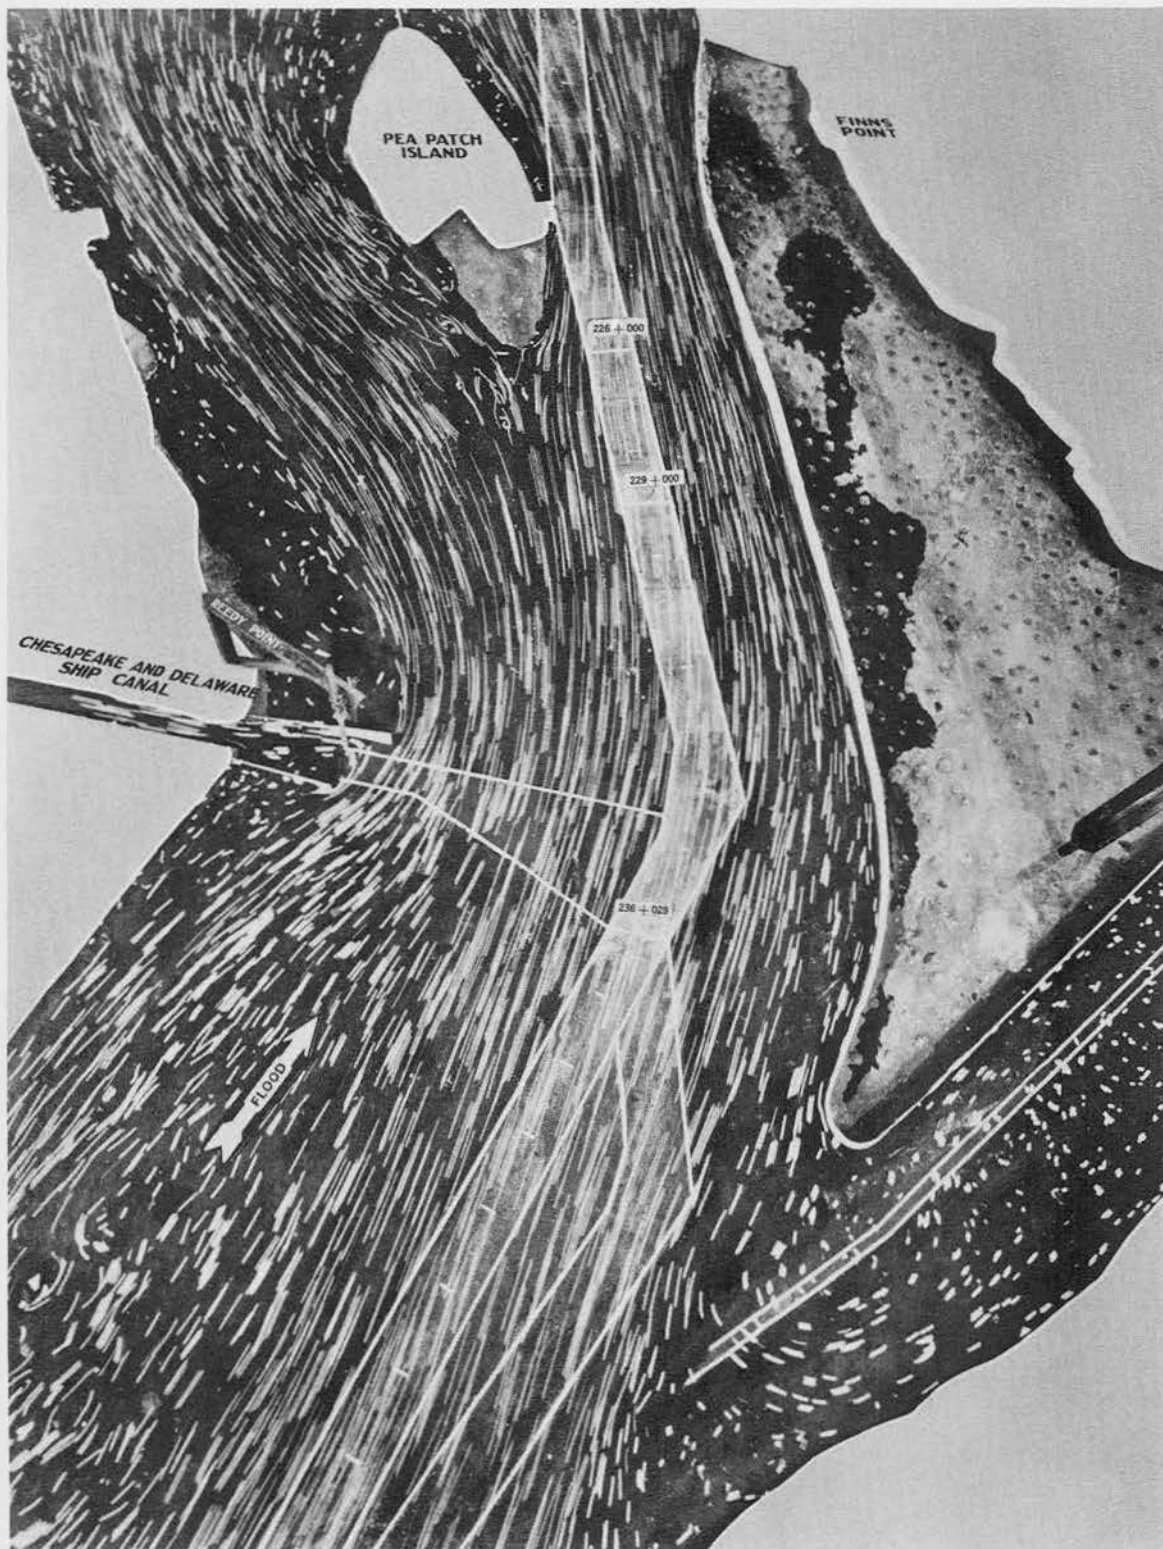
Plan 6, Strength of Ebb

43. The shoaling index obtained from the test of this plan was 0.87 (table 1), indicating that this plan would reduce to some extent the present rate of shoaling within the problem area. The greater portion of this reduction occurred in sections 1 and 2, the rate of shoaling in section 3 being about the same as observed during the base test. There was a general increase in flood velocities at station 223+500 with little change in ebb velocity. There was no appreciable change in velocities at station 239+000. (See plate 15 for tide and velocity measurements.) Both flood and ebb currents followed the alignment of the channel through sections 1 and 2, current directions in section 3 being

about the same as observed during the base test (photographs 15 and 16).

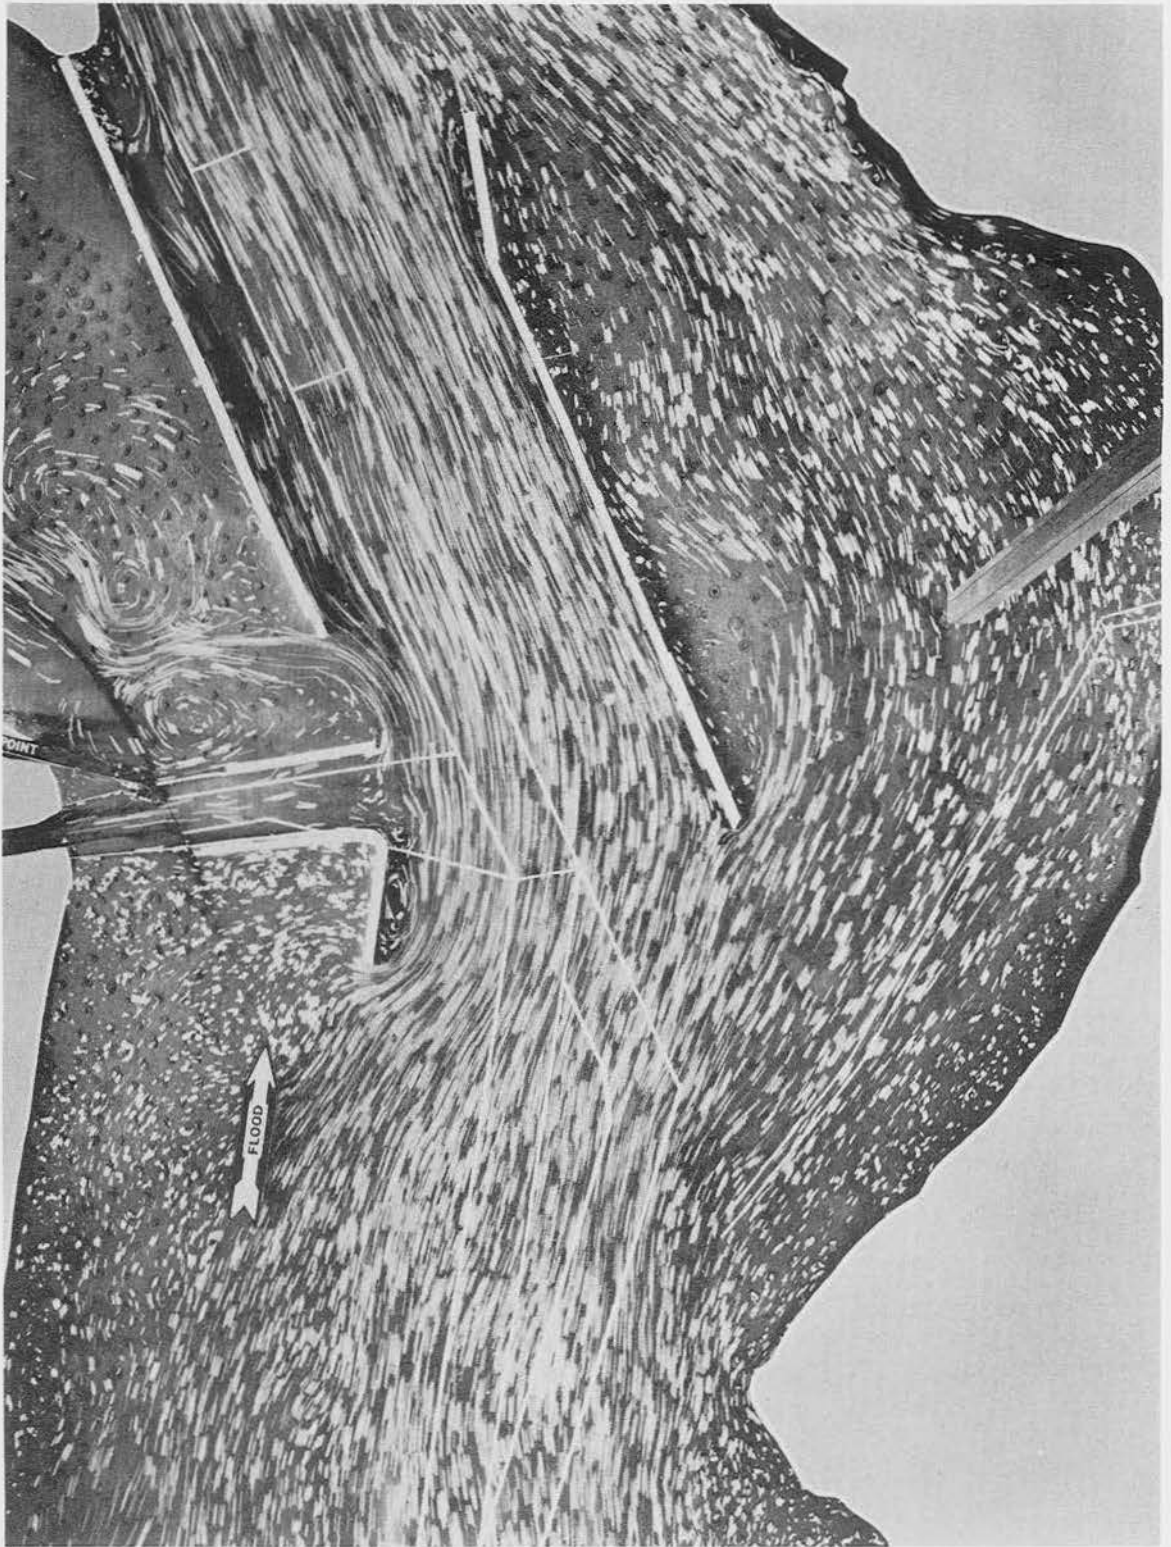
Plan 12, Strength of Ebb

53. This plan consisted of: a dike extending from station 237+350, 1600 ft east of and parallel to the ship channel, to station 229+300, at which point it turned 13.5 degrees east and extended 2300 ft upstream; a dike similar to the structure of plan 2A; and extensions to both the north and south jetties of the Chesapeake and Delaware Canal (plate 6). The object of this plan was to cause the currents, normally flowing back and forth in the secondary channel west of Pea Patch Island, to flow through the main channel.

54. Only photographic tests showing current directions with this plan installed were made (photographs 31 and 32). The model study of the entrance to the Chesapeake and Delaware Canal indicated that further extensions to the jetties, other than the ones already authorized, would have harmful effects on the shoaling conditions in the entrance. Since this plan involved extensions to both the north and south jetties at the entrance to the canal, and since the greater portion of the dike called for in plan 12 would be located in relatively deep water, making the cost of the dike system prohibitive, it was decided that any further testing of this plan should be omitted.

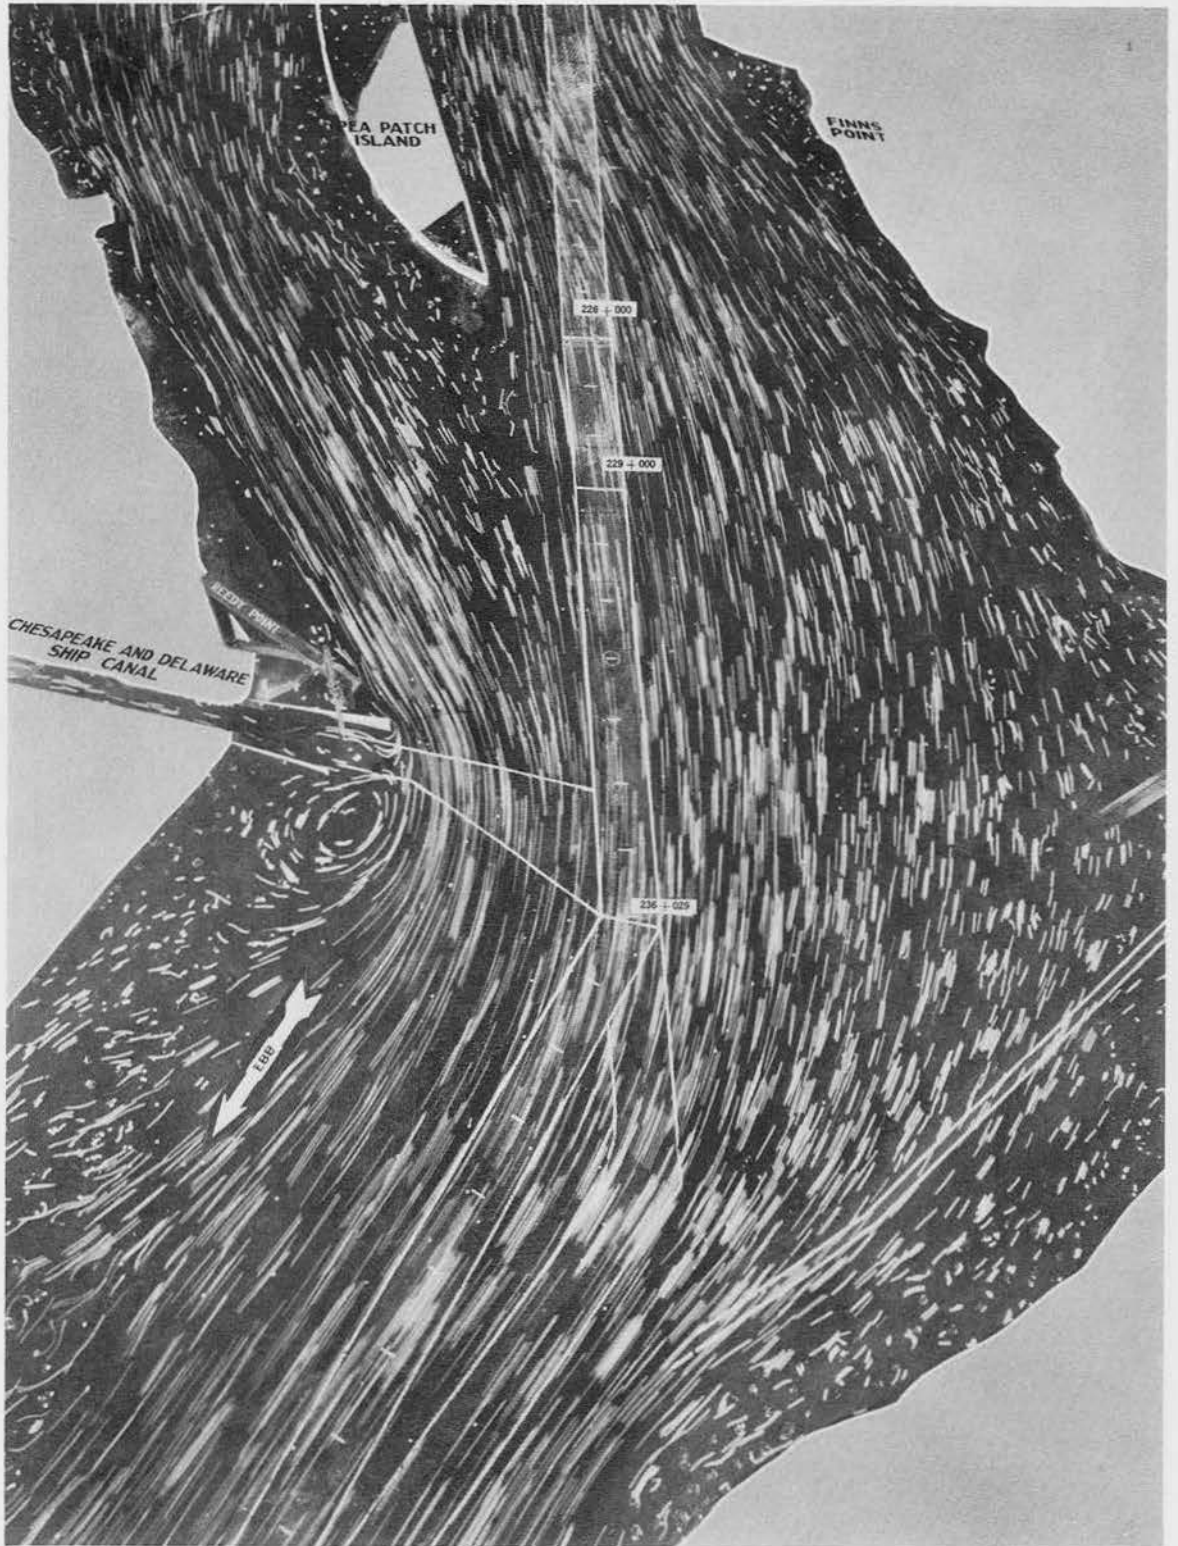
Plan 17, Strength of Ebb

0.85 (table 1), indicating that this plan would reduce to some extent the present rate of shoaling in the problem area. Due to the enlarged cross section of the channel, there was some decrease in the flood and ebb velocities at station 223+500, although not so great as was observed for plan 17. There was no appreciable change in flood or ebb velocities at station 239+000. (See plate 19 for tide and velocity measurements.) The direction of ebb flow was in alignment with the dredged channel, and that of flood flow was more nearly in alignment with the channel than for plan 17 (photographs 43 and 44).
