DRAINAGE SYSTEMS AND ENGINEERING
MEASUREMENT DEVICES
ST. JOHNS BAYOU FLOODGATE, MISSOURI

TECHNICAL MEMORANDUM NO. 3-425

WATERWAYS EXPERIMENT STATION
VICKSBURG, MISSISSIPPI

JANUARY 1956

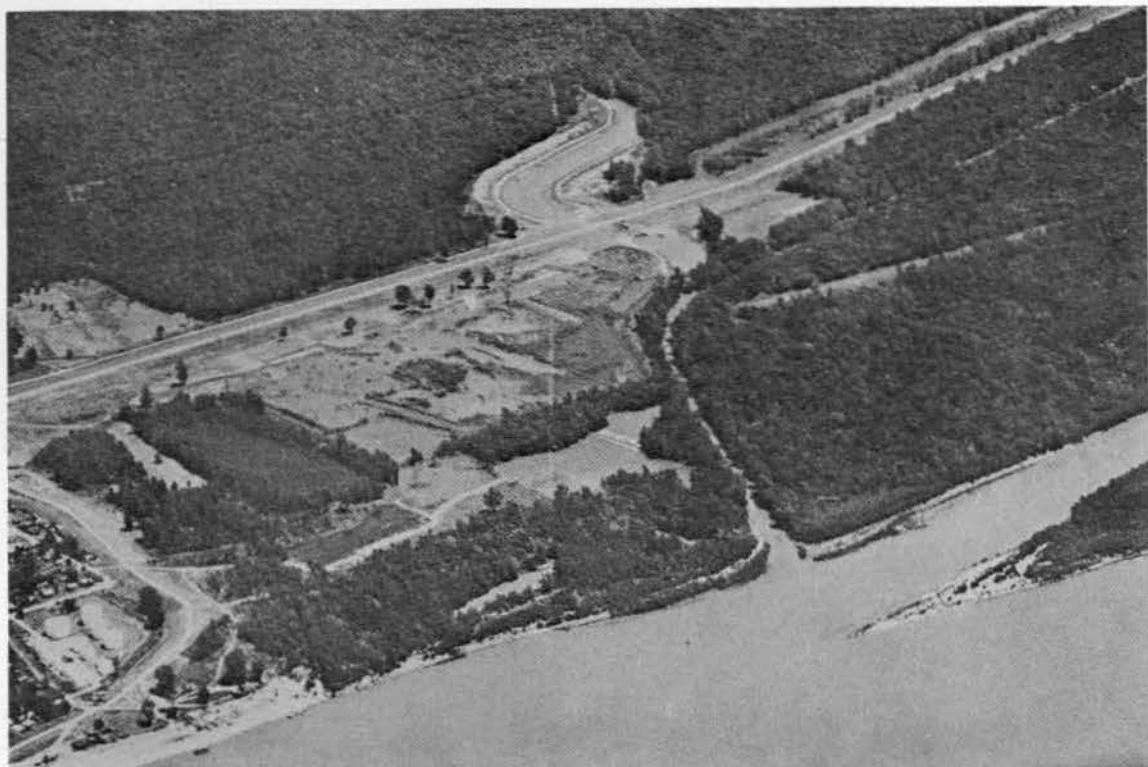
Fig. 2. Aerial view of structure (June 1955)

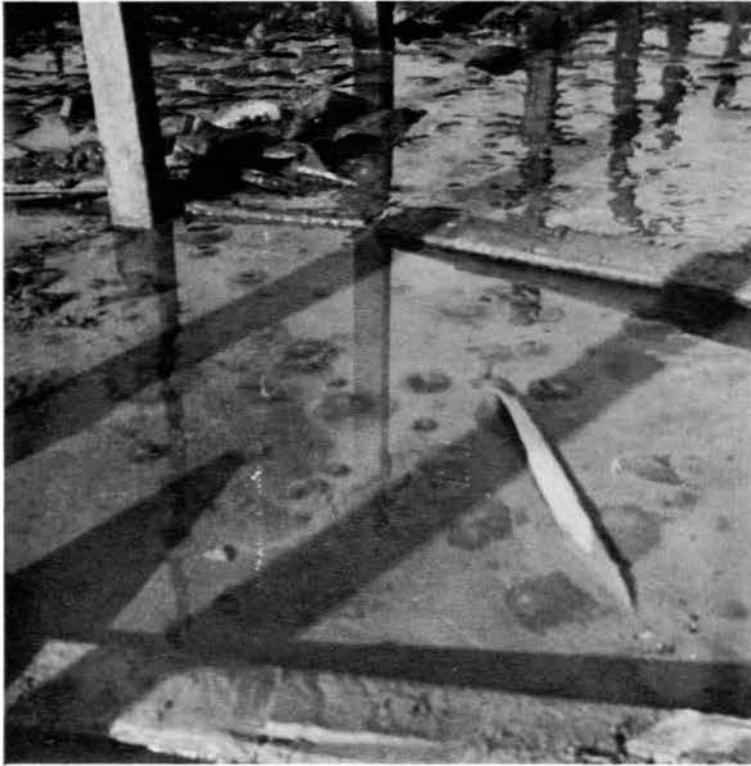
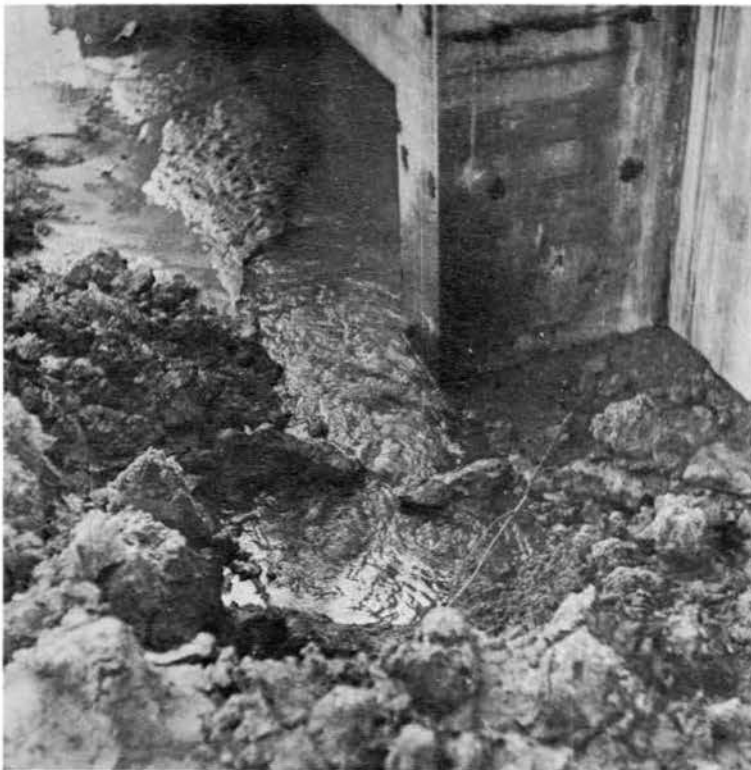
Fig. 7. Sand boils that occurred during construction of St. Johns Bayou floodgate

21. Piezometer 5 indicated an excess head of about 9 ft above the invert of the conduits. Although this head was not sufficient to raise the conduits, it caused seepage and sand boils along the edge of the structure, particularly at monolith 7 (see fig. 7).

Numerous sand boils upstream of conduits (9 June 1951)

Large boil along east side of conduits at monolith 7 (12 Dec 1951)

26. Elevations of the settlement hubs were obtained shortly after the hubs were installed and also in November 1952. The locations of the hubs and corresponding settlements are given in table 1. It is estimated that the fill was 75 per cent complete in November 1952. The amount of settlement is shown to be negligible except at monolith 7 (see fig. 1 for location) where approximately 1 in. of settlement was observed at hubs 3 and 3A. It is of interest to note that, as previously mentioned, a large sand boil was found in December 1951 on the east side of monolith 7 (see fig. 7(b)); this boil was estimated to be discharging approximately 150 gpm. The comparatively large settlement at monolith 7 might well have been caused by a void under the slab as a result of this sand boil.

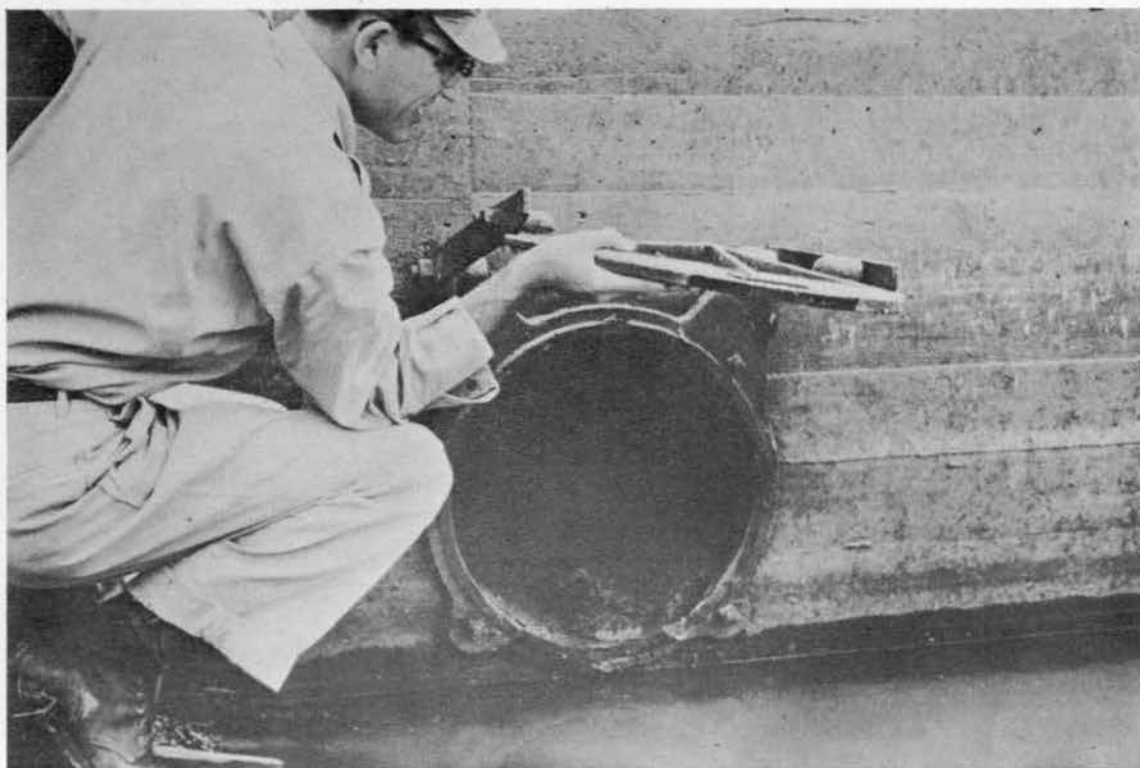
28. During a recent visit to the structure by a representative of the Waterways Experiment Station, a considerable quantity of mud was noted at the ends of the 18-in. discharge pipes from the Y and Z wells (see fig. 8). Inspection of the manhole covers revealed that they were not watertight, and silt- and clay-laden surface water could enter the collector pipes and wells. It could not be determined if the mud observed in the collector pipes had entered through the manholes or was the result of backflow through the flap gates.

29. It was also noted that when the 18-in. Calco gates were opened manually and released so as to swing free, they did not close completely.

Fig. 8. Mud behind 18-in. flap gate (July 1955)

33. The present manhole covers should be replaced by metal lids which can be tightened down on rubber gaskets by bolts embedded in the concrete manhole to prevent surface and flood waters from entering the manholes.

34. The 18-in. Calco flap gates should be replaced with bronze-faced and bronze-hinged flap gates, the faces of which should be inclined outward from the vertical to insure proper closing when the wells are not flowing. Rubber gaskets should be installed on the stationary face of the gates to insure a watertight seal when the gates close. Vertical check valves, such as recently developed by the WES and installed on Bayou Cocodrie Drainage Structure, would be more desirable but the cost
