SOIL COMPACTION INVESTIGATION

REPORT NO. 3

COMPACTION STUDIES ON SAND SUBGRADE

**TECHNICAL MEMORANDUM NO. 3-271**

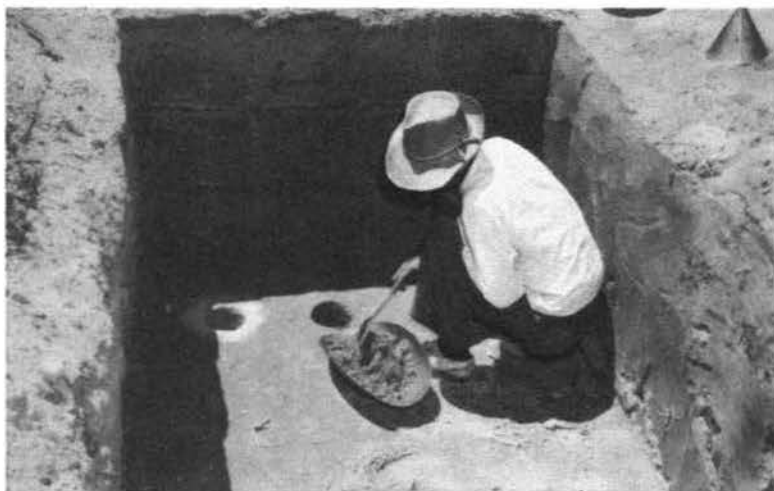
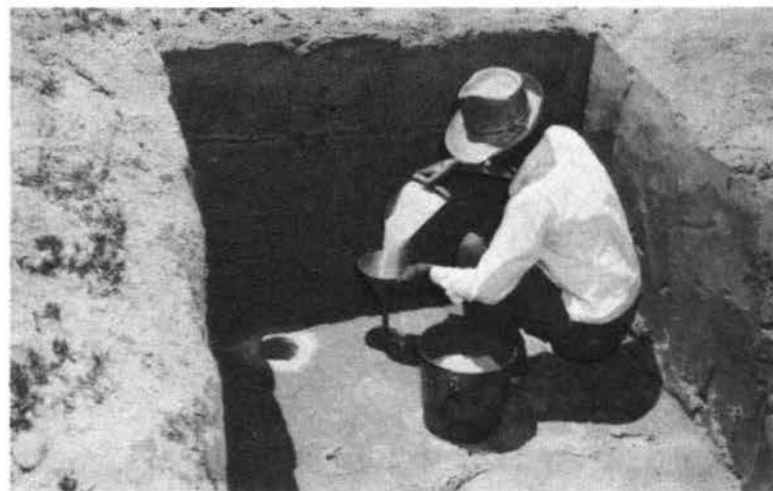
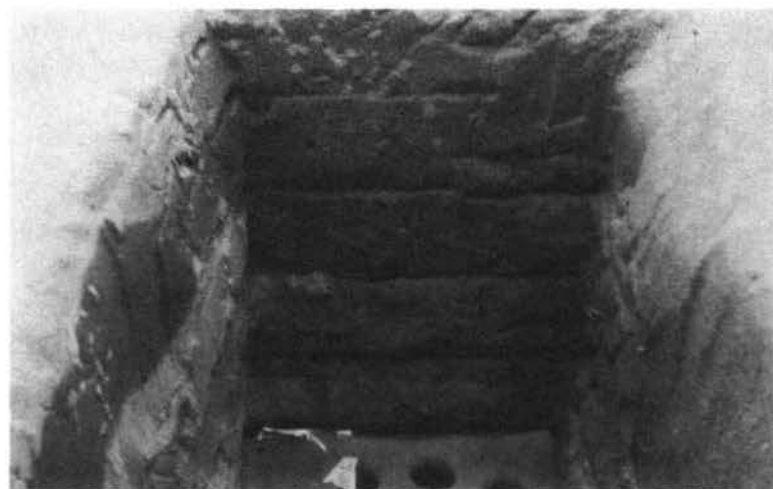
Photograph 1. Density determinations by sand displacement method in preliminary investigation

Excavating hole for field density determination

Determining volume of density hole

Determining depths in test pit

Test pit several days after excavating

9. The data secured in the preliminary investigation were obtained from 27 test pits excavated at various stages of the tests for the purpose of taking samples and making density and moisture determinations at 1-ft intervals down to a depth of 6 ft. All densities were taken by the sand displacement method. Details of this method are shown by photograph 1, which also illustrates the stable appearance of the vertical sides of the test pit several days after excavation.

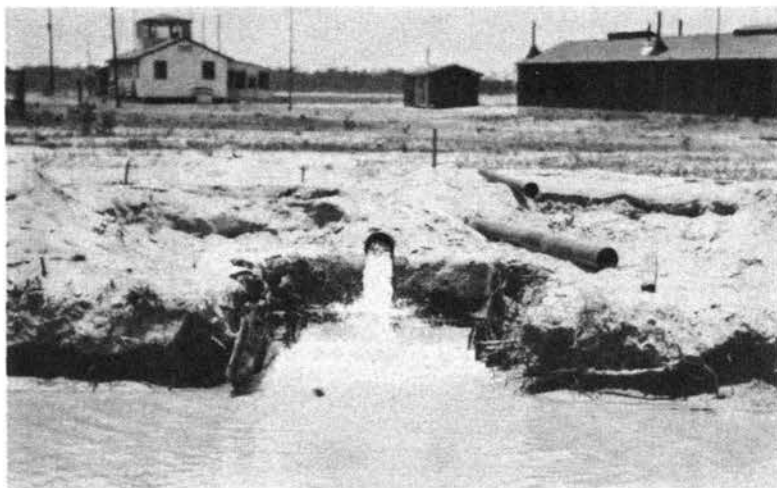
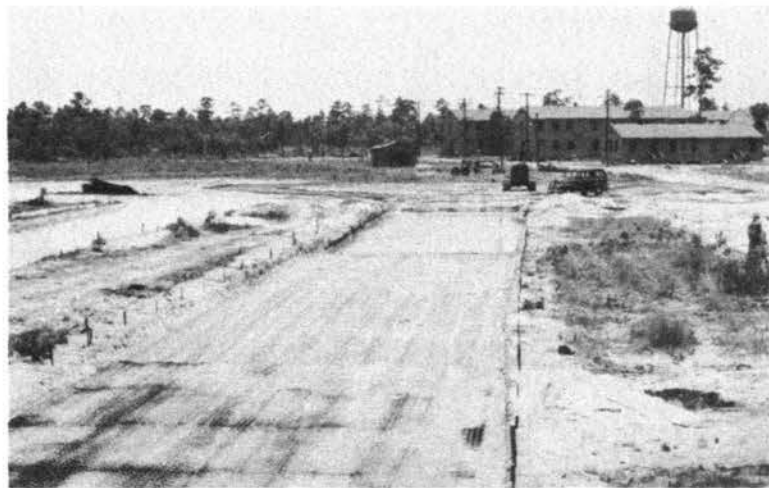
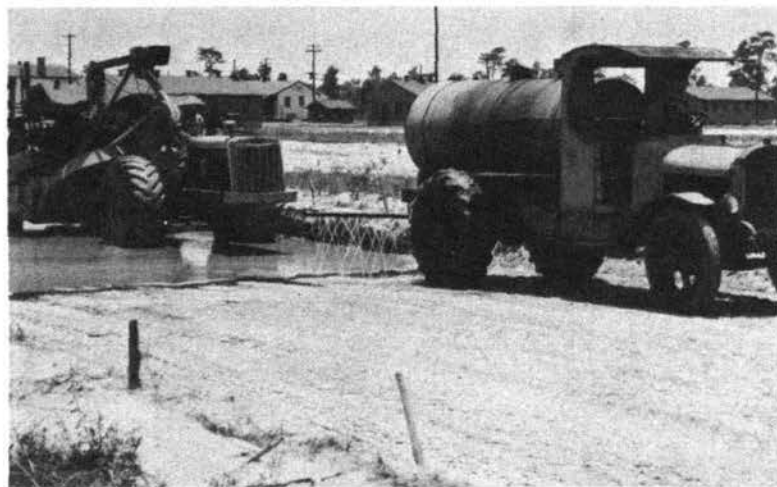
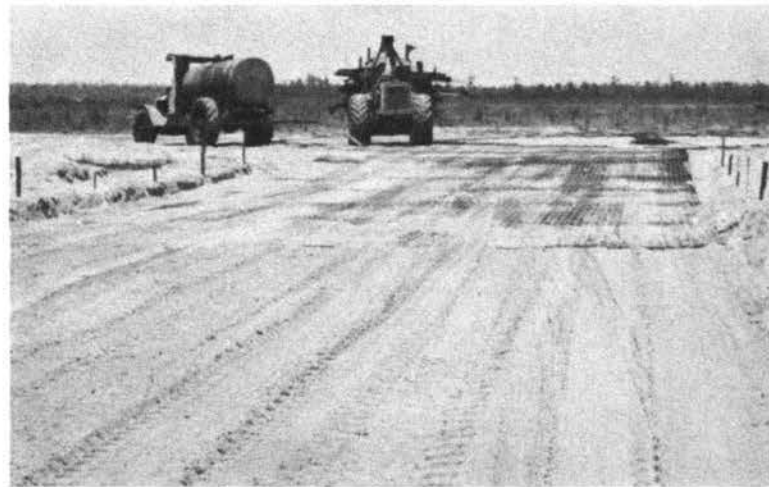
Photograph 4. Ponded, sprinkled and natural-water areas of Section 2

6-in. pipe discharging into sump for ponded area

Conclusion of tracking with water still in ponded area

Sprinkling operation during tracking

Sprinkled and natural-water areas during tracking;  
latter area covered with mat

Similarly, it was extended to the sump on Section 3. A view of water discharging into the sump for Section 2 is shown in photograph 4.

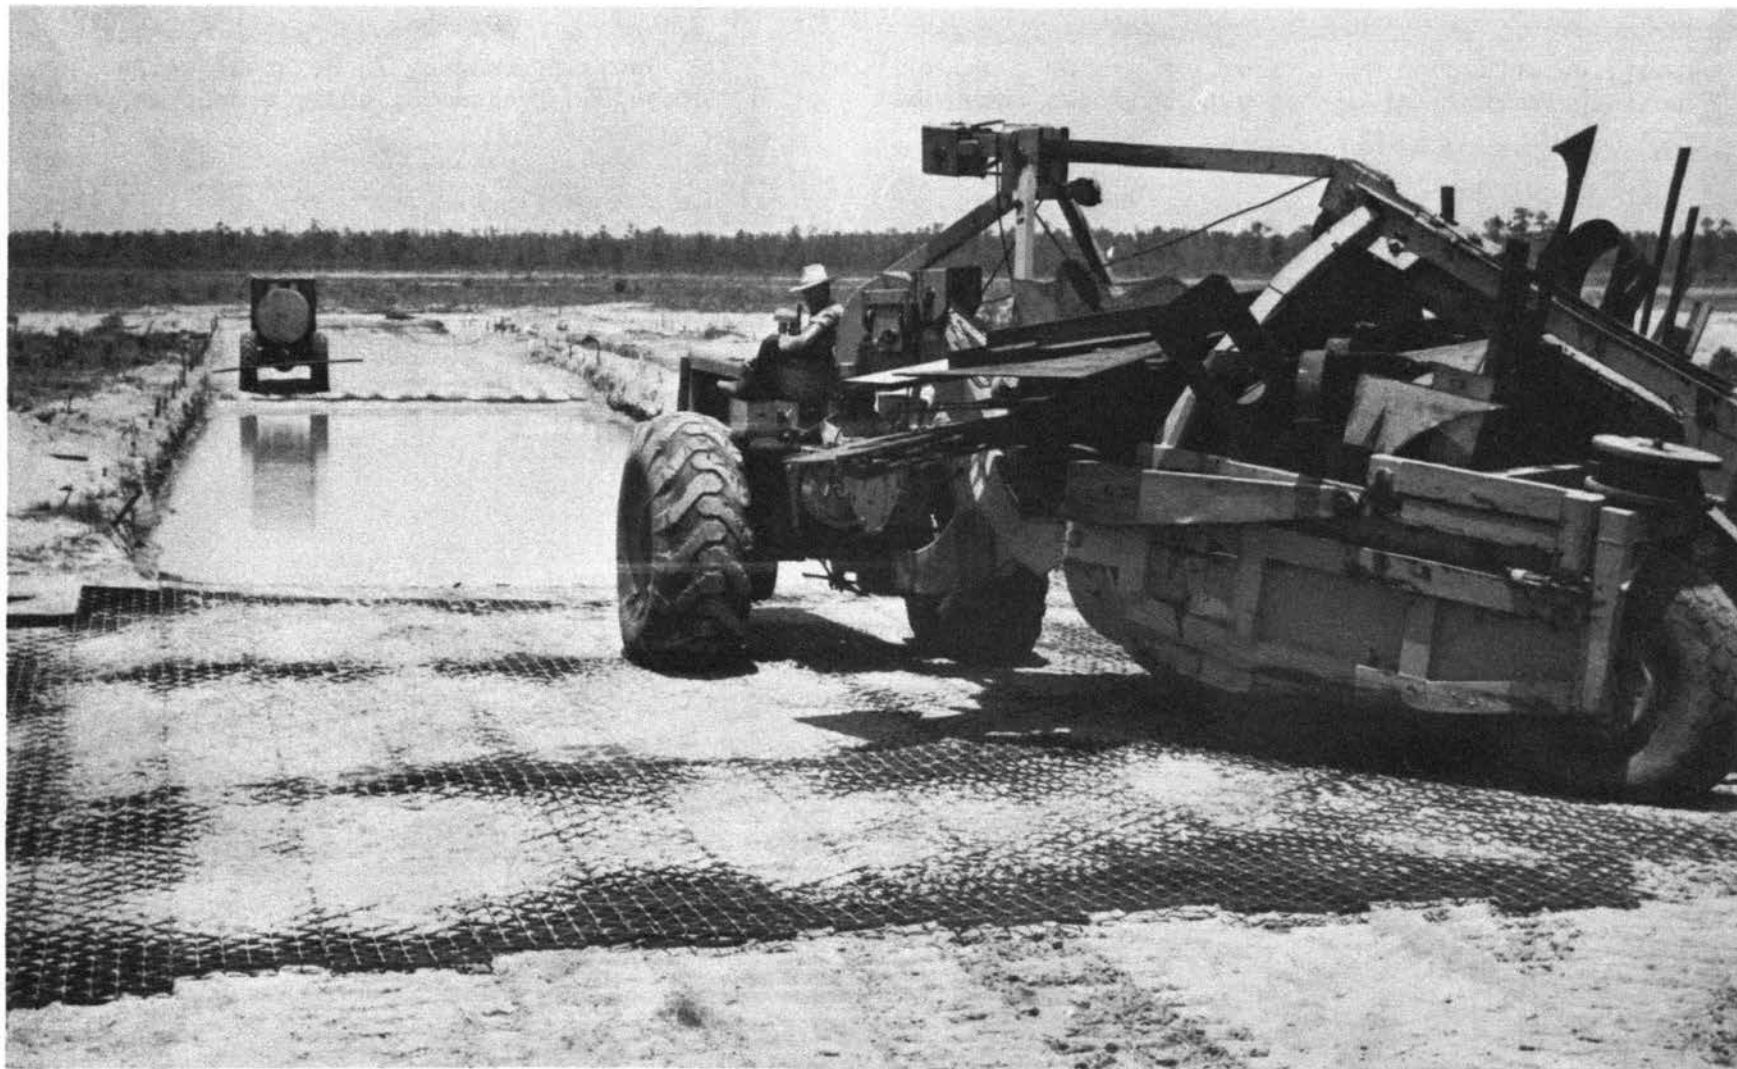
Photograph 5. Tournapull loaded to 15,000 lb per wheel entering ponded area of Section 2

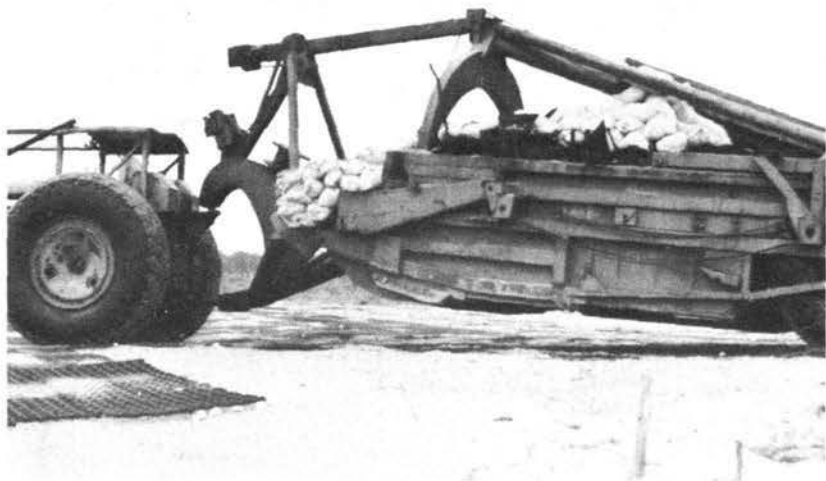
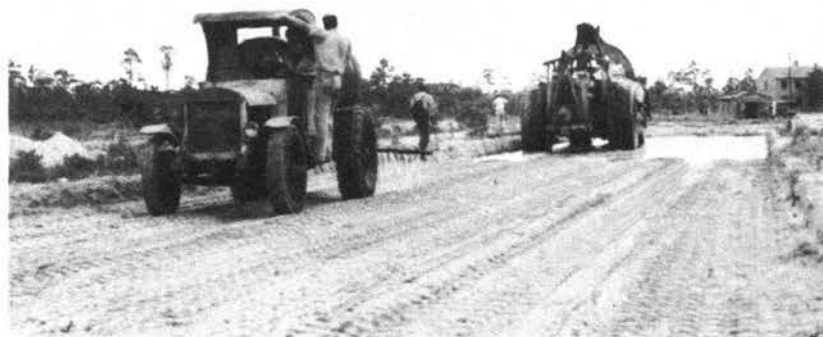
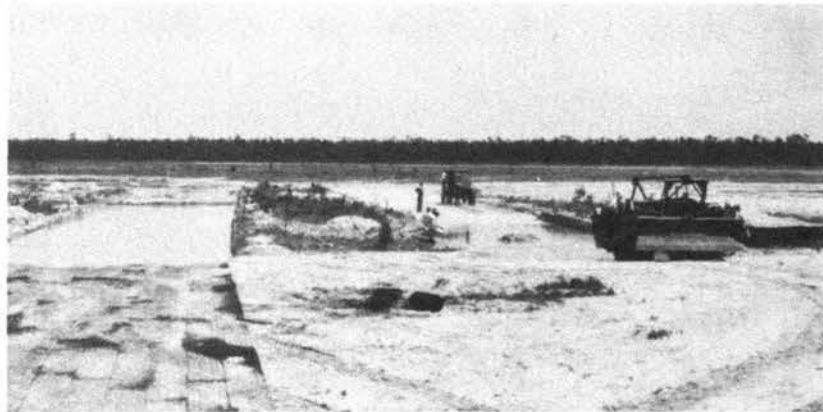
Photograph 6. Equipment and tracking on Sections 3 and 4

Large Tournapull loaded to 60,000-lb wheel load

Tracking in Section 3

Loaded tractor & large Tournapull on Section 3  
after tracking by Tournapull alone

Beginning tracking with 80,000-lb tractor, Section 4  
Ditch between Sect.3 & 4 left, both ponded areas flooded

29. To expedite the test a ditch was cut between Sections 3 and 4 (see photograph 6), thus keeping both sections flooding during the tests on the latter section. It was necessary to use more than 125,000 gal of water during the test of Section 4 to keep the ponded area at desired water level. Section 5 ponded area was also flooded from the sump in

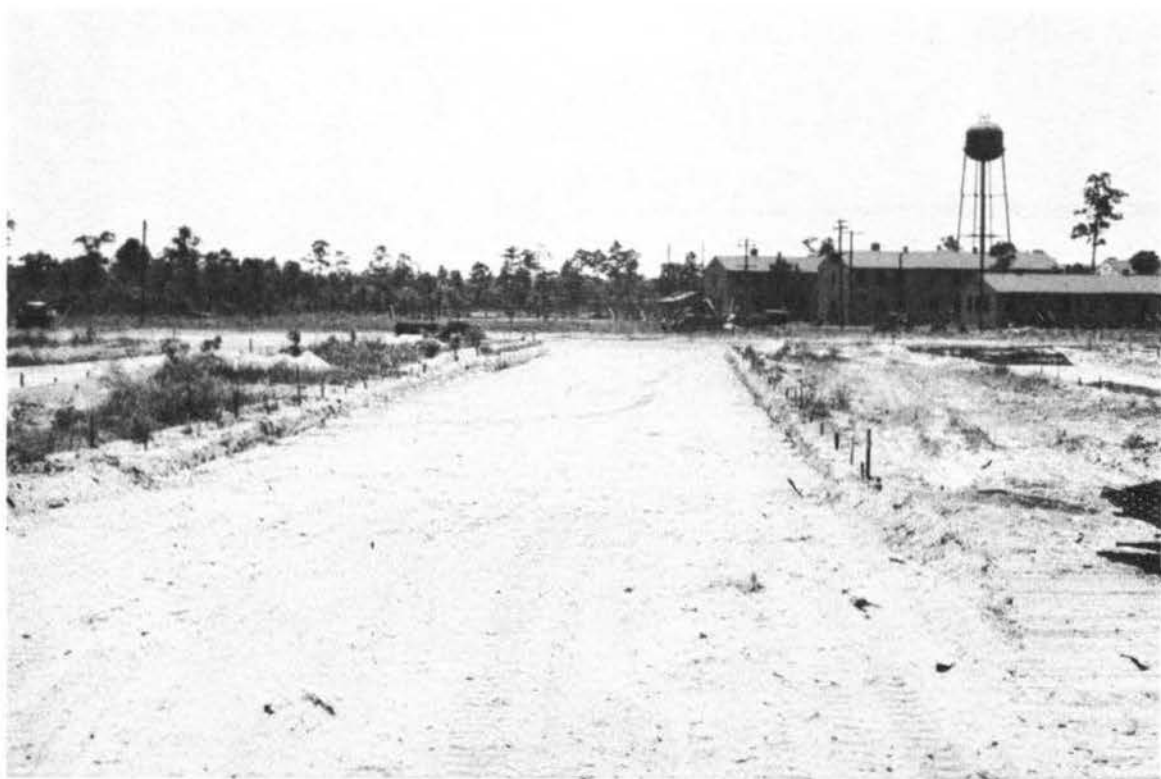
Photograph 7. Section 3 after grading

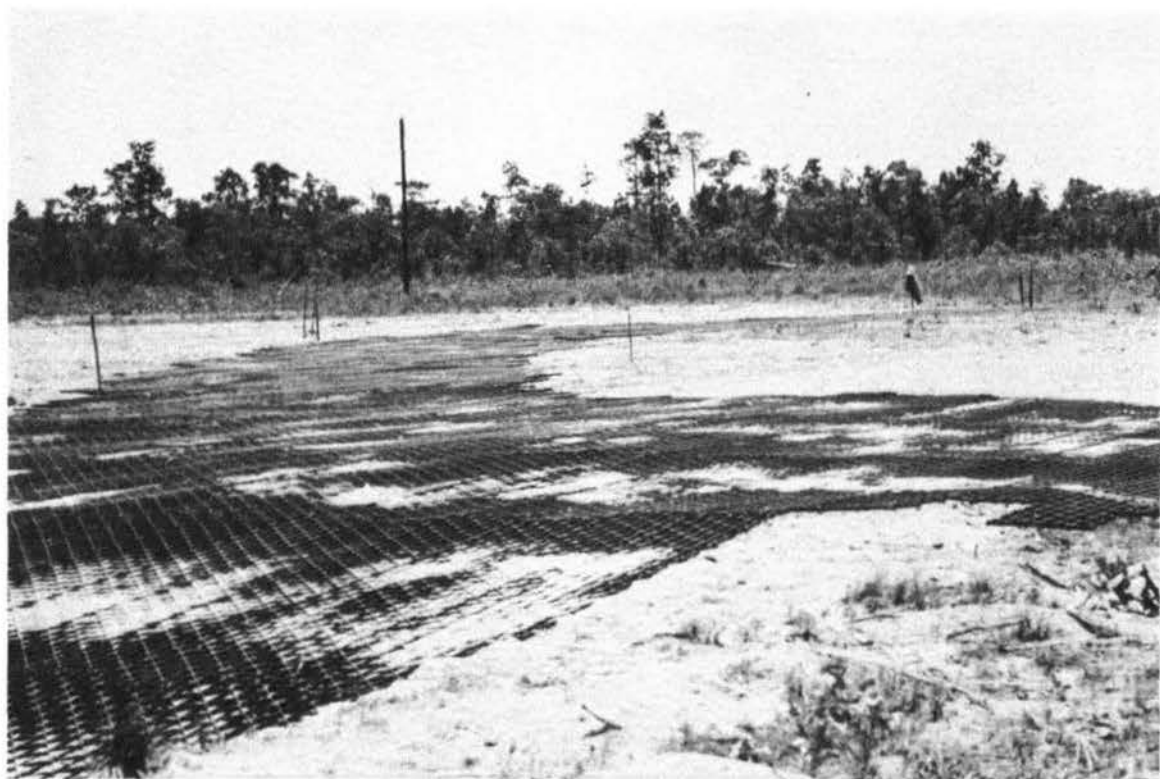
Photograph 8. Landing mat turnaround at south end of Section 2

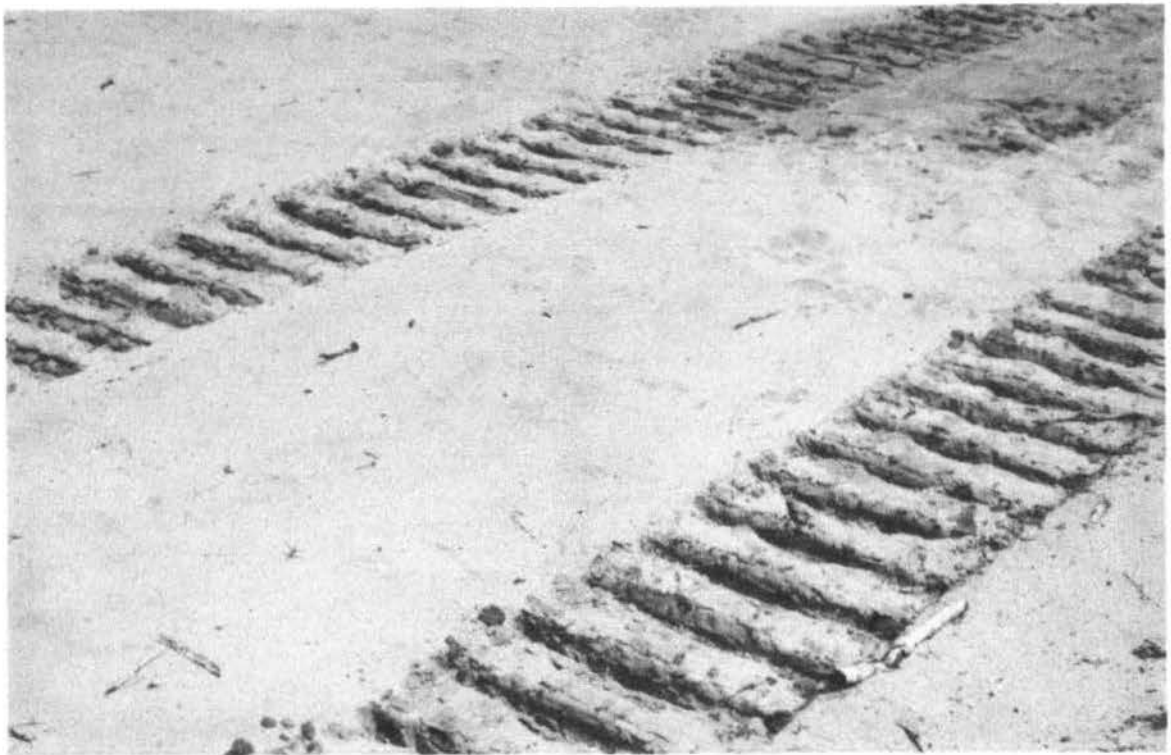
Photograph 9. Tread marks of 80,000-lb tractor, Section 4

condition of the front tires, it was not deemed feasible to increase the air pressure in them to 45 psi. The RD-8 tractor used in Section 1 was loaded by constructing two compartments, one on either side, and filling these with steel shot until the gross weight was 80,000 lb for compaction of Section 4 (photographs 6 and 9).

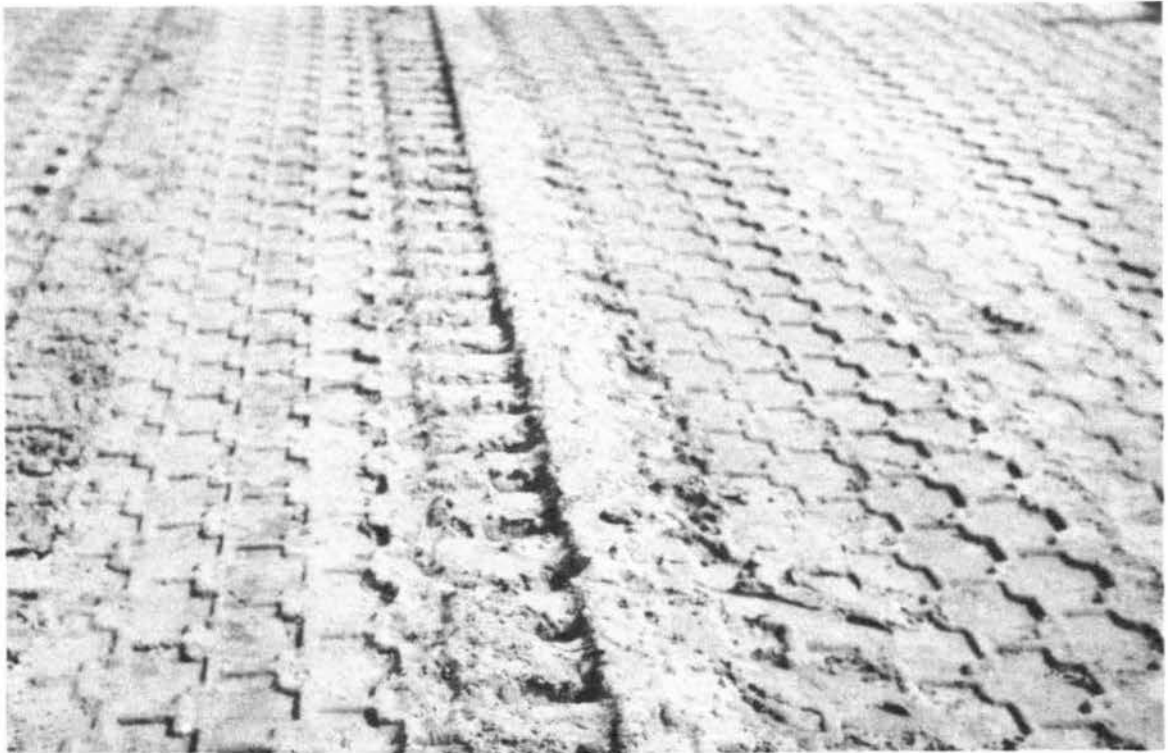
Photograph 10. Tire marks of 60,000-lb wheel load in sprinkled area of Section 3
