SOIL STABILIZATION

INITIAL LABORATORY AND  
FIELD TESTS OF QUICKLIME AS  
A SOIL-STABILIZING MATERIAL

TECHNICAL REPORT NO. 3-455

U. S. Army Engineer Waterways Experiment Station  
CORPS OF ENGINEERS  
Vicksburg, Mississippi

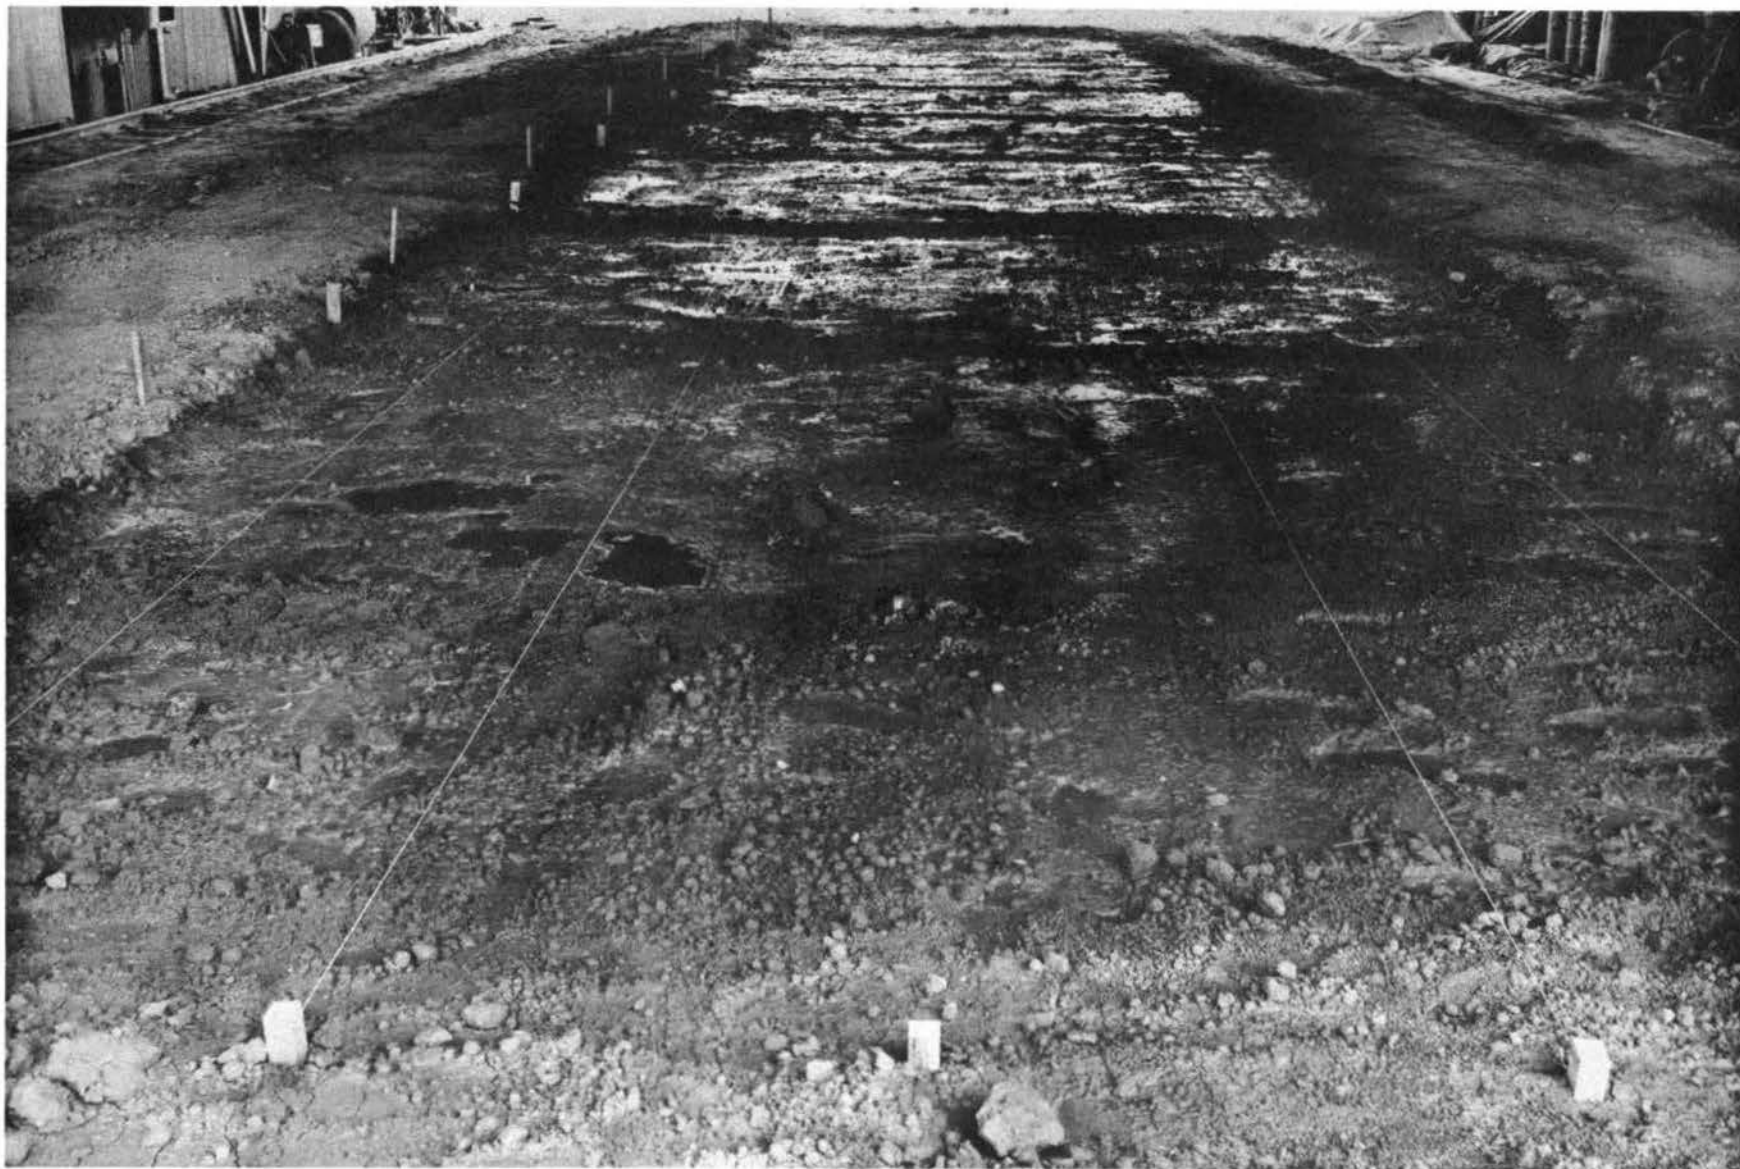
Fig. 7. Completed subgrade immediately prior to spreading of quicklime

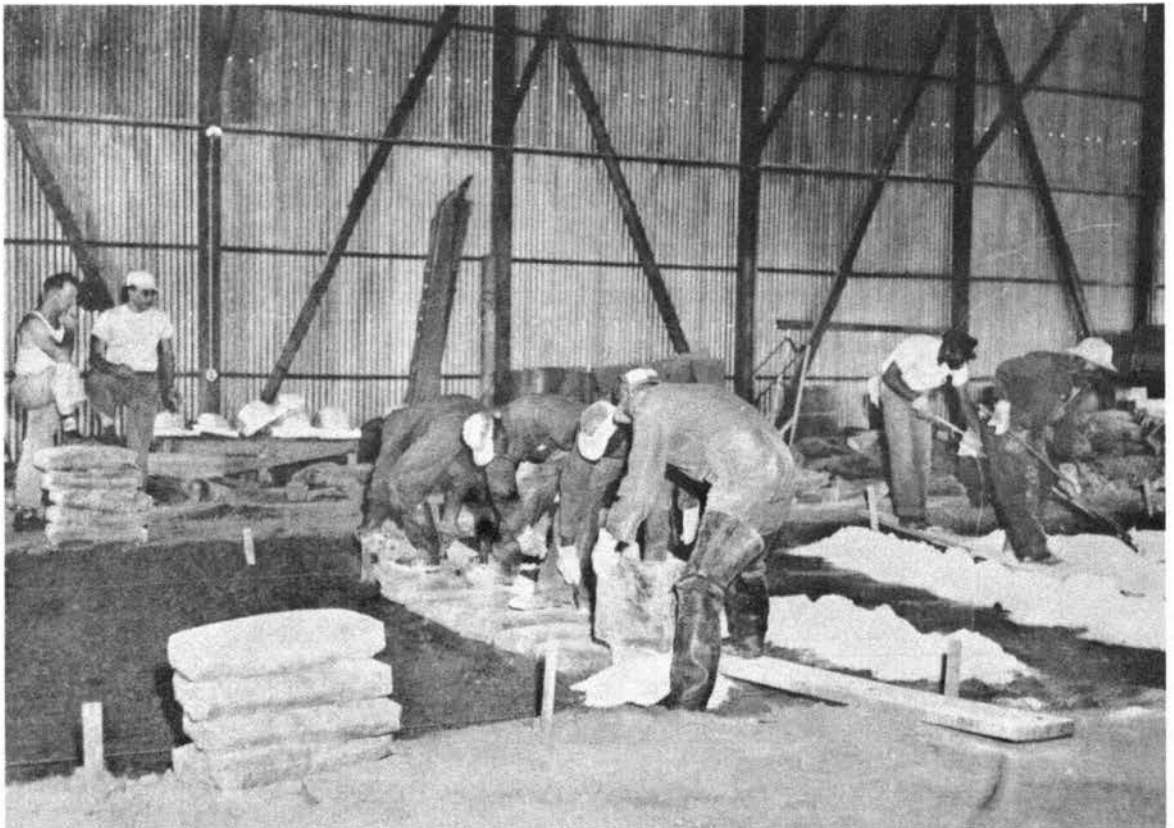
Fig. 9. Placing and spreading quicklime on test strip

treatment of quicklime should be provided. Although the laboratory cone index tests showed strengths considerably higher than the desired 120 cone index with this percentage of admixture (table 2), experience has shown that strengths achieved in the field may be 50%, or less, of that obtainable in the laboratory because of differences in mixing efficiency. Therefore, it was anticipated that an 8.0% treatment would, in all probability, provide cone indexes not far in excess of the desired minimum of 120. Sufficient quicklime was used to achieve the desired treatment for the top 12 in. of the test lane. Bags of quicklime were stacked at equal intervals along the lane adjacent to the test strip; the quicklime was then dumped on the surface of the lane and spread by hand to a uniform thickness over the entire area to be treated. Since the untreated soil was too soft to support a man's weight, it was necessary to span the lane with plank bridges to enable the workmen to apply the lime. These operations, and the appearance of the test lane immediately before mixing, are shown in figs. 9 and 10.

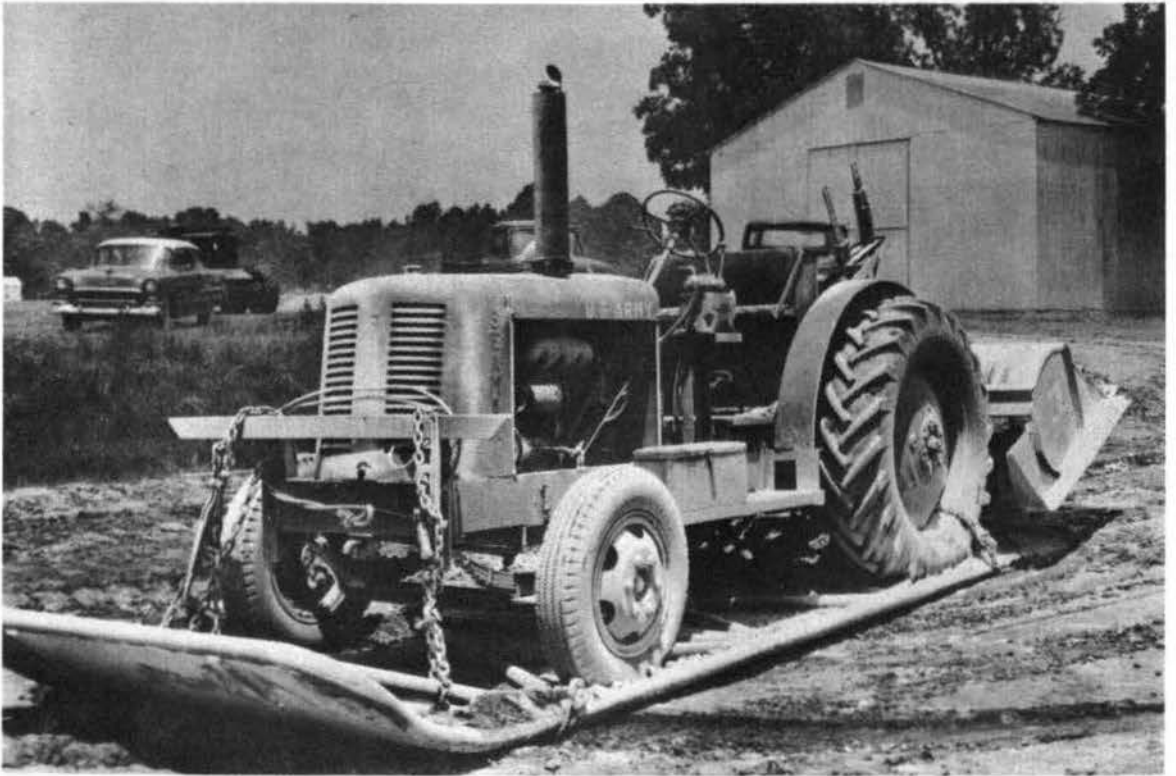
Fig. 11. Pulvimixer and sled arrangement devised to provide support for the mixer on the low-strength test lane

23. A standard self-propelled Seaman pulvimixer was employed to mix the lime with the soil. However, because the soil would not support the pulvimixer, it was necessary to devise a method for pulling the mixer over the lane without its sinking into the subgrade. This was accomplished by placing the tractor portion on a "mud" sled, with the mixer unit protruding beyond the rear of the sled as shown in fig. 11. The rotors were adjusted to achieve a 12-in. mixing depth. Mobility was provided by attaching a heavy cable to the front of the sled and pulling the unit over the test lane by means of a power winch attached to a D-7 tractor. A preliminary test run of this rig was conducted during construction of the subgrade and was reasonably successful, though the process was slow and time consuming. Since the width of the test lane was 12 ft, two passes in opposite directions were necessary to obtain one complete mixing coverage with the 7-ft-wide rotor unit.

observed deformation. However, several other difficulties were evident. The quicklime piled up in front of the sled to some extent and formed a windrow of material along the sides. This material was shoveled back, to be mixed on the next pass. It was also observed that the depth of mixing achieved was considerably less than the 12 in. desired because the rotors tended to ride on the surface rather than cut into the soil. This caused a considerable amount of quicklime to be thrown into the air, creating difficulty and discomfort for the operator in the sheltered area. After the two complete mixing coverages had been made, the pulvimixer was dismounted from the sled and an attempt was made to drive it over the lane under its own power. It was hoped that the initial mixing had been sufficient to provide a surface capable of supporting the pulvimixer. Unfortunately, this was not the case, and the pulvimixer bogged down after traveling about 20 ft. The mixer was winched through the remaining distance, creating ruts 12 to 18 in. deep, and no further mixing was attempted. Approximately one hour was consumed in the mixing operation.

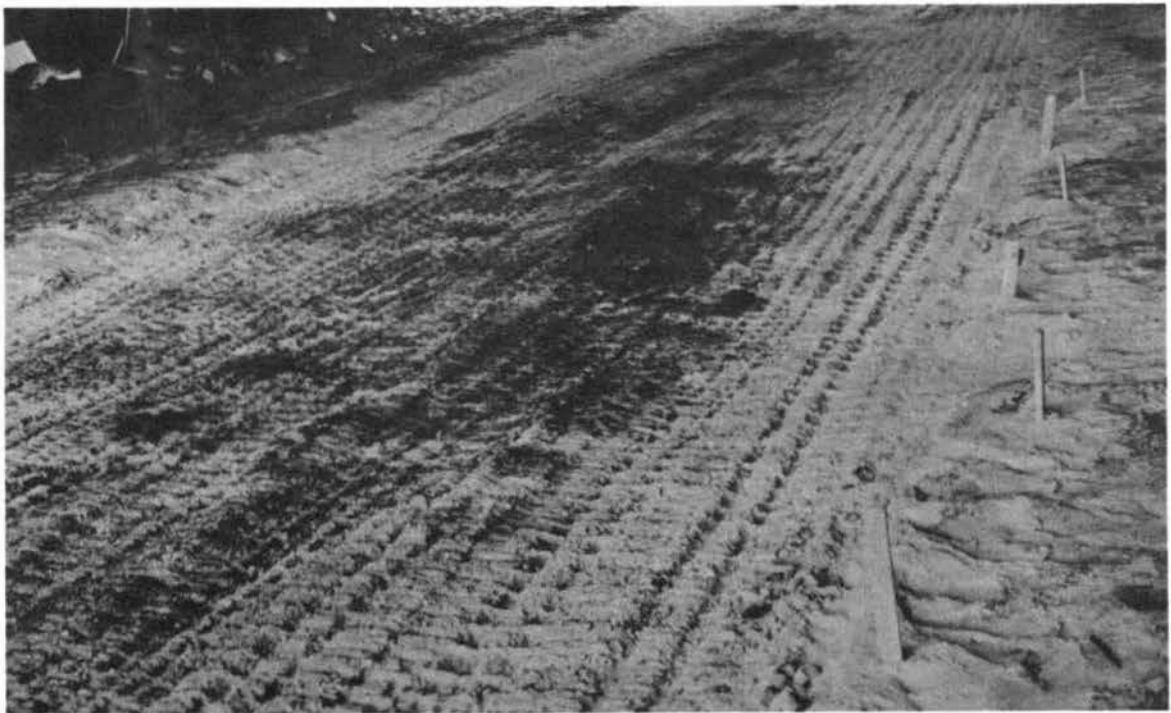
Fig. 12. Completed test lane. Note unmixed quicklime on and adjacent to lane

25. Compaction. Immediately after mixing, an attempt was made to compact the test lane by "walking-down" with a D-7 tractor. Although the tractor made two successful passes under its own power, considerable shoving was observed and ruts in excess of 12 in. deep were formed. To smooth out the ruts and complete compaction, a standard M-29C cargo carrier (weasel) was operated over the lane for a total of 25 passes (about three complete coverages). No difficulties were encountered with this vehicle, although large deflections of the surface were observed under the moving load. The appearance of the test lane at completion of construction is shown in fig. 12. The presence of a considerable amount of unmixed

quicklime along the sides of the test lane and also on the surface is evident in the photograph. The total elapsed time from the start of the mixing operation to completion of compaction was two hours.

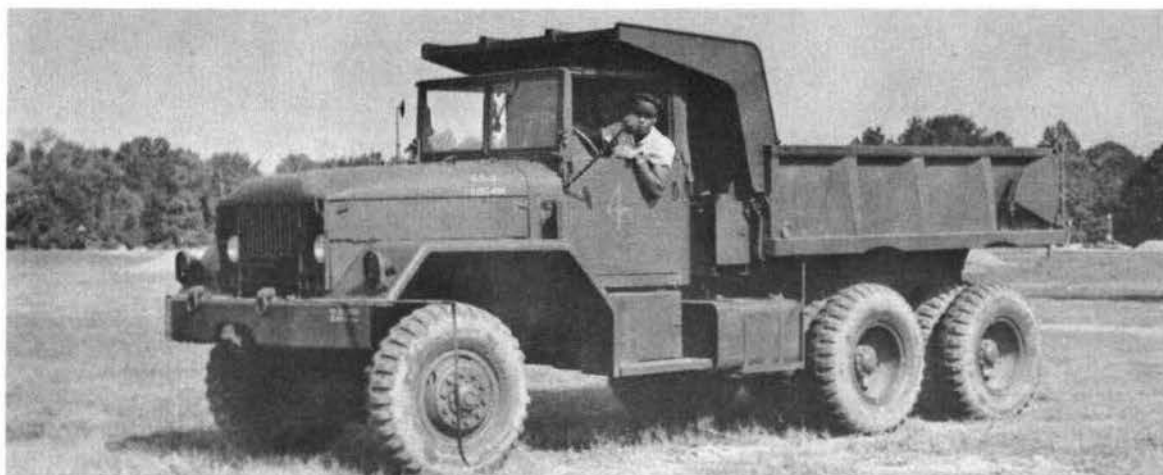
Fig. 13. M-51 test vehicle; 31,800-lb gross load, 50-psi tire pressure

and were inflated to a pressure of 50 psi. The gross load of the vehicle was 31,800 lb, of which 23,000 lb were distributed to the rear wheels.

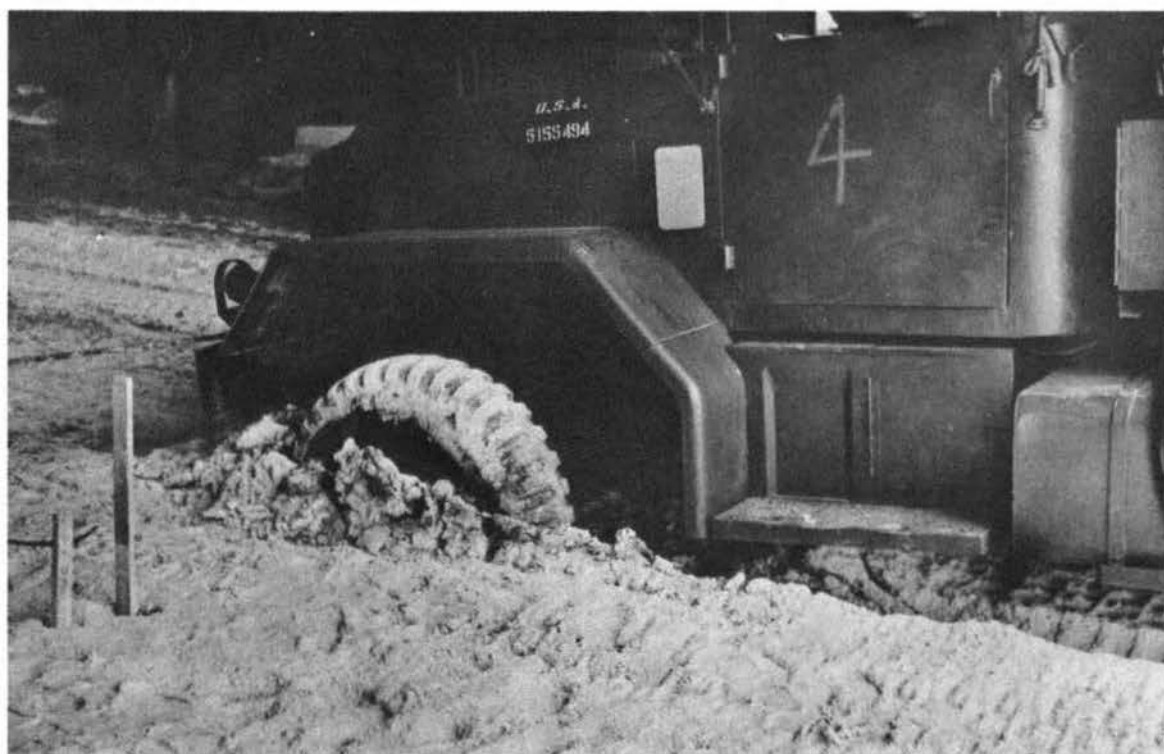
Fig. 14. Failure of test section at sta 0+00 during entry of vehicle

30. An initial attempt by the vehicle to enter the test lane at sta 0+00 proved unsuccessful, as illustrated in fig. 14. Immediately upon entering the area of weak subgrade, the front wheels broke through the thin, stabilized crust and settled into the soft soil beneath. The vehicle

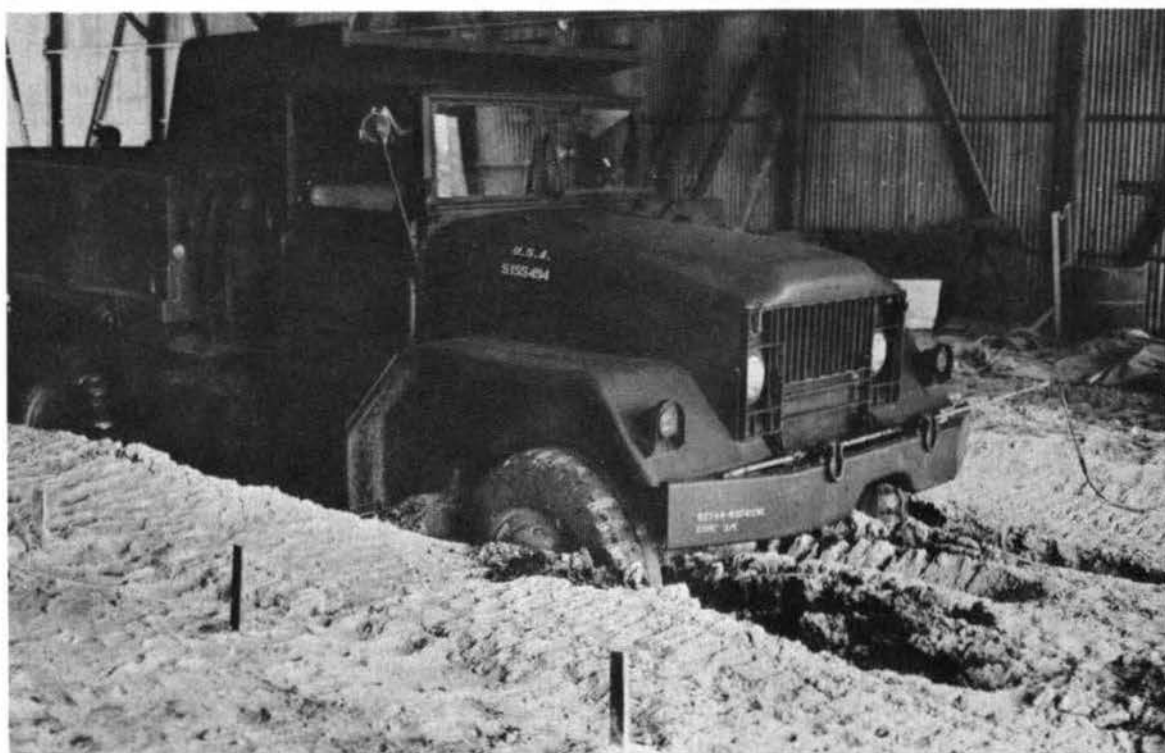
a. Front of vehicle at sta 0+10

b. View from sta 0+75 of rear of truck. Note differences in depth of ruts throughout length of test lane

Fig. 15. Immobilization of test vehicle after first pass

was backed out without difficulty, and an attempt was made to enter the lane from the other end at sta 0+75. This was accomplished successfully and the vehicle was allowed to continue through the test lane. Shallow ruts ranging from 2 to 6 in. in depth were observed from sta 0+75 to 0+60 during the first pass. From sta 0+55 to 0+10, the axle of the vehicle was dragging and ruts 7 to 12 in. deep were formed. The truck was able to complete the initial pass without immobilization but could not pull out of the test lane at sta 0+00. An unsuccessful attempt was made to back the truck out in the path created by the first pass, and it was necessary to winch the vehicle out with the D-7 tractor. Immobilization of the truck after completion of the first pass is shown in figs. 15a and 15b.
