BLACKSTONE RIVER FLOOD-CONTROL PROJECT AT WOONSOCKET, RHODE ISLAND

Hydraulic Model Investigation

TECHNICAL REPORT NO. 2-468

U. S. Army Engineer Waterways Experiment Station
CORPS OF ENGINEERS
Vicksburg, Mississippi

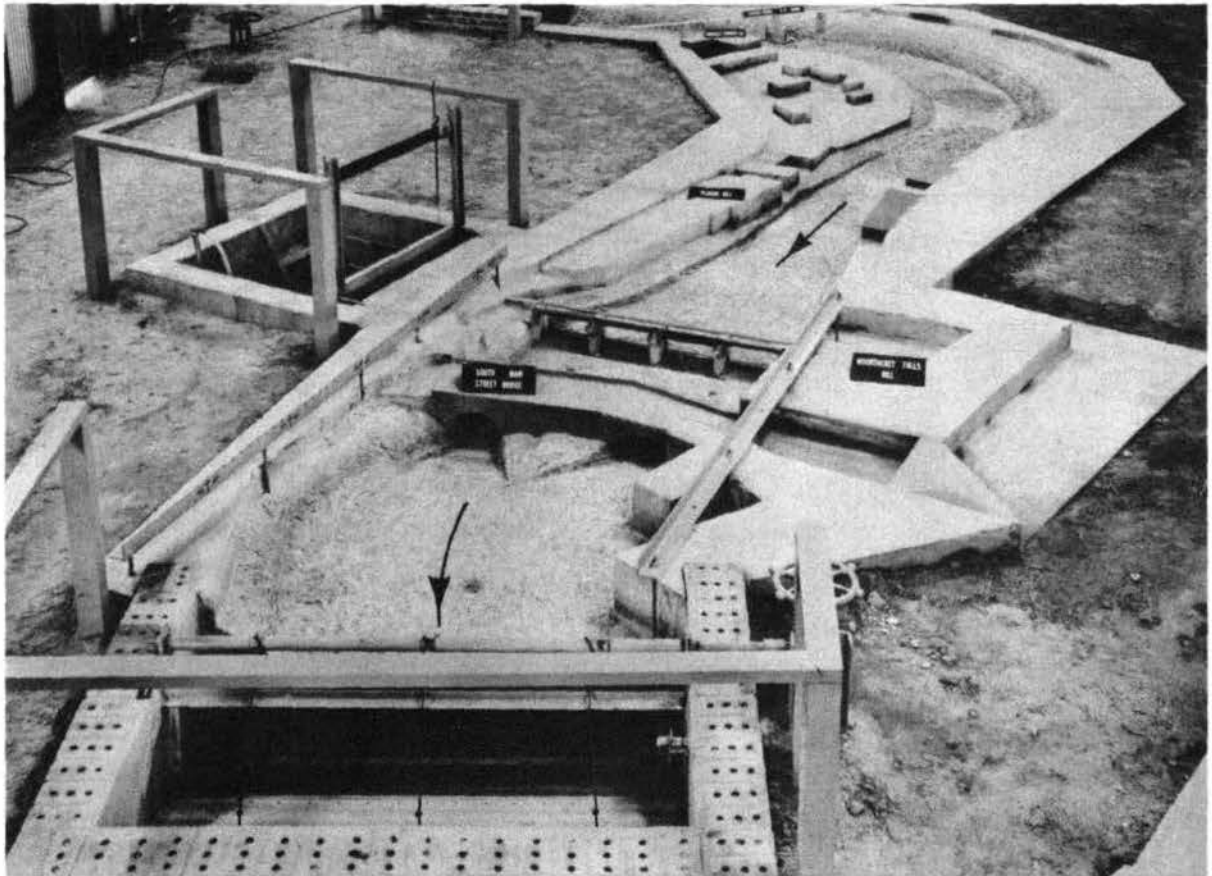
Fig. 2. General view of model

8. The model reproduced a 2225-ft reach of the Blackstone River in the city of Woonsocket near the lower end of the flood-control project. It was of the fixed-bed type with the channel and floodway molded of sand-cement mortar to female sheet-metal templets (fig. 2). Piers for the Pascoag Branch Railroad bridge and for the Woonsocket Falls Dam were fabricated of wood. The South Main Street bridge and the Woonsocket Falls Dam were constructed of sheet metal. Buildings and other structures within the floodway areas were constructed of sand-cement mortar. As constructed, the model reproduced the originally proposed design for the reach.

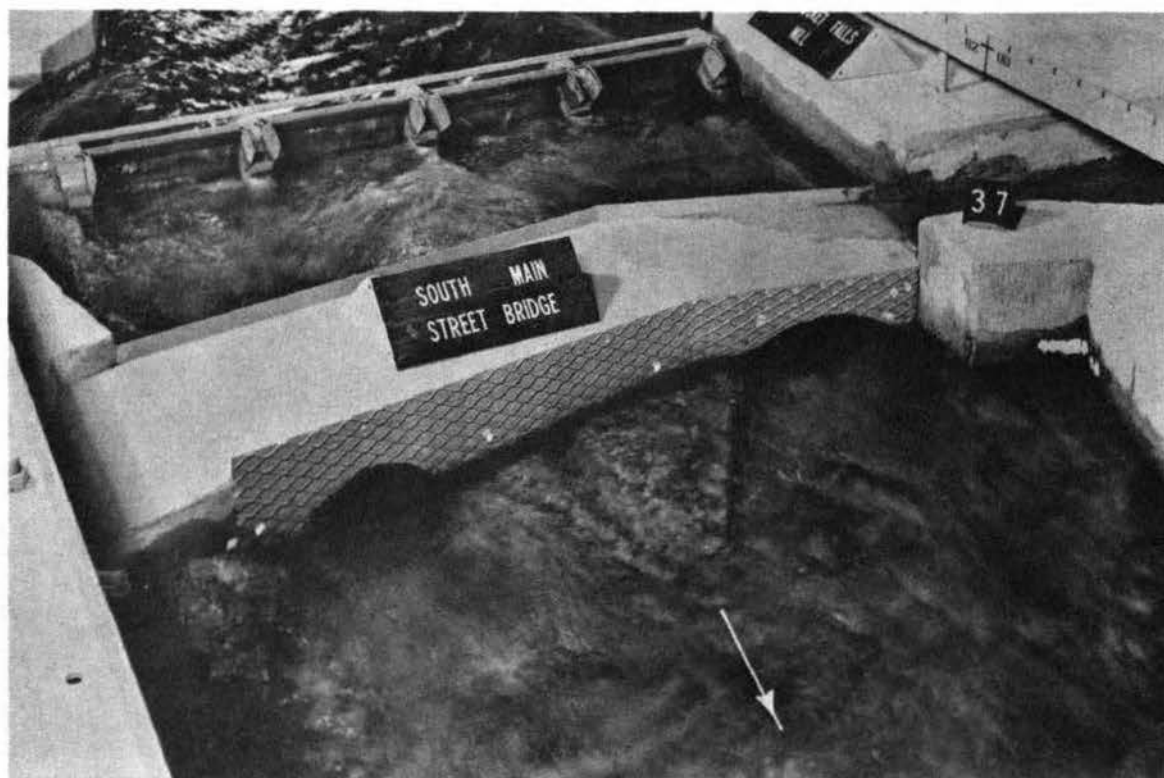
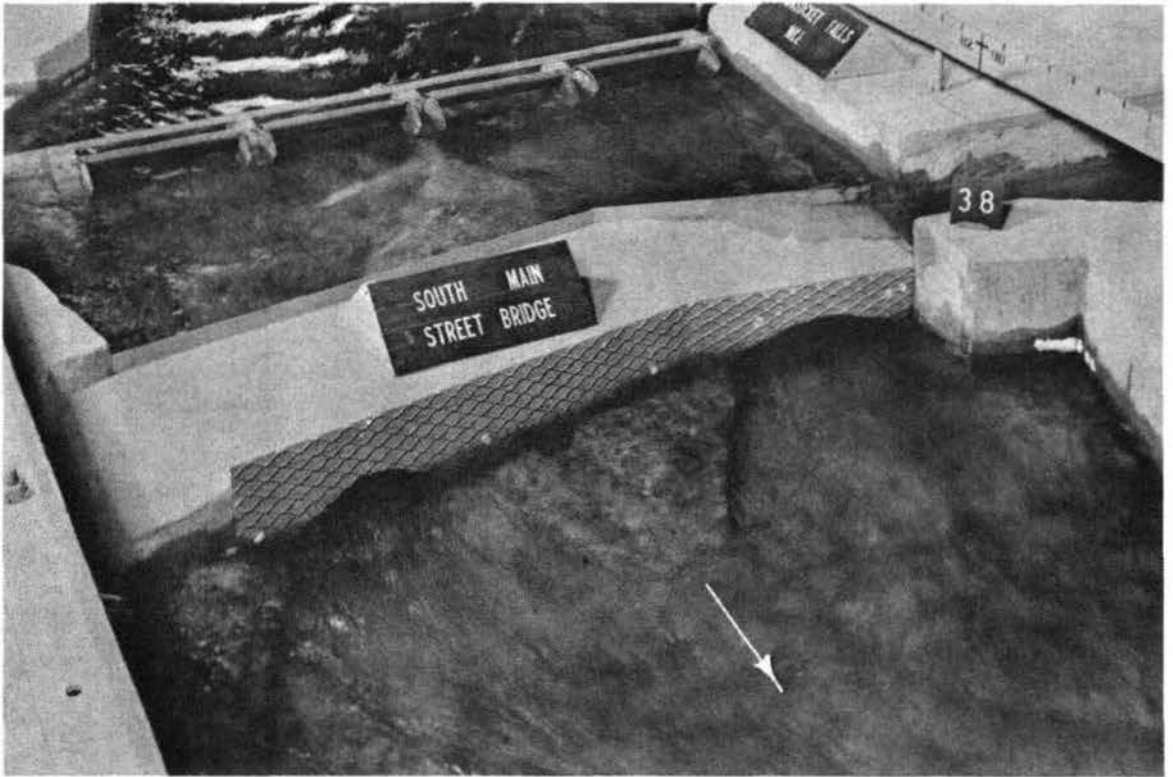
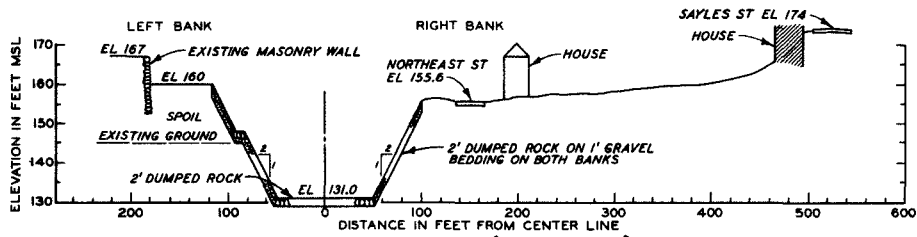
Photograph 19. Plan B: Flow conditions below South Main Street bridge, discharge 20,000 cfs

Photograph 20. Plan B: Flow conditions below South Main Street bridge, discharge 30,000 cfs

Photograph 21. Plan B: Flow conditions below South Main Street bridge, discharge 42,600 cfs

23. The results of the test of plan B, shown in photographs 19-21 and plate 9, indicate that changing the flare in the channel downstream of the west arch from 15 degrees to 10 degrees had no appreciable effect on flow conditions.

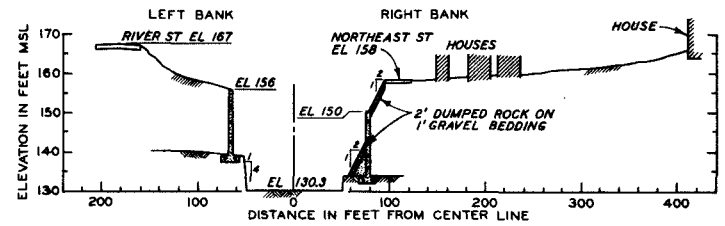
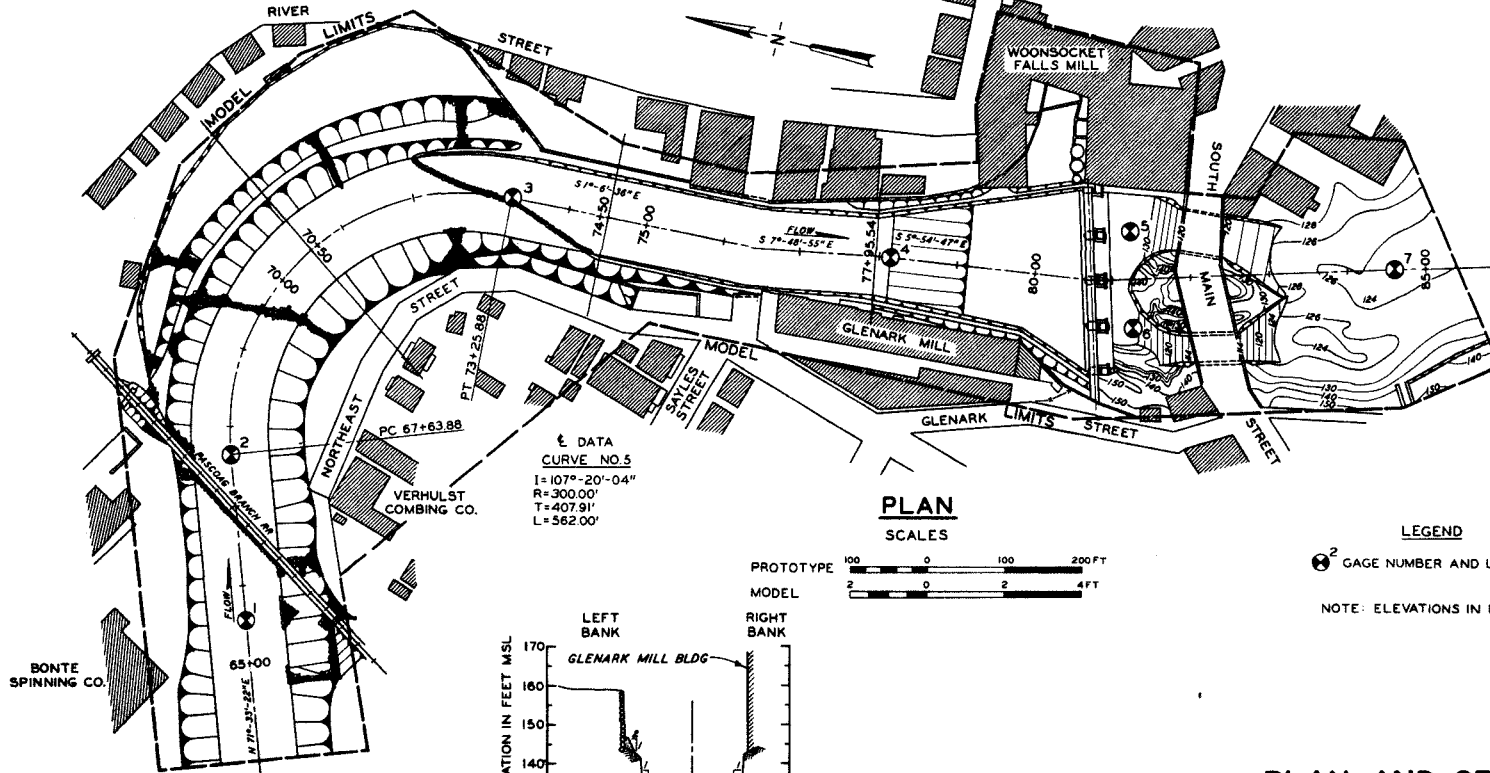
PLAN AND SECTIONS
ORIGINAL CHANNEL
IMPROVEMENT PLAN

DATA
 CURVE NO. 5
 I = 107°-20'-04"
 R = 300.00'
 T = 407.91'
 L = 562.00'

- a. Channel improvements from sta 63+70 to just upstream of the dam. The alignment and cross section of this reach of channel were controlled by existing buildings and other structures rather than by hydraulic considerations, and of necessity involved varying channel sections and transitions.
- b. Modification of the Pascoag (Harrisville) Branch Railroad bridge including the construction of an additional span and the underpinning of the piers to meet the requirements of the increased cross-sectional area.
- c. Construction of a new dam consisting of four 50-ft gated spillway sections and a short nonoverflow section forming

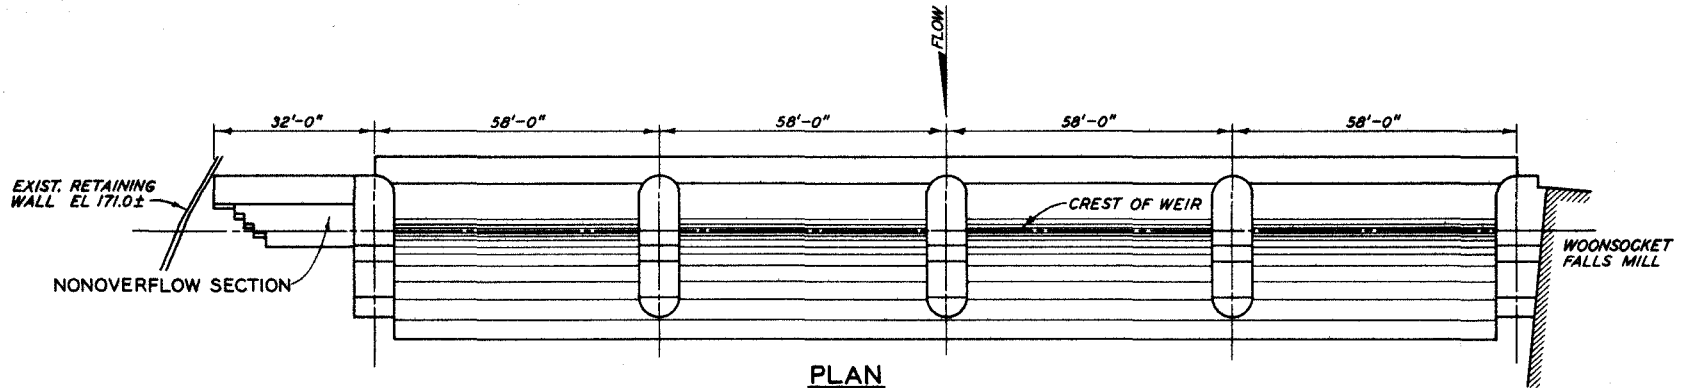
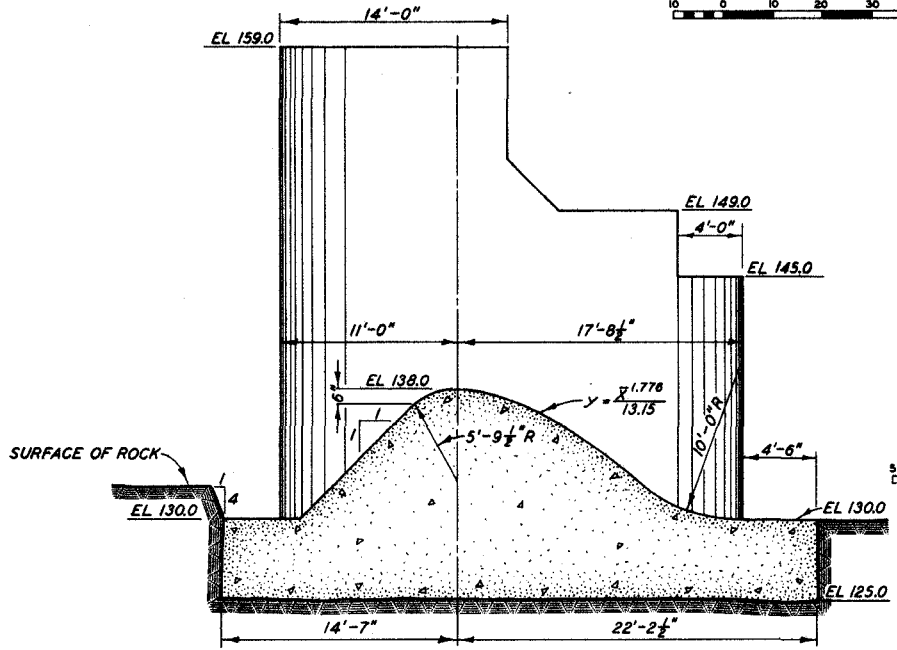
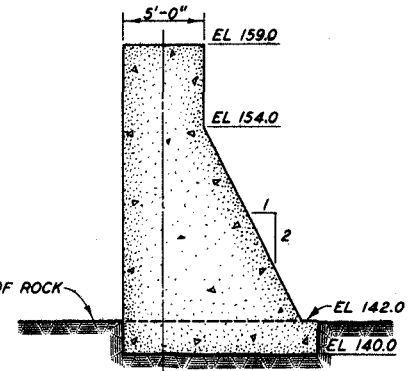
PLAN AND SECTIONS
WOONSOCKET FALLS DAM

TYPICAL CREST SECTION

NONOVERFLOW SECTION

the right abutment. The dam was designed to maintain the present pool elevation of 148.1 ft msl in order to make available process water for industrial plants during normal flow, and to provide lower headwater elevations during flood flows.

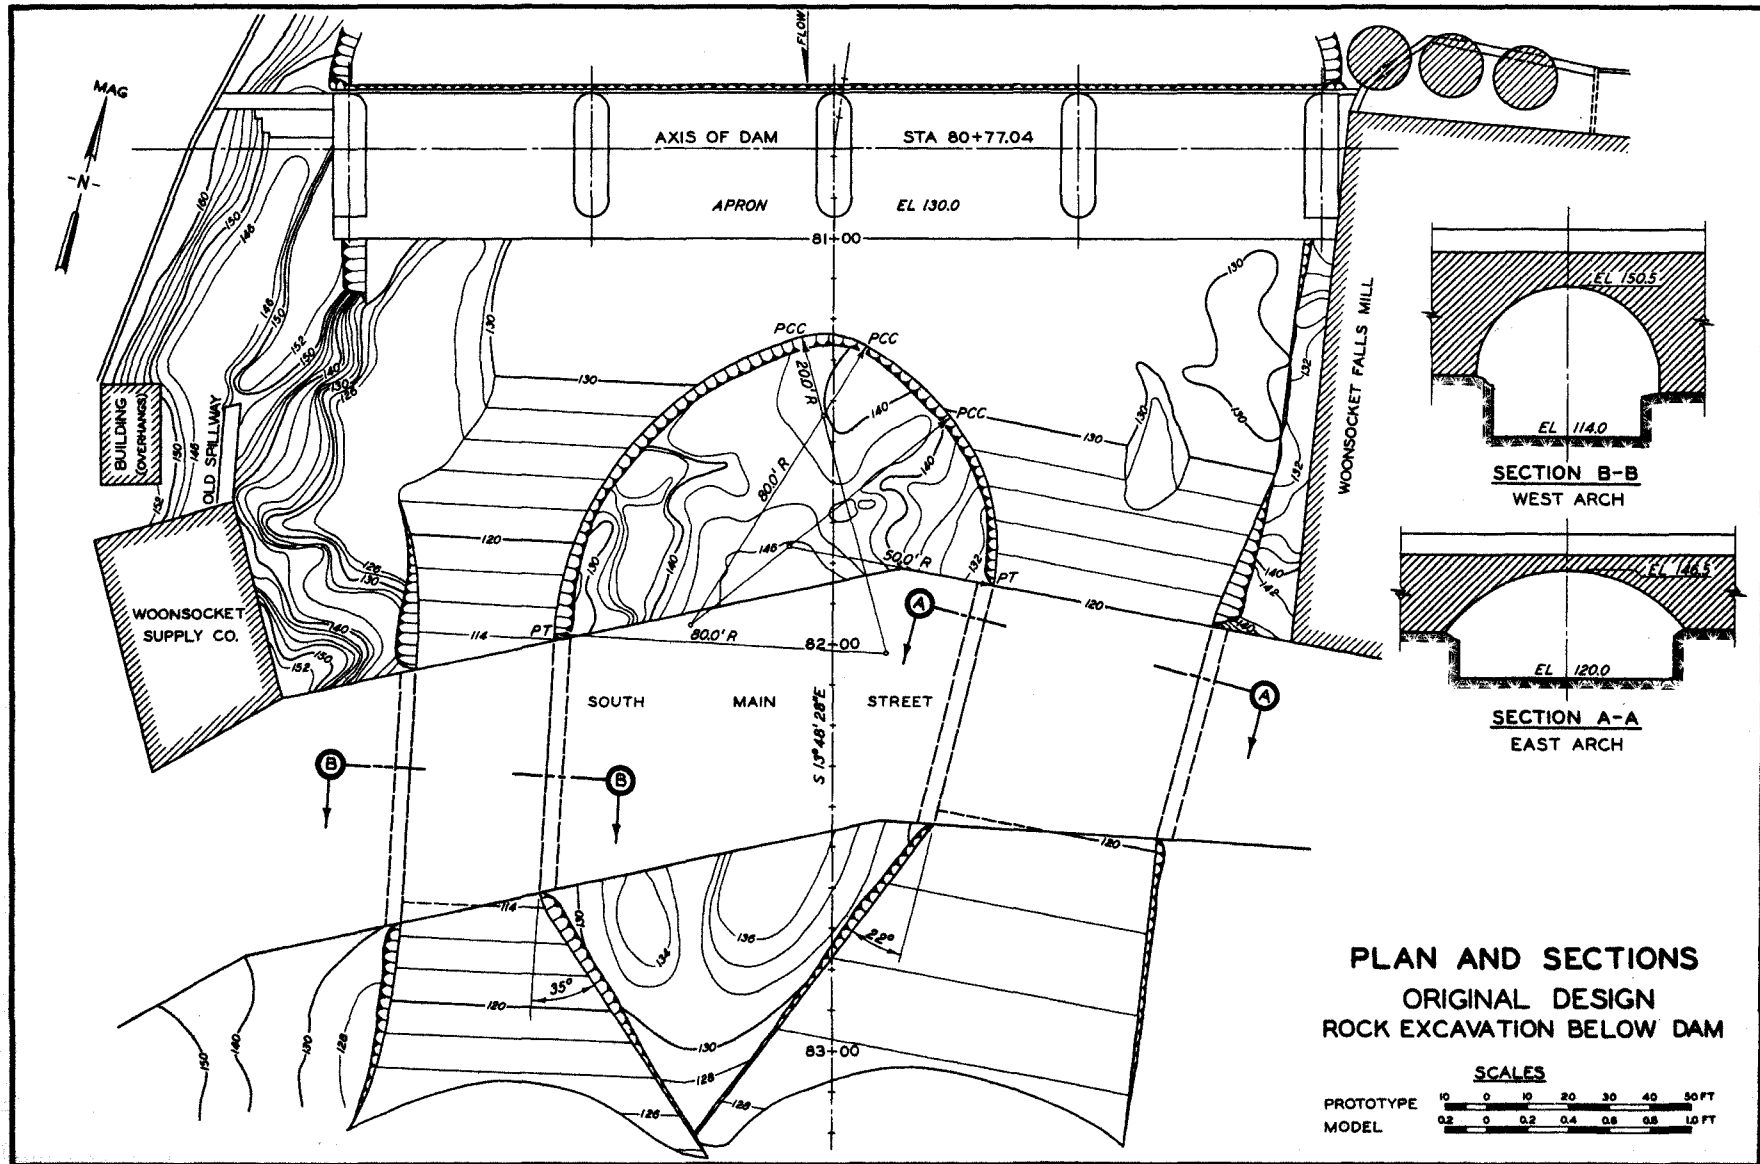
PLAN AND SECTIONS
 ORIGINAL DESIGN
 ROCK EXCAVATION BELOW DAM

SECTION B-B
WEST ARCH

SECTION A-A
EAST ARCH

- d. Rock excavation downstream of the dam and under the South Main Street bridge to lower tailwater elevations at the dam by increasing the capacity of waterway openings of the bridge and directing flow through the openings more efficiently.
