INFANT MORTALITY TESTING OF HIGH ENERGY-DENSITY CAPACITORS USED ON NOVA*

B. T. Merritt, K. Whitham
Lawrence Livermore National Laboratory
P.O. Box 5508, L-494
Livermore, CA 94550

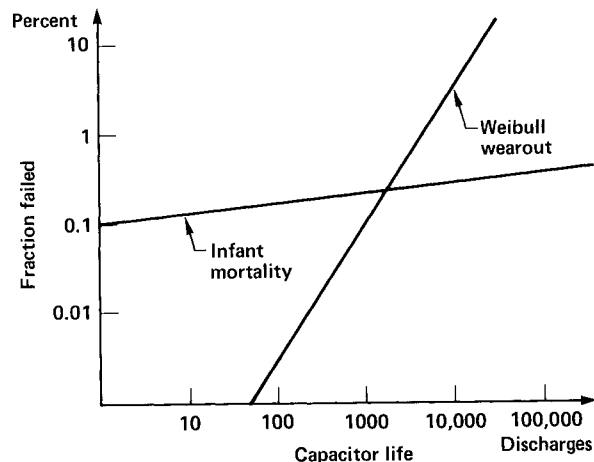
FIGURE 1

Weibull statistics describe the failure rate of a sample in the wear out mode. Early or infant mortality failures do not fall into this category nor are they described by the statistics. Figure 1 shows the shape of the Weibull curve which slowly rises monotonically from the initial level. Projecting our data for the Weibull curve into the region of less than 1,000 shots would indicate a failure rate of less than .05%. This is not observed. In fact, prior data has shown that infant mortality failures range from 1 to 7 percent depending on the quality assurance plan of the vendor³. Applying this failure rate to the Nova Bank would mean MTBF's of 10 to 20 which is undesirable. In order to remove the infant mortality failures from the distribution we embarked on the following.

CAPACITOR FAILURE VERSUS LIFE

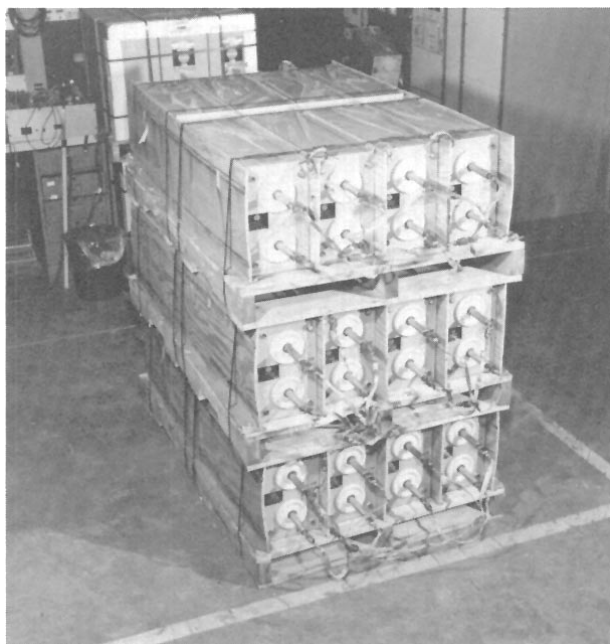
FIGURE 2

PALLETS OF CAPACITORS READY FOR HIPOT TEST

In Figure 2 are shown three pallet of capacitors ready for the high-potential test. The bushing-to-case insulation is stressed to a level of 35 kVdc for 1 minute. Four units are tested together. This test was used to eliminate bad bushings.

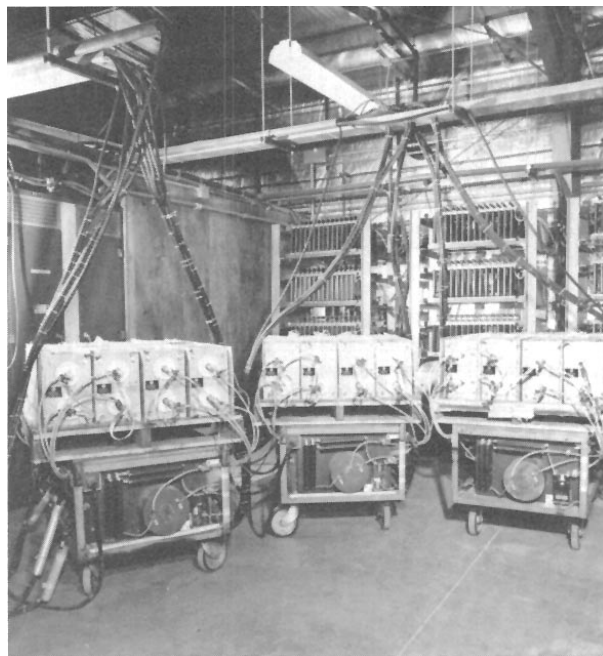
FIGURE 3

Figure 3 shows three pallets of capacitors ready for pulse-discharge testing. A description of the test circuit and hardware are given below.

PALLETS OF CAPACITORS READY FOR PULSE DISCHARGE TEST

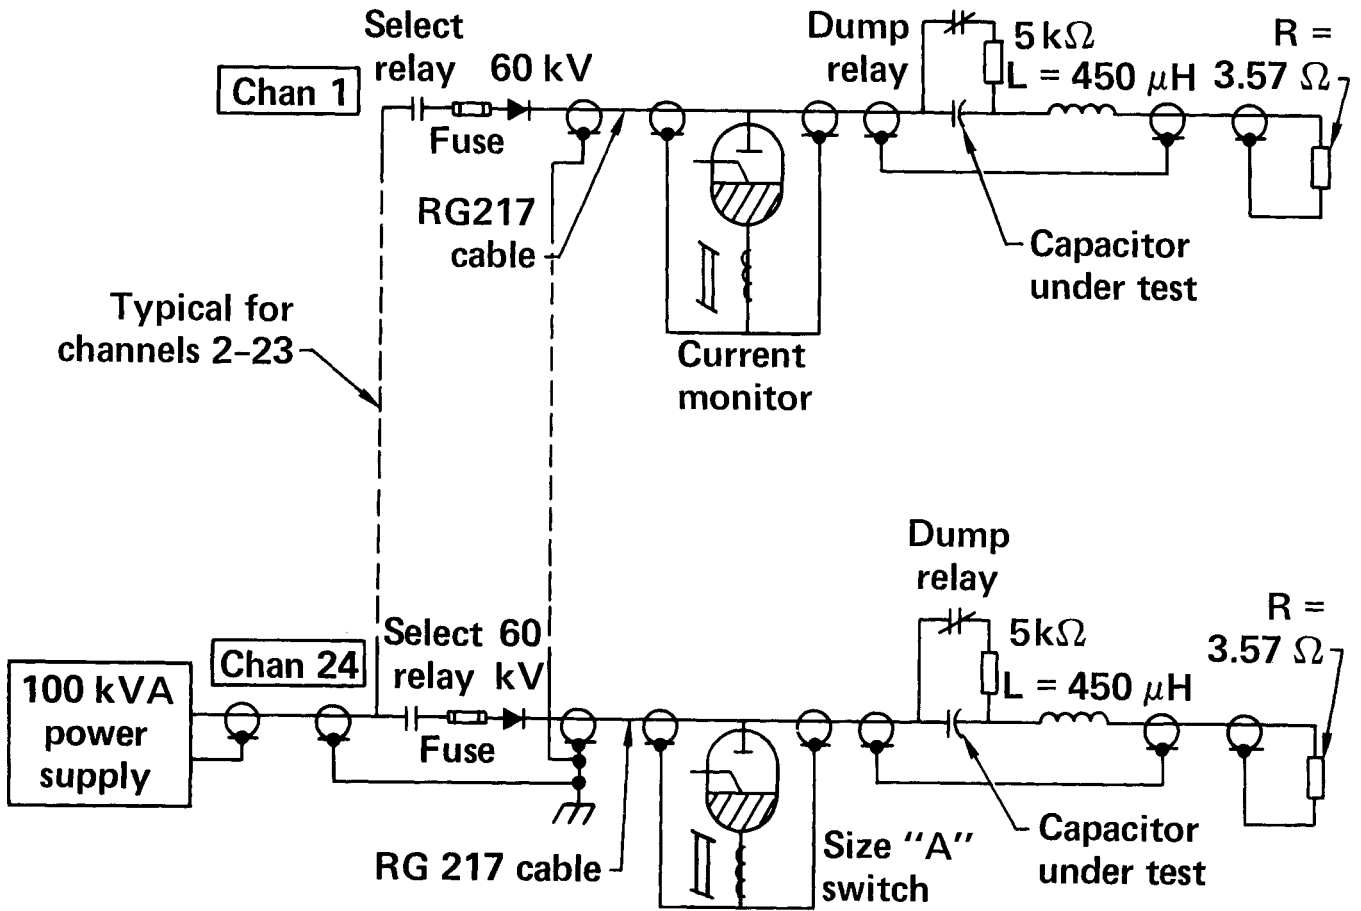
A schematic of the test circuits is shown in Figure 4. There are essentially 24 individual test circuits. Each capacitor is tested separately. Each circuit contains its own, 50 KV diode fanout (see Figure 5), size 'A' ignitron switch, 450 μ H pulse forming inductor, 3.576 Ω load bank, and dump mechanism. All circuits are charged from the same power supply. The circuits are laid out and constructed to as much as possible duplicate normal operating conditions. Figure 6 is a photograph of the control racks and power supply.

FIGURE 4
SCHEMATIC OF CAPACITOR TEST

The test was designed to run with minimum supervision. Each circuit was monitored by a current transformer. The outputs of these current transformers were input to a peak detector chassis. The peak detector chassis provides a window comparator. If the current in any circuit is too high or too low the test shuts itself down. When shutdown occurs, the test was "safed" out and the cause determined. If a failed capacitor was found, that capacitor was deselected. Each of our circuits were individually selectable by Ross switches in the fanout, so that, if a failure occurred, the failed circuit would be remotely disconnected and the test continued.

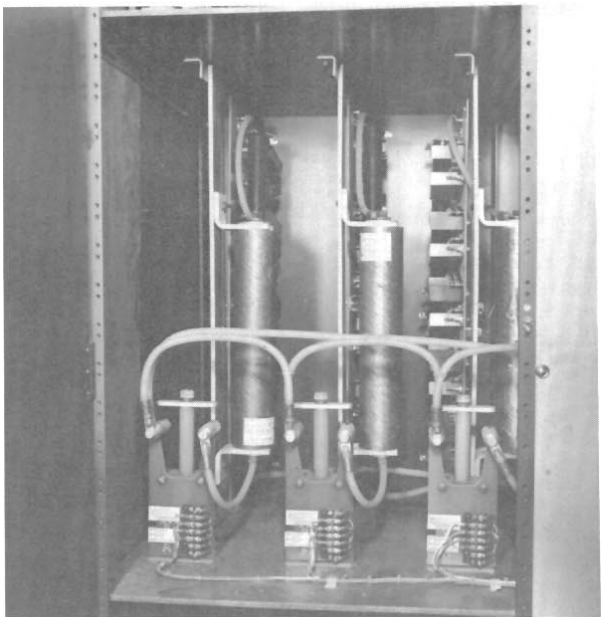
FIGURE 5
50 KV DIODE FANOUT

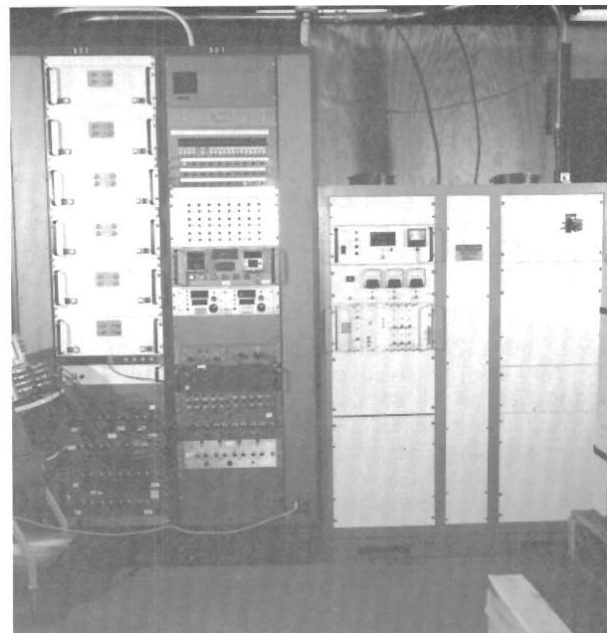
FIGURE 6
CONTROLS RACKS AND POWER SUPPLY
