NATIONAL ADVISORY COMMITTEE FOR AERONAUTICS

*1942A* MEMORANDUM REPORT

Bureau of Aeronautics, Navy Department  
FLIGHT TESTS OF VARIOUS TAIL MODIFICATIONS  
ON THE BREWSTER XSRA-1 AIRPLANE  
III - MEASUREMENTS OF FLYING QUALITIES  
WITH TAIL CONFIGURATION 3

By H. L. Crane and J. P. Reeder  
Langley Memorial Aeronautical Laboratory  
Langley Field, Va.

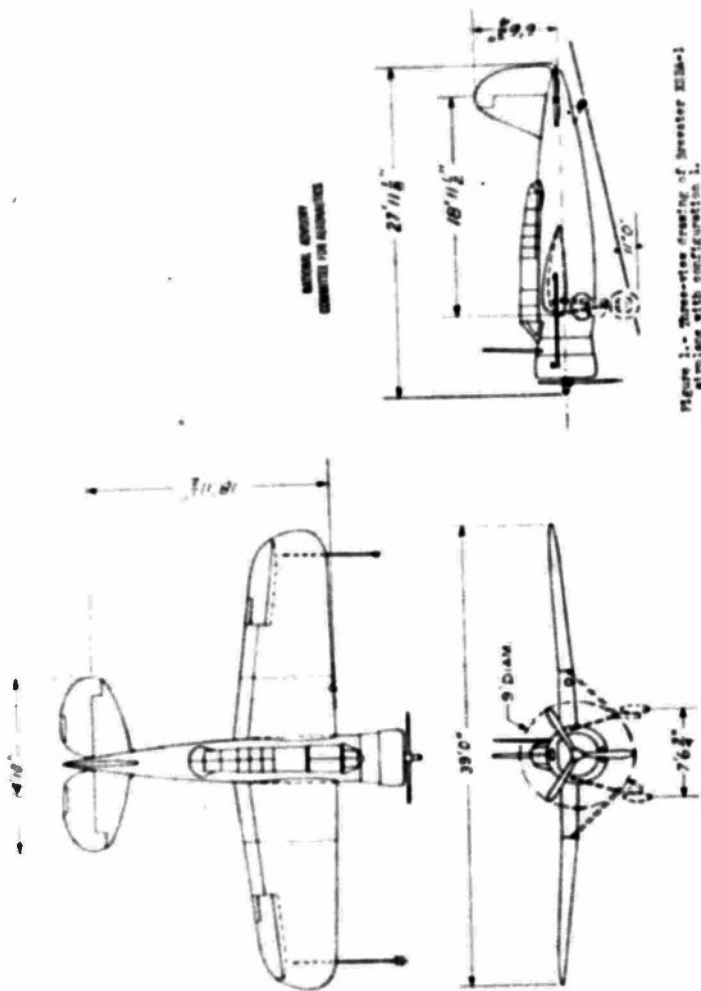
Figure 1.-Illustrative drawing of biplane 1085-T.

The XSBA-1 airplane is a two-place, single-engine, midwing, cantilever monoplane with retractable landing gear. For this series of investigations, the cut-outs in the flaps were covered to give conventional partial-span split flaps. The general specifications of the airplane are given in reference 1. Figure 1 is a

three-view drawing of the airplane with tail configuration 1. Figure 2 is a side-view photograph of the airplane with tail configuration 3.

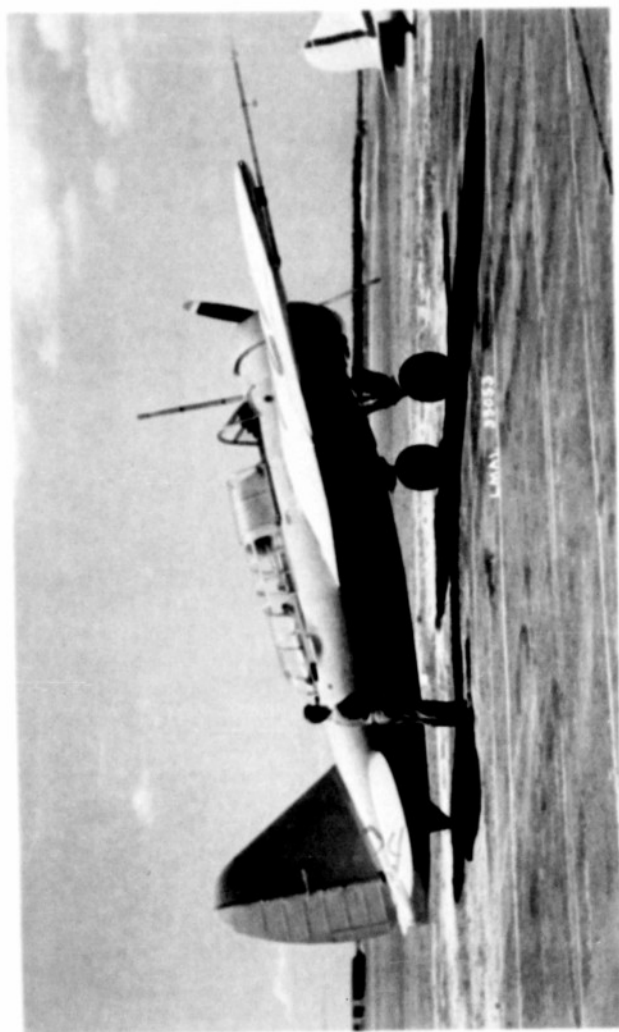
Figure 2 - Side view of X-52A-1 with tail configuration 2.

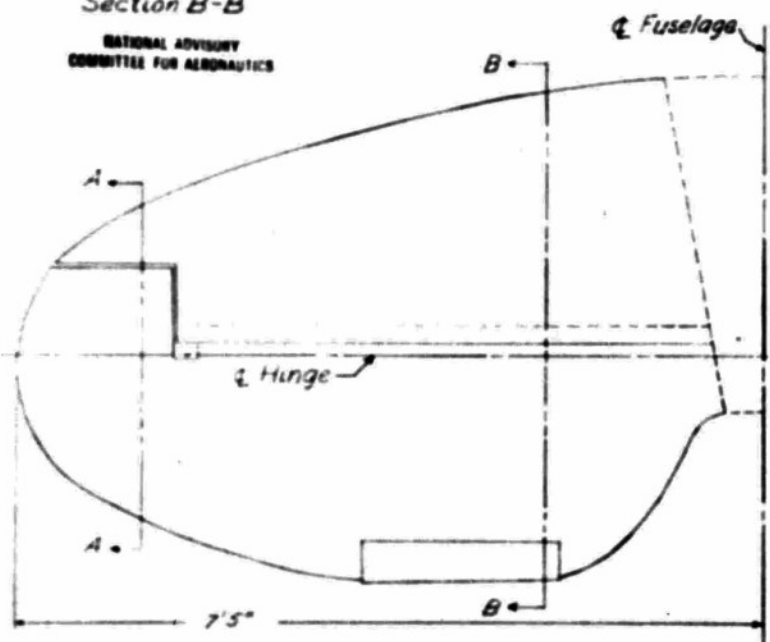
Section B-B  
 Trailing edge angle 23°

Figure 1.- Horizontal tail configuration number one. Brewster XB3A-1 airplane.

The surfaces of tail configuration 1, which are shown in figures 3 and 4, were horn-balanced and had approximately equal movable and fixed areas. The surfaces of configuration 2 (figs. 5 and 6) had approximately equal movable and fixed areas but were not horn-balanced. The elevator area of configuration 3 (figs. 7 through 10) was reduced to about 25 percent of the total horizontal area and the rudder area was reduced to 35 percent of the total vertical-tail area. Figure 11 shows trailing-edge sections of the various tail surfaces. The positions of the hinge lines with reference to the fuselage were the same in all cases so that the tail length of tail 3 was about 1 foot less in 17 than that of tails 1 and 2.

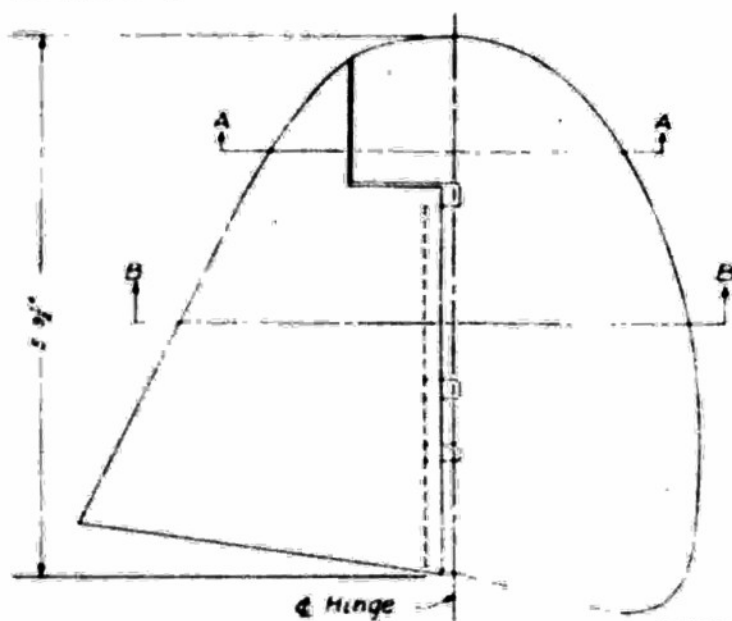
Figure 4.- Vertical tail configuration under way. Brewster BNA-1 airplane.

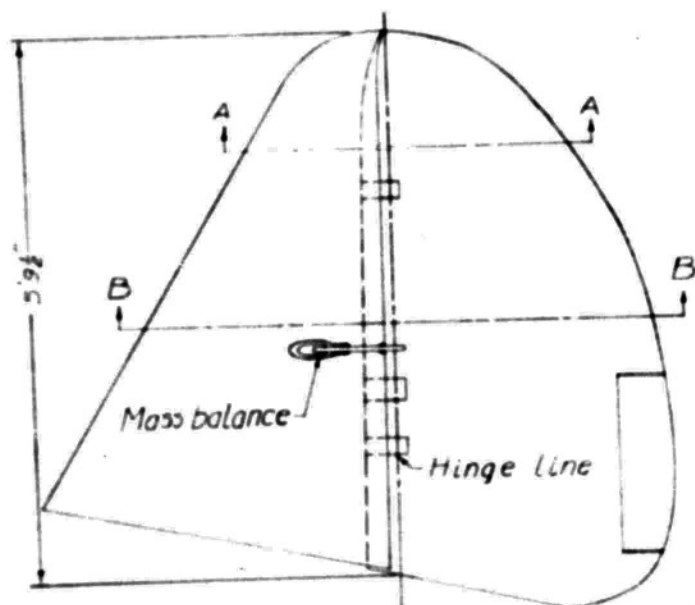
Figure 6.- Vertical foil configuration number ten. Brewster BSB-1 airplane.

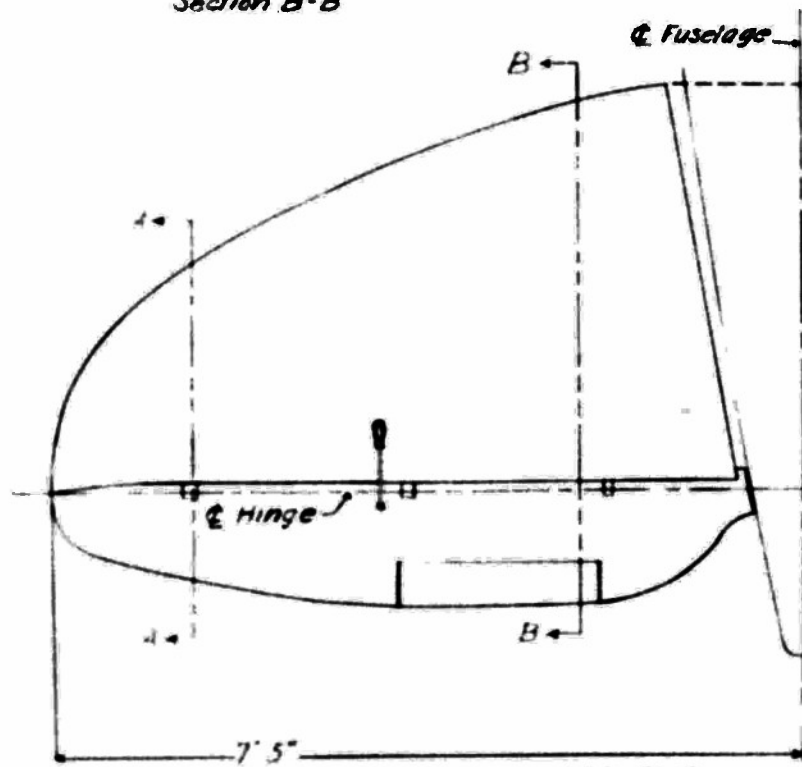
Figure 7.- Horizontal tail configuration of Brewster B2A-1 airplane.

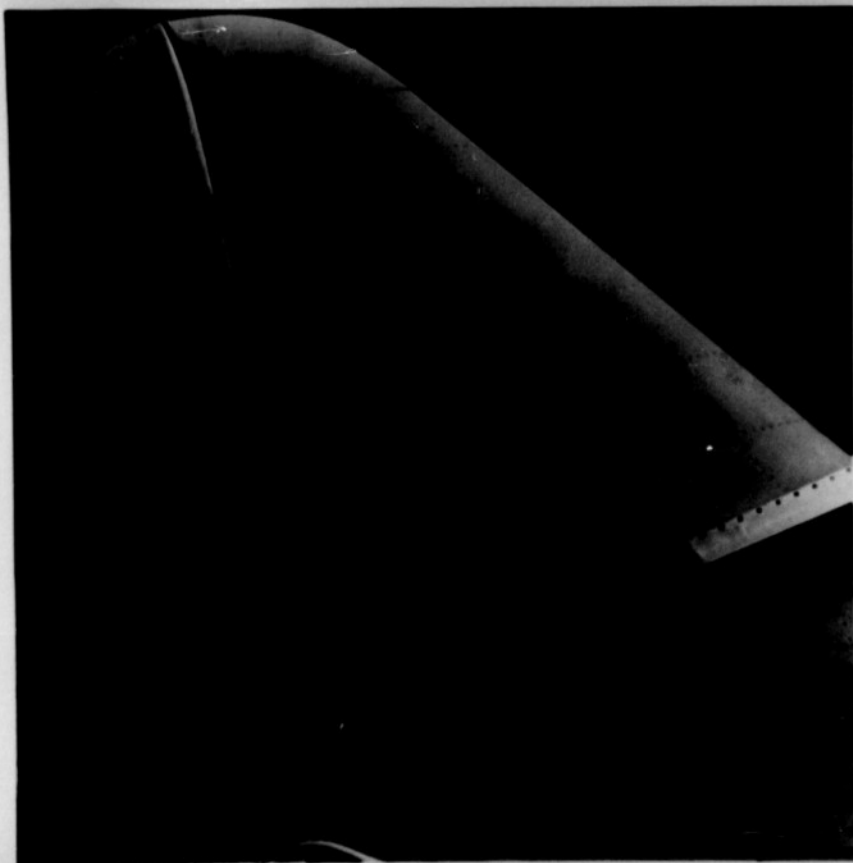
Figure 9.- Close-up of the vertical tail of configuration 3:  
XSEA-1 airplane.

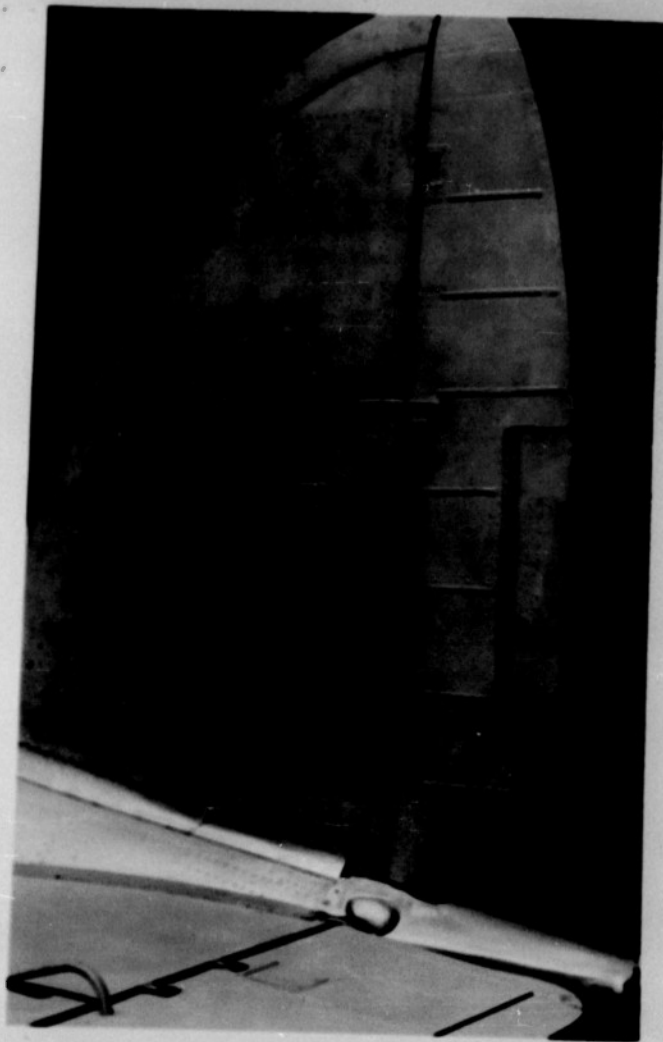
Figure 10.- Close-up of the horizontal tail of configuration 3:  
XSDA-1 airplane.

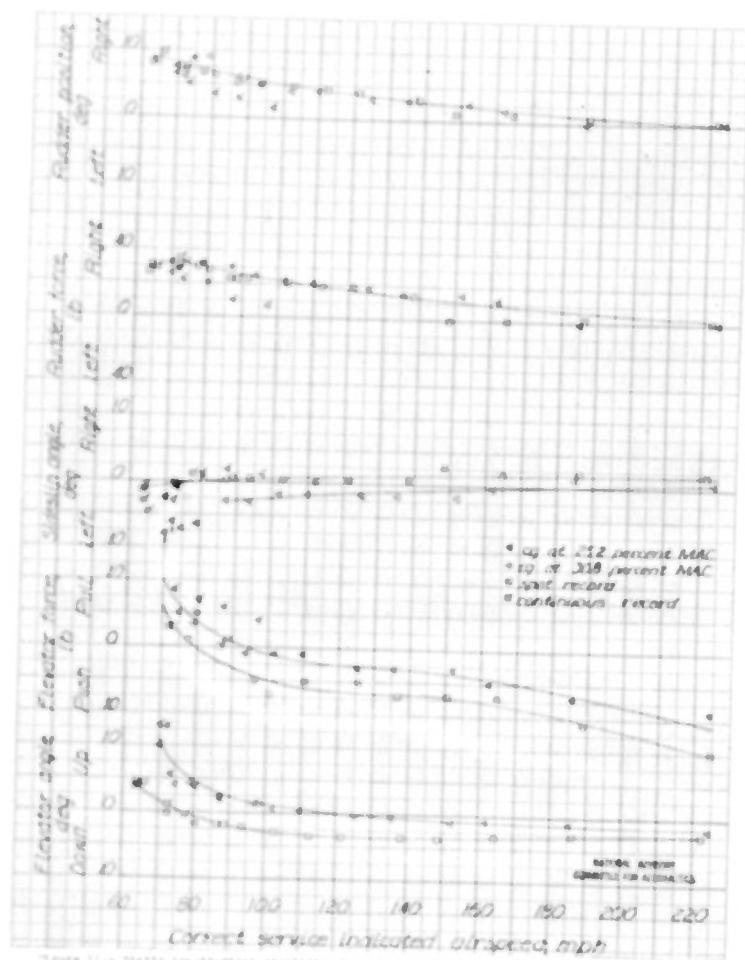
Figure 11. Static longitudinal stability characteristics of the F-4 Phantom II aircraft with full multi-spanning 1 to 100 percent control.

the speed range, the stick-fixed static stability had decreased but was still at least slightly positive for all flight conditions. This is illustrated by the curves of elevator position against airspeed in figures 15 through 20.

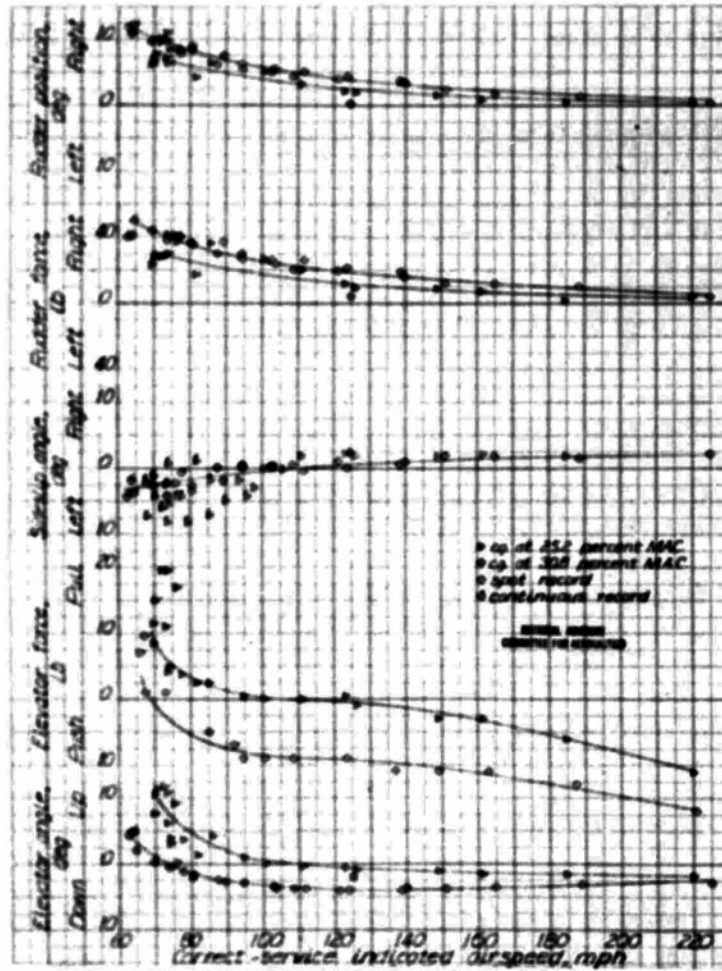
Figure 1. Data simplified statistics characteristic of the trial airplane with tail configuration 9 in the steady condition.

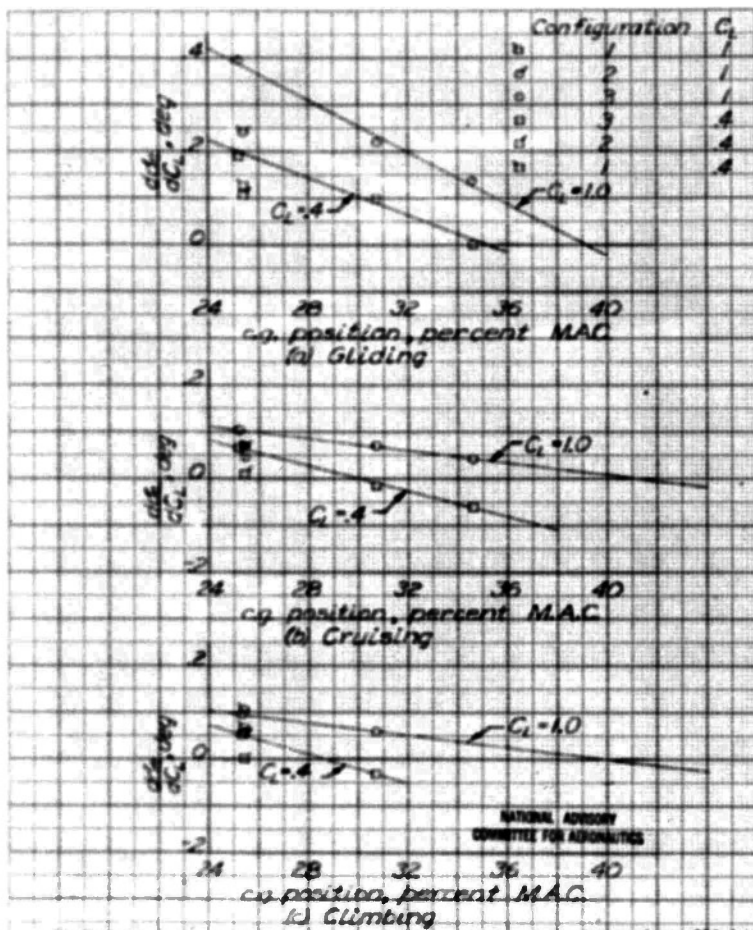
Figure 21. Plots showing stick-fixed neutral points in various flight conditions for the XRB-1 airplane.

1(b). The stick-fixed neutral points have been determined for the airplane with tail 3 at lift coefficients of 0.4 and 1.0 from flight tests at three center-of-gravity positions. Figure 21 contains the plots of  $\delta_e/dC_L$  against center-of-gravity position, where  $\delta_e$  is elevator position and  $C_L$  is airplane lift coefficient, from which the stick-fixed neutral points were determined. Figure 22, a plot of  $\delta_e$  against  $C_L$ , illustrates for one condition, landing, the intermediate step between the plots of elevator deflection against airspeed and the plots of  $\delta_e/dC_L$  against center-of-gravity position.

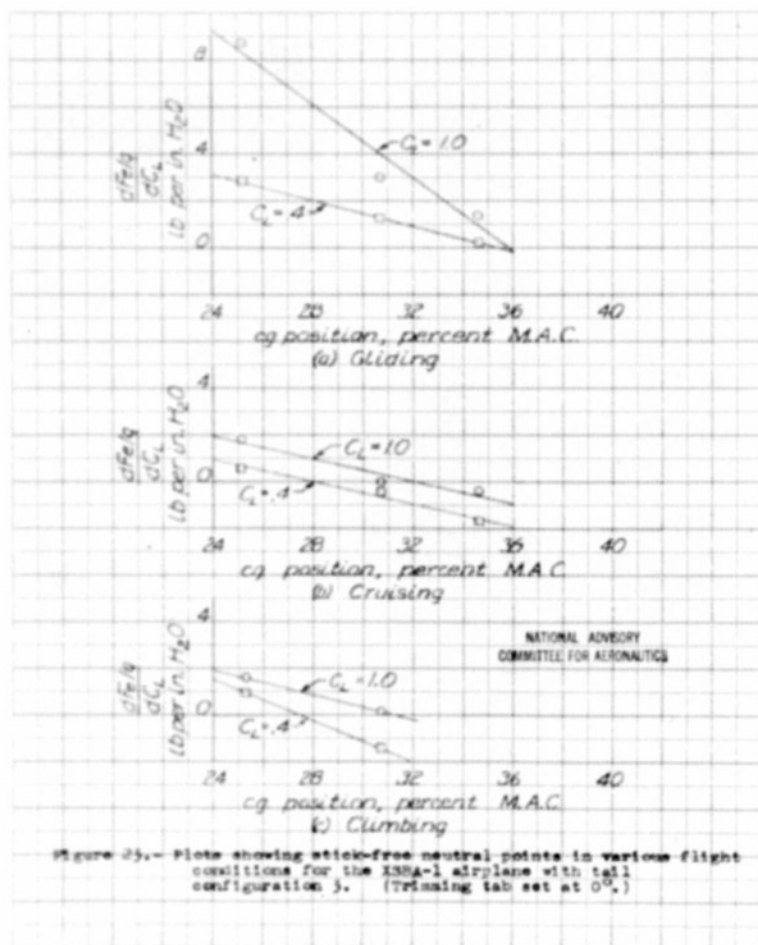
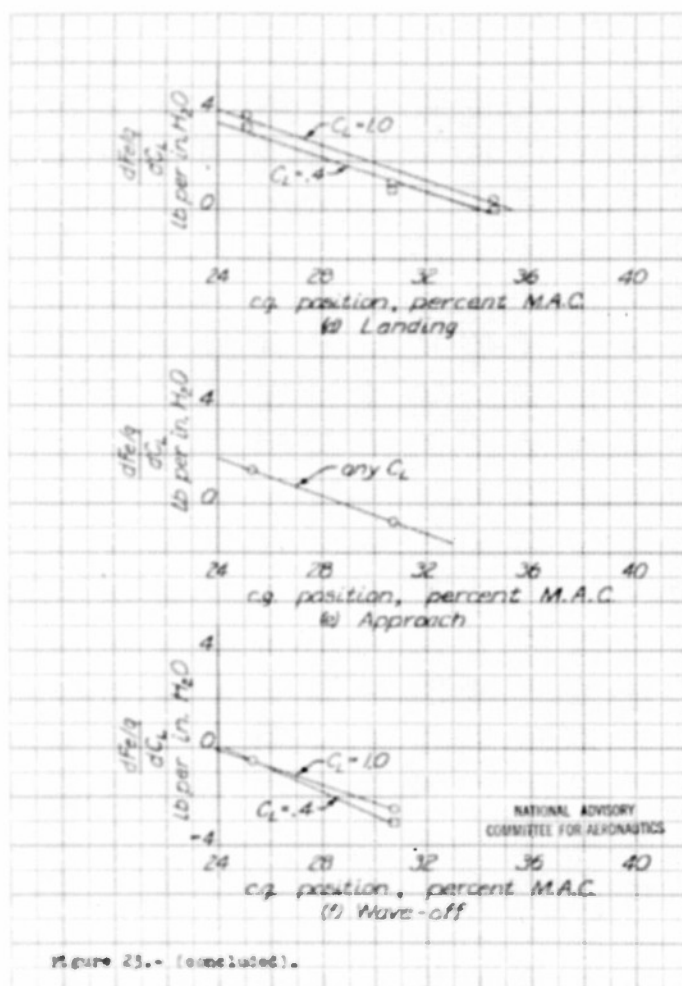
Figure 23.—Plots showing stick-free neutral points in various flight conditions for the XSB-1 airplane with tail configuration 3. (Trimming tab set at  $0^\circ$ .)

2(b). The stick-free neutral points have been determined at lift coefficients of 0.4 and 1.0 for the airplane with tail configuration 3 from flight tests at three center-of-gravity positions. Figure 23 contains plots of the variation of  $P/q_c$  with  $C_L$  against center-of-gravity position, where  $P$  is elevator control force and  $q_c$  is impact pressure, from which the neutral points are determined. The intermediate step, a plot of  $P/q_c$  against  $C_L$ , is again illustrated for one condition by figure 22.

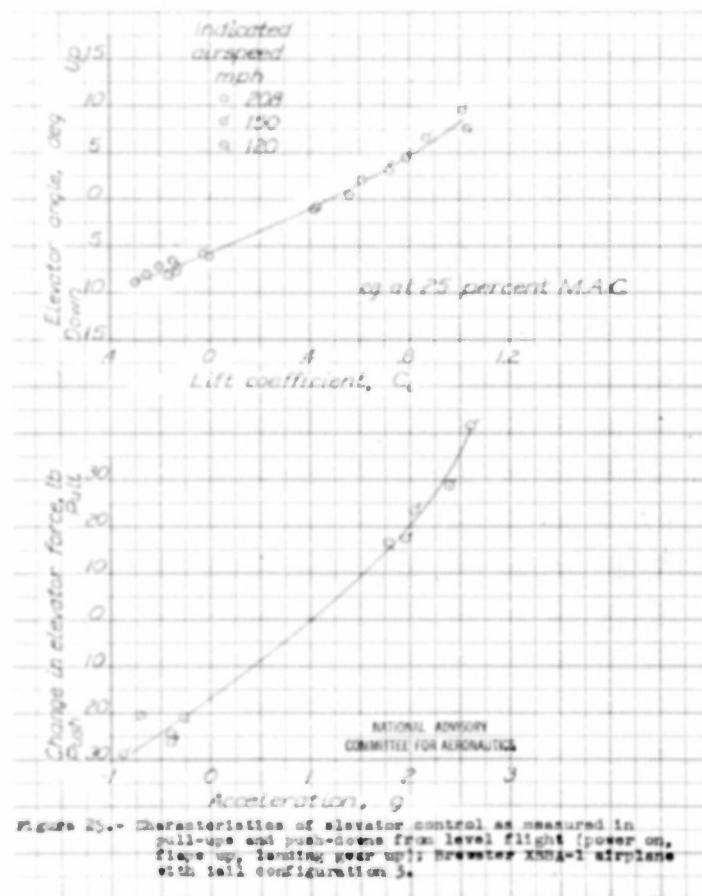
Figure 25.- Characteristics of elevator control as measured in pull-ups and push-downs from level flight (power on, flaps up, landing gear up); Brewster XN24-1 airplanes with tail configuration 3.

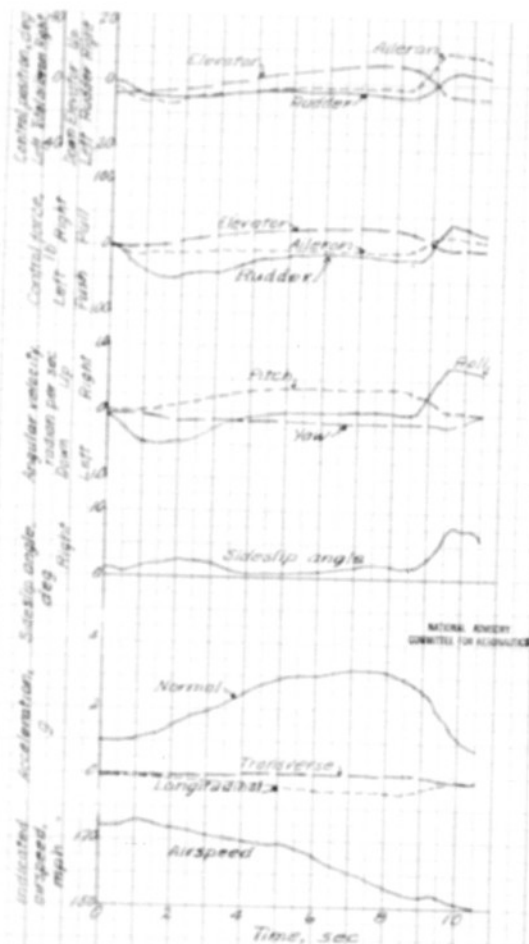
Figure 21. Time history of an abrupt left turn at 2 1/4 rolls per hour. Elevator 100A-1 airplane with tail configuration 3; rad. at 50,000 feet, 10,000 ft.

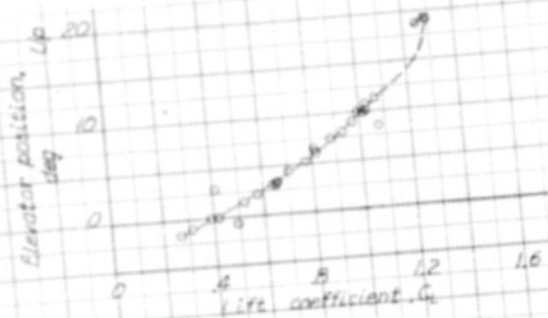
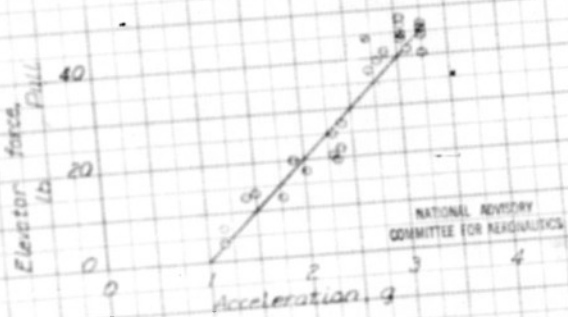
Figure 30.- Variation of elevator control force with normal acceleration, and variation of elevator position with lift coefficient in turns; Brewster XNNA-1 airplane with tail configuration 51 a.g. at 25.2 percent W.L.C.

Characteristics of elevator control in accelerated flight.—The characteristics of the elevator control of the XSB-1 airplane in accelerated flight were determined from measurements taken in abrupt pull-ups and push-downs from level flight, and in turns. The results of the pull-ups and push-downs with tail configuration 3 are presented in figure 25. Time histories of representative turns are presented in figures 26 to 29. The variation of stick force with normal acceleration and elevator position with  $C_L$  in turns for three center-of-gravity positions is plotted in figures 30 to 32. Figure 33 shows the stick-fixed and stick-free neutral points for accelerated conditions.

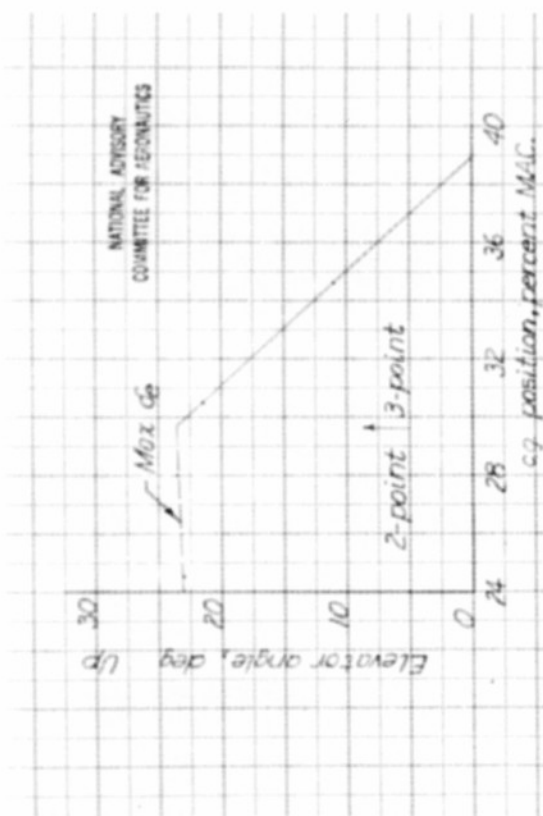
Figure 34.- Elevator deflection required to land XPM-1 airplane with tail configuration 3 (power off, flaps down).

aerodynamic chord the elevator did not have sufficient power to stall the airplane in the landing condition either at altitude or during an actual landing, as shown by figures 22 and 34. With the wider chord surfaces of tails 1 and 2 the elevator angles required for trim were well within the available range for all flight conditions.

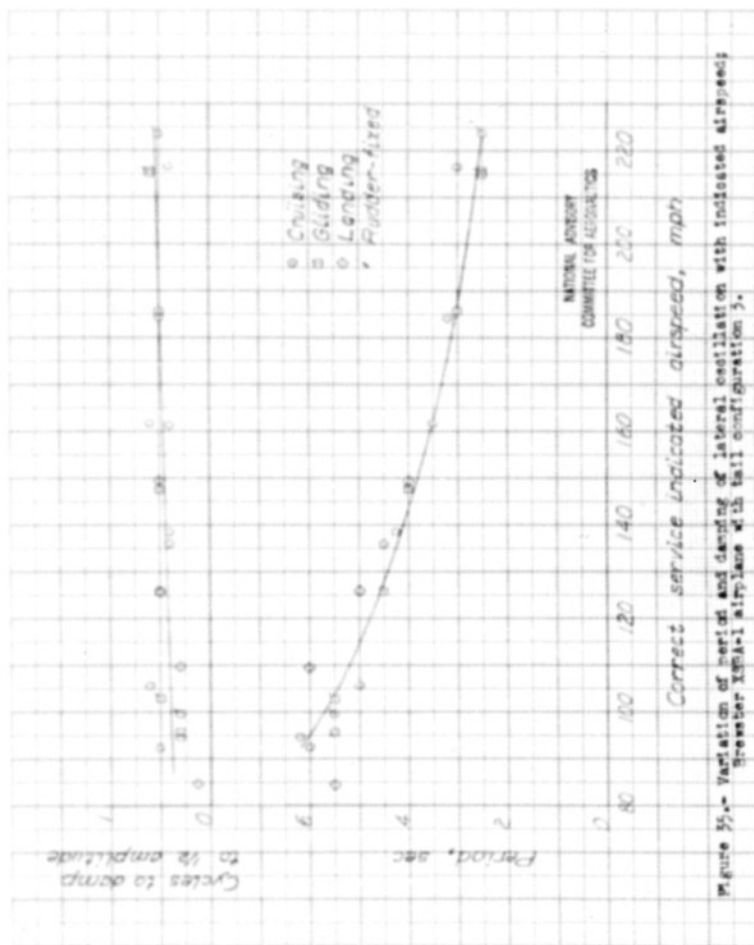
Figure 55.- Variation of period and damping of lateral oscillation with indicated airspeed; B-29 Superfortress airplane with tail configuration 3.

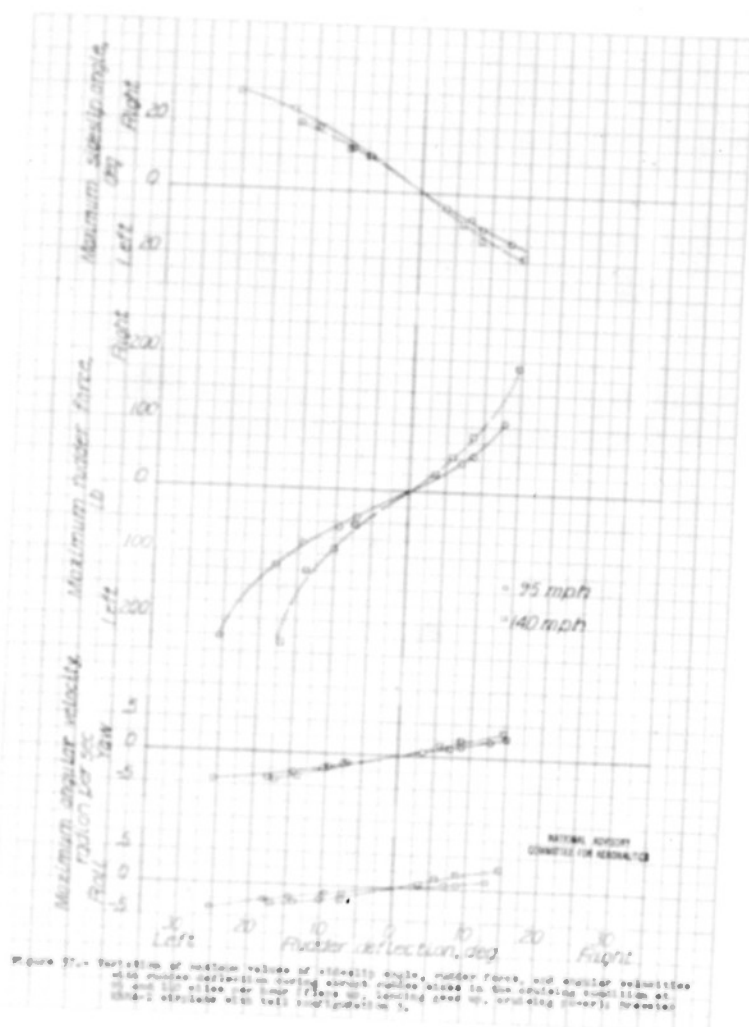
Figure 37.- Variation of maximum values of side-slip angle, rudder force, and angular velocities with rudder deflection during abrupt rudder moves in the following conditions: at 75 and 140 miles per hour (flaps up, landing gear up, cruising 20-25); trimmed 20-25; airplane with tail configuration 2.

Rudder control characteristics.- The rudder control characteristics were measured in steady flight, in rolls, in sideslips, and in abrupt rudder kicks. In the rudder-kick maneuvers, records were taken of rudder position, rudder force, rolling velocity, yawing velocity, and sideslip angle resulting from abrupt deflections of the rudder in steady flight while the other controls were held fixed. The results of the rudder kicks are shown in figures 36 through 38. The results of the sideslips are shown in figures 39 through 46. The rolls were made as turn entries with full aileron deflection using the rudder to maintain zero sideslip and also with the rudder locked in its trim position. Figures 47 through 51 are time histories of these maneuvers.

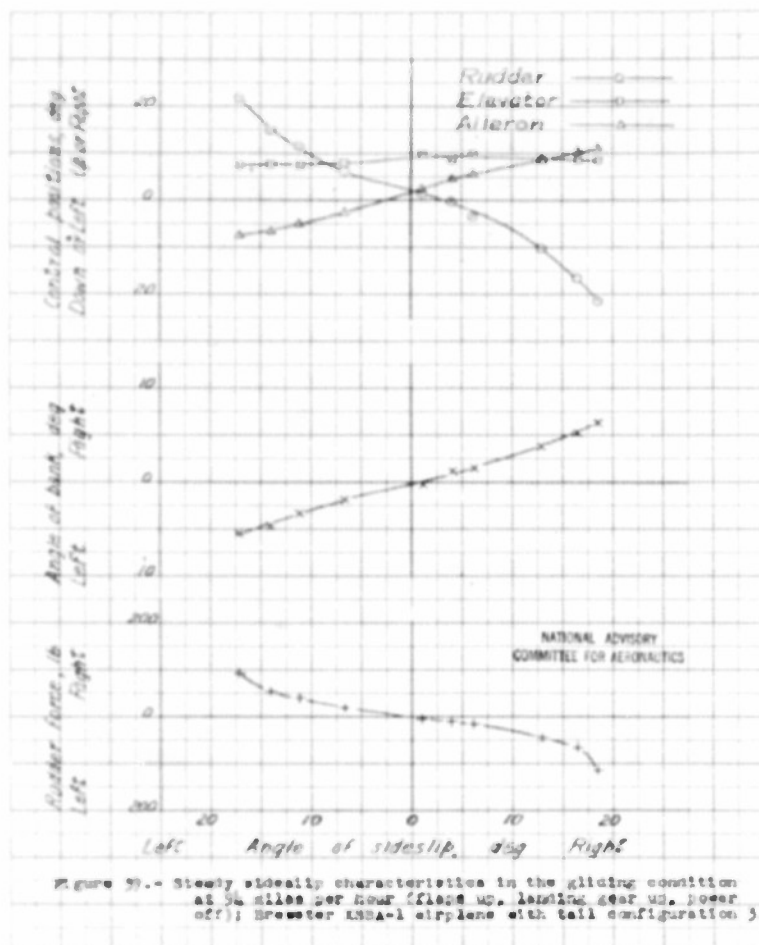
Figure 29.- Steady sideslip characteristics in the gliding condition at 50 miles per hour (flaps up, landing gear up, power off); Brewster BNA-1 airplane with tail configuration 3.

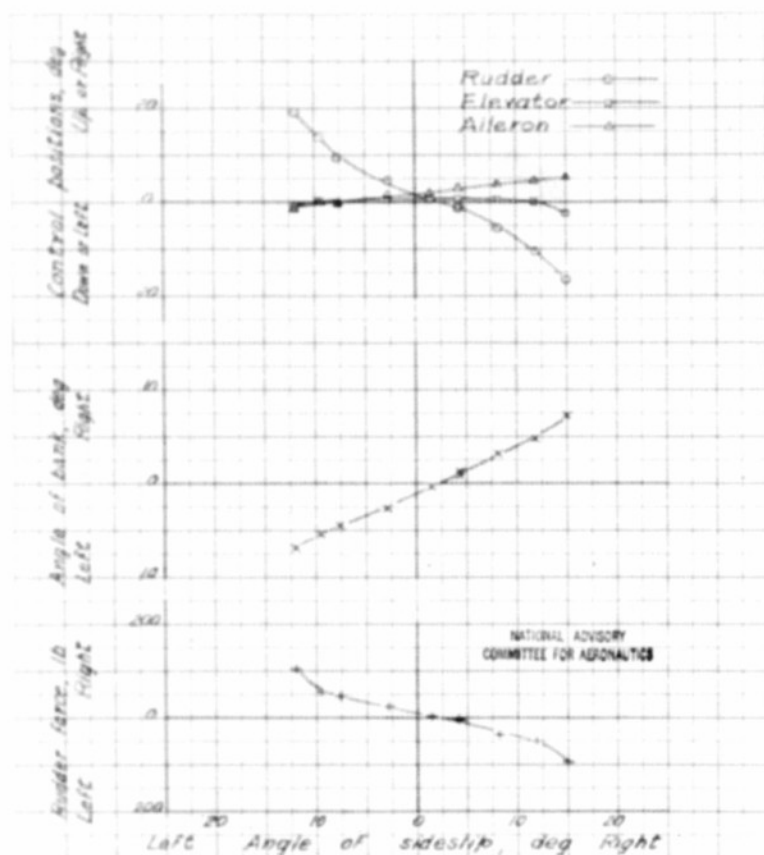
Figure 44.- Steady sideslip characteristics in the landing condition at 112 miles per hour (flaps down, landing gear down, power off); Brewster BSA-1 airplane with tail configuration 3.

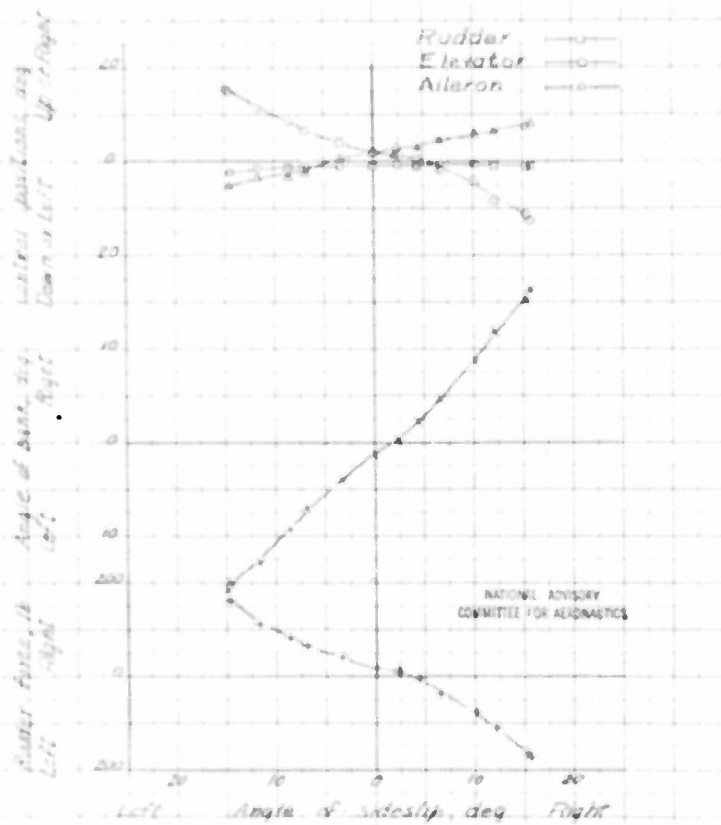
Figure 45. - Steady sideslip characteristics in the level flight condition at 157 miles per hour (flaps up, landing gear up, power on); Brewster XSB-1 airplane with tail configuration 3.

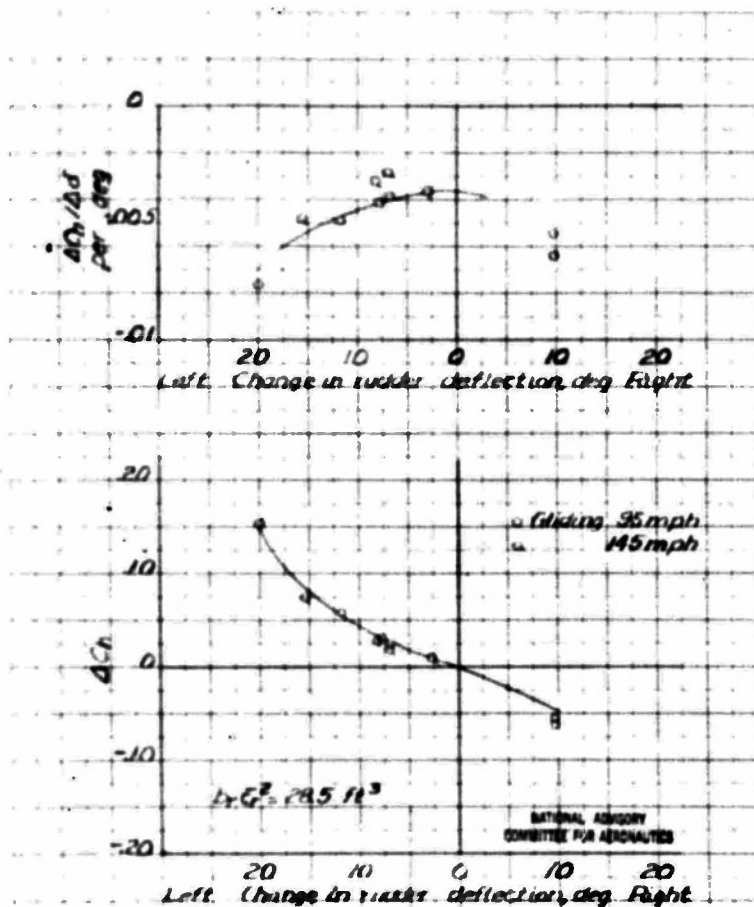
Figure 32.- Plots of  $\Delta C_Y/\Delta \delta$  and  $\Delta C_D$  for constant  $\alpha$  against change of rudder deflection during rudder kicks; XSB-1 airplane with tail configuration 1.

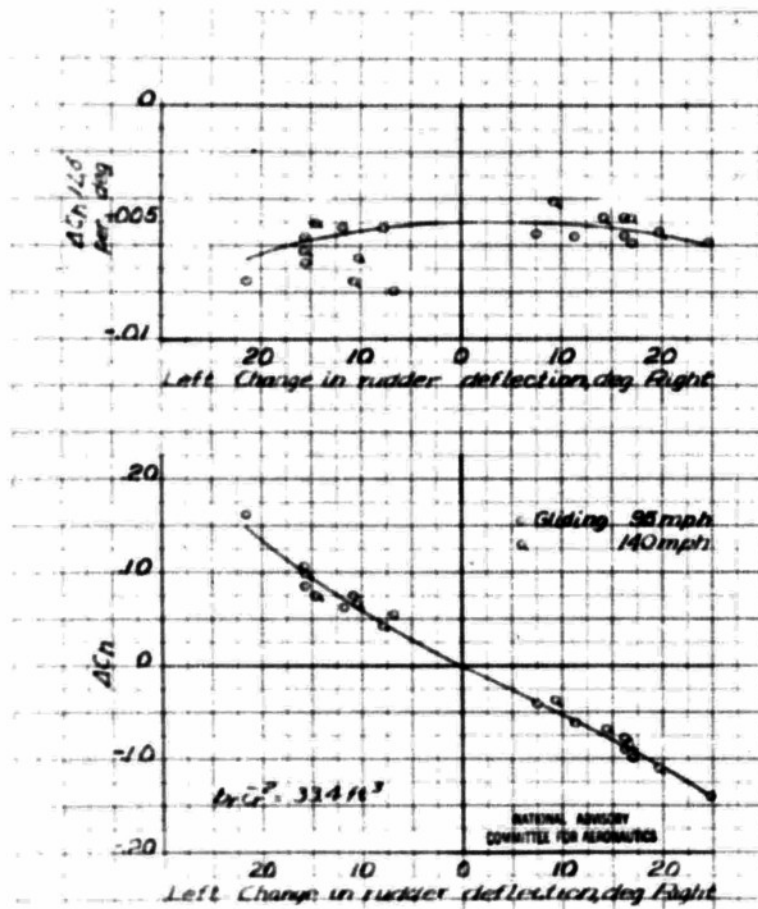
Figure 55.- Plots of  $\Delta C_n / \Delta \delta$  and  $\Delta C_n$  for constant  $\alpha$  against change of rudder deflection during rudder kicks; XSB-1 airplane with tail configuration 2.

Figure 55.- Plots of  $\Delta C_h / \Delta \alpha$  and  $\Delta C_h$  against change of sideslip angle during rudder kicks; XSBA-1 airplane with tail configuration 2.

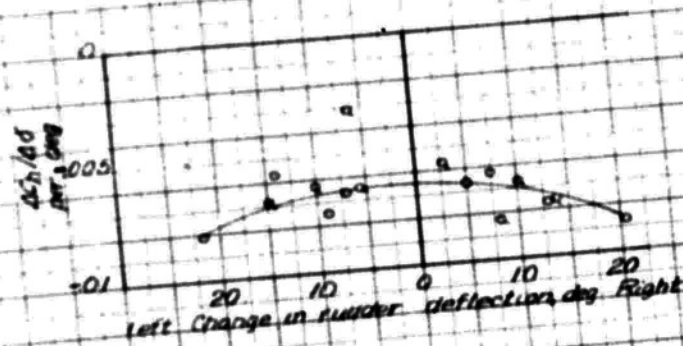
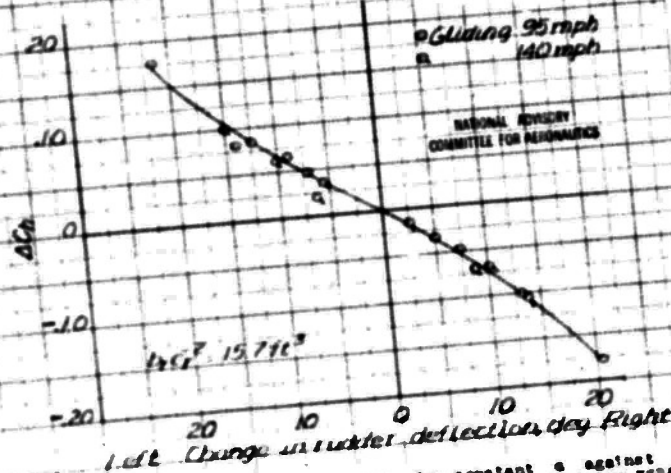
Figure 3.- Plots of  $aC_n/\delta\delta$  and  $\Delta C_n$  for constant  $\alpha$  against change of rudder deflection during rudder kicks; XPA-1 airplane with tail configuration 5.

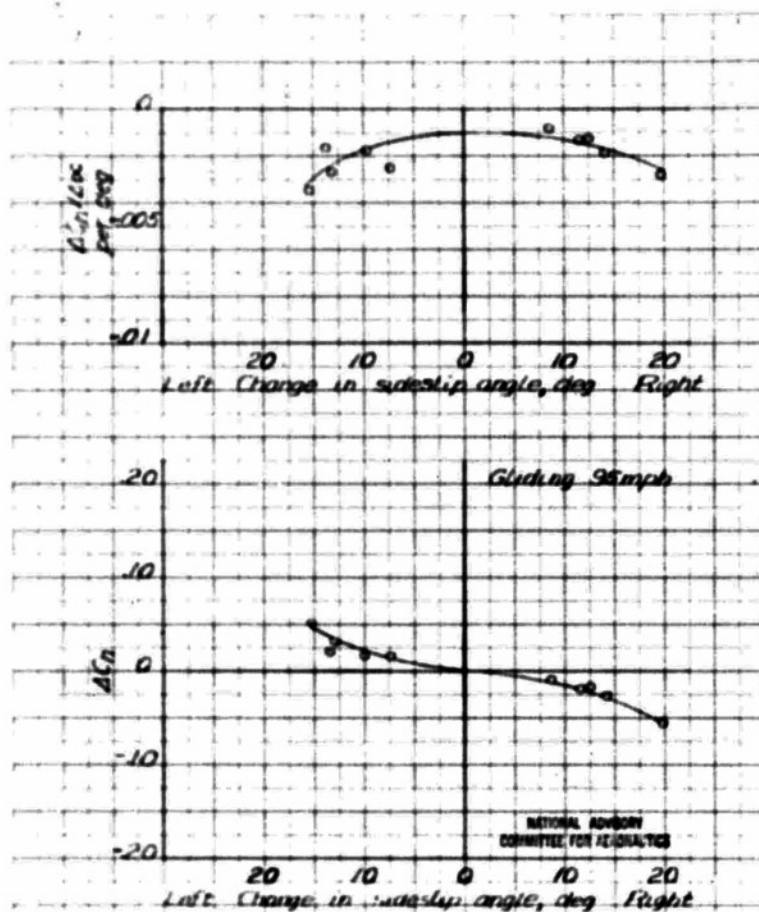
Figure 55.- Plots of  $\Delta C_{l, \text{ per deg}}$  and  $\Delta C_{D, \text{ per deg}}$  against change of sideslip angle during rudder kicks; XSA-1 airplane with tail configuration 2.

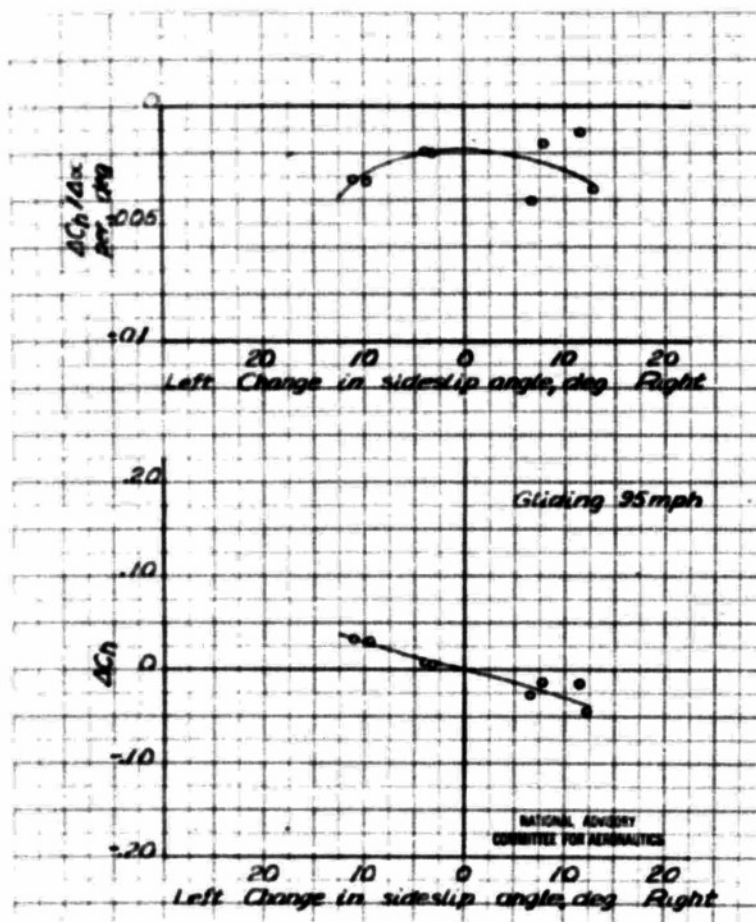
Figure 56.- Plots of  $\Delta C_n / \Delta \alpha$  and  $\Delta C_n$  against change of sideslip angle during rudder kicks; XRA-1 airplane with tail configuration 3.
