December 1944 as  
Memorandum Report A4L18

HIGH-SPEED WIND-TUNNEL TESTS OF SEMISPAN HORIZONTAL  
TAILS WITH FABRIC-COVERED AND METAL-COVERED  
ELEVATORS FOR A BOMBER AIRPLANE

By Albert L. Erickson and Warren H. Nelson

Ames Aeronautical Laboratory  
Moffett Field, California

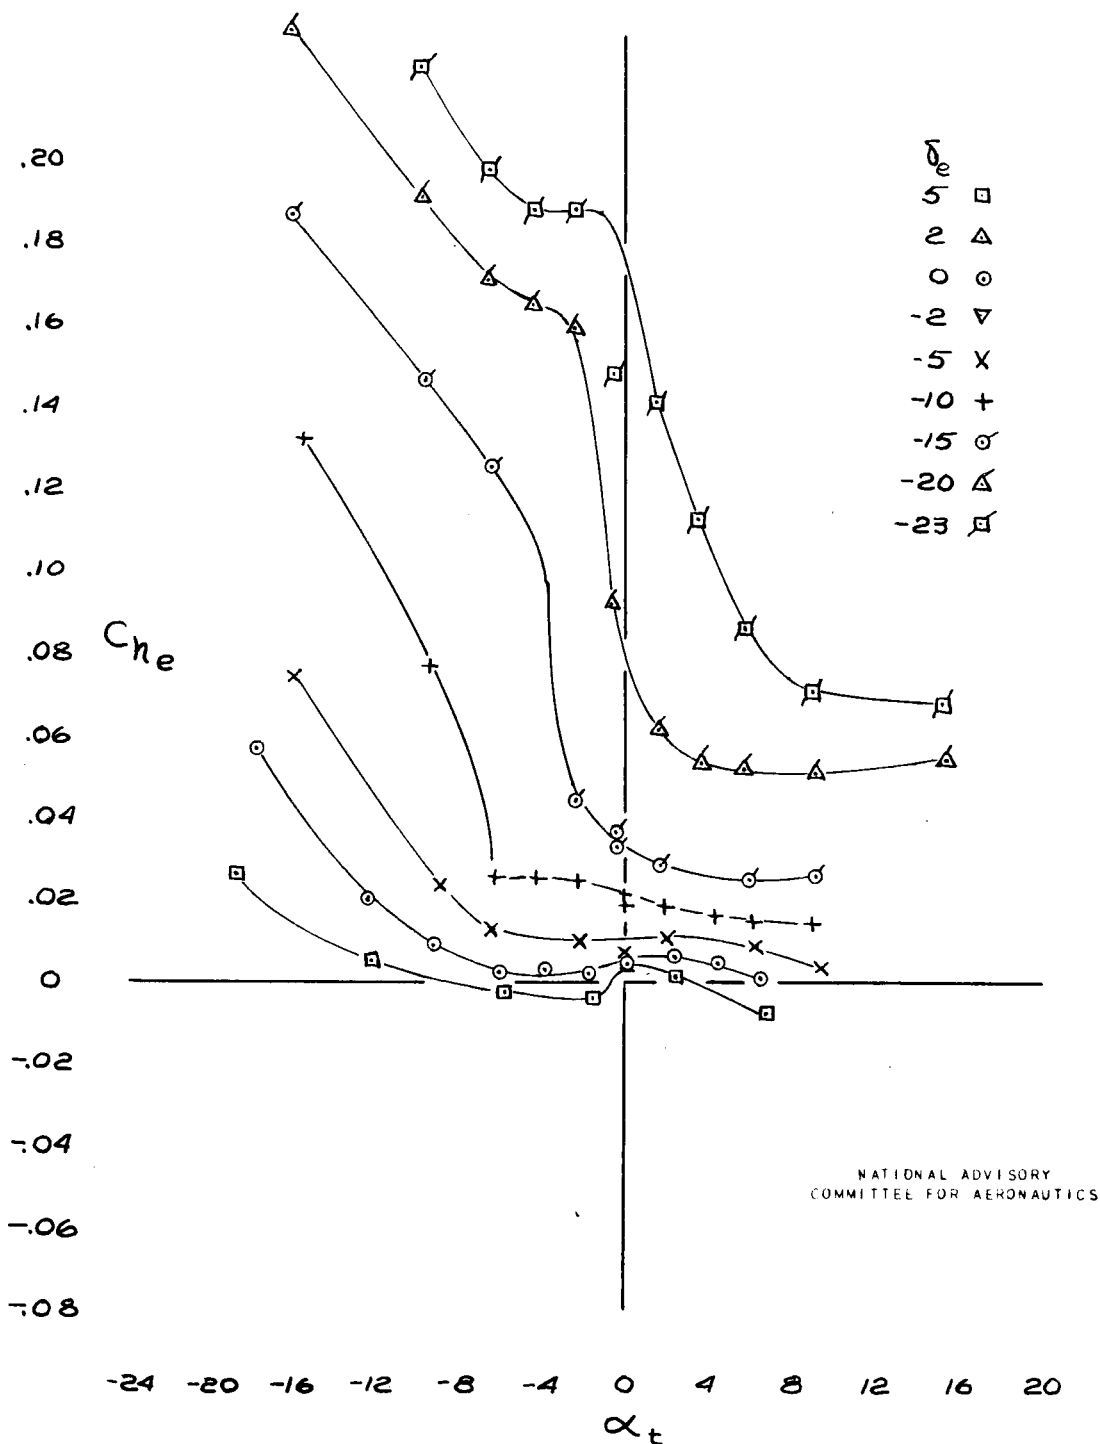
(Q.) FABRIC-COVERED ELEVATOR  
 FIGURE 5. - VARIATION OF HINGE-MOMENT  
 COEFFICIENT WITH TAIL ANGLE OF ATTACK.  
 $M, 0.133$  ;  $\delta_t, 0^\circ$ .

(6) METAL-COVERED ELEVATOR  
FIGURE 5. - CONCLUDED.

At a Mach number of 0.133 there was no noticeable distortion of either elevator. Figures 5 to 8 show that, as would be expected, the fabric-covered and metal-covered elevators had similar aerodynamic characteristics at this low Mach number.

The breaks in  $\partial C_{he}/\partial \alpha t$  and  $\partial C_{mt}/\partial \alpha t$ , noted in figures 5(a) and 6(a), were believed to be caused by a sudden forward movement of the transition point. Transition was fixed at 20 percent chord by means of a strip of carborundum in order to investigate this effect, and the results are shown in figures 37 and 38. These results show that there were no breaks in the curves (fig. 38) when the transition point was fixed, hence the breaks that occurred when the point of transition was not fixed were probably caused by a forward movement of the transition point. Figure 39 shows that, at an elevator angle of  $-20^\circ$ , the pressure distribution on the stabilizer with the fabric-covered elevator changes from a favorable gradient at  $4^\circ$  angle of attack to an unfavorable gradient at  $-4^\circ$ . Transition would be expected to occur at about  $0^\circ$  or at a slightly more negative angle, which would agree with the transition breaks noted on the curves (figs. 37 and 38). The breaks noted in these data are probably not as sharp on the airplane due to the interference of the fuselage. The turbulence level of the 16-foot wind tunnel is very low, and probably the effective Reynolds number in the tunnel closely approximates that at the tail of the airplane in free air.

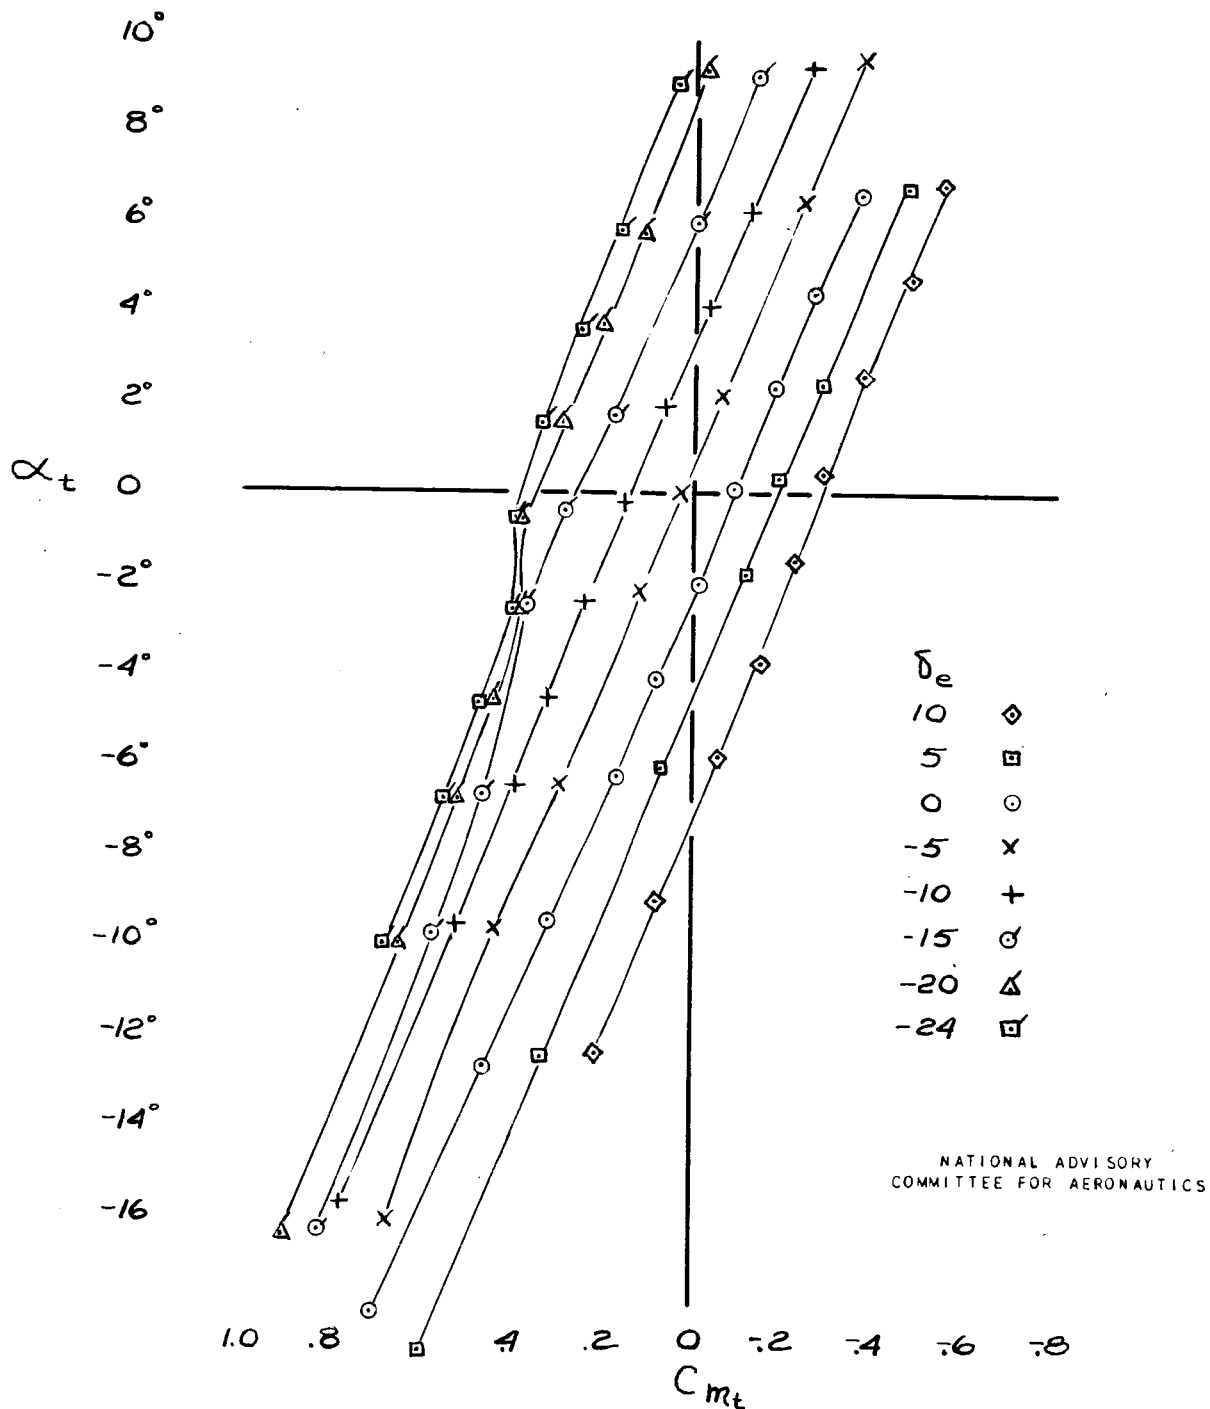
(a) FABRIC-COVERED ELEVATOR.  
FIGURE 6.- VARIATION OF PITCHING-MOMENT  
COEFFICIENT DUE TO THE TAIL WITH  
TAIL ANGLE OF ATTACK.  $M, 0.133$ ;  $\delta_t, 0^\circ$ .

(b) METAL-COVERED ELEVATOR  
FIGURE 6.- CONCLUDED.

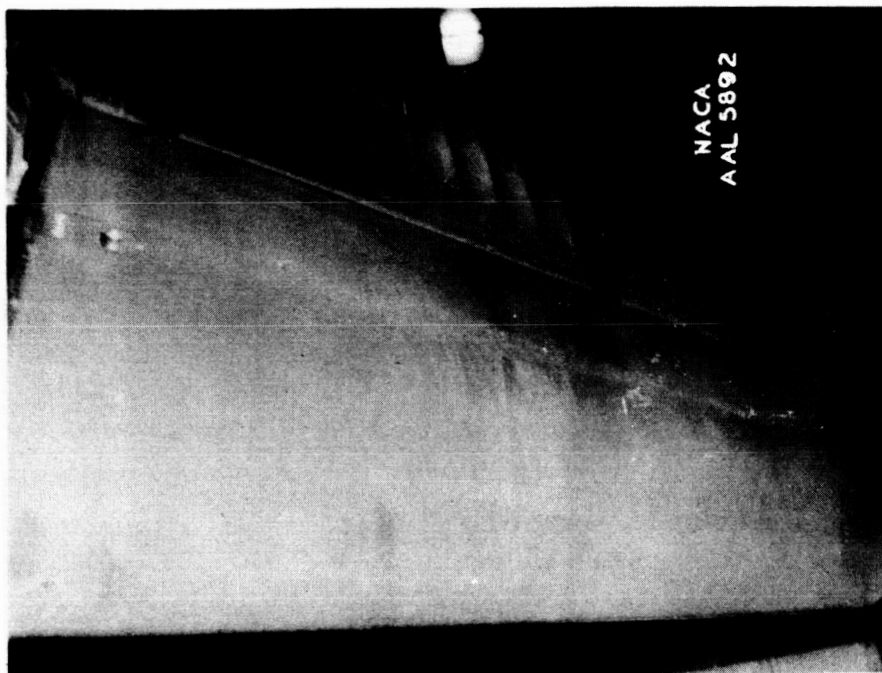
(a) Upper surface.

(b) Lower surface.

Figure 14.- The bomber stabilizer with the fabric-covered elevator.  $M$ , 0.72;  $\alpha_t$ ,  $-3^\circ$ ;  $\delta_e$ ,  $0^\circ$ .

The deformations of the fabric-covered and metal-covered elevators at 0.72 Mach number are shown in figures 14 and 15. These figures show that the fabric was distorted to a concave shape on both the upper and lower surfaces, as was true under all conditions tested. In figure 15 it is seen that the metal surface was slightly distorted so that its characteristics are not those of a rigid surface. From these pictures it should be recognized that the differences shown in comparing the fabric surface with the metal surface are not as large as the differences between the fabric-covered elevator and a rigid-surface elevator.

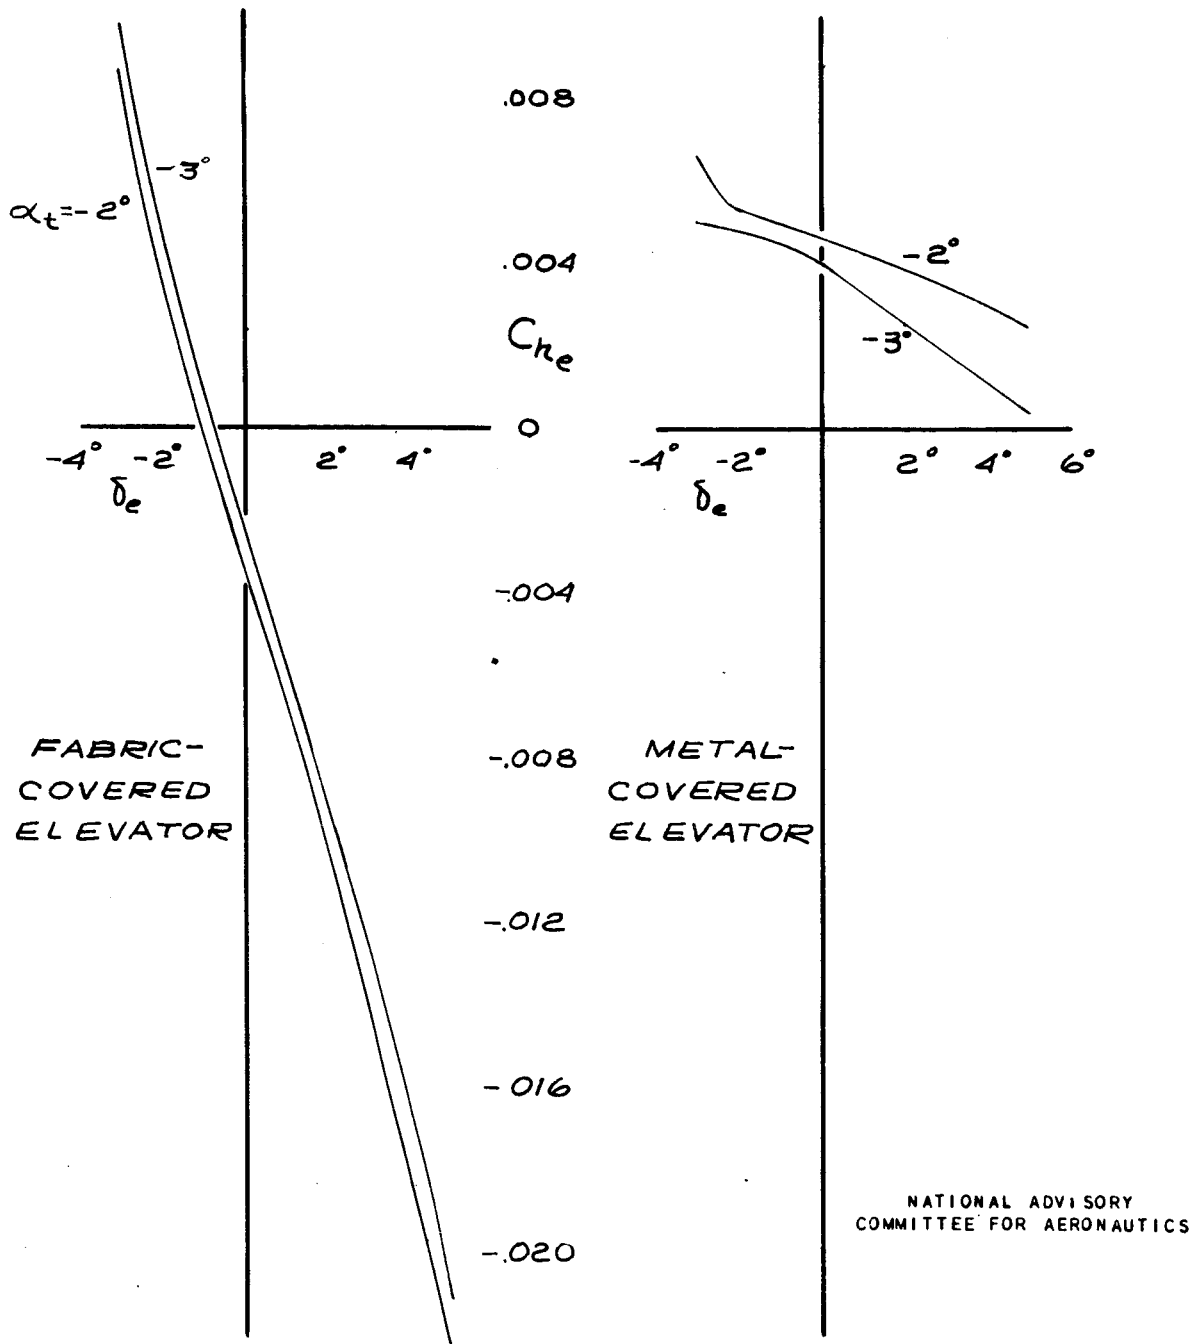
FIGURE 17.- VARIATION OF ELEVATOR HINGE-MOMENT COEFFICIENT WITH ELEVATOR ANGLE.  $M, 0.72$ ;  $\delta_t, 0^\circ$ .

At 0.72 Mach number an extremely large change is effected in the comparative aerodynamic characteristics of the fabric-covered and metal-covered elevators. Although the data at 0.72 Mach number were limited by the model strength, the large differences are clearly evident (figs. 16 to 22). In figures 16(a) and 16(b),  $\partial C_{he}/\partial \alpha_t$  is 0.0020 for the metal-covered elevator and -0.0010 for the fabric-covered elevator. The curves of  $\partial C_{he}/\partial \alpha_t$  for the metal-covered elevator have a discontinuity between  $-2^\circ$  and  $-2.3^\circ$  angle of attack, which is probably due to separation caused by supercritical speeds. Figure 17 shows an extreme difference in  $\partial C_{he}/\partial \delta_e$ . This slope is -0.0033 for the fabric surface and -0.0005 for the metal surface. The small value of  $-\partial C_{he}/\partial \delta_e$  for the metal-covered elevator at 0.72 Mach number (fig. 17) was determined from a very limited amount of data. Since the elevator profile has but slight effect on  $-\partial C_{he}/\partial \delta_e$  at large elevator angles, this slope would probably assume a value similar to that for the fabric-covered elevator at larger negative and positive elevator angles. Figures 18(a) and 18(b) show that the tail effectiveness  $\partial C_{mt}/\partial \alpha_t$  remains the same for both elevators. The effect of the distortion of the fabric surface on the various parameters is to be expected, and probably could be predicted if the exact distortion were known (references 2 and 3).

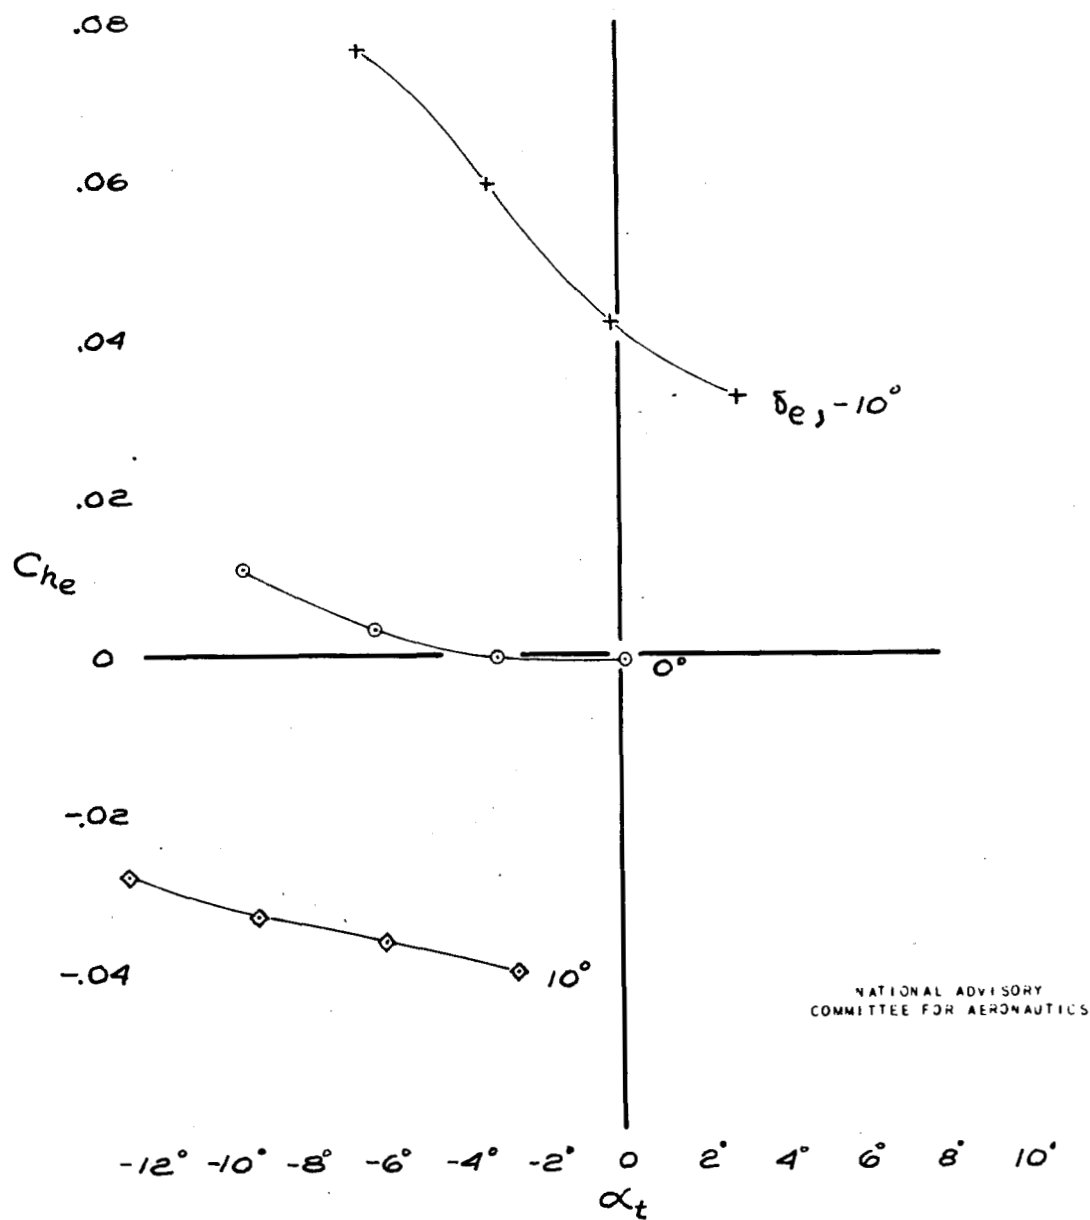
FIGURE 29.-VARIATION OF HINGE-MOMENT COEFFICIENT WITH TAIL ANGLE OF ATTACK, FABRIC-COVERED ELEVATOR WITH LEAK HOLES IN BALANCE SEAL.  $M, 0.33$ ;  $\delta_t, 0^\circ$ .

Sixteen holes, 1-1/16 inches in diameter, were cut in the balance seal, as noted in figure 3. The effects of these openings are presented in figures 26 to 32. The slope  $-\partial C_{he}/\partial \alpha_t$  was not changed by the leak holes, but the slope  $-\partial C_{he}/\partial \delta_c$  was about doubled. The calculated stick force per g at 0.33 Mach number for sea-level conditions is about 13 pounds with the sealed balance and about 26 pounds with the holes in the seal. In general, the stick-force gradients are about doubled when the leak holes are placed in the balance seal.

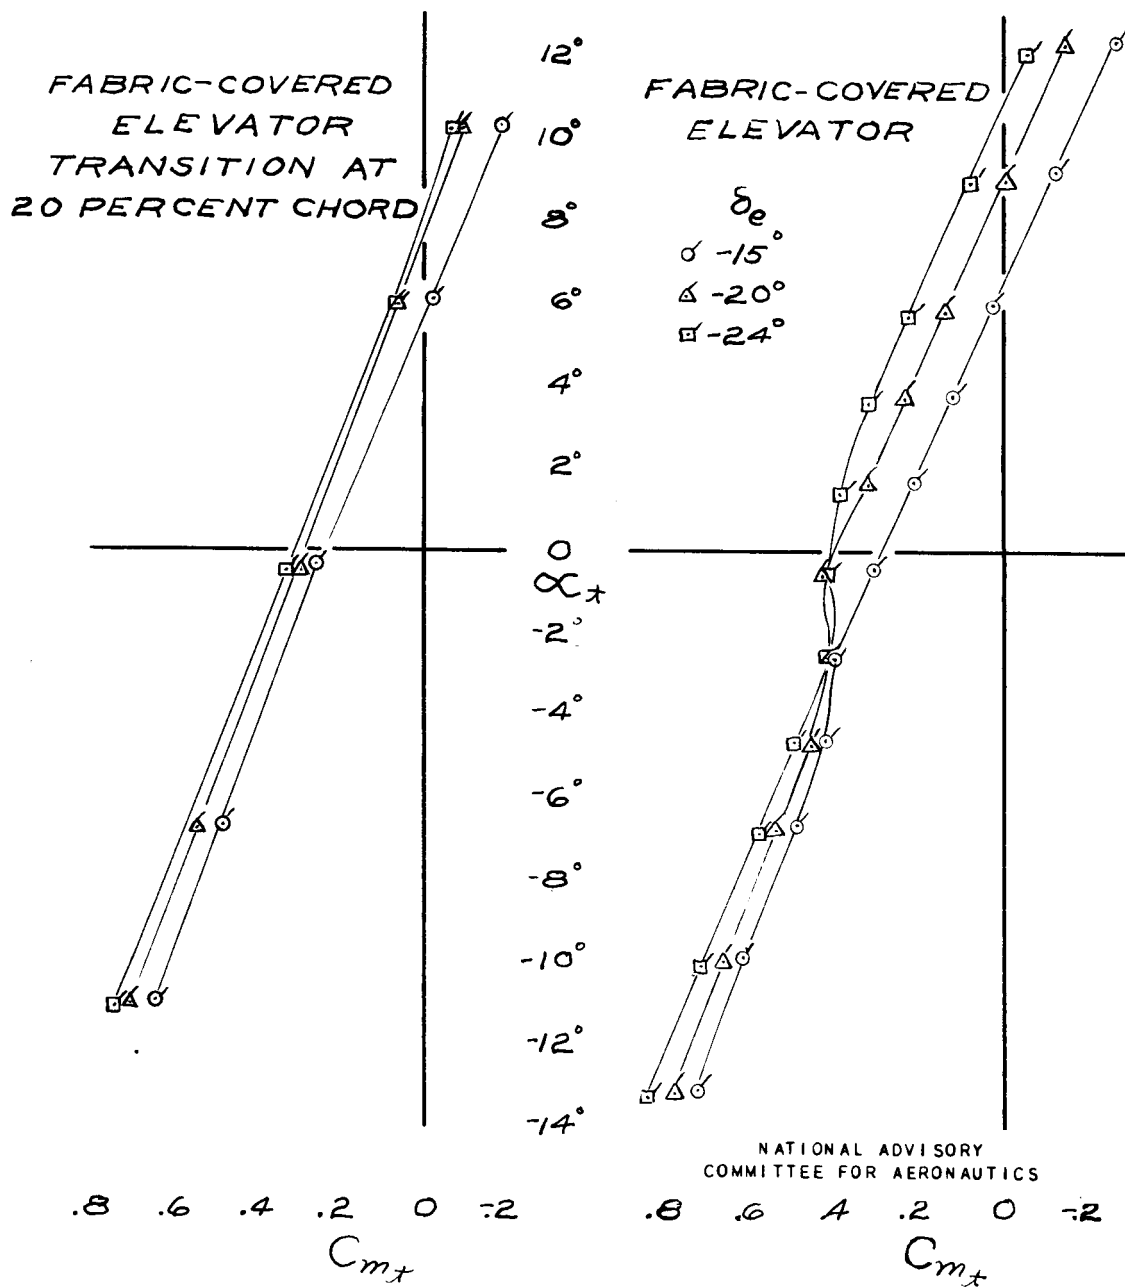
FIGURE 38.- VARIATION OF PITCHING-MOMENT COEFFICIENT DUE TO THE TAIL WITH TAIL ANGLE OF ATTACK, WITH AND WITHOUT TRANSITION FIXED;  $M, 0.133$ ;  $\delta_t, 0^\circ$ .

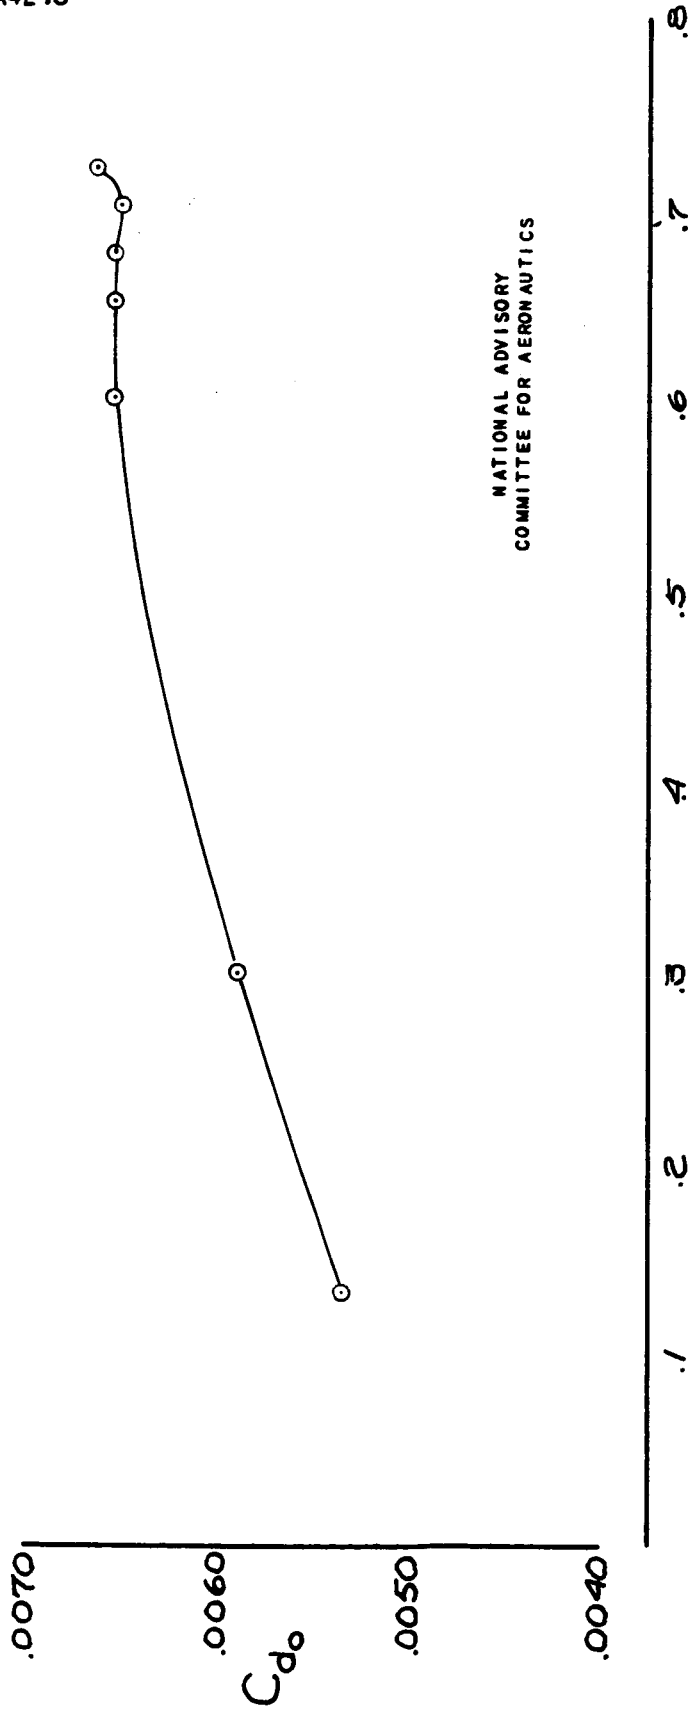
FIGURE 41. - VARIATION OF SECTION DRAG COEFFICIENT WITH MACH NUMBER, BOMBER STABILIZER WITH FABRIC-COVERED ELEVATOR; STATION 83.5;  $\delta_e = 0^\circ$ ;  $\delta_t = 0^\circ$ .

The section drag of the bomber horizontal tail was measured by the momentum method, and the results are presented

in figures 40 and 41. The surface was not prepared specially, except that all obvious rough spots were lightly sanded. A two-dimensional smooth model of this stabilizer and elevator was tested in the Langley two-dimensional wind tunnel, where the lowest section drag obtained was about 0.0045. Compared to this value, the production tail plane in the 16-foot high-speed wind tunnel at the Ames Laboratory had a minimum section drag of about 0.0052 at one station. The momentum-drag measurements are of questionable accuracy because of the spanwise flow on the three-dimensional body.
