TECHNICAL NOTE

No. 1224

FLIGHT TESTS OF A DOUBLE-HINGED HORIZONTAL TAIL SURFACE WITH REFERENCE  
TO LONGITUDINAL-STABILITY AND -CONTROL CHARACTERISTICS

By Carl M. Hanson and Seth B. Anderson

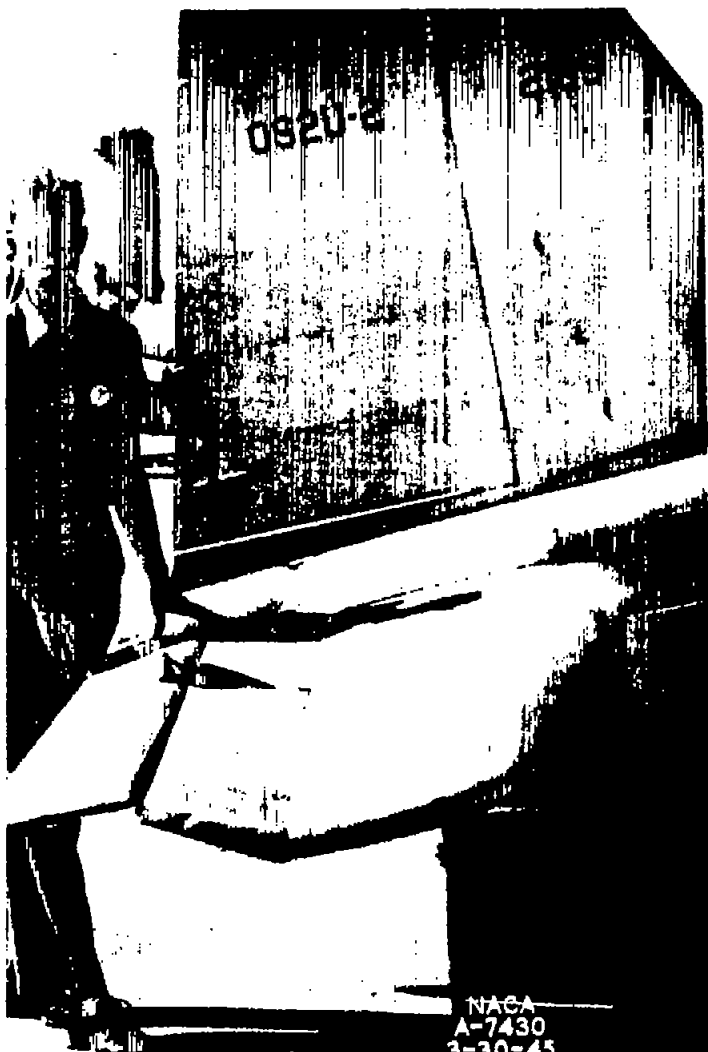
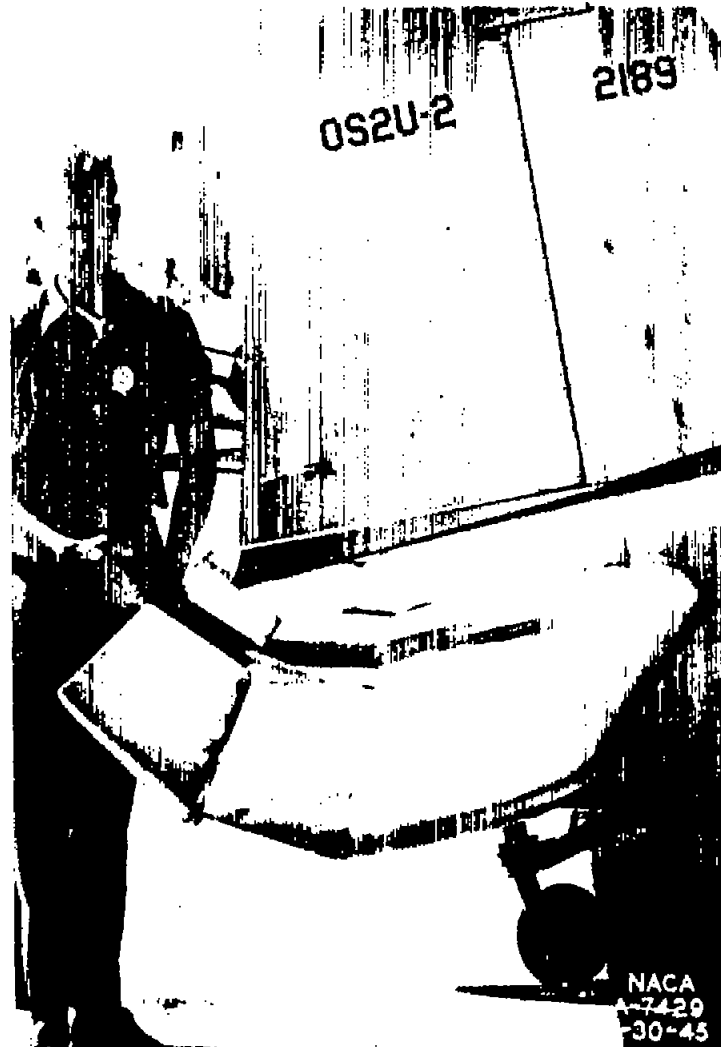
(c) Trimmer full up, elevator full down. (d) Trimmer full up, elevator full up.

Figure 3.- Concluded.
