ORIGINALLY ISSUED  
June 1944 as  
Restricted Bulletin 4F06

AN INVESTIGATION OF THE CHARACTERISTICS OF A  
PROPELLER ALCOHOL FEED RING

By Carr B. Neel, Jr.

Ames Aeronautical Laboratory  
Moffett Field, California

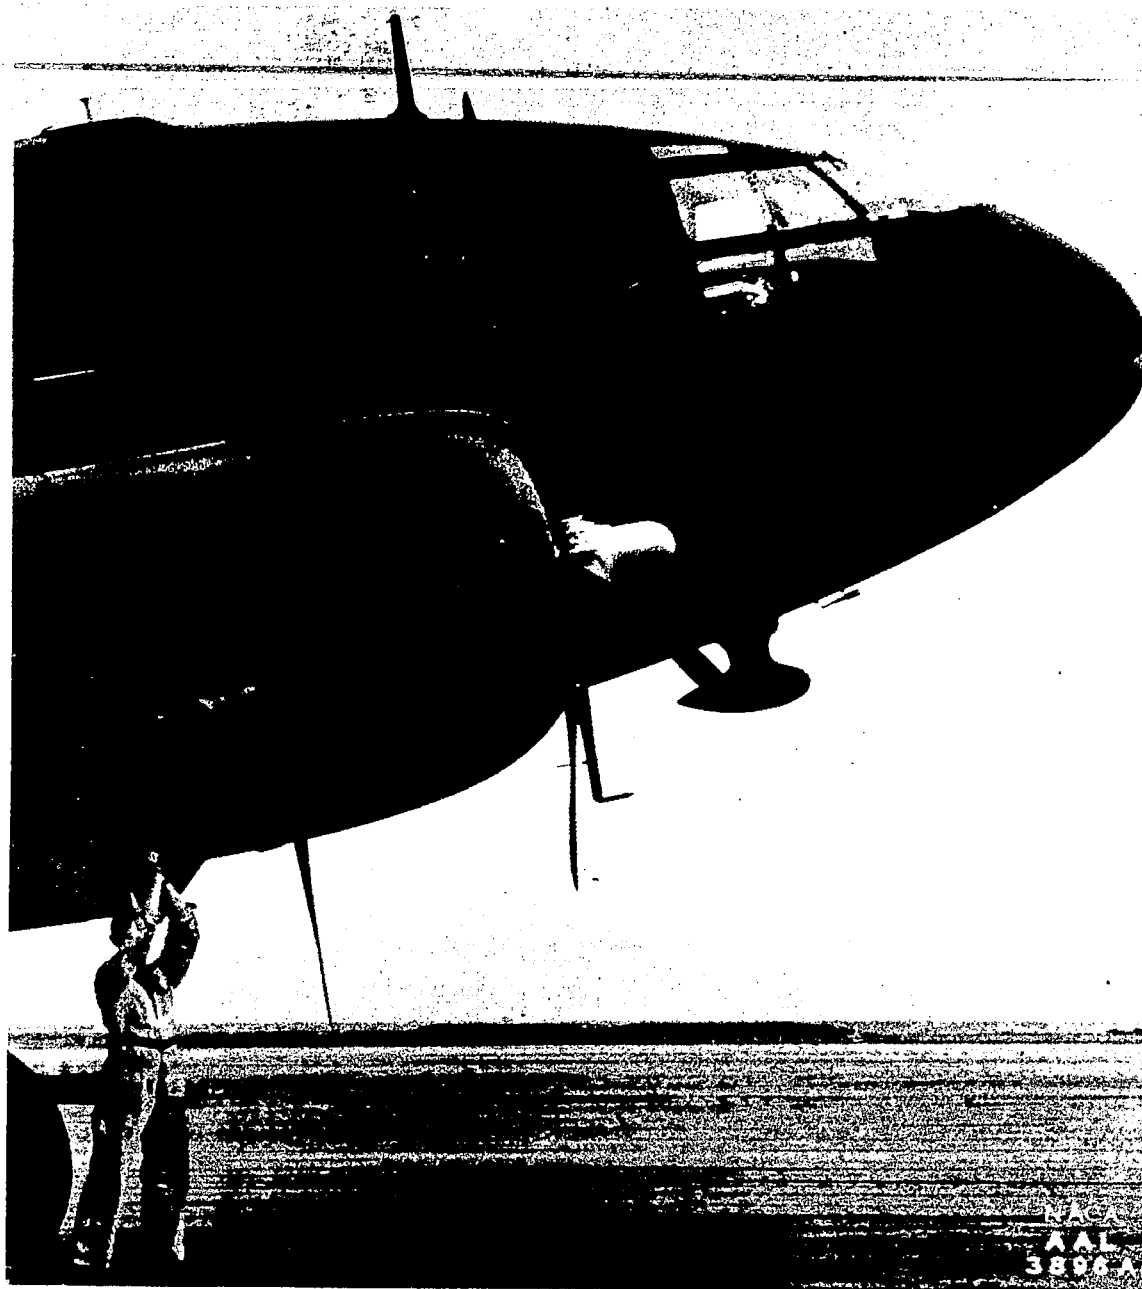
Figure 1.- The right propeller and engine cowl of the C-46 airplane on which the tests of the alcohol feed rings were made.

The propellers on which the tests were conducted were Hamilton Standard hydromatic three-blade propellers, design number 6194A-0, hub number 23E50-473, 15 feet 0 inch in diameter. Anti-icing feed shoes 52 inches in length were cemented to the leading edges of the propeller blades. Figure 1 shows the shape of the C-46 airplane cowl and its relation to the propeller, which are believed to influence the distribution of alcohol on the propeller blades. The photograph (fig. 1) was taken prior to the installation of the ice-prevention equipment on the test airplane.

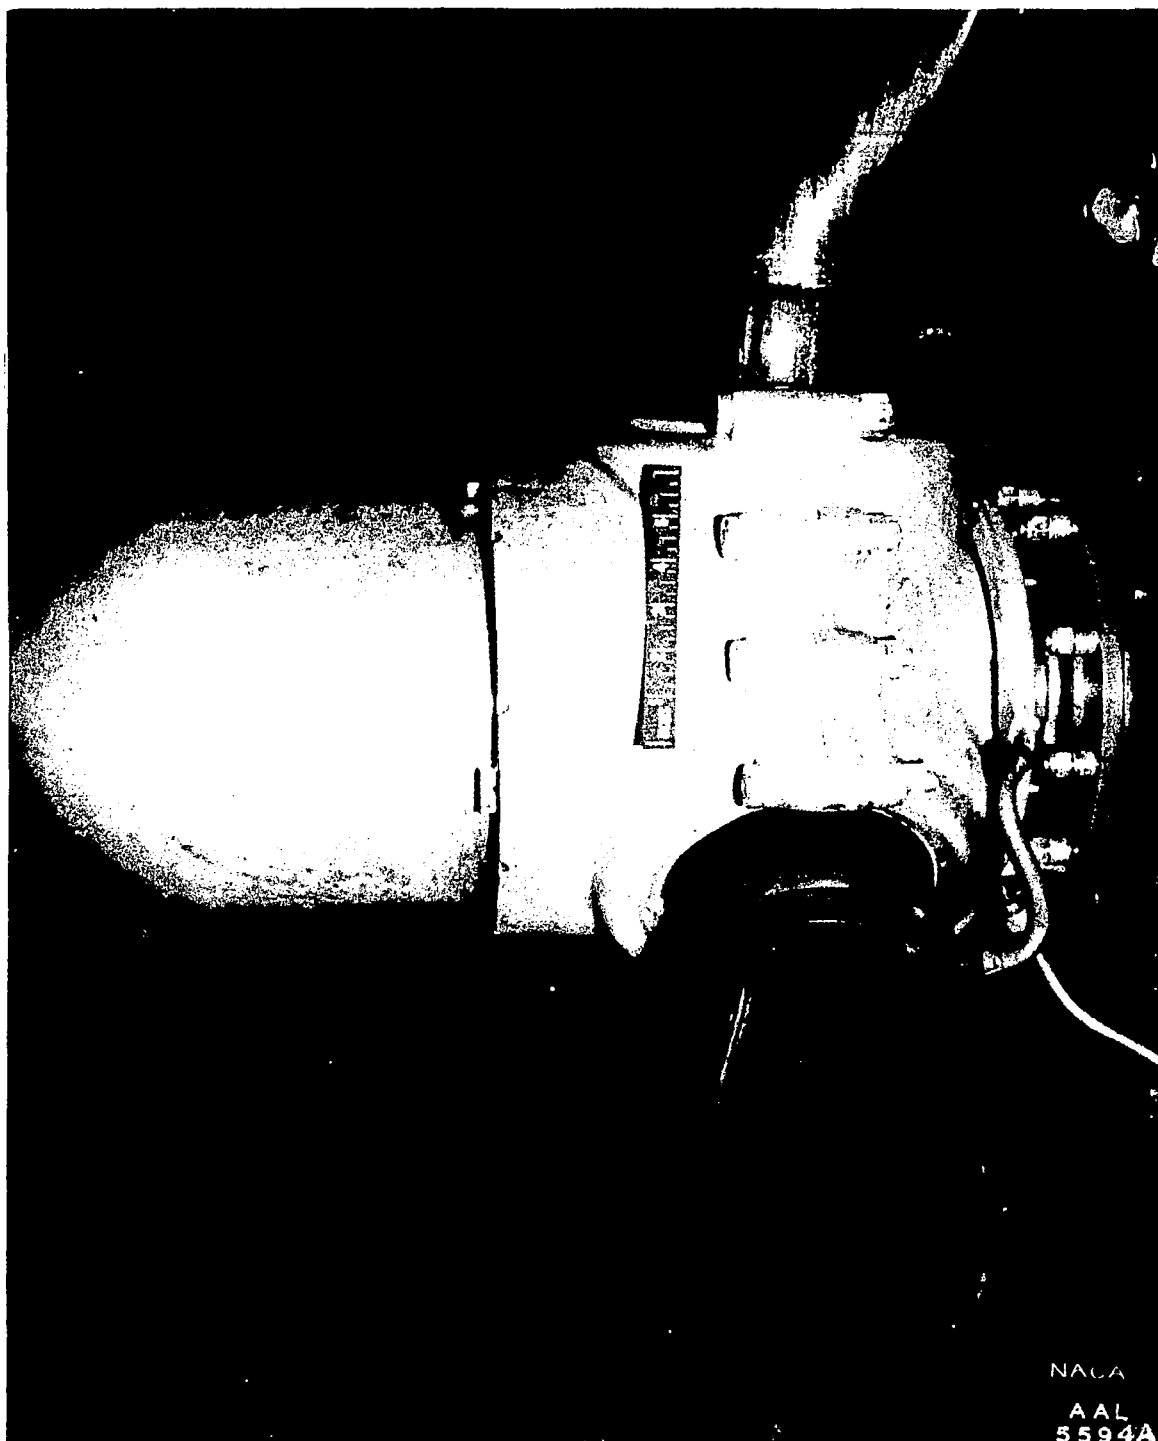
Figure 3.— The B. F. Goodrich Co. propeller alcohol feed rings installed on the propeller blades of the C-46 airplane.

The alcohol feed ring, Goodrich number 453642F, consisted of a molded neoprene ring provided with a hollow metal stem and was cemented, in accordance with the manufacturer's instructions, to the propeller-blade shank as shown in figure 3. The neoprene ring was internally cored in such a manner as to permit flow of alcohol from the metal stem to a discharge slot which extended over the anti-icing feed-shoe grooves at the hub end of the propeller blade. The metal stem of the feed ring was connected to the slinger ring with a flexible U.S.A. 20-28 natural-rubber tube. The feed-ring installation, therefore, provided for the flow of alcohol from the slinger ring to the hub end of the blade anti-icing feed shoe at all blade angles without loss of fluid. The connecting rubber tubes were secured to the feed-ring stems and the slinger-ring outlets by safety-wire wrappings at each end. The total weight of the rings and connecting tubes for one propeller was 10 ounces.
