# RESEARCH MEMORANDUM

FLIGHT MEASUREMENTS OF THE DIRECTIONAL STABILITY AND CONTROL  
OF A P-51D AIRPLANE WITH A HORN-BALANCED RUDDER AS  
COMPARED WITH PREVIOUSLY TESTED VERTICAL-TAIL CONFIGURATIONS

Robert G. Mungall

NACA RM No. L6J25

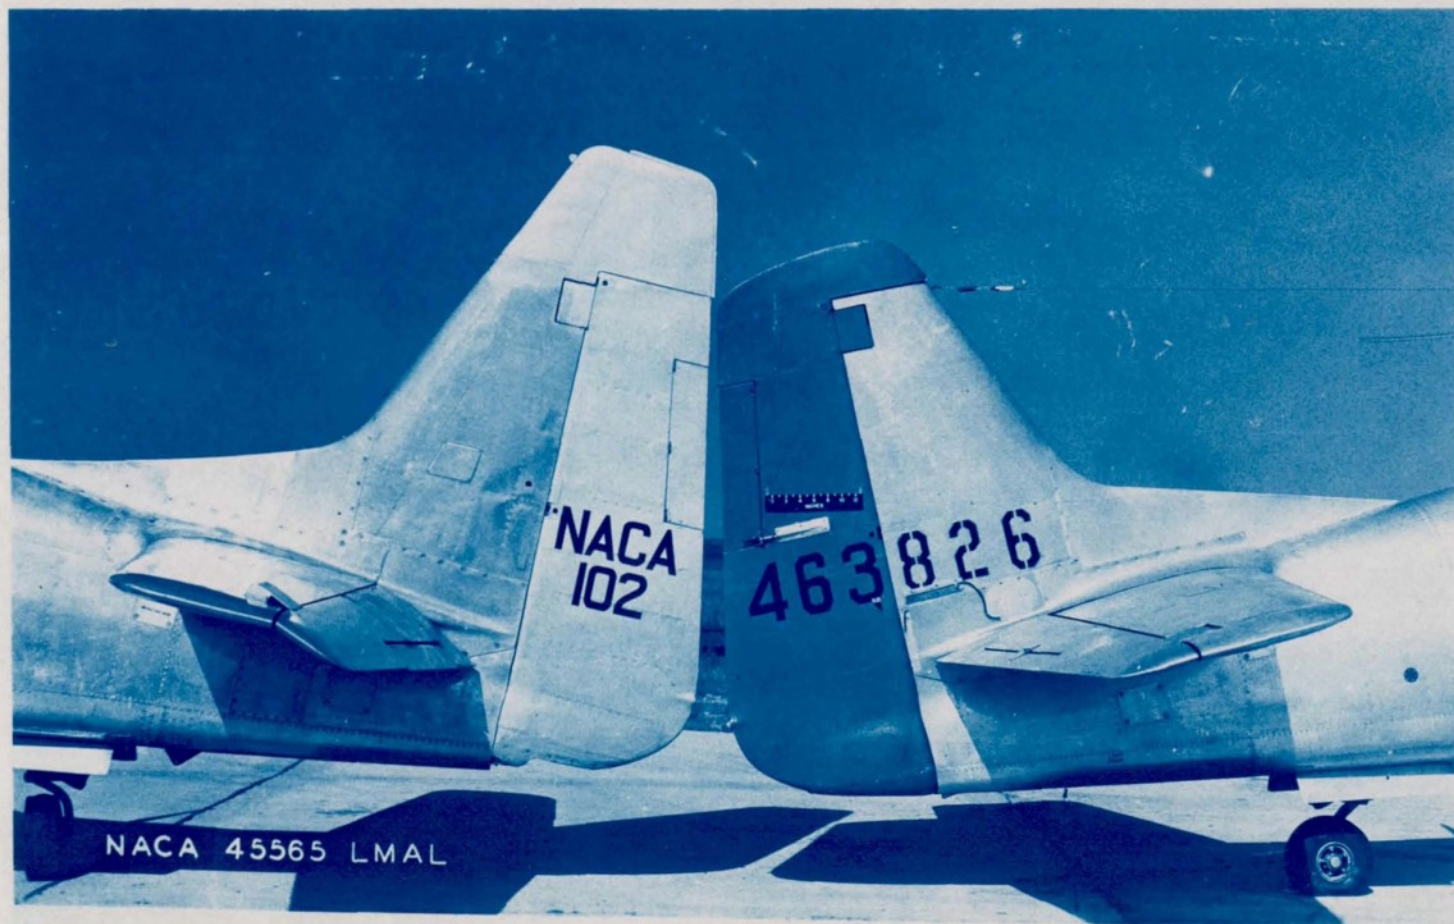
Figure 3.- Comparison of a P-51D-5-NA airplane with an extended tail and P-51D-20-NA (AAF No. 44-63826) with a horn balanced rudder.

The P-51D-20-NA airplane is a single-place, low wing, fighter-type monoplane. A three-view drawing of the airplane as tested is shown in figure 1. A side view of the airplane is shown in figure 2. Figures 3 and 4 show the comparison between the original production, extended tail and horn-balanced rudder configurations tested. Figure 5 is a drawing comparing the rudders of the three airplanes.

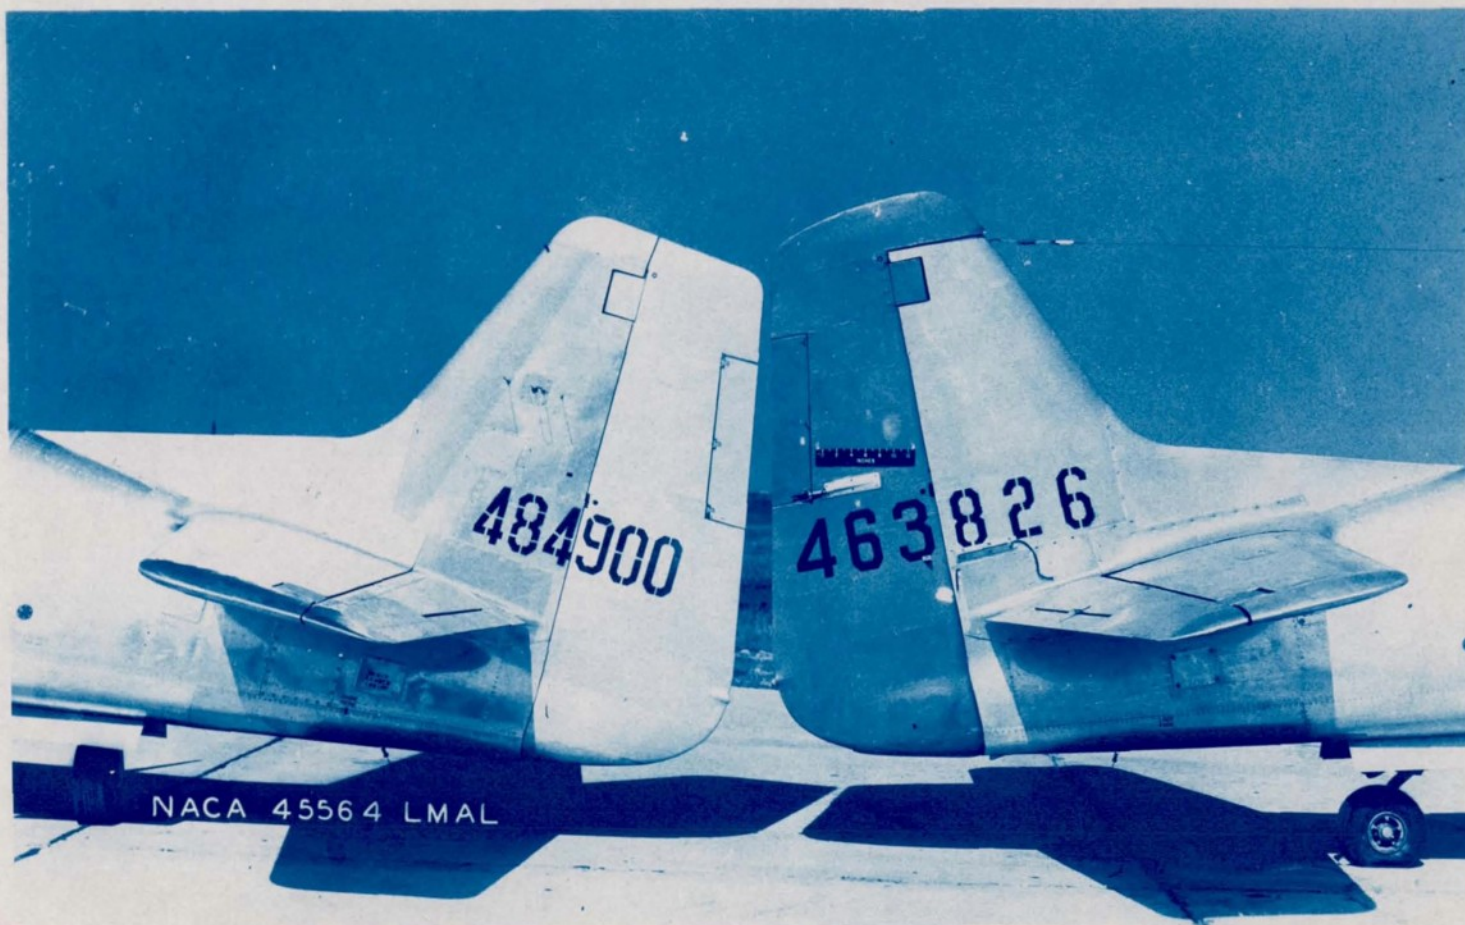
Figure 4.- Comparison of a P-51D-25-NT airplane with an original production configuration and the P-51D-20-NA (AAF No. 44-63826) with a horn balanced rudder.
