ENGINEER DESIGN TEST OF  
5.56-MM HECKLER AND KOCH MACHINE GUN,

MODEL 23A1

FINAL LETTER REPORT

**US ARMY ABERDEEN PROVING GROUND**  
**ABERDEEN PROVING GROUND, MARYLAND**

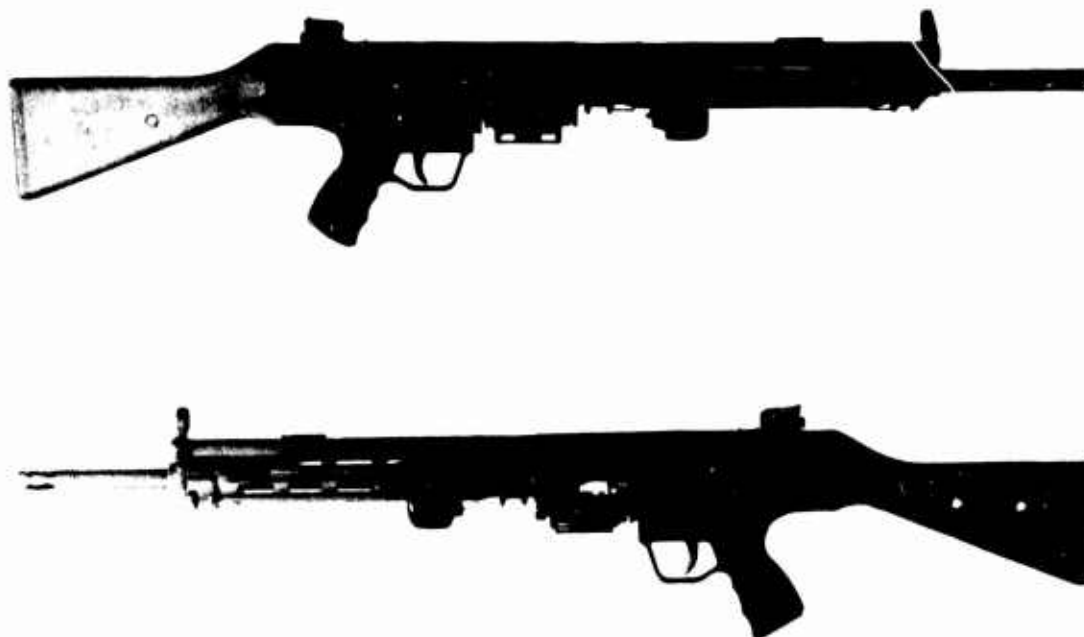
Figure 1.1-1: The 5.56-MM HK-23A1 Machine Gun, Adapted for Belt Feed. Right (TOP) and Left Sides.

Figure 1.1-1 shows the right and left side views of the HK-23A1 machine gun.

The HK-23A1 machine gun received for test could be fired in either a belt-fed configuration as shown in Figure 1.1-1, or in a magazine-fed configuration as shown in Figure 1.2-4. The components added to the basic weapon for belt feed are the feeder assembly, cartridge guide, and bolt-and-carrier assembly. An ammunition container holds 200 rounds of belted ammunition and is attached to the bottom of the feeder assembly by means of four studs on the cover of the box. These studs engage mating rectangular-shaped slots in the feeder. A latch on the feeder securely positions the box and prevents its unintentional removal. The weapon is changed to a 20- or 40-round, conventional, spring-loaded, box-magazine feed (HK-33 rifle magazines) by removing the previously mentioned belt-feed components and replacing them with a different bolt-and-carrier assembly and magazine-adaptor assembly; unlinked ammunition is used in this configuration. Photographs comparing the configuration differences of component feed parts are shown in Figures 1.2-5 through 1.2-10. Only the belt-fed configuration was evaluated by firing.

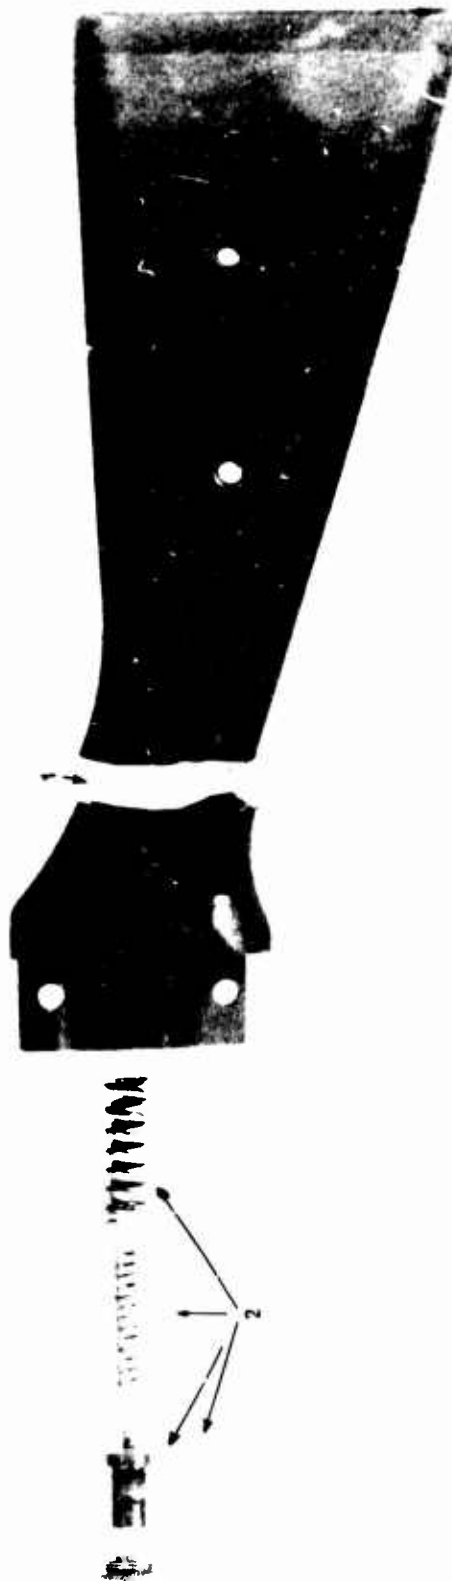
Figure 1.2-2: Broken Buttstock (Arrow No. 1) as Received for Test. Buffer Components (Arrow No. 2) were Disassembled for Illustration.

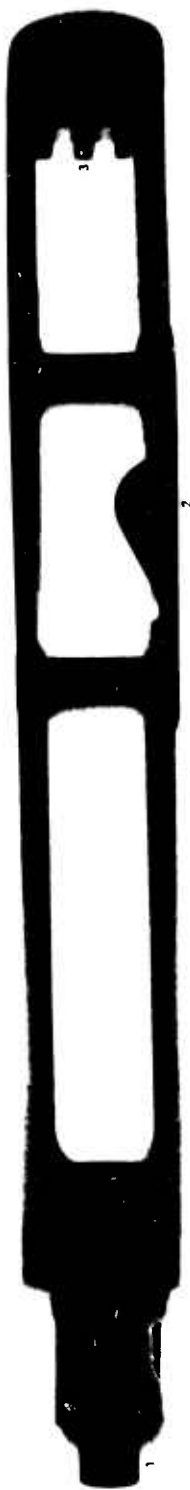
Figure 1.2-3: Radiograph of Top and Left Side Views of HK-23A1 Buttstock. The Buffer Assembly (1), Rear Sling Swivel Base (2), Buttplate (3), and Buttstock Body Wall (4) Are Shown.

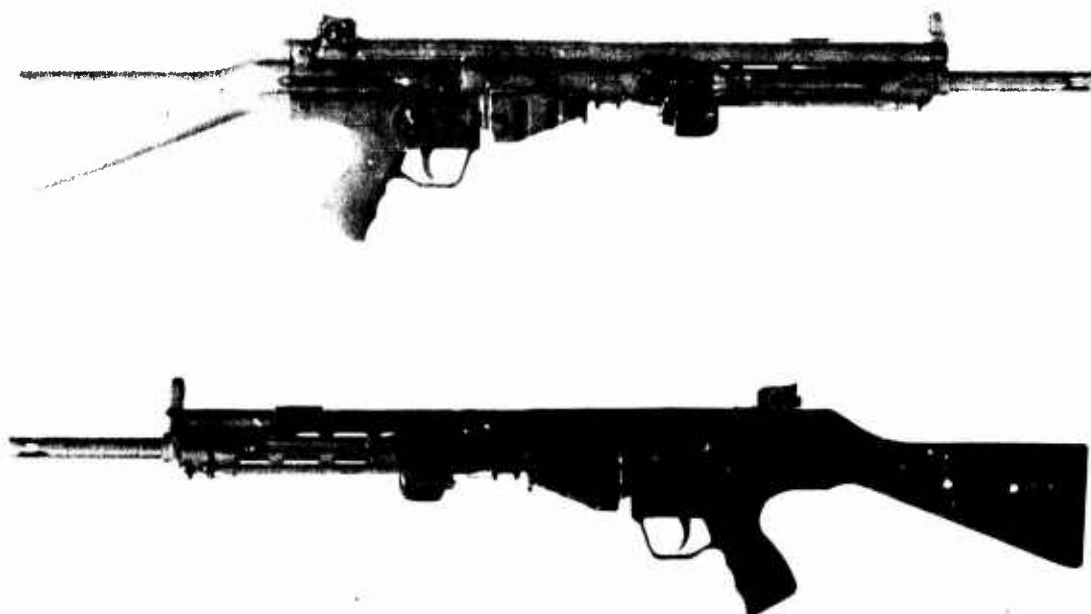
Figure 1.2-4: The 5.56-MM HK-23A1 Machine Gun, Adapted for Magazine Feed. Right (TOP) and Left Sides.

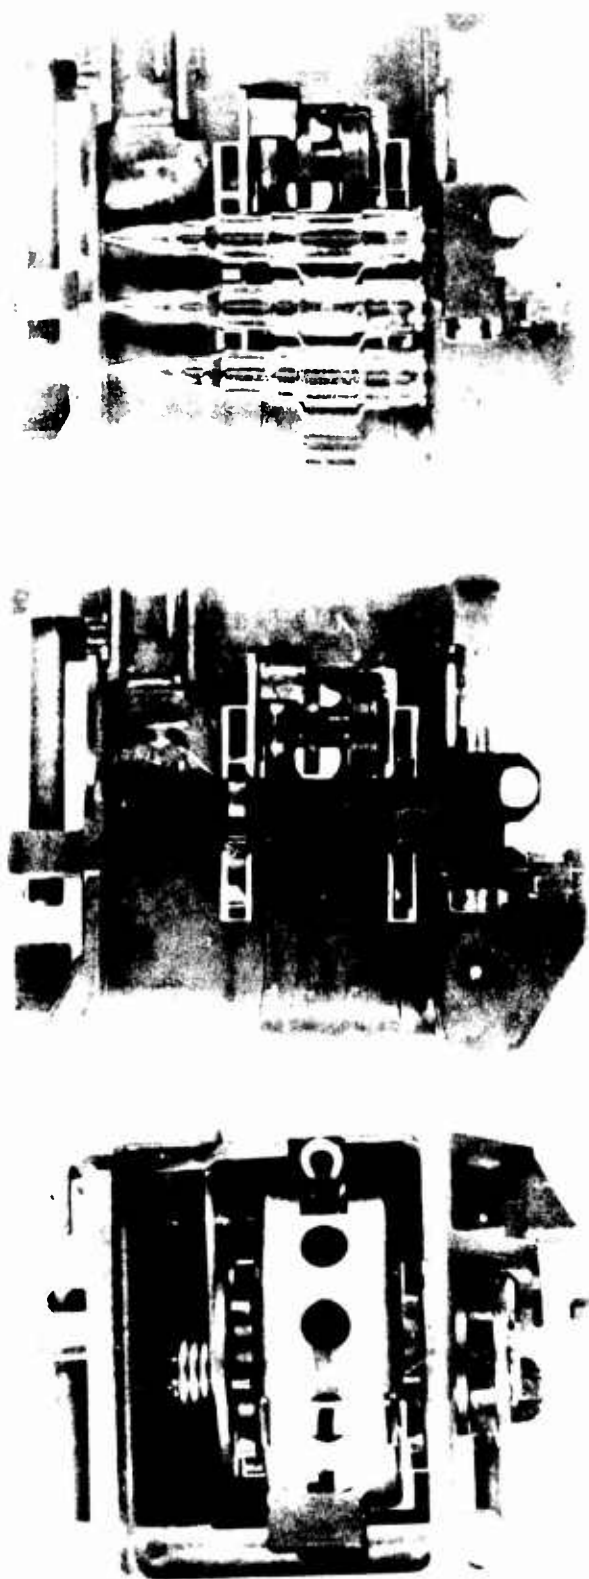
Bottom View.

Top View.

Top View with Ammunition in Position to Be Fed Over For Chambering.

Figure 1.2-8: Feeder Mechanism for the 5.56-MM HK-23A1 Machine Gun.

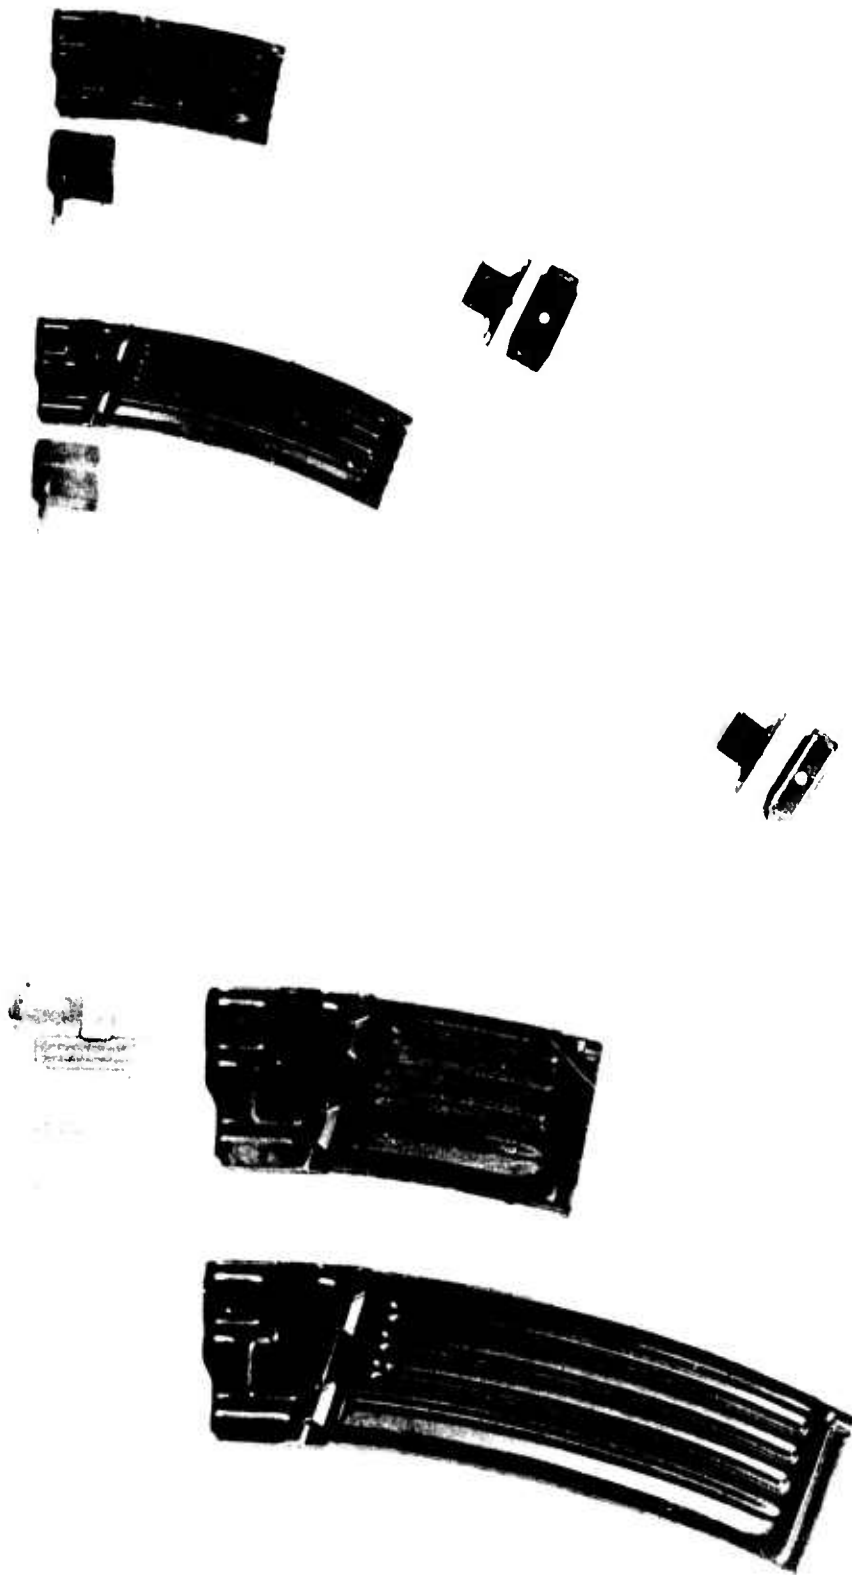
Figure 1.2-10: Assembled (LEFT) and Disassembled Views of 40- and 20-Round-Capacity Magazines for the 5.56-MM HK-23A1 Machine Gun; Magazine Adapter Is Shown Next to Assembled 20-Round Magazine.

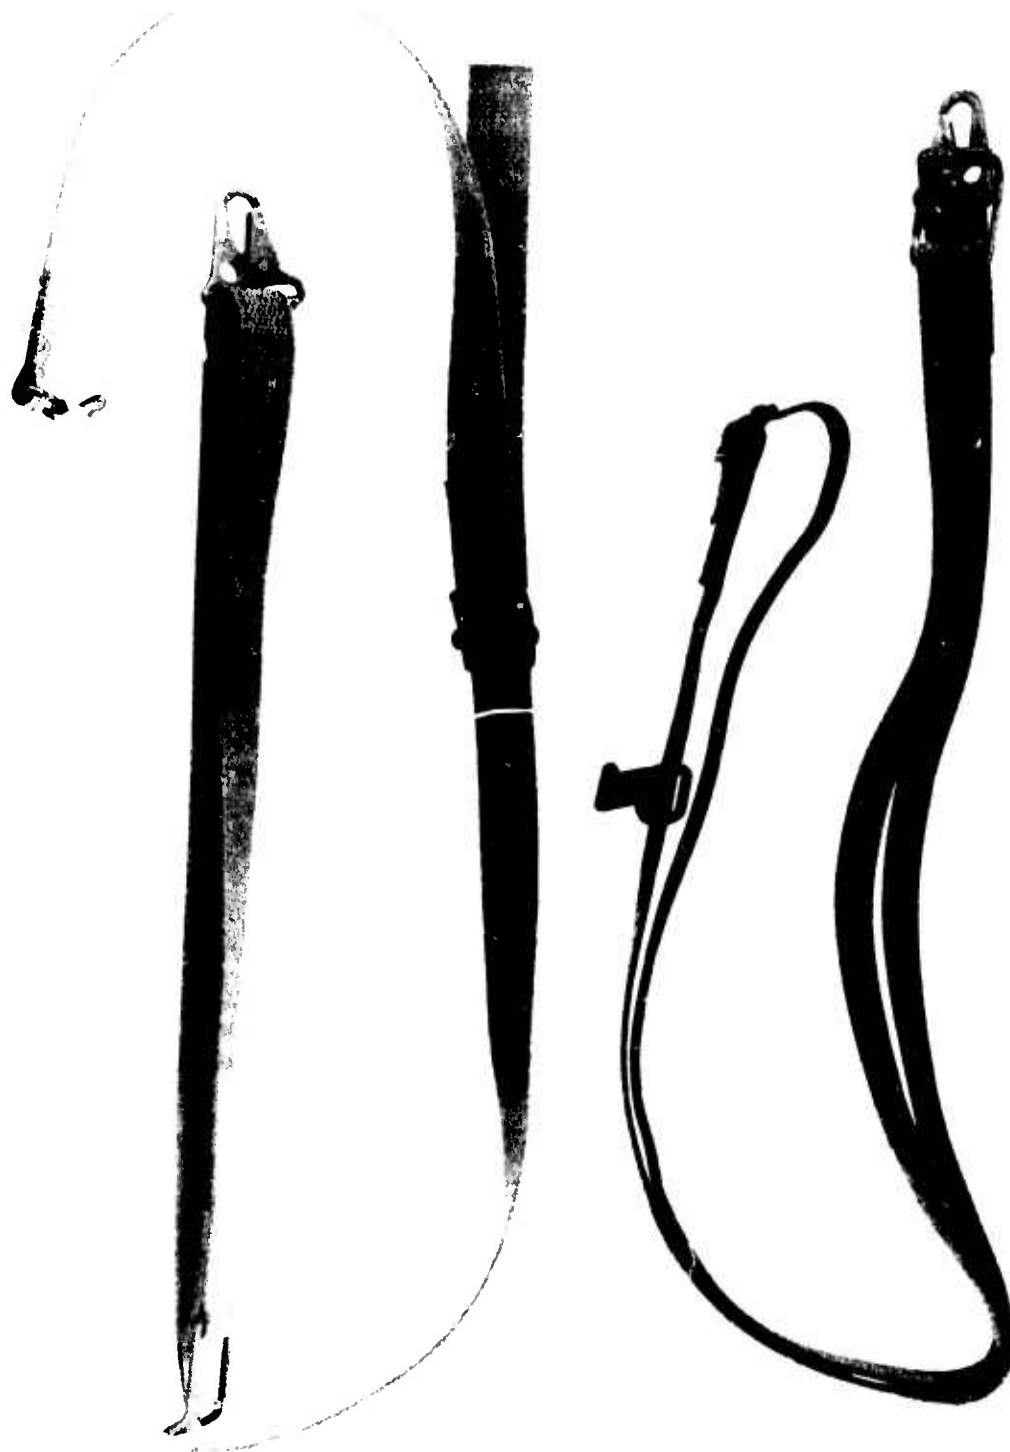
Two slings were provided with the weapon. One was designated as a firing sling, which was used during underarm firing for better weapon control; the other was designated a carrying sling and was used for transporting the weapon.

Figure 1.2-14: Firing Sling (LEFT) and Carrying Sling (RIGHT) for the 5.56-MM HK-23A1 Machine Gun.

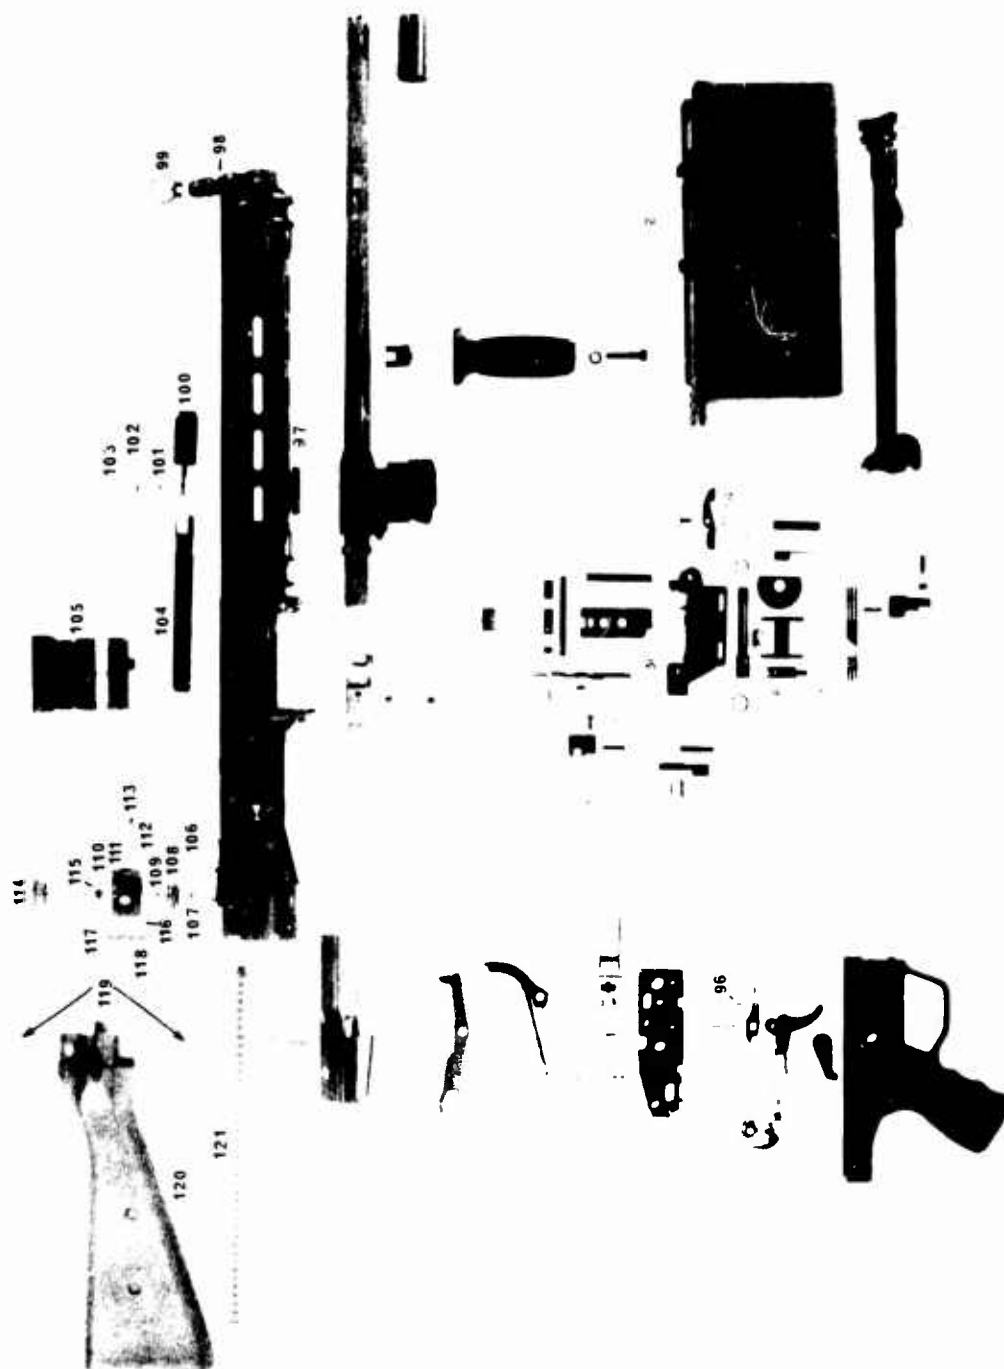
A photograph of the weapon, disassembled in detail, is in Figure 1.2-15; a list of the various weapon components, numerically keyed to the photograph, is in Table 1.2-5.

Figure 1.2-15: Detailed Disassembly of 5.56-MM HK-23A1 Machine Gun in Belt-Fed Configuration. Component Parts Are Keyed Numerically to Table 1.2-5.

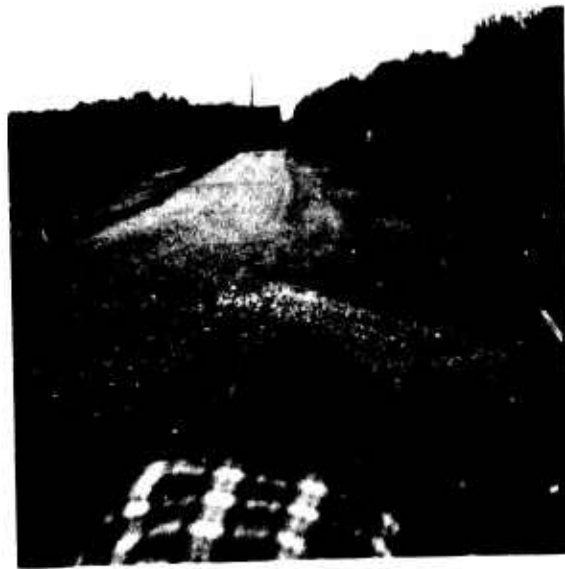
Figure 1.2-23 presents the data for the first hand-held firing of the weapon in contact with the shooter's body, which was accomplished during the evaluation of the effects of gunsmoke on target obscuration and weapon signature. Figure was conducted from the prone, bipod-supported position. One 25-round automatic burst was fired; the results were photographed immediately after firing the last round. The wind velocity at the time of firing was from left to right of the shooter at 3 mph.

Figure 1.2-23: Effects of Gun Smoke on Target Obscuration (TOP) and Weapon Signature (BOTTOM) at 100-Meter Range. Target Grid is 12 Inches (One-Inch-Wide Grid Lines).
