# EVALUATION OF A PRE-ACTIVATED SEALANT SELF-SEALING CONCEPT FOR PROTECTING AIRCRAFT FUEL TANKS AGAINST SMALL ARMS PROJECTILES

ELASTOMERS AND COATINGS BRANCH  
NONMETALLIC MATERIALS DIVISION

TECHNICAL REPORT AFML-TR-75-22  
FINAL REPORT FOR PERIOD DECEMBER 1972 - JUNE 1973

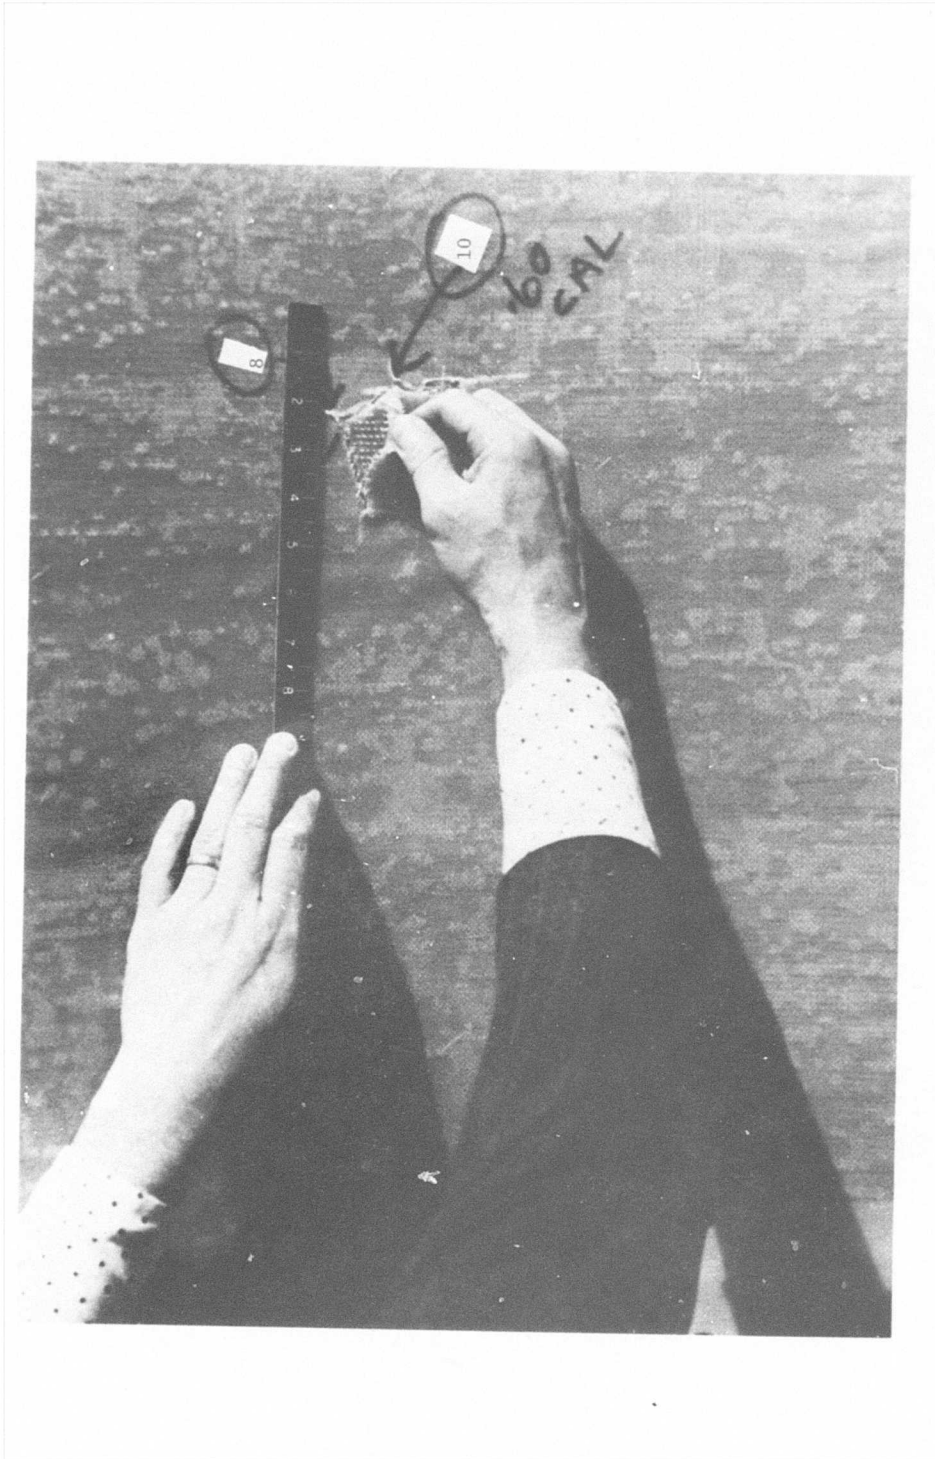
Figure 16. Exit Test Panel, .60 Cal. Shot
