AFATL-TR-76-105

**DEVELOPMENT OF XM714A3  
DELAY FUNCTION FUZE**

**HONEYWELL INC.**

**FINAL REPORT: DECEMBER 1975 - AUGUST 1976**

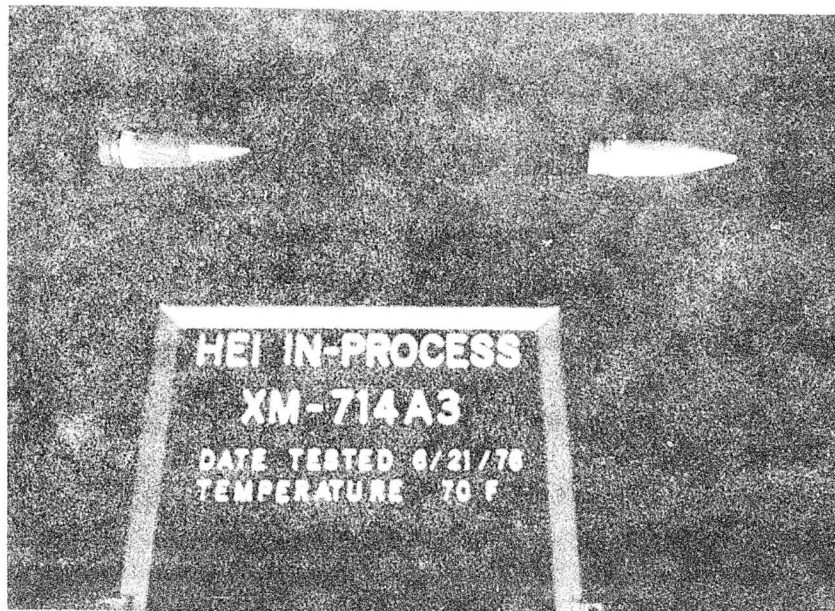
Figure 15. Inflight Photographs of Polarylene-Banded Projectile Assembly (Shot No. 795) after Exposure to 28-day Temperature and Humidity (Test 105 of Mil-Std 331)

(a) Single Exposure of Projectile

(b) Double Exposure of Projectile

Post-delivery tests also verified projectile accuracy (standard deviation of radius = 0.81 mil at a 1707-inch range), polyarylene rotating band retention after 28-day T&H exposure, and long (500-meter) range delay function against 0.125-inch 2024-T3 aluminum at a high (3700-ft/s) muzzle velocity launch condition (17 for 17 delay functions).
