MEMORANDUM REPORT ARBRL-MR-02943

MEASURED CARBON FIBER EXPOSURES TO  
MALFUNCTION FOR CIVILIAN ELECTRONIC ITEMS

US ARMY ARMAMENT RESEARCH AND DEVELOPMENT COMMAND  
BALLISTIC RESEARCH LABORATORY  
ABERDEEN PROVING GROUND, MARYLAND

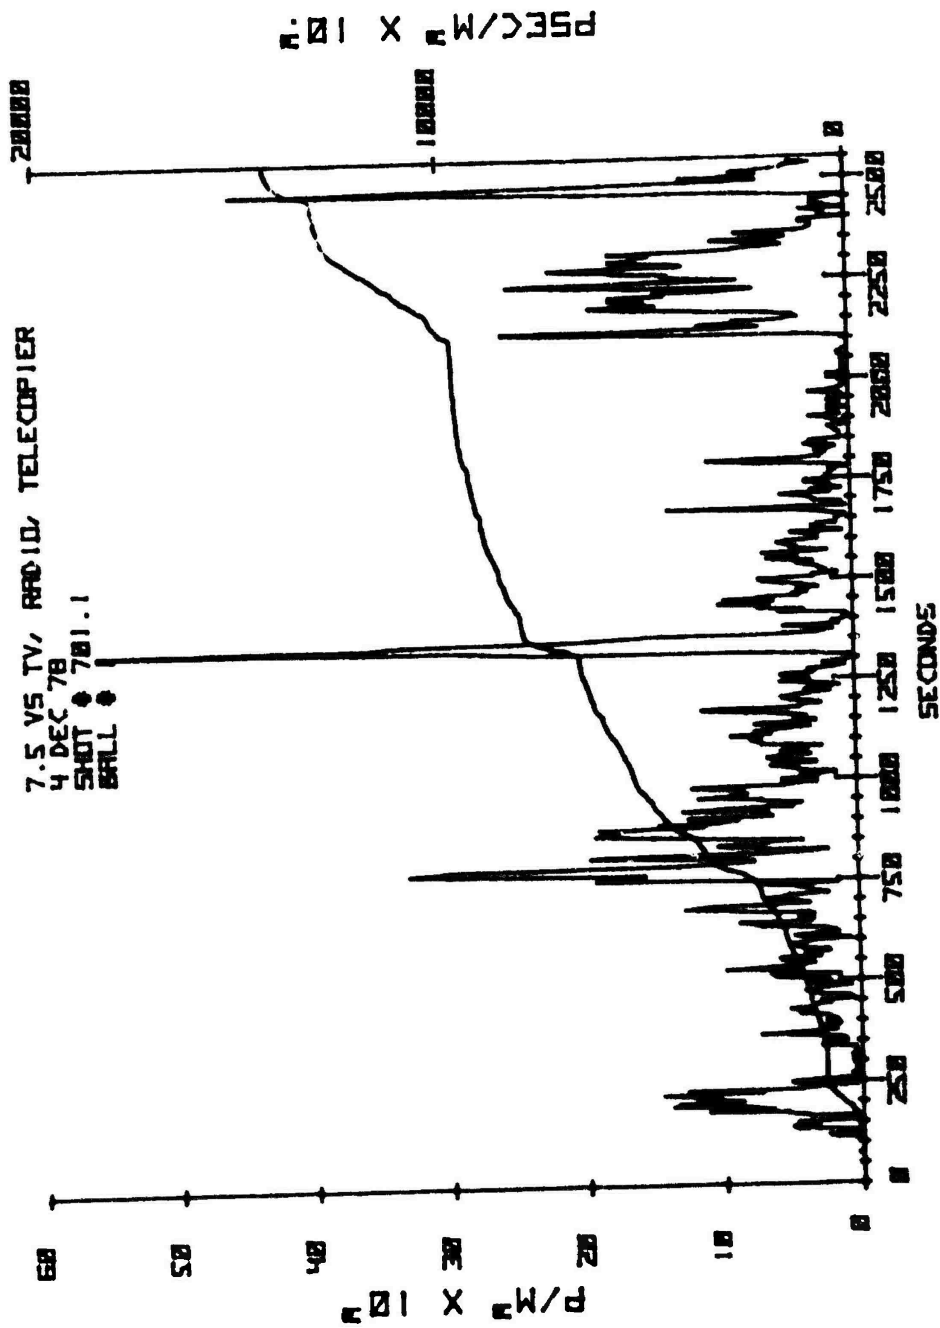
Figure 1. Typical Plot of Concentration and Exposure as a Function of Time
