# WARTIME REPORT

FLIGHT INVESTIGATION AT HIGH SPEEDS OF FLOW CONDITIONS

OVER AN AIRPLANE WING AS INDICATED BY SURFACE TUFTS

By Clotaire Wood and John A. Zalovecik

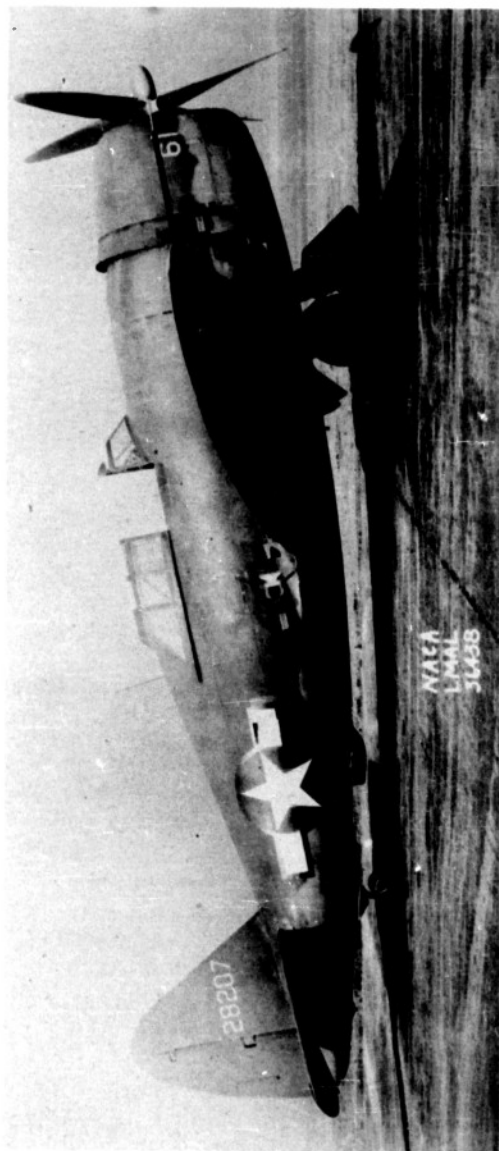
Fig. 1

Figure 1.- Republic P-47D airplane used for tuft surveys.

Tufts were located on the upper surface of the right wing of a P-47D airplane (fig. 1) at four spanwise stations: 39.5, 43.5, 48, and 52.5 percent semispan from the plane of symmetry (fig. 2). The tufts consisted of strands of white wool yarn arranged in chordwise rows with each row attached to the surface by a continuous strip of black "Scotch" cellulose tape. Spanwise chalk lines were drawn on the surface of the wing at intervals of 10 percent chord, and each line was identified by a number beginning with 1 at the 10-percent-chord station and continuing through 7 at the 70-percent-chord station (fig. 3).

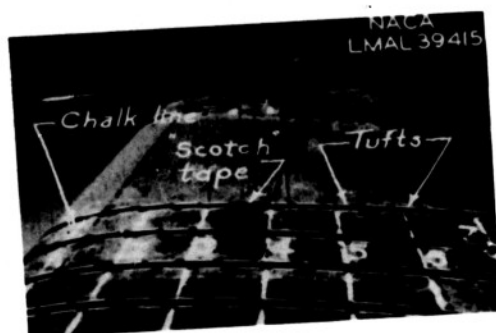
Figure 3.- Test panel on right wing of Republic P-47D airplane, showing rows of tufts at 39.5, 43.5, 48, and 52.5 percent semispan. Numbers identify spanwise lines at intervals of 10 percent chord.

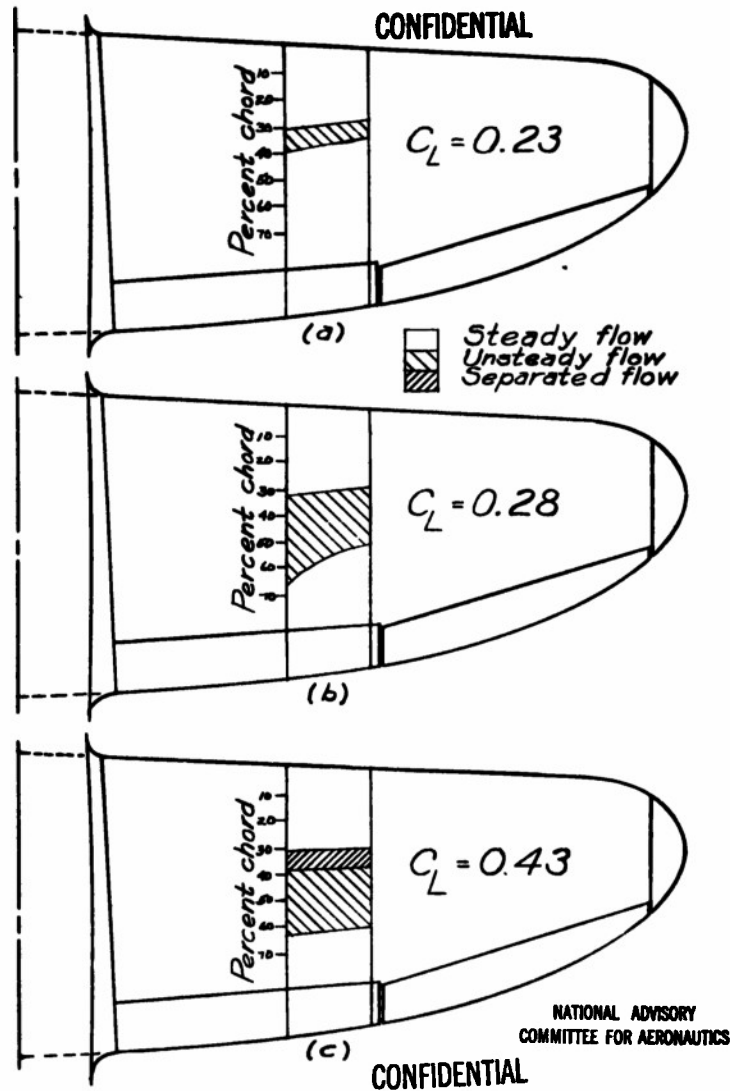
Fig. 6d

Figure 6.- Flow conditions at test section  
for an airplane Mach number of 0.71.

Figure 6.- Concluded.

An enlargement of one frame of the motion-picture film taken during flight is shown as figure 4. The quality of the photographs was, in general, too poor to permit satisfactory reproduction in this form; in figures 5 to 8, therefore, sketches based on the original photographs are used to illustrate, for a few typical flight conditions, the flow conditions indicated by the tufts. The flow conditions for various airplane lift coefficients at constant airplane Mach numbers of 0.69 and 0.71 are shown in figures 5 and 6, respectively; the flow conditions for various airplane Mach numbers at constant airplane lift coefficients of 0.13 and 0.43 are shown in figures 7 and 8, respectively. Inasmuch as the field of the camera covered only the forward 70 to 80 percent chord, the flow conditions downstream of this region are not known.

The flow conditions indicated by the tufts at various lift coefficients and Mach numbers are summarized in figure 9. The interpretation of the behavior of the tufts is as follows: Tufts lying straight back and motionless indicate smooth flow, tufts oscillating laterally indicate unsteady flow, and tufts "flopping" around leisurely or lying curved on the surface indicate flow separation. (Compare figs. 4 and 6(d).)

The sketches of figures 5 to 8 show that, as Mach number or lift coefficient increased, the flow first became unsteady over a small chordwise region; this region then became more extensive, and finally local separation occurred. The region of separated flow originated in the neighborhood of 30 percent chord at high lift coefficients and 45 percent chord at low lift coefficients. The region of separation appeared to extend over not more than 15 percent chord and was followed by a region of unsteady flow beyond which the flow again was steady.
