AN INVESTIGATION OF A THERMAL ICE-PREVENTION SYSTEM  
FOR A C-46 CARGO AIRPLANE

VII - EFFECT OF THE THERMAL SYSTEM ON THE  
WING-STRUCTURE STRESSES AS ESTABLISHED IN FLIGHT

By Alun R. Jones and Bernard A. Schlaff

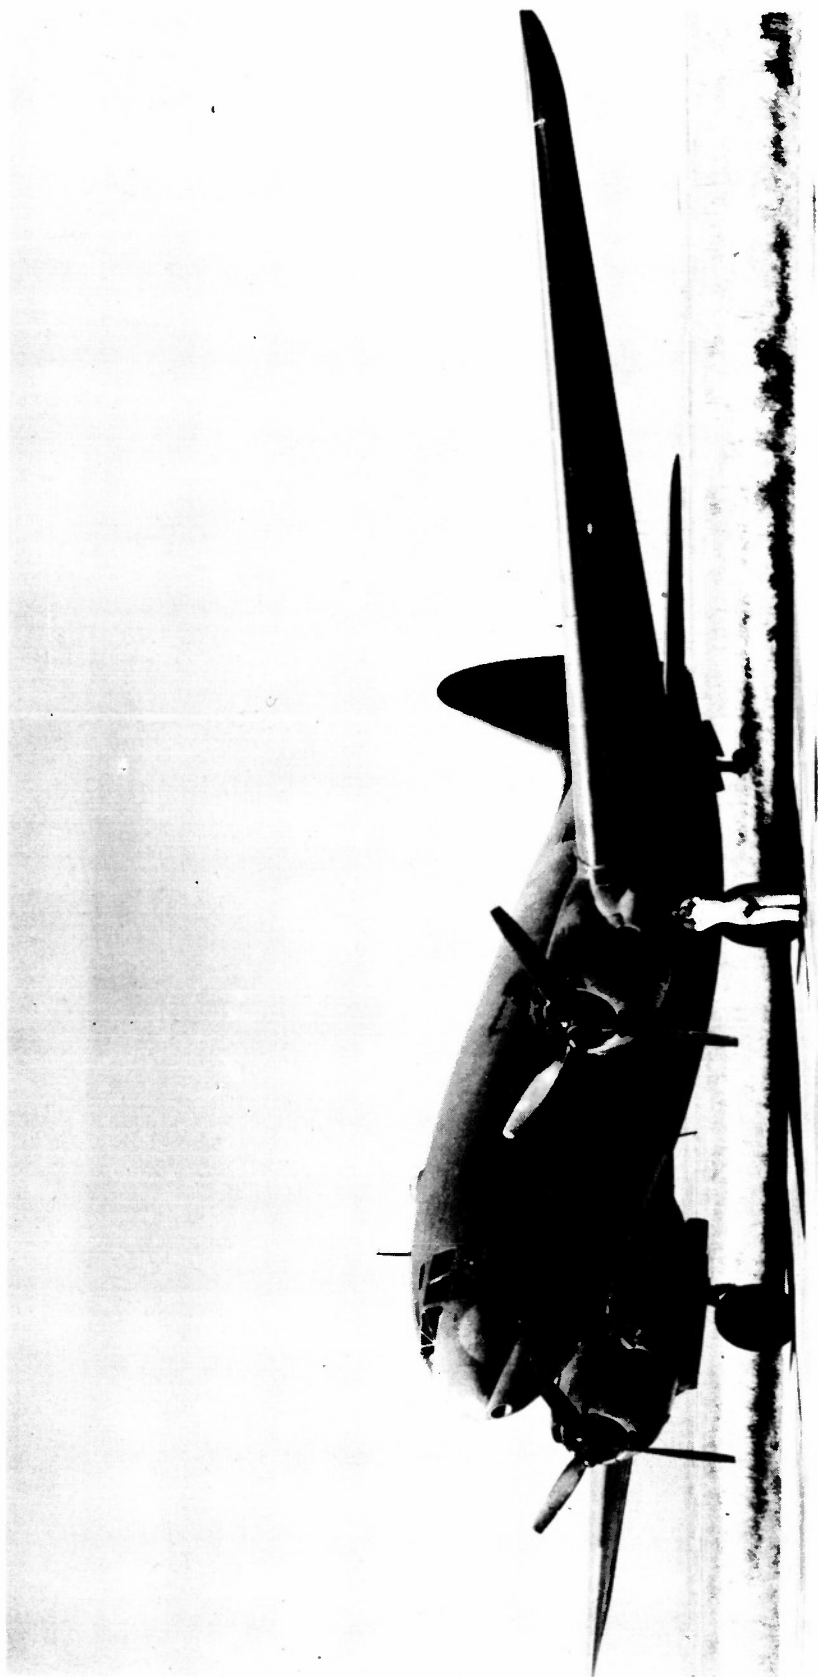
Figure 1.- The C-46 airplane equipped with a thermal ice-prevention system.

The C-46 airplane (fig. 1) is a twin-engine, low-wing, transport-cargo monoplane powered by Pratt & Whitney model R-2800-51 engines having a sea-level rating of 2000 horsepower each. The wing span is 108 feet, the wing area 1360 square feet, and the normal gross weight 45,000 pounds.

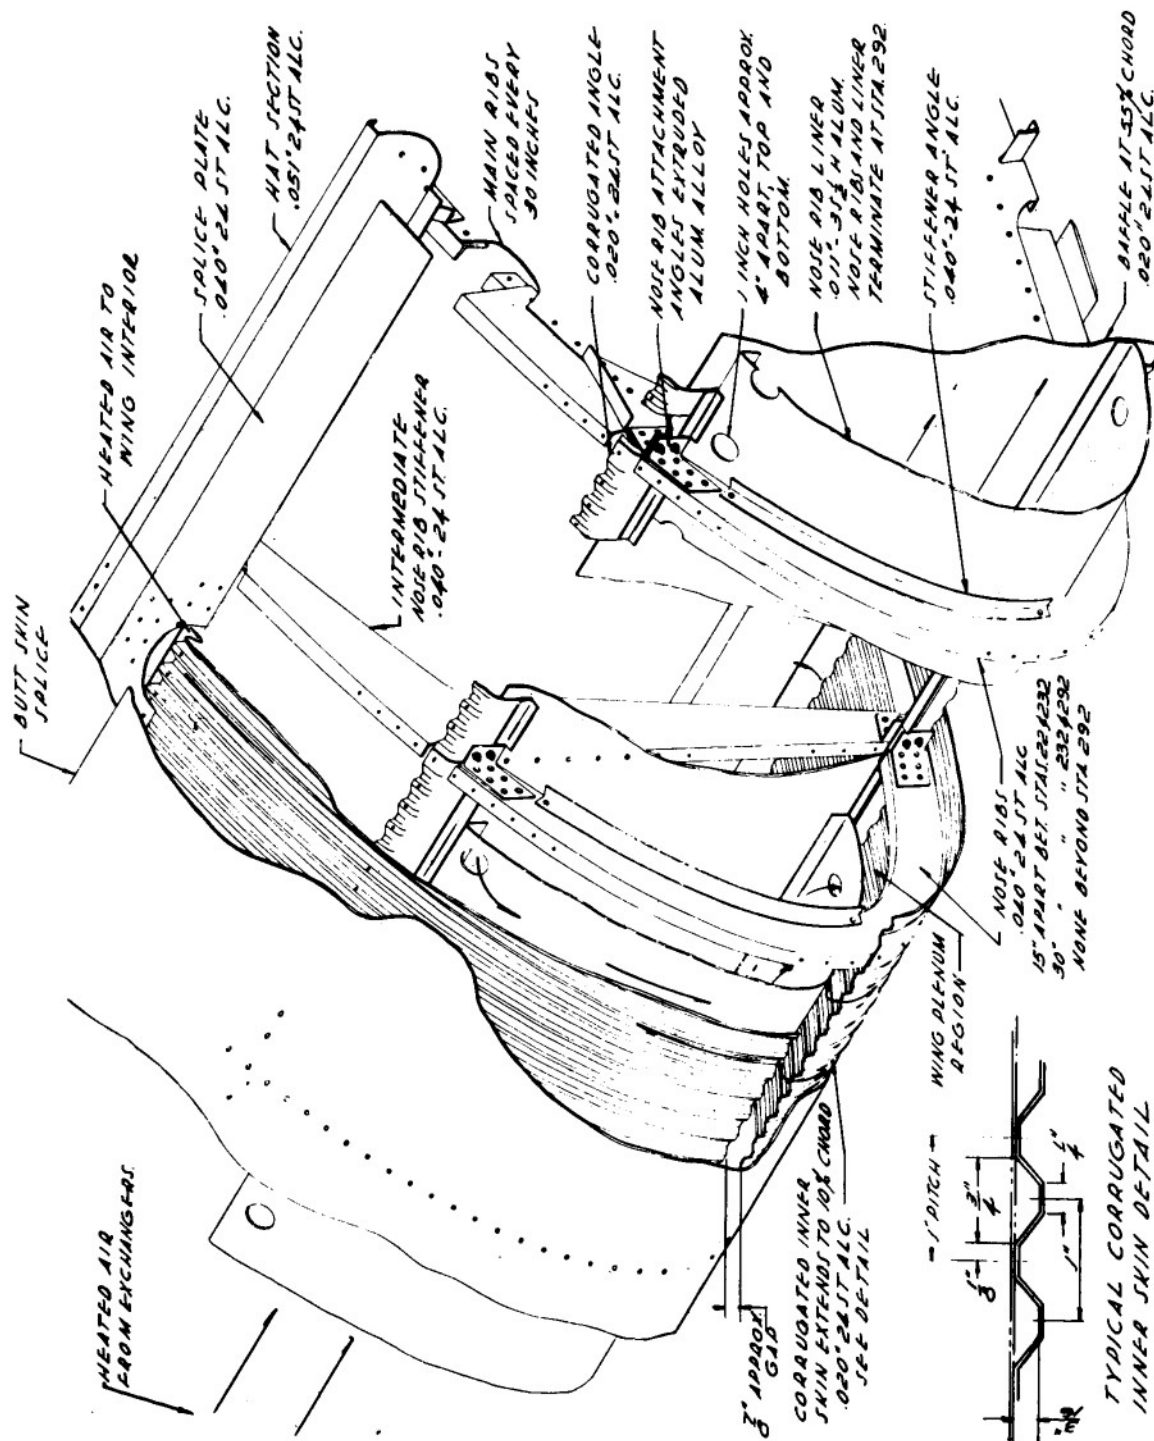
Figure 3.- Typical wing outer-panel leading-edge section as revised for thermal ice-prevention, O-46 airplane.

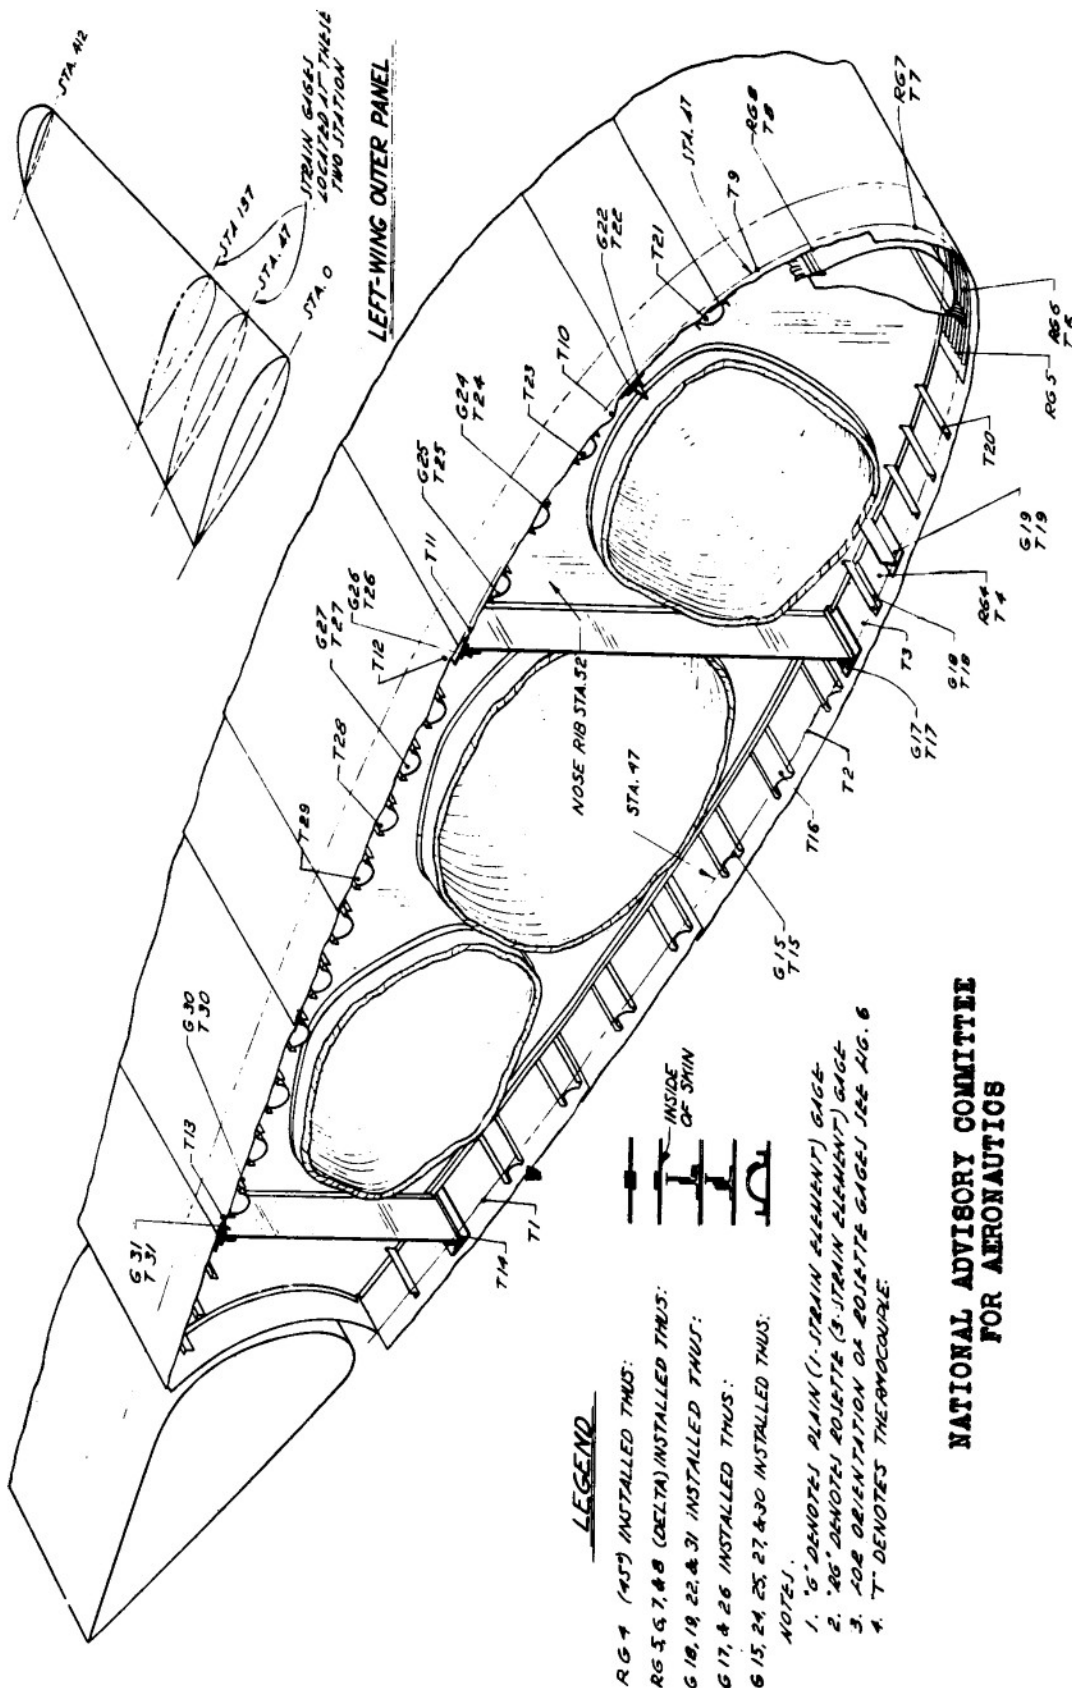
Figure 4.- Location of strain gages and thermocouples at wing outer-panel station 47, C-46 airplane.

The individual locations of the strain gages and thermocouples are shown in figures 4 and 5. Two general types of gages were employed: namely, single-element gages on structural members such as hat sections and spar caps where the direction of stress was known, and triple-element gages on the wing skin where the direction, as well as the magnitude, of the maximum stress had to be established. All the single-element gages (hereinafter referred to as plain gages) are designated in figures 4 and 5 by the letter G before the gage number and were Baldwin-Southwark type A-7 gages. The triple-element gages (hereinafter referred to as rosette gages) are designated in figures 4 and 5 by the letters RG and were Baldwin-Southwark type ABR-4 gages forward of 10-percent chord and type AR-1 gages aft of that point. The ABR-4 gage is a high-temperature type required on the heated leading edge. The discontinuities in the strain-gage numbering system are the result of omitting from the list of gages those which failed.

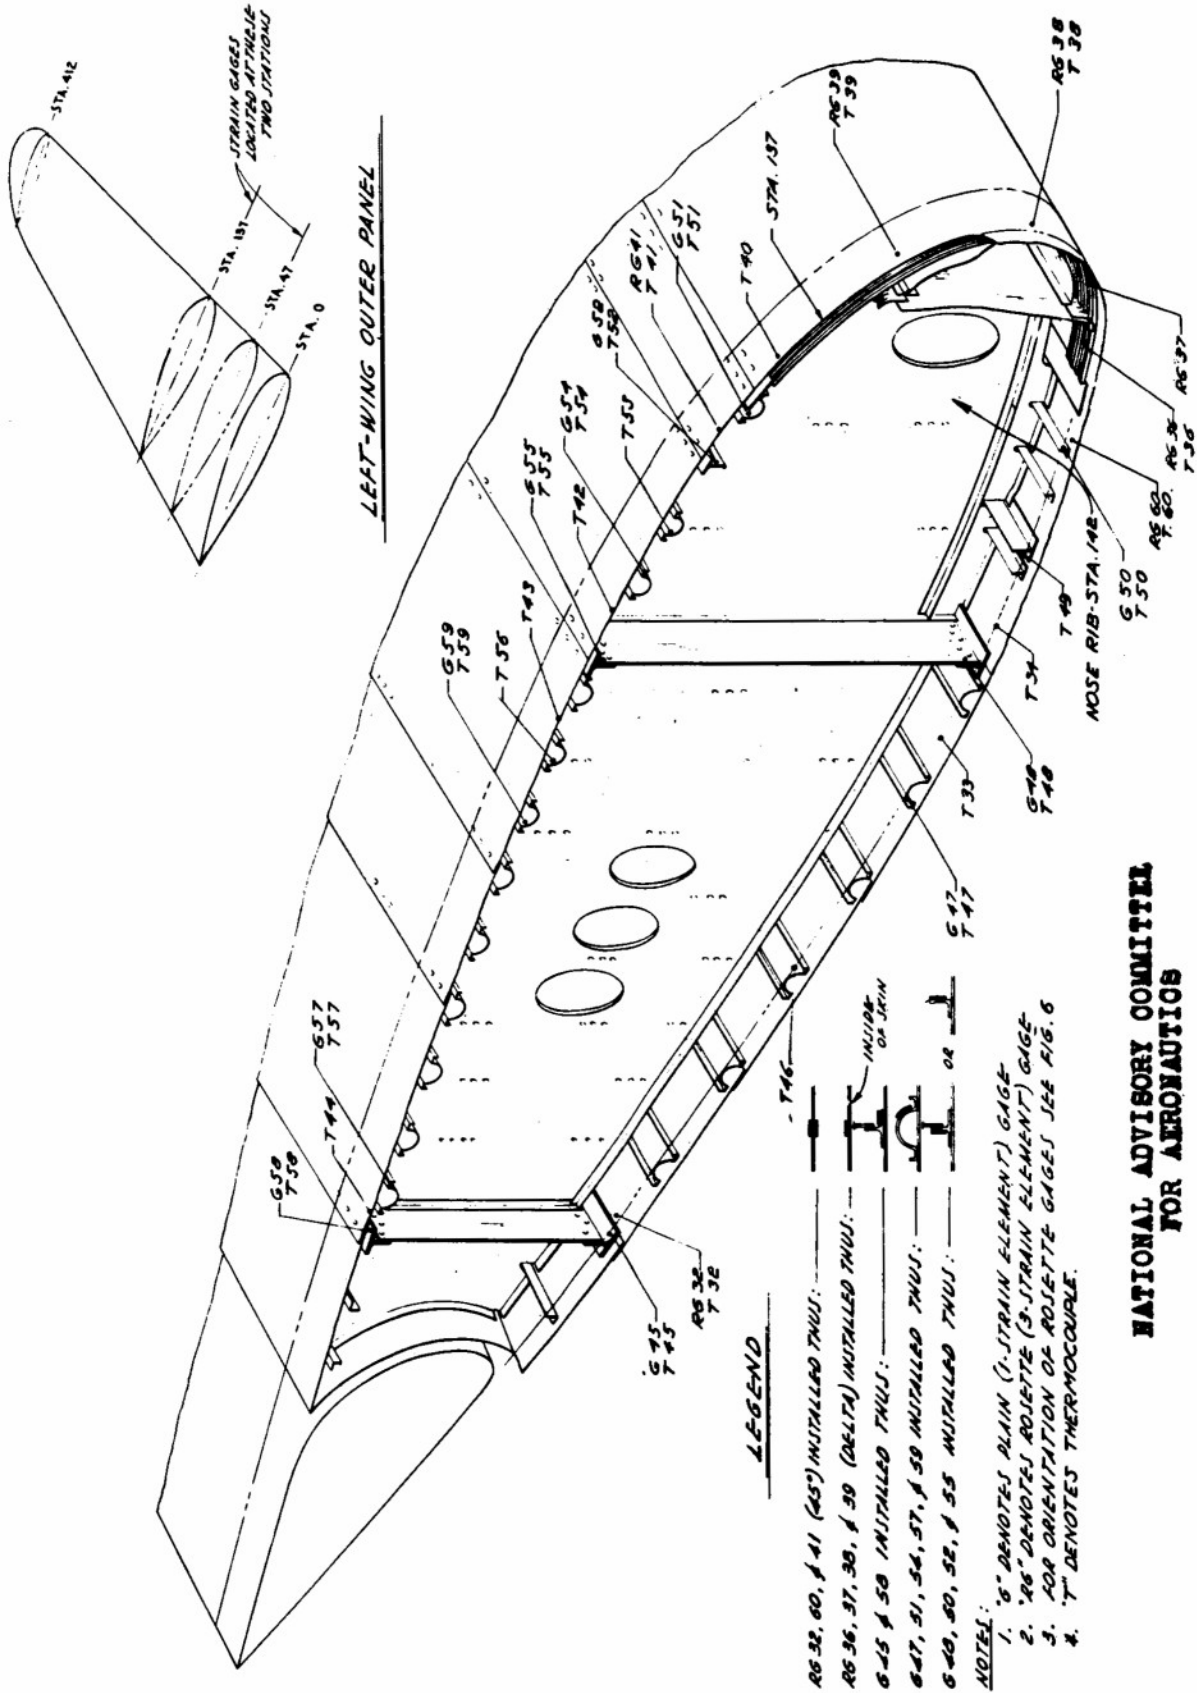
Figure 5.- Location of strain gages and thermocouples at wing outer-panel station 137, C-46 airplane.

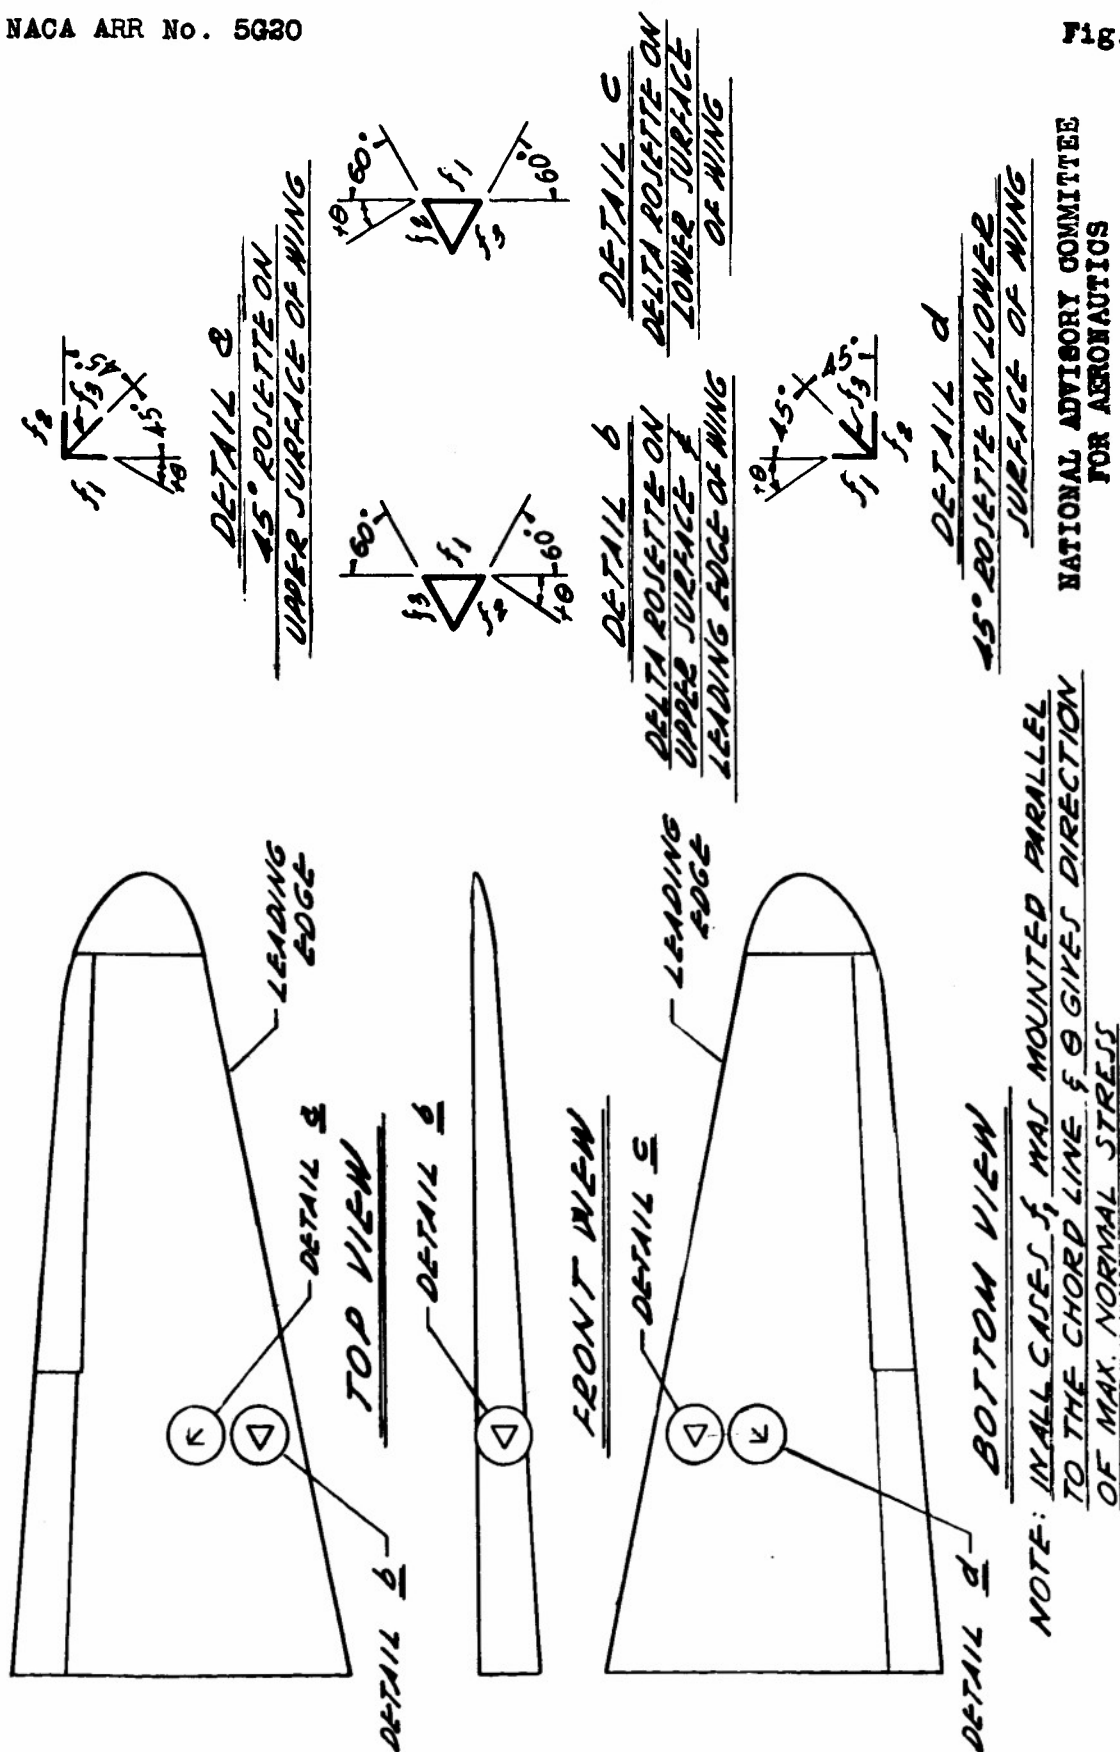
Figure 6.- Orientation of rosette gages on the left-wing outer panel of the C-46 airplane.

The plain gages were installed with their strain-sensitive axes parallel to the longitudinal axes of the structural members. The rosette gages were oriented as shown in figure 6, which also gives the designation for the three strain elements. The fact that the high-temperature rosettes were supplied in a delta arrangement and the low-temperature rosettes in a  $45^\circ$  pattern has no particular significance. Aft of the double-skin region the rosette gages were mounted in pairs, back to back, and connected in series in order to eliminate strain indications caused by possible local skin buckling. This procedure was not feasible in the double-skin region but was considered unnecessary because of the stabilizing effect of the inner corrugations. Two typical plain-gage and one rosette-gage installations are shown in figure 7.
