June 1945 as  
Advance Restricted Report L5F01a

EFFECT OF FABRIC DEFLECTION AT HIGH SPEEDS ON THE  
AERODYNAMIC CHARACTERISTICS OF THE HORIZONTAL  
TAIL SURFACE OF AN SB2D-1 AIRPLANE

By Carl F. Schueller and Peter F. Korycinski

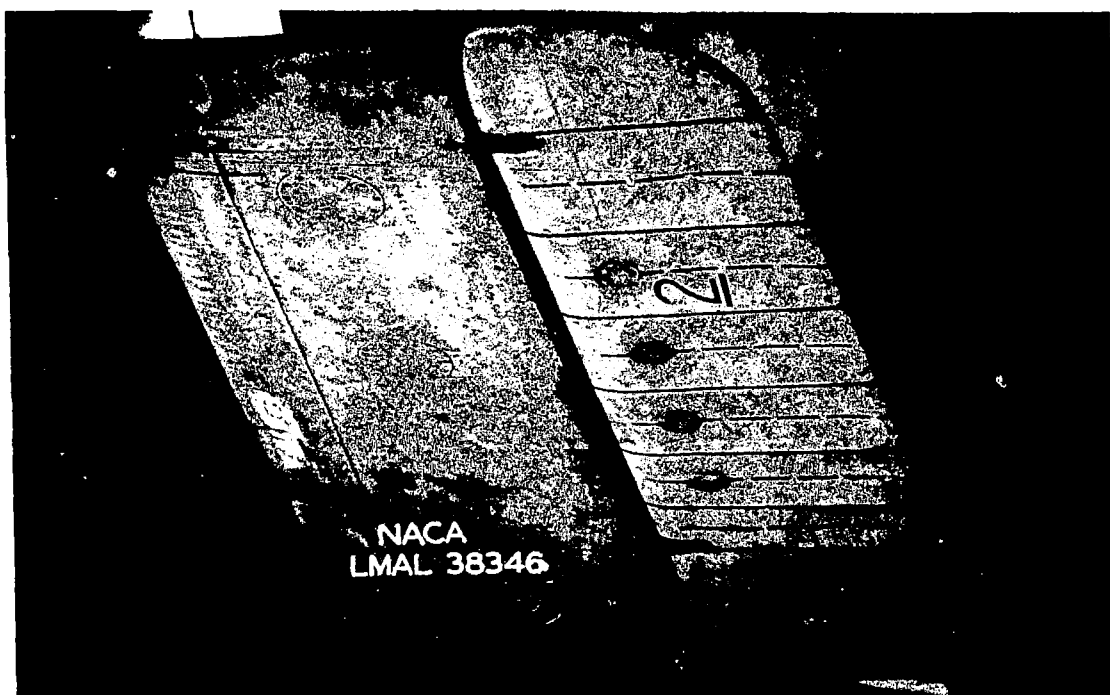
Figure 9.- Fabric deflection of elevator 2 (8-inch rib spacing).  
 $M = 0.55$ ;  $\alpha = 0^\circ$ ;  $\delta = 3.3^\circ$ ; elevator seal removed; elevator vents at trailing edge.

Elevator 2.- Figure 9 is a photograph of the fabric deflection of both surfaces of elevator 2 (6-inch rib spacing) at  $\alpha = 0^\circ$ ,  $\delta = 3.3^\circ$ , and  $M = 0.55$ . Considerable bulge occurred on the top surface behind the hinge line. This bulge changed to depression on the rear part of the elevator. Since the fabric was sewed to the elevator ribs, the solid stripes should show no deflection. A number of solid stripes, however, are deflected. (See fig. 9(a).) Deflection of the solid stripes indicates failure of the fabric attachment at these points and is the beginning of a condition that would result in complete failure of the surface if the air loads were increased. Figure 10 is a photograph of the fabric deflection at  $\alpha = 3^\circ$ ,  $\delta = -0.7^\circ$ , and  $M = 0.62$ . In general, the upper surface is slightly bulged just behind the hinge line. The most serious bulge occurs at the inboard hinge and is believed to be a result of weak fabric attachment around the hinge-pocket cut-out rather than of local-suction peak pressures. Figure 10 also shows the fabric pulled away from the ribs. (Note solid stripes.)

Figure 20 is a photograph of the fabric deflection with vents at the elevator leading edge for  $\alpha = 0^\circ$ ,  $\delta = 4^\circ$ , and  $M = 0.55$ . Comparison of figures 20 and 9 shows that the upper-surface bulge is changed to depression with vents at the elevator leading edge, except for a small local bulge at the upper surface near the inboard hinge. It is apparent from figures 19 and 20 that location of the vents at the elevator leading edge will eliminate the danger of the fabric pulling loose from the ribs and failing for elevator angles up to at least  $4^\circ$ .

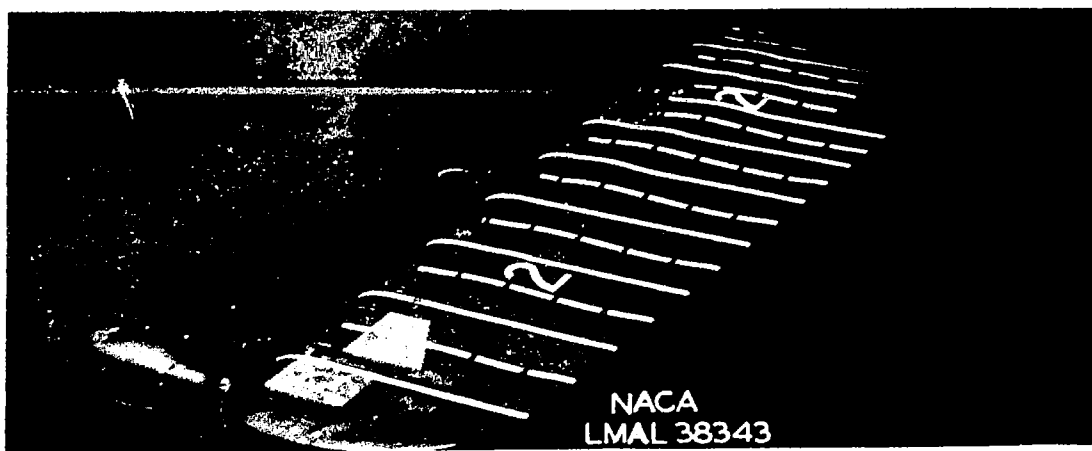
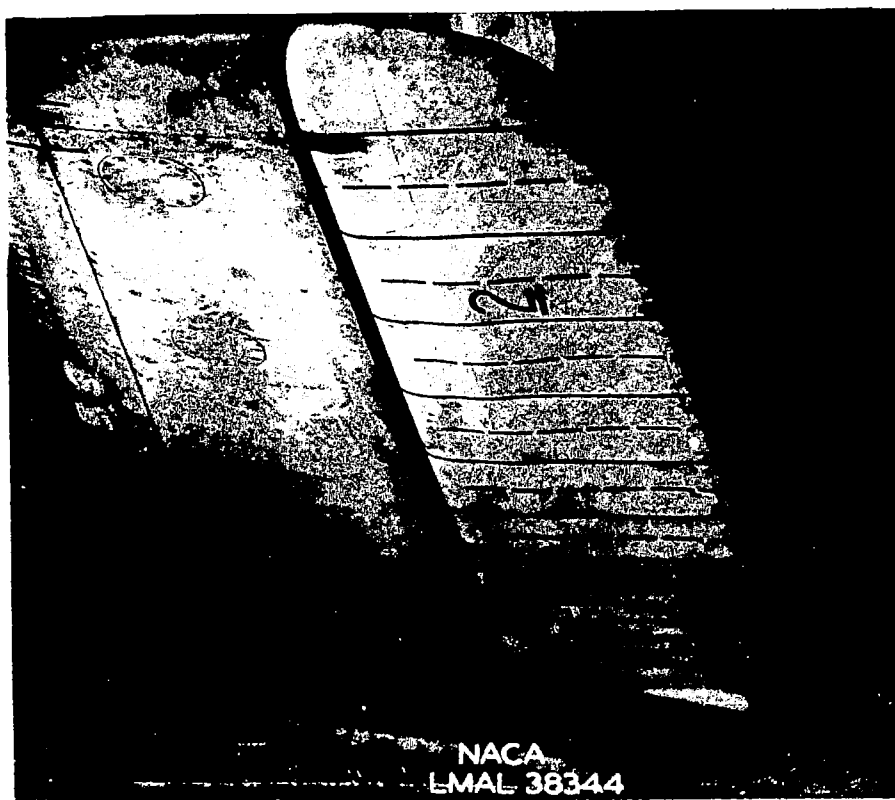
Figure 10.- Fabric deflection of elevator 2.  $M = 0.62$ ;  
 $\alpha = 3^\circ$ ;  $\delta = -0.7^\circ$ ; elevator vents at trailing edge.

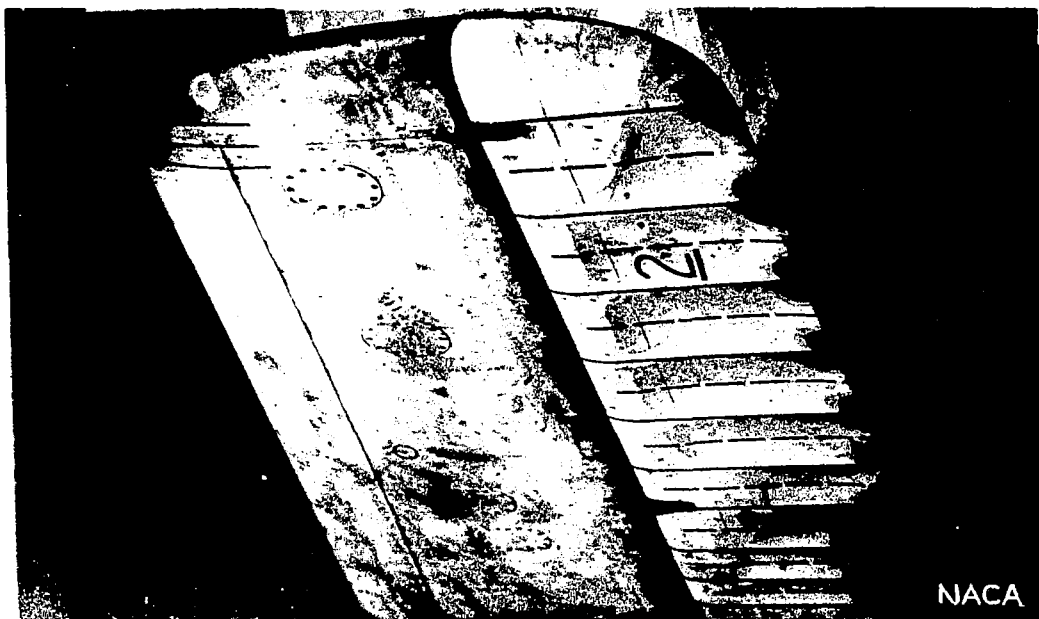
Figure 20.- Fabric deflection of elevator 2.  $M = 0.55$ ;  
 $\alpha = 0^\circ$ ;  $\delta = 4^\circ$ ; elevator vents at leading edge.
