# Aging Aircraft Subsystems

## Equipment Life Extension within the Tornado Program

Dipl. Ing. G. Blech  
PANAVIA Aircraft GmbH  
Am Söldnermoos 17  
85399 Hallbergmoos  
Germany

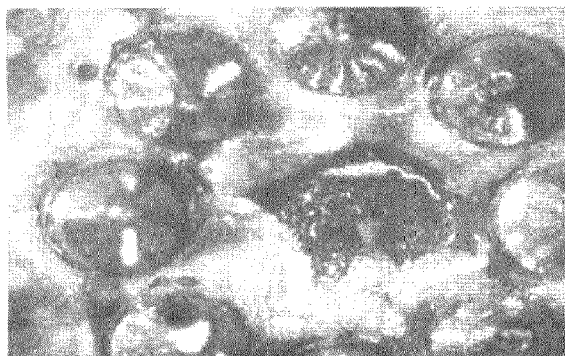
**Fig. 8:** Aged solder joints of PCB's

Load-Life during different usage of the aircraft and maintenance may stress these electronic components.
