TITLE: A USN Strategy for Mechanical and Propulsion Systems  
Diagnostics and Prognostics, Life Usage Monitoring and Damage  
Tolerance: Applications to Aging Aircraft Problems

# A USN Strategy for Mechanical and Propulsion Systems Diagnostics and Prognostics, Life Usage Monitoring and Damage Tolerance: Applications to Aging Aircraft Problems

Naval Air Warfare Center Aircraft Division  
Propulsion and Power Dept.  
22195 Elmer Rd. Bldg. 106  
Patuxent River, MD 20670-1534, USA

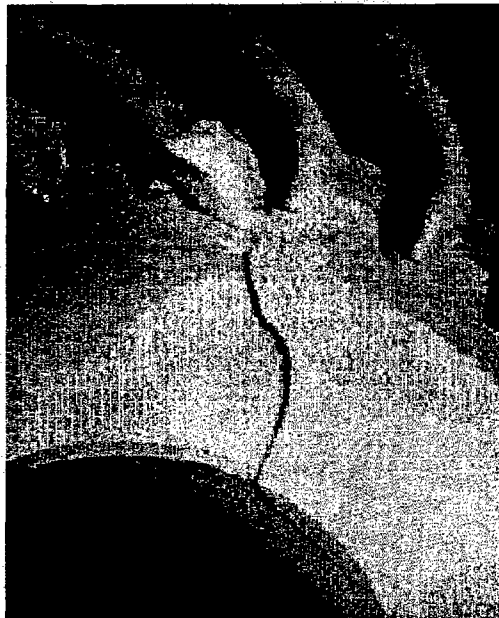
**Fig. 10. Cracked Intermediate Gearbox Pinion.**

the HP36650 Spectrum Analyzer. Subsequent to test termination the gearbox was disassembled and inspected. The input pinion's faulted tooth exhibited a crack initiating from the tooth root and extending through the gear web and stopping at a bearing support diameter. Figure 10 exhibits the subject pinion at the end of the test. There is a void at the toe end of the notched tooth where a large section of the tooth broke off, and a large web crack extending to the bearing support diameter. No indication from the gearbox chip indicator was observed.

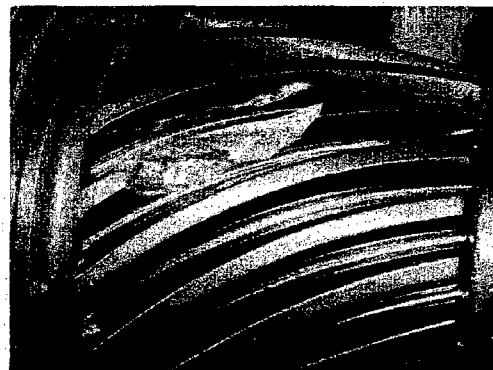
**Fig. 11. Main Transmission Input Pinion Crack.**

Two EDM notches were implanted in the root of one gear tooth and run for 12 million cycles at 110% power, removed and inspected, and then tested for another 10 million cycles. After 12 million cycles, small cracks less than 2mm in length emanating from the notch corners were present. Figure 11 exhibits the pinion after another 10 million cycles. A large part of the faulted tooth has broken off, and a crack propagated the length of the part forward (toe end), and aft (heel end) to the bearing support. No indication from the gearbox chip indicator was observed.
