TITLE: Design and Testing of the Minotaur Advanced Grid-Stiffened Fairing

TITLE: Proceedings of the International Conference on Composite Structures [12th] [ICSS/12] Held in Melbourne, Australia on 17-19 November 2003

# Design and testing of the Minotaur advanced grid-stiffened fairing

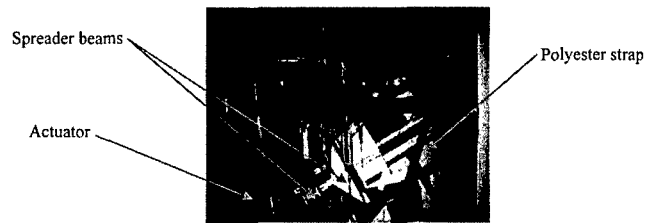
Fig. 15. Typical actuator connections.

The Minotaur Fairing Qualification tests were conducted in a general-purpose steel frame load fixture. The test fixture was used previously to flight qualify two separate payload adapter structures; EELV Secondary Payload Adapter (ESPA) for the EELV launch vehicle and a Multiple Payload Adapter (MPA) unit for the Minotaur launch vehicle. To suit the dimensions of the Minotaur fairing, the top cross bracing of the fixture was temporarily removed and an additional 12 feet of vertical column members were inserted at the four vertical uprights of Fig. 14. Actuators connected the load frame to belts that were draped into position with gravity off-load springs. These belts applied the three lower lateral loads to the fairing. These belts distributed load to the fairing through 2 cm thick felt padding on the inside face of the belts. Aluminum spreader bars were provided to prevent contact of belt to fairing on the unloaded face of the fairing. Load angle was confirmed by multiple measurements with a digital inclinometer at 10%, 20%, 30% and 40% of design load. Typical frame to actuator connections and actuator to belt/nose plate connections are illustrated in Fig. 15.

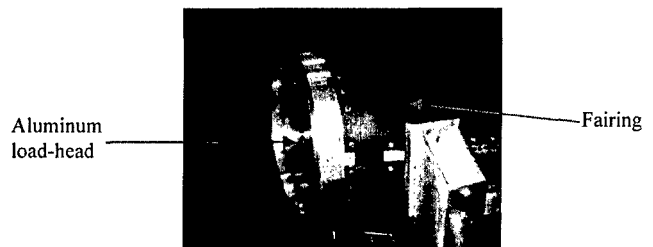
Fig. 16. Aluminum nose plate test fixture.

The largest load in each test was applied axially through a strap extending through the interior of the fairing and pulling downward. The nose cone for the fairing was replaced in these tests with a thick aluminum plate (see Fig. 16). The plate rested on a circumferential rib supported by numerous vertical ribs at the nose. This plate was loaded by an internal belt from below and by a fourth (upper) actuator laterally.
