Report No. RR-49

AN ELECTROLYTIC PAINT SYSTEM

U. S. Army Ordnance Tank-Automotive Command  
1501 Beard  
Detroit 9, Michigan

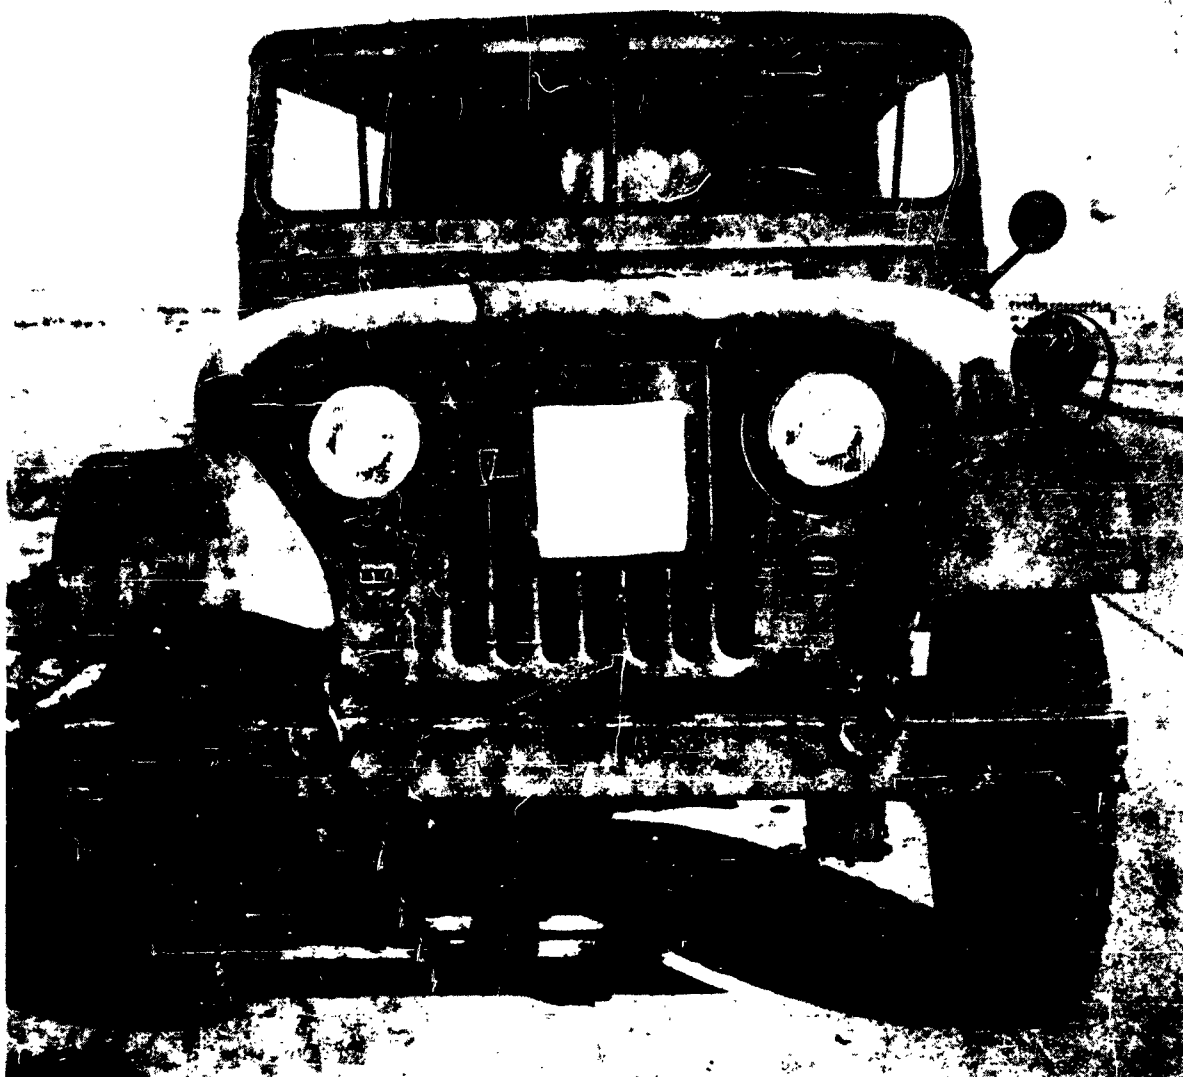
FIGURE 63

The general outside condition of the vehicle after it was removed from the test blocks and put into operation is shown in Figures 61 thru 64.

M38A1 TEST VEHICLE AFTER 35 MONTHS EXPOSURE (COMPLETION OF TEST)

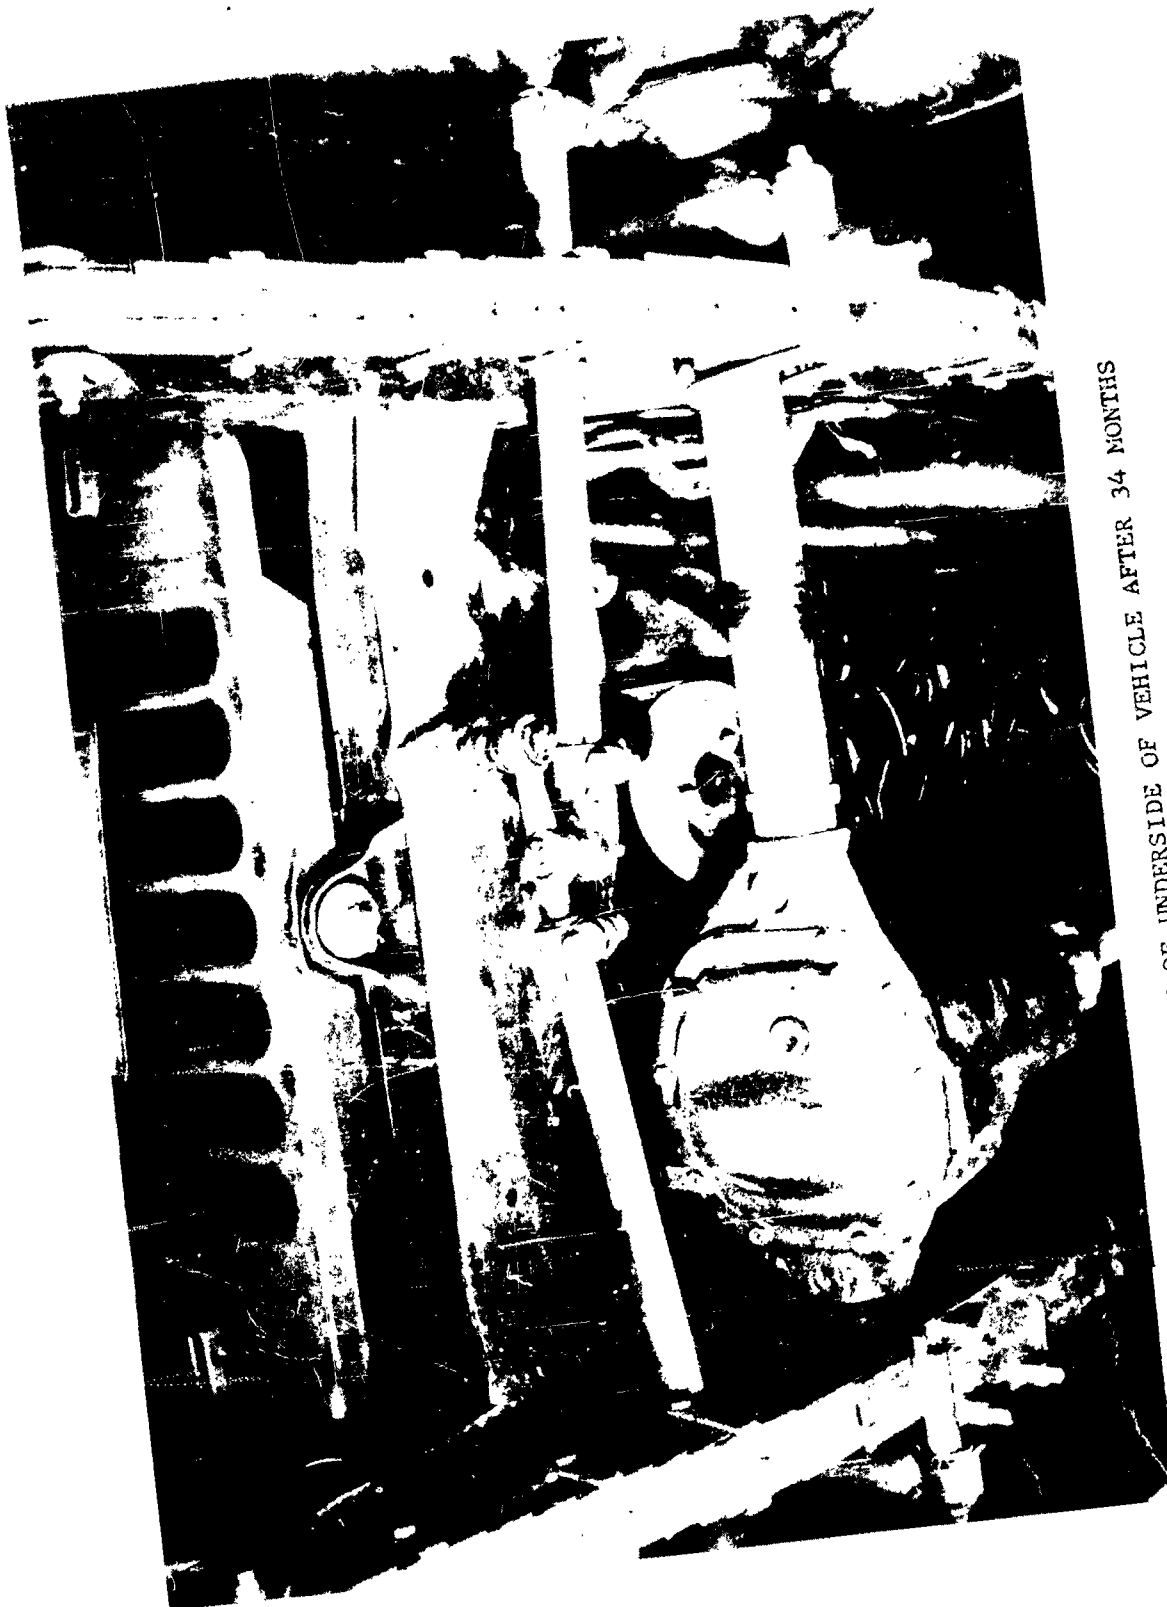
FIGURE 68

| <u>Before Exposure</u> | <u>After 35 Months Exposure</u> | <u>Component</u> |
|---|---|---|
| Fig 65 | Fig 68 | Front Differential & Springs |

M38A1. CONDITION OF UNDERSIDE OF VEHICLE AFTER 34 MONTHS  
ATMOSPHERIC EXPOSURE
