TERMINAL BALLISTIC TARGET ANALYSIS AND STUDY  
OF TARGET VULNERABILITY TO VERY HIGH SPEED IMPACT

Technical Documentary Report No. ATL-TDR-64-51  
August 1964 Project No. 5841  
Task No. 02

Directorate of Armament Development  
Det 4, Research and Technology Division  
Air Force Systems Command  
Eglin Air Force Base, Florida

(Prepared under Contract No. AF 08(635)-3641 by the Hayes  
International Corporation, Birmingham, Alabama)

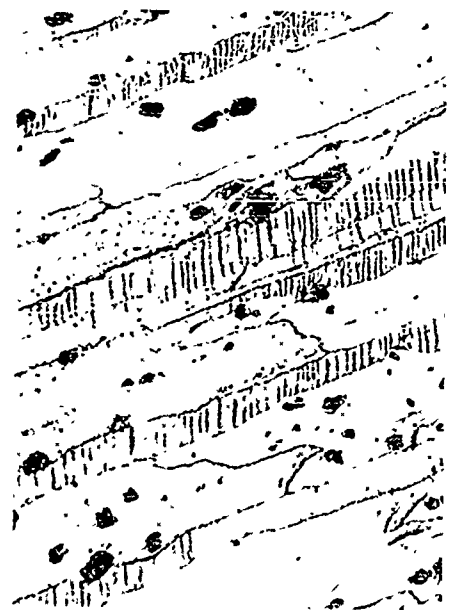
No evidence such as eutectic melting or grain boundary precipitation was found of high temperature effects on the target upon examination of a polished specimen at high magnification (500X). Individual grains were deformed in a plastic manner around the impact area. What appear to be slip bands were found in the area around perforation A. Multiple slip systems are shown in Figure 26. Electron micrographs of surface replicas of an area near perforation A are presented in Figures 27, 28, and 29. The electron micrographs were prepared by the Electron Microscope Laboratory, Engineering Experiment Station, Georgia Institute of Technology. Structures which may be slip bands are evident in the electron micrographs. Microfissures and alloying constituents are also evident. Damage to the replica may have occurred in the area shown in the upper left corner of Figure 28.

FIGURE 26 SLIP SYSTEMS NEAR PERFORATION A,  
TARGET 63-09, 2024-T4 ALUMINUM,  
0.5 INCH THICK

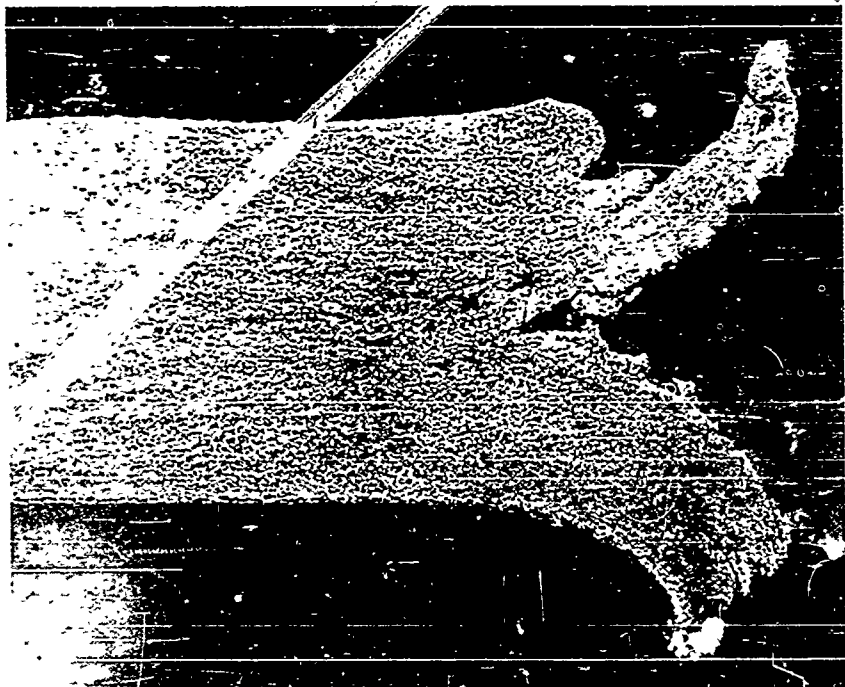
FIGURE 52 PERFORATION A, TARGET 63-21, AZ31B-H24  
MAGNESIUM, 0.1 INCH THICK (20X)
