THE GREAT ALASKA EARTHQUAKE

Volume II

Illustrations and Maps

TECHNICAL REPORT NO. AFWL-TR-65-92, Vol II

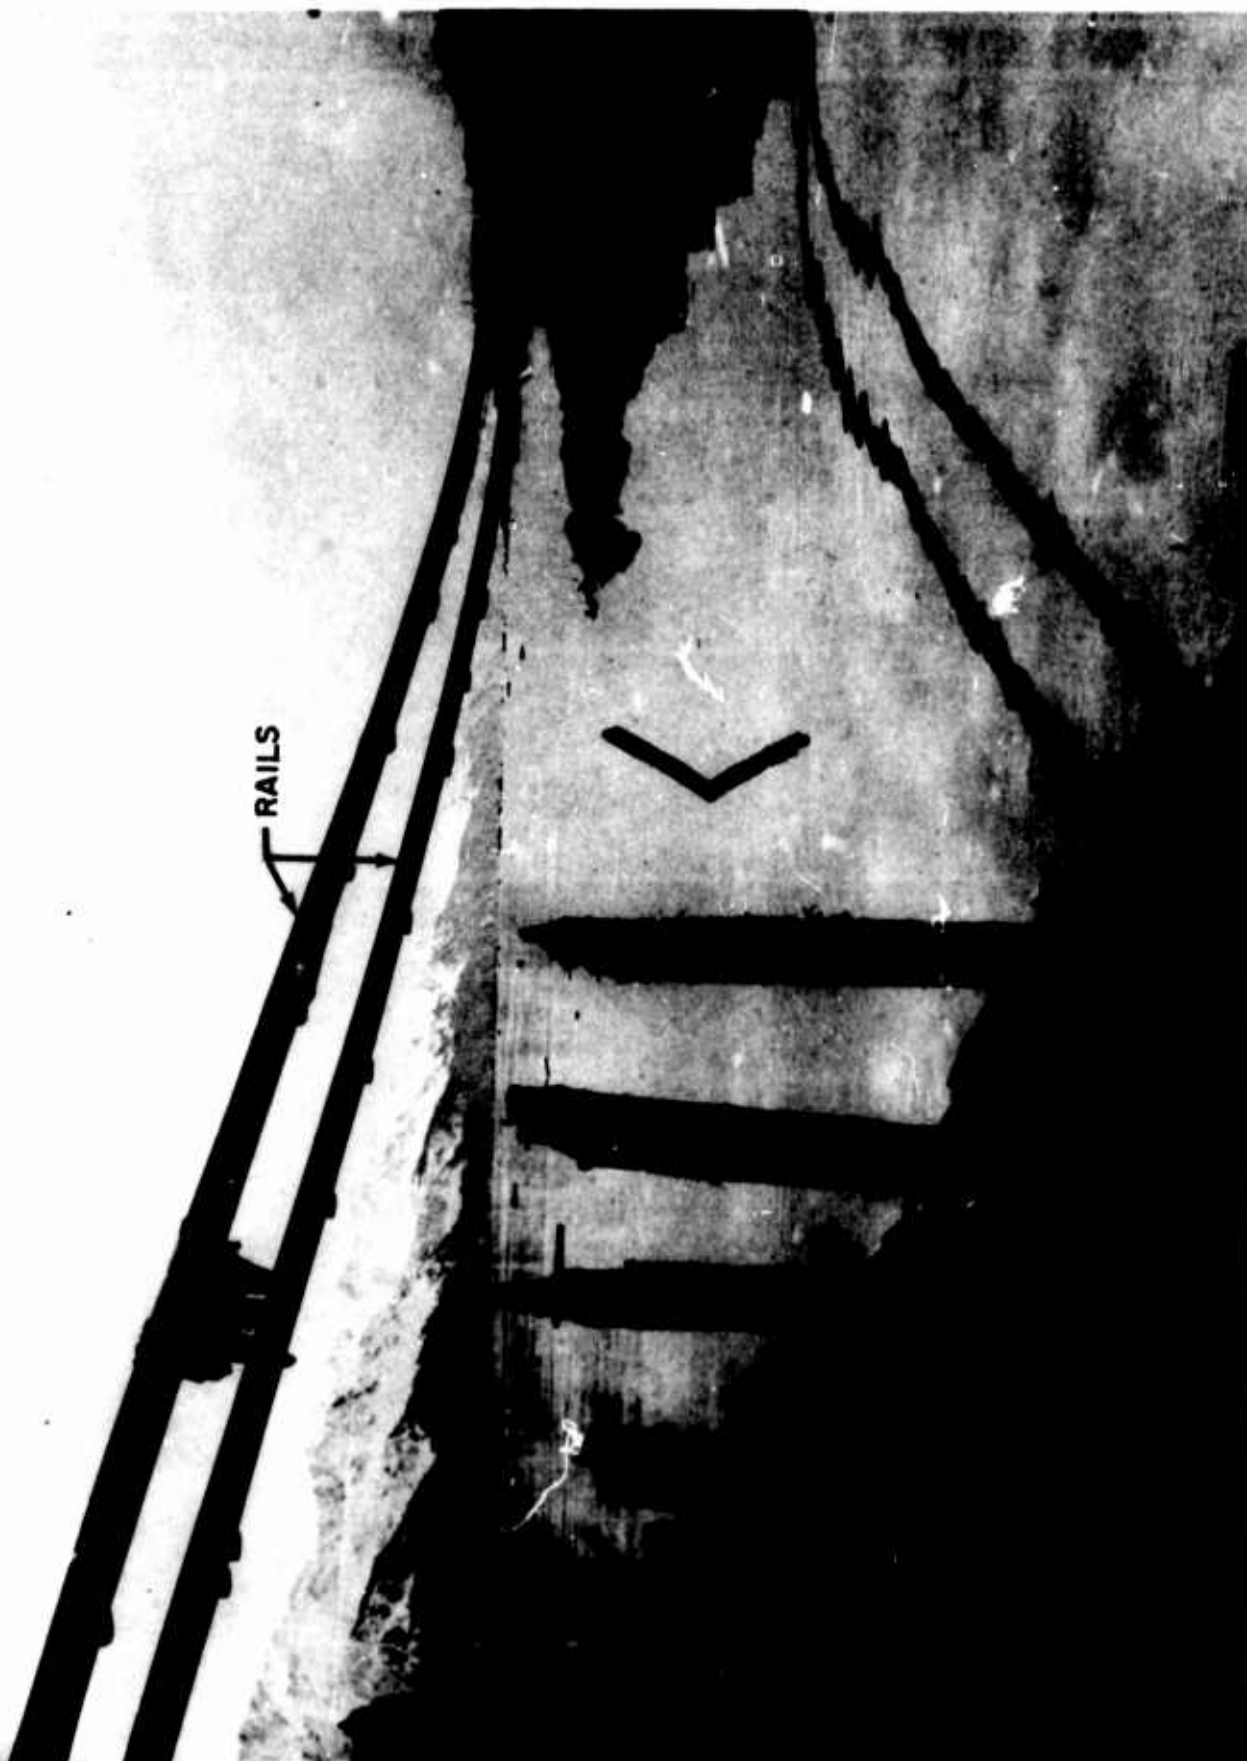
Figure 22. Railroad Bridge in Seward Destroyed by Seismic Sea Wave

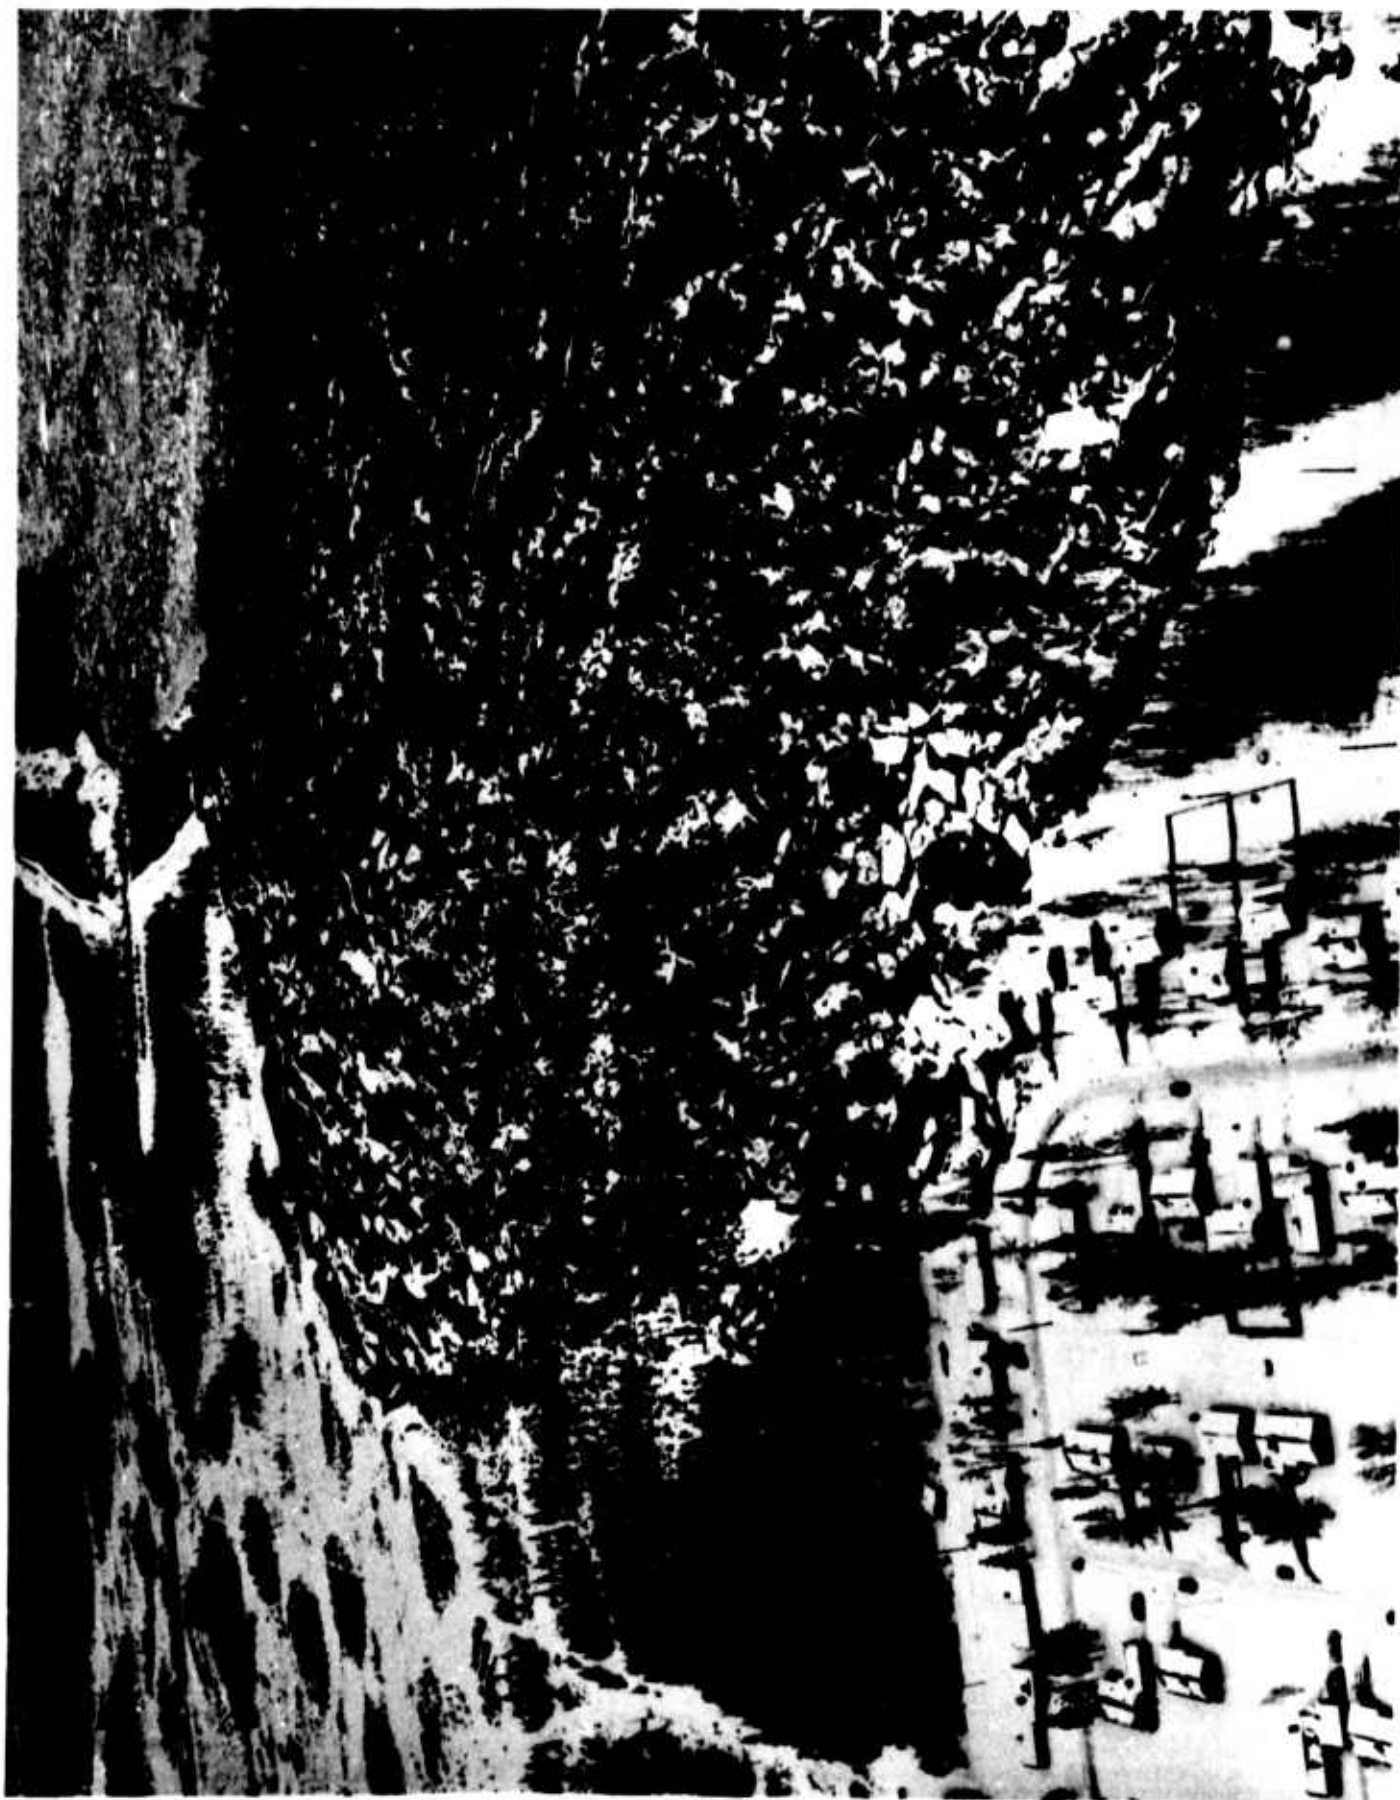
Figure 32. Turnagain Slide (Uninhabited region)

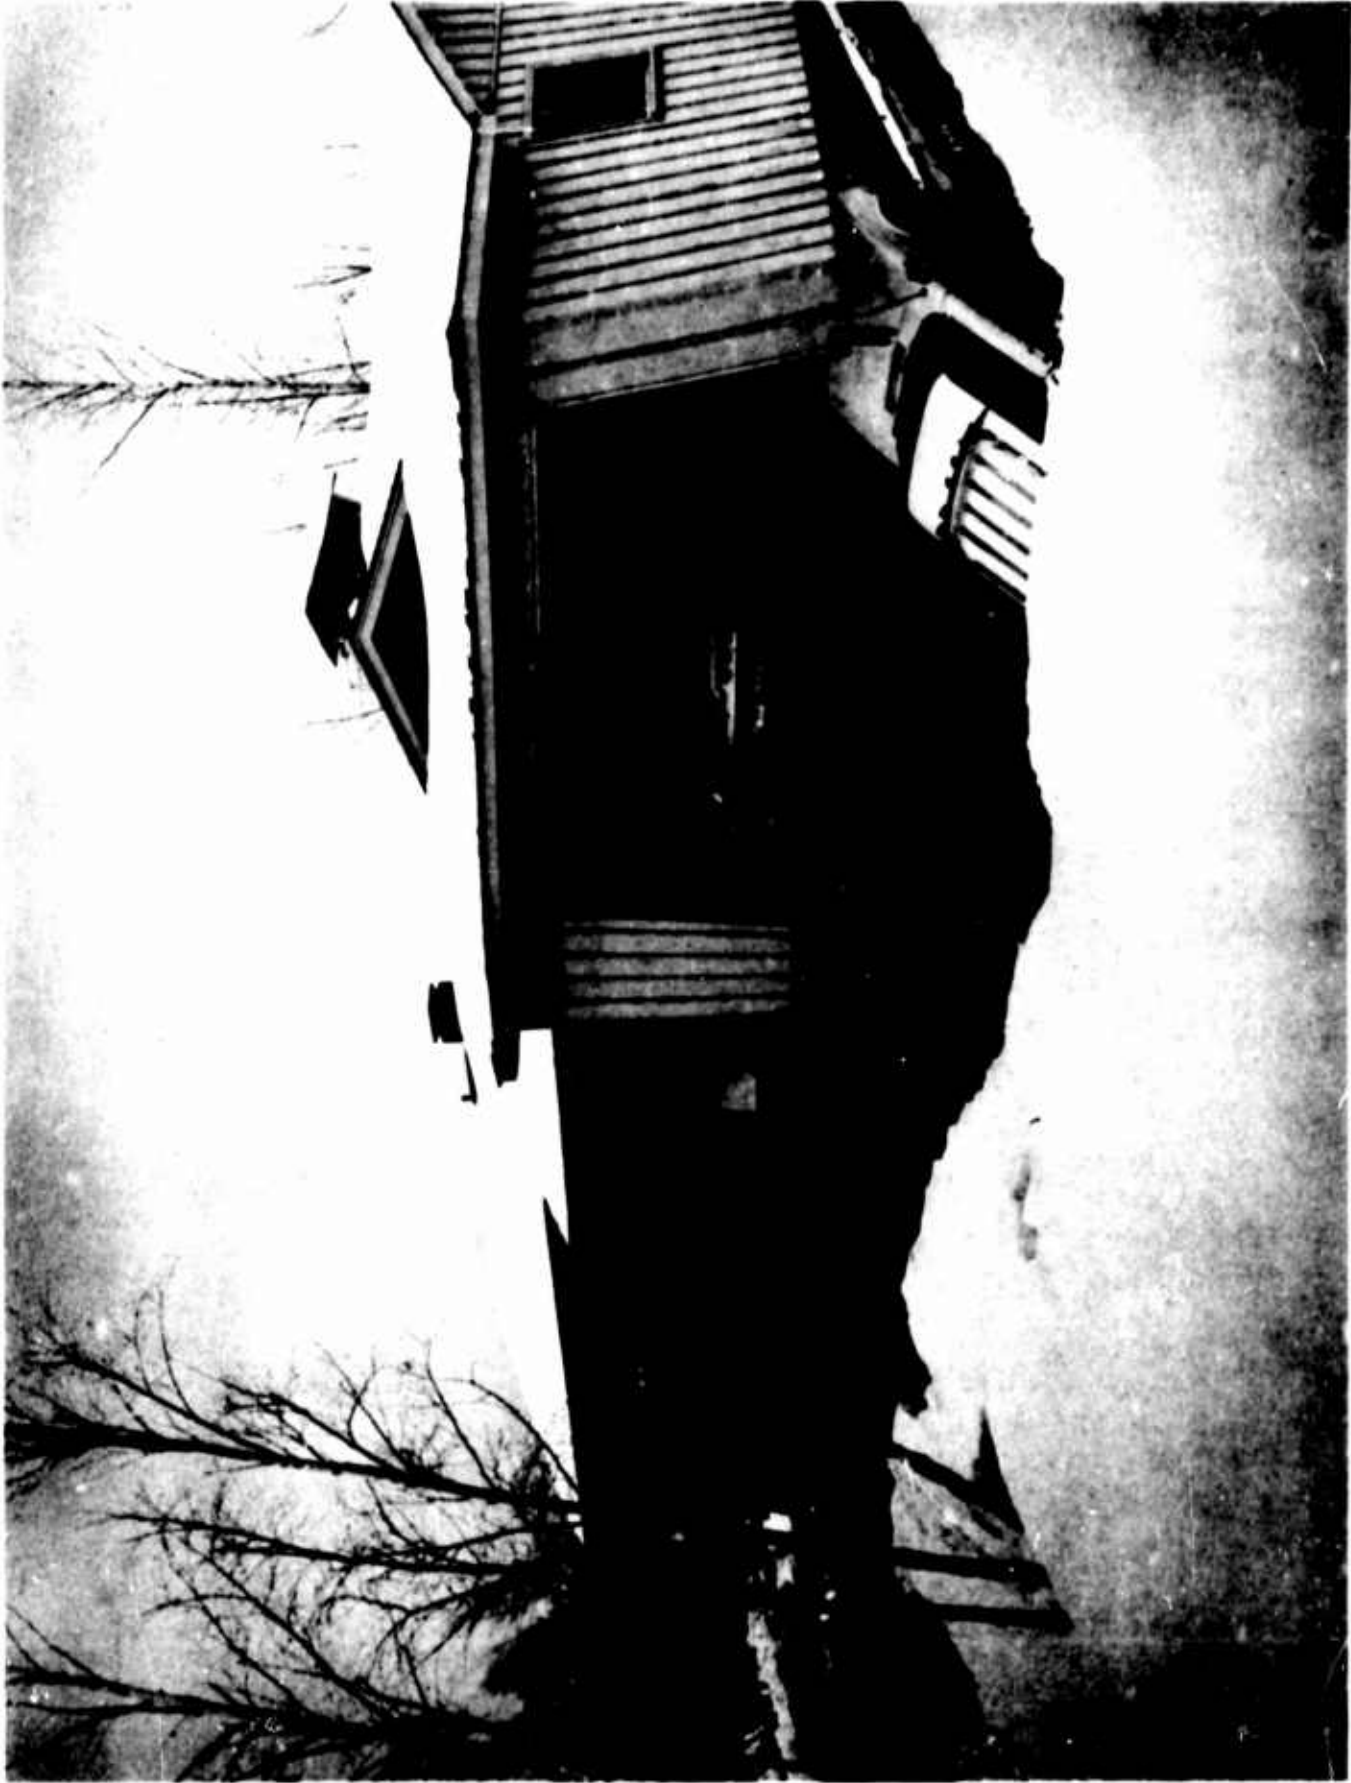
Figure 38. Turnagain Slide (Damage to residential buildings)

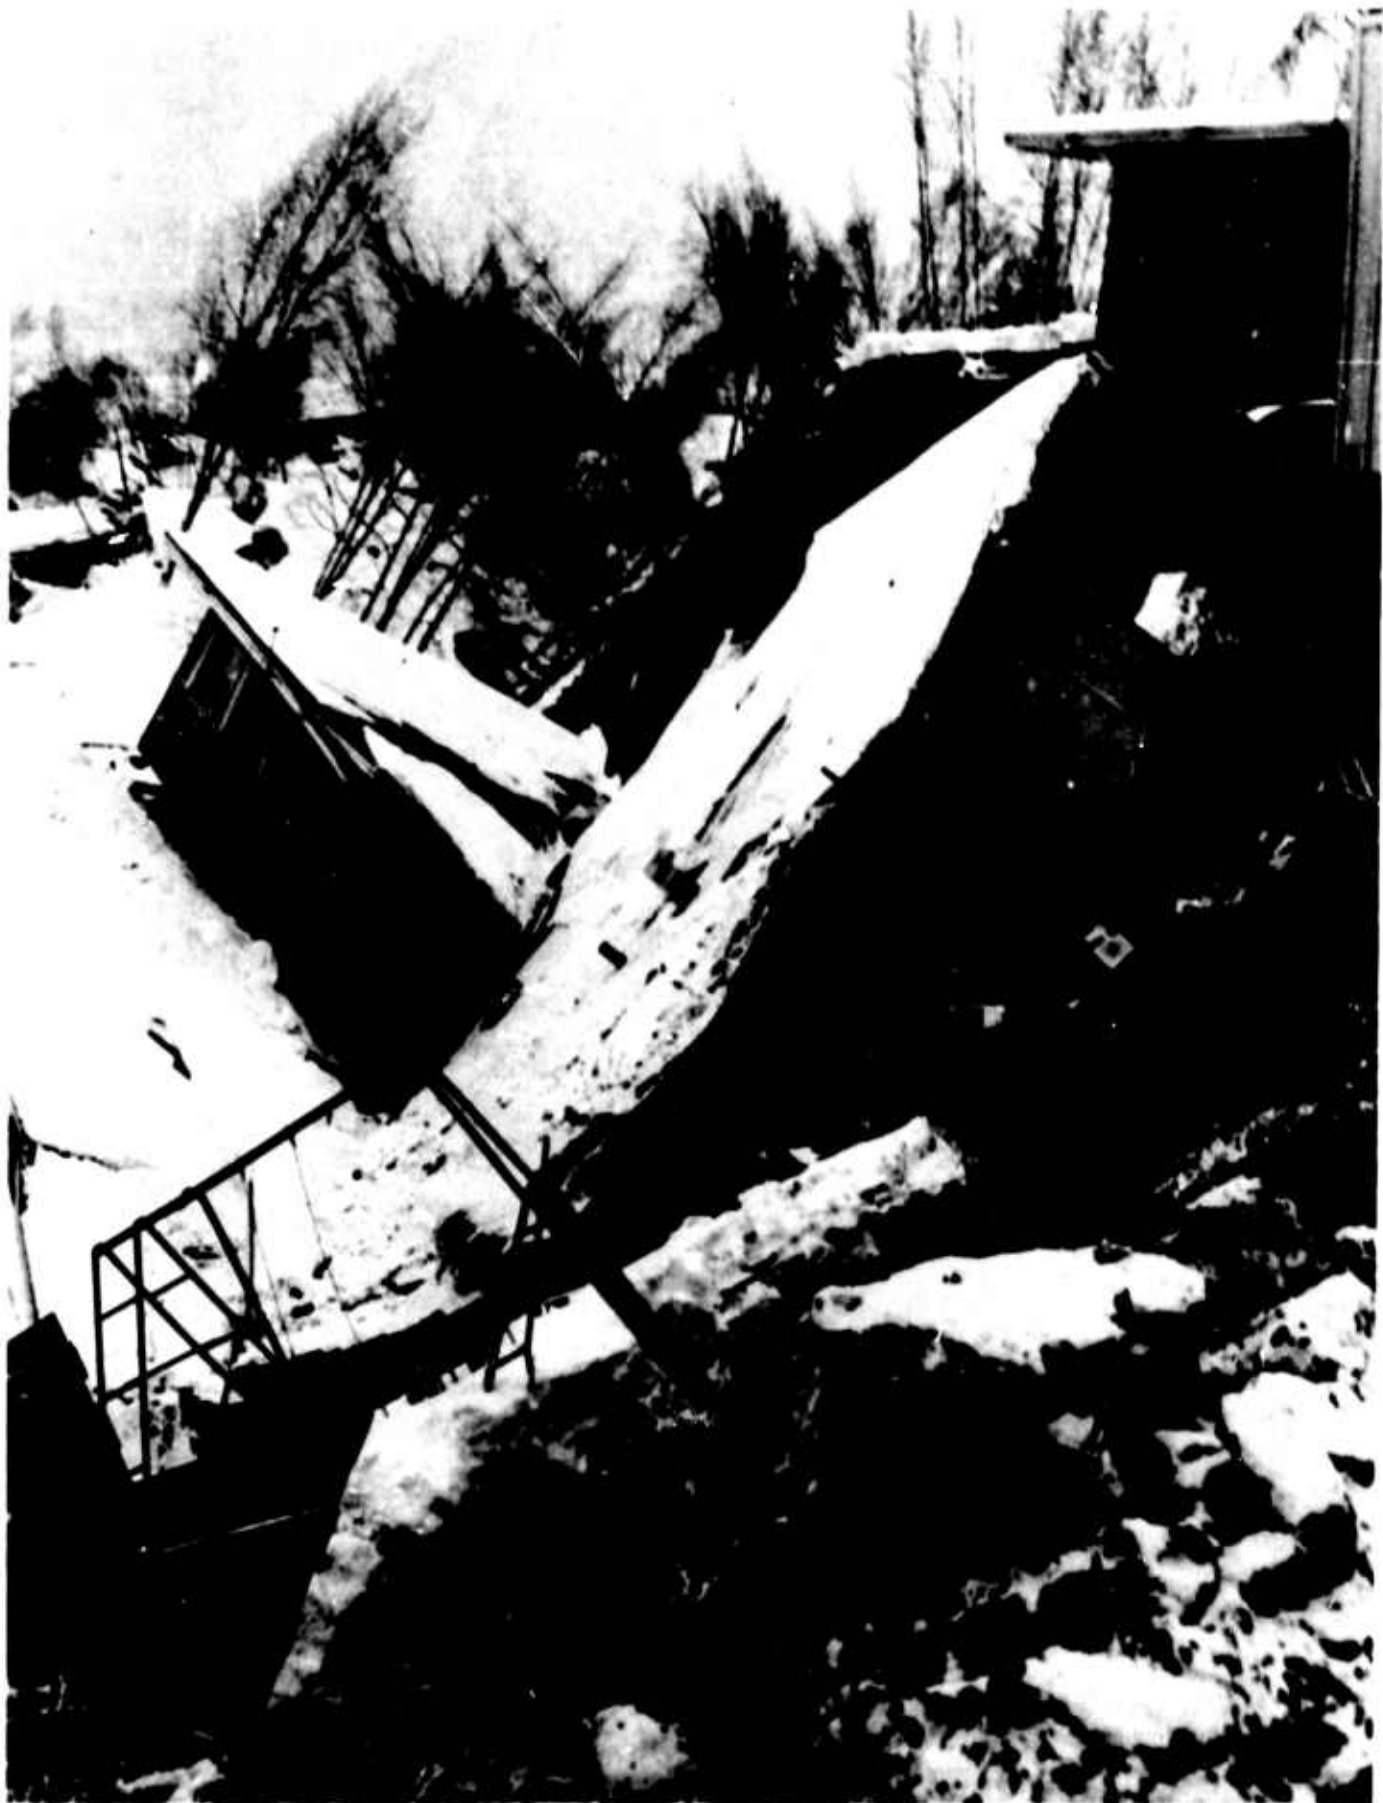
Figure 39. Turnagain Slide (Damage to residential buildings)

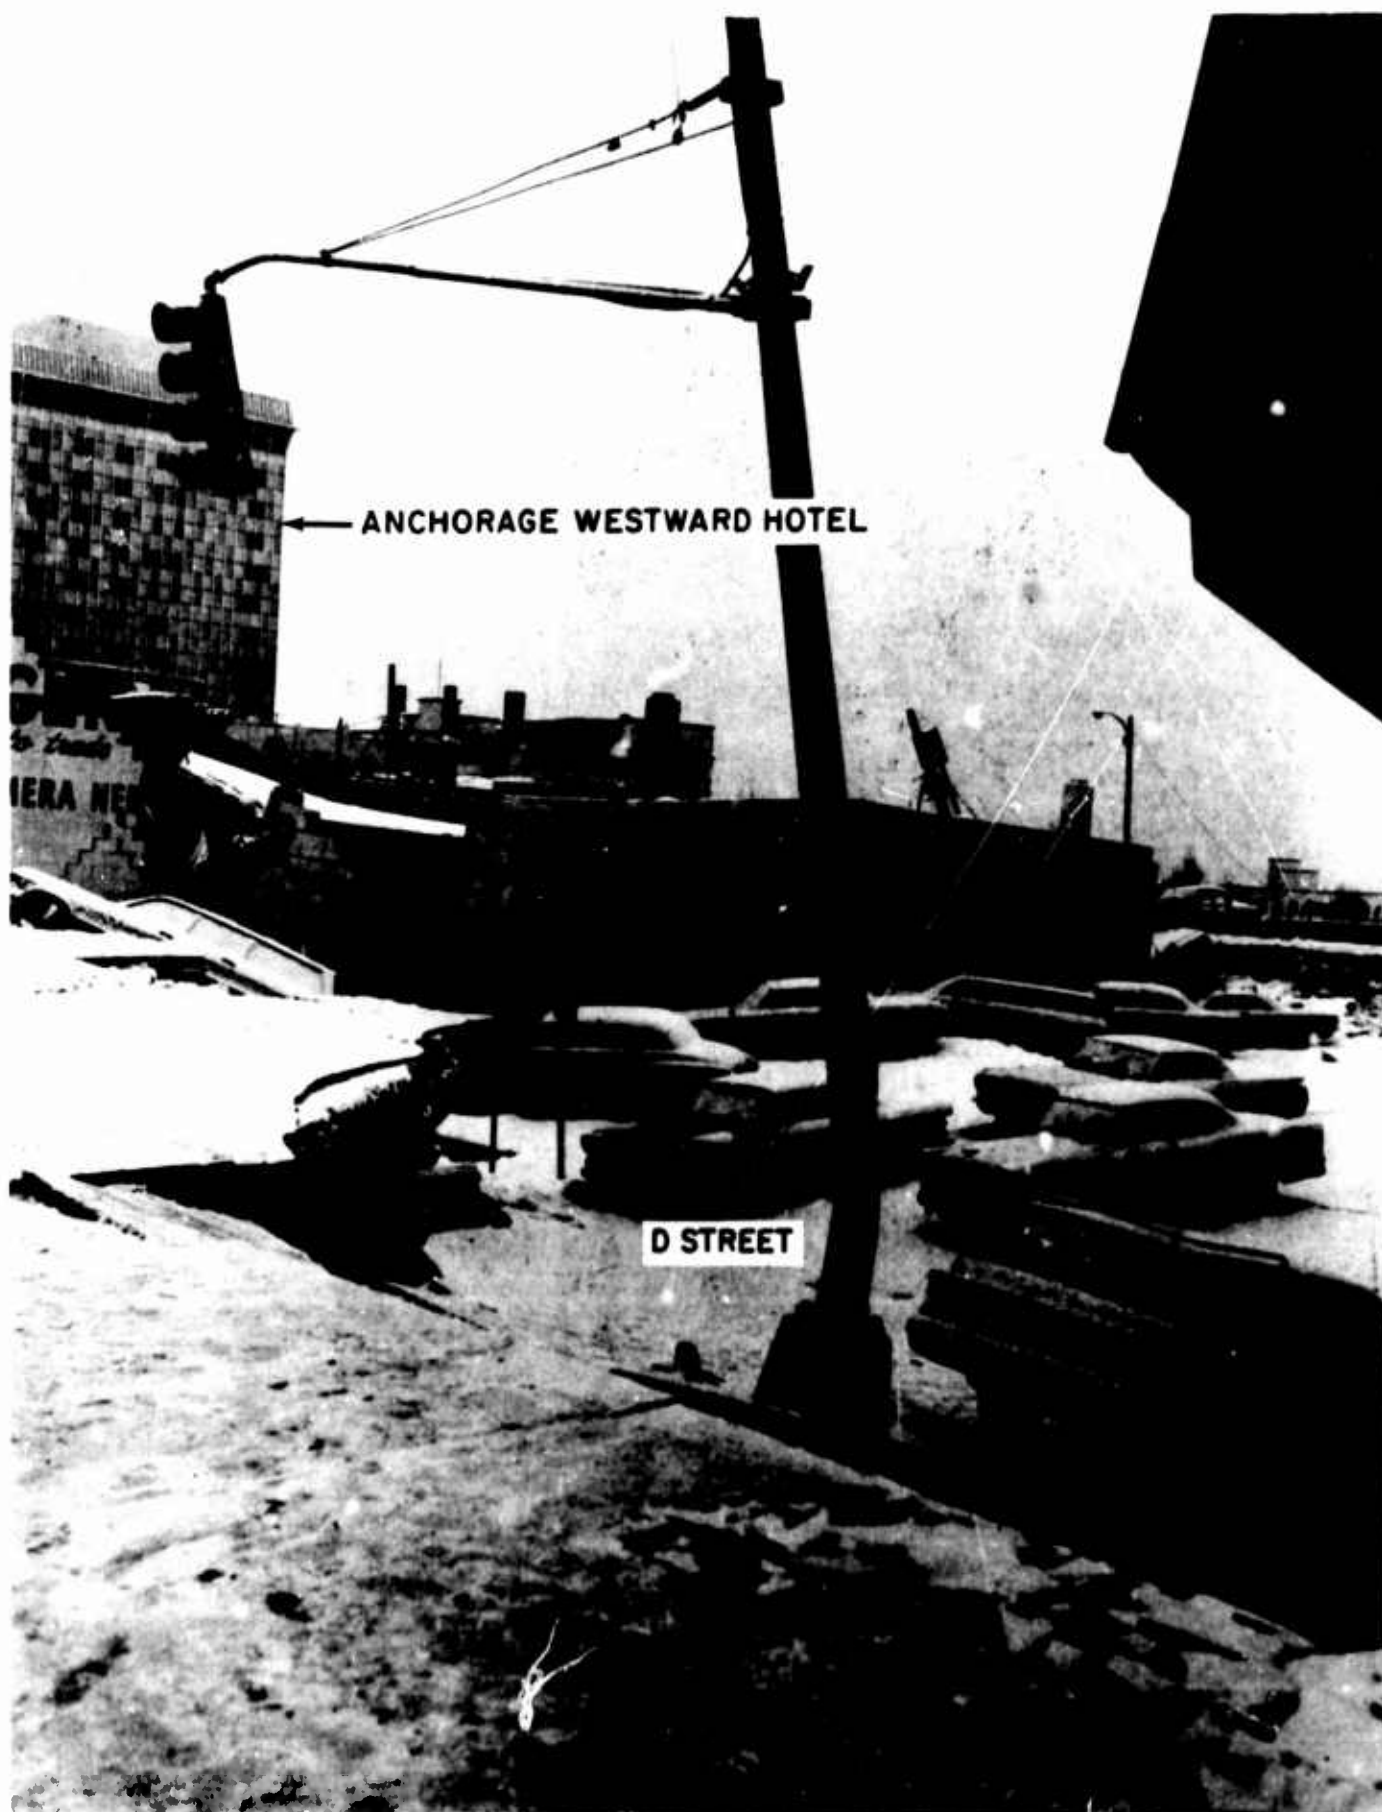
Figure 62. Fourth Avenue Slide (D Street north of Fourth Avenue)

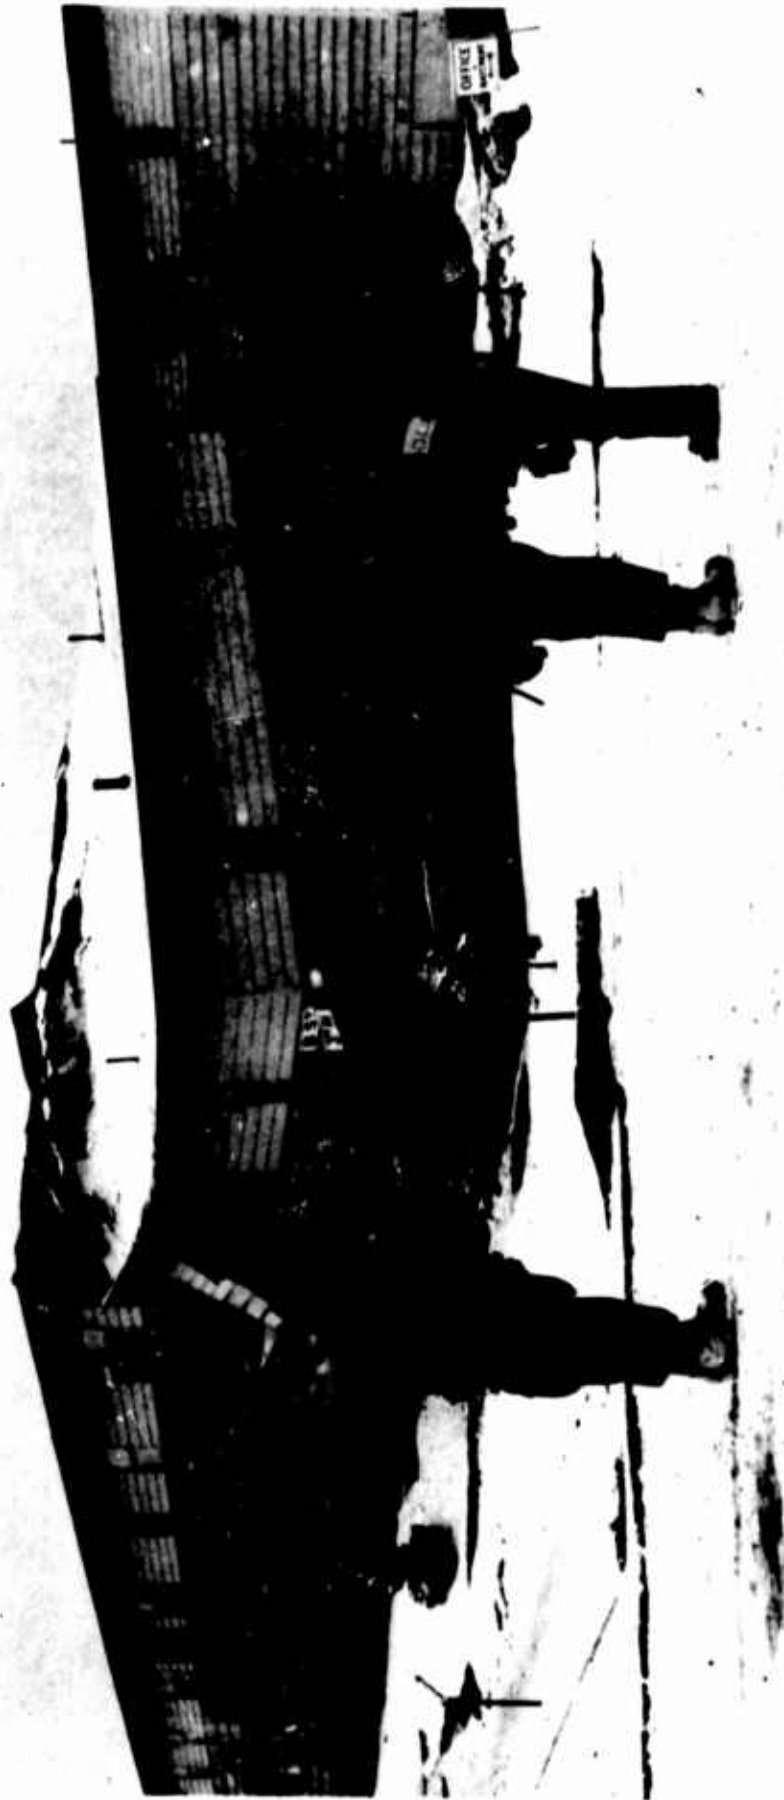
Figure 65. Fourth Avenue Slide (Damage to the E and F Apartments)

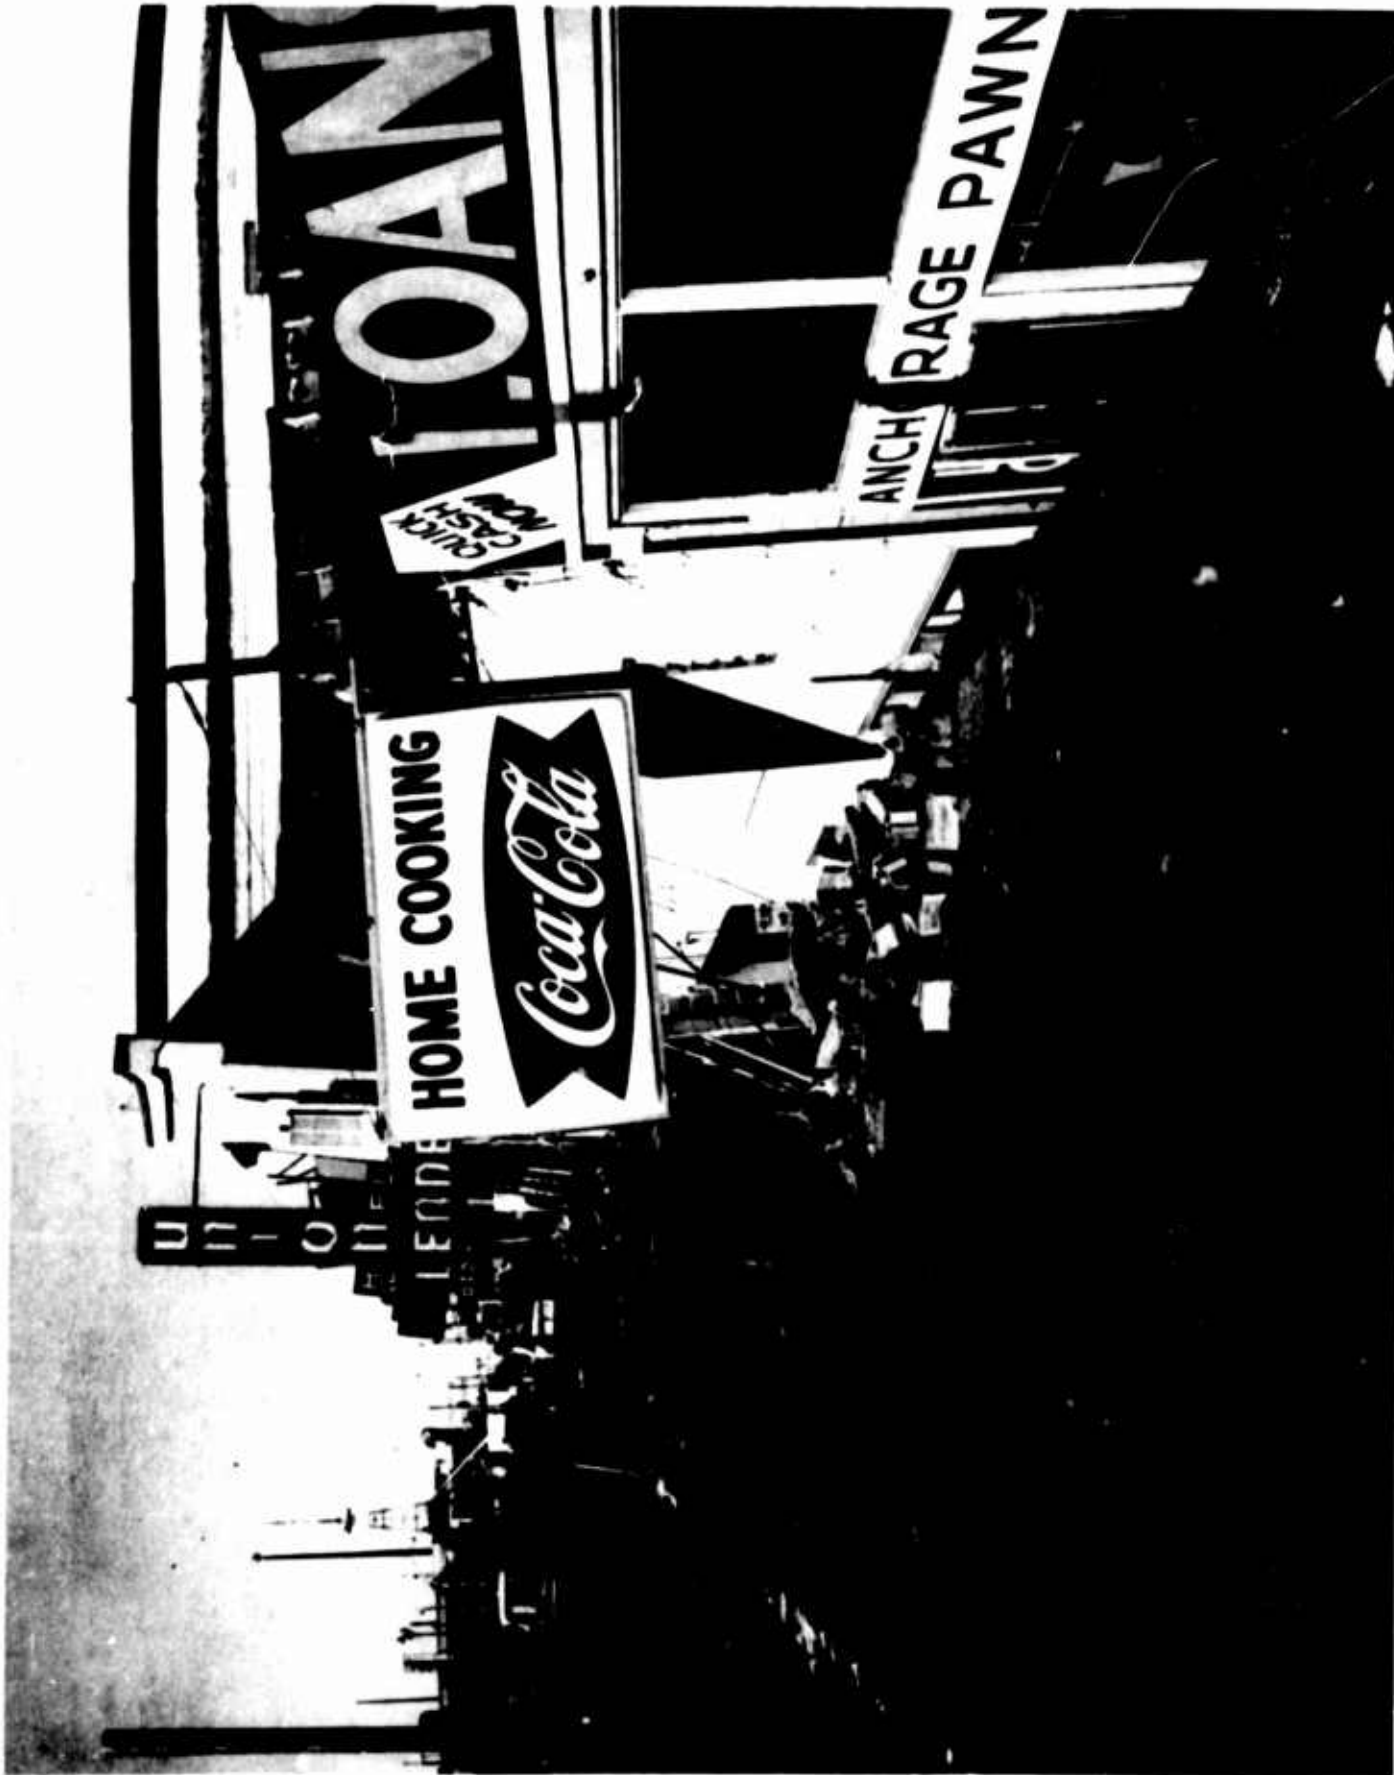
Figure 69. Fourth Avenue Slide (Uncracked window glass)

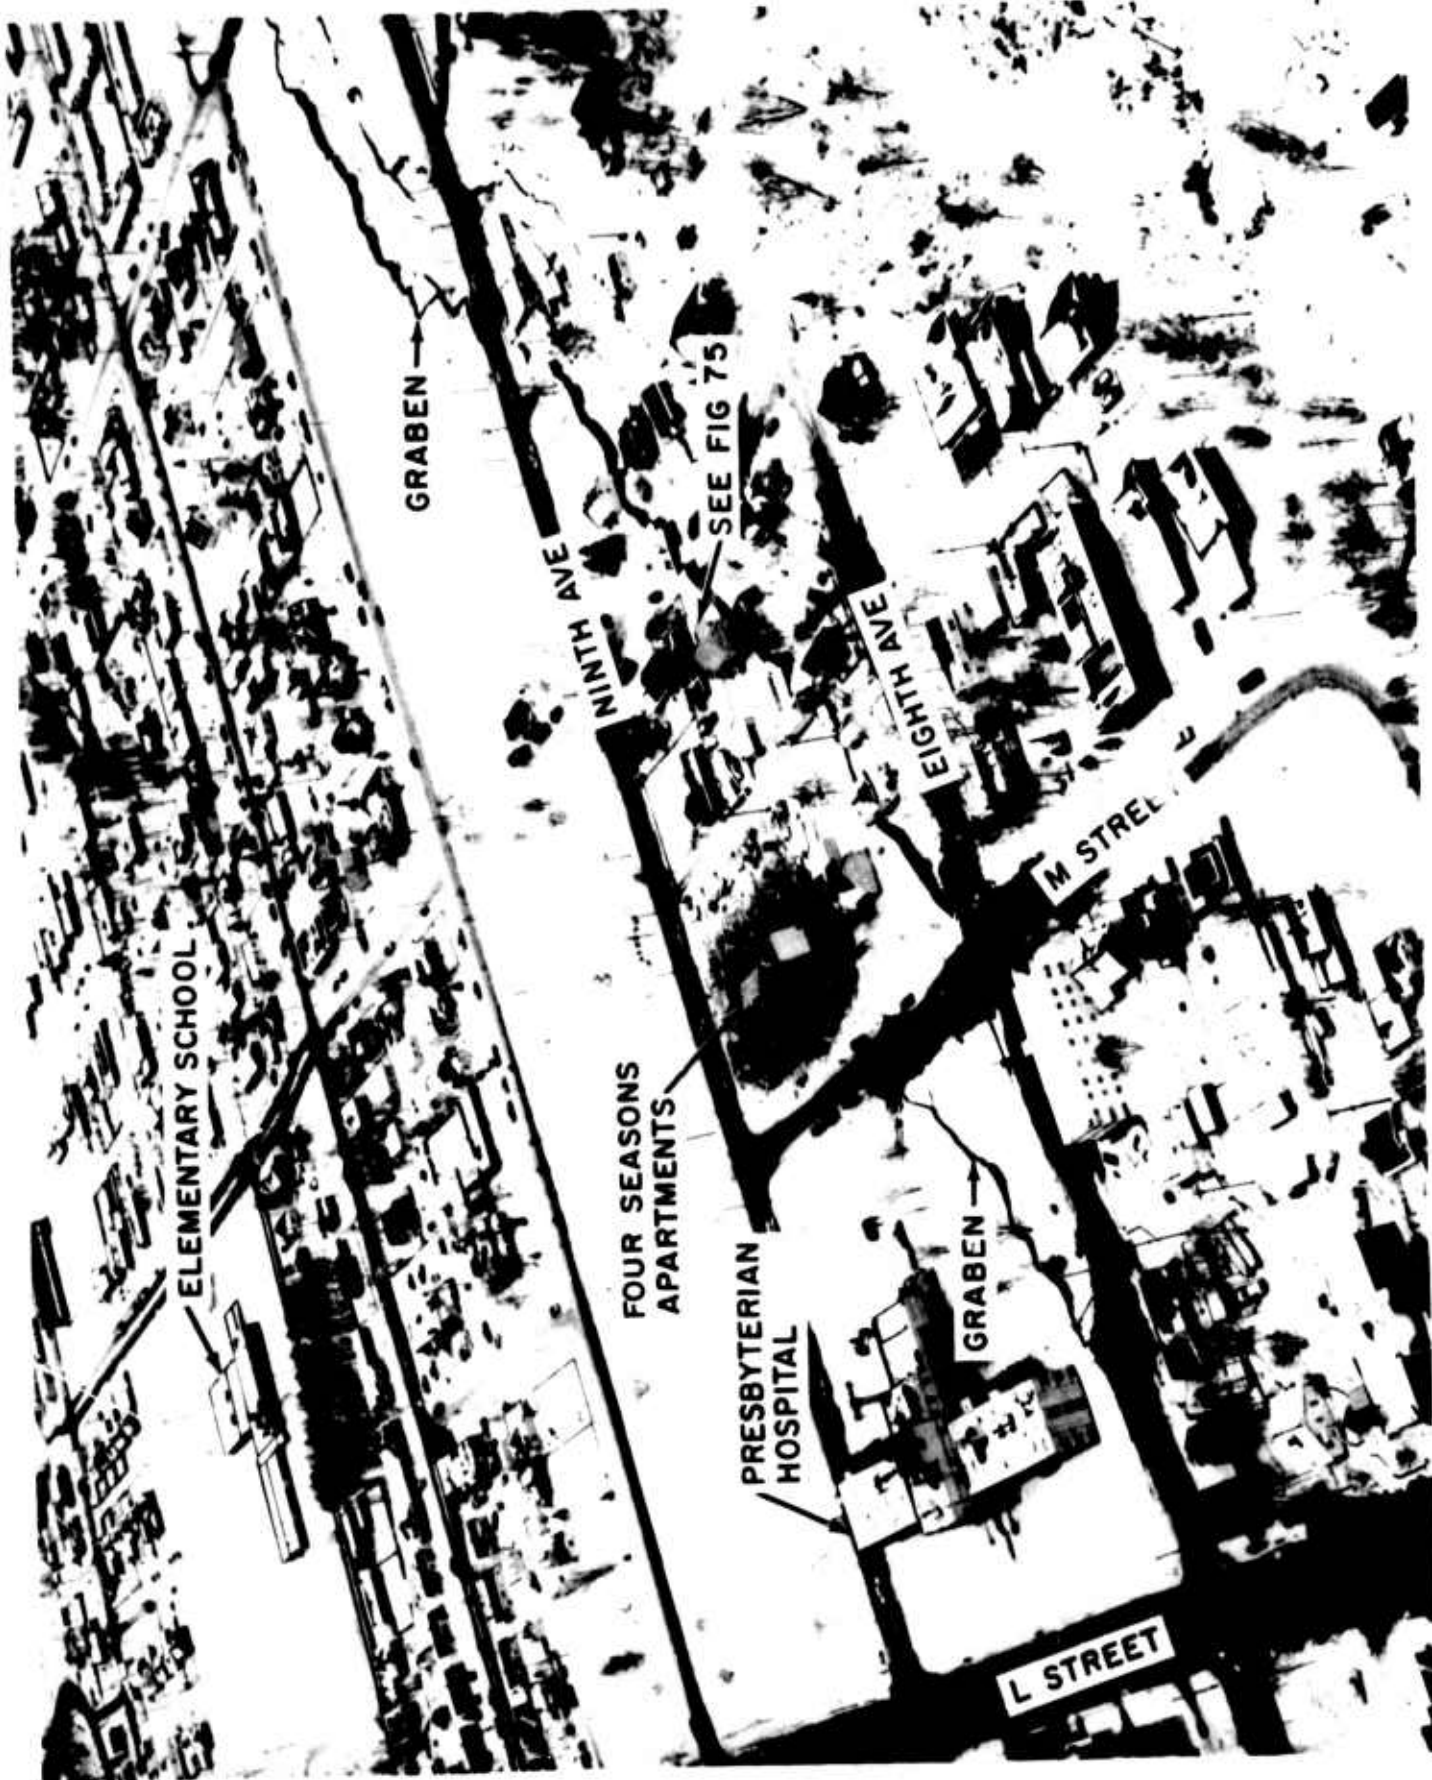
Figure 78. L Street Slide (Four Seasons Apartments)

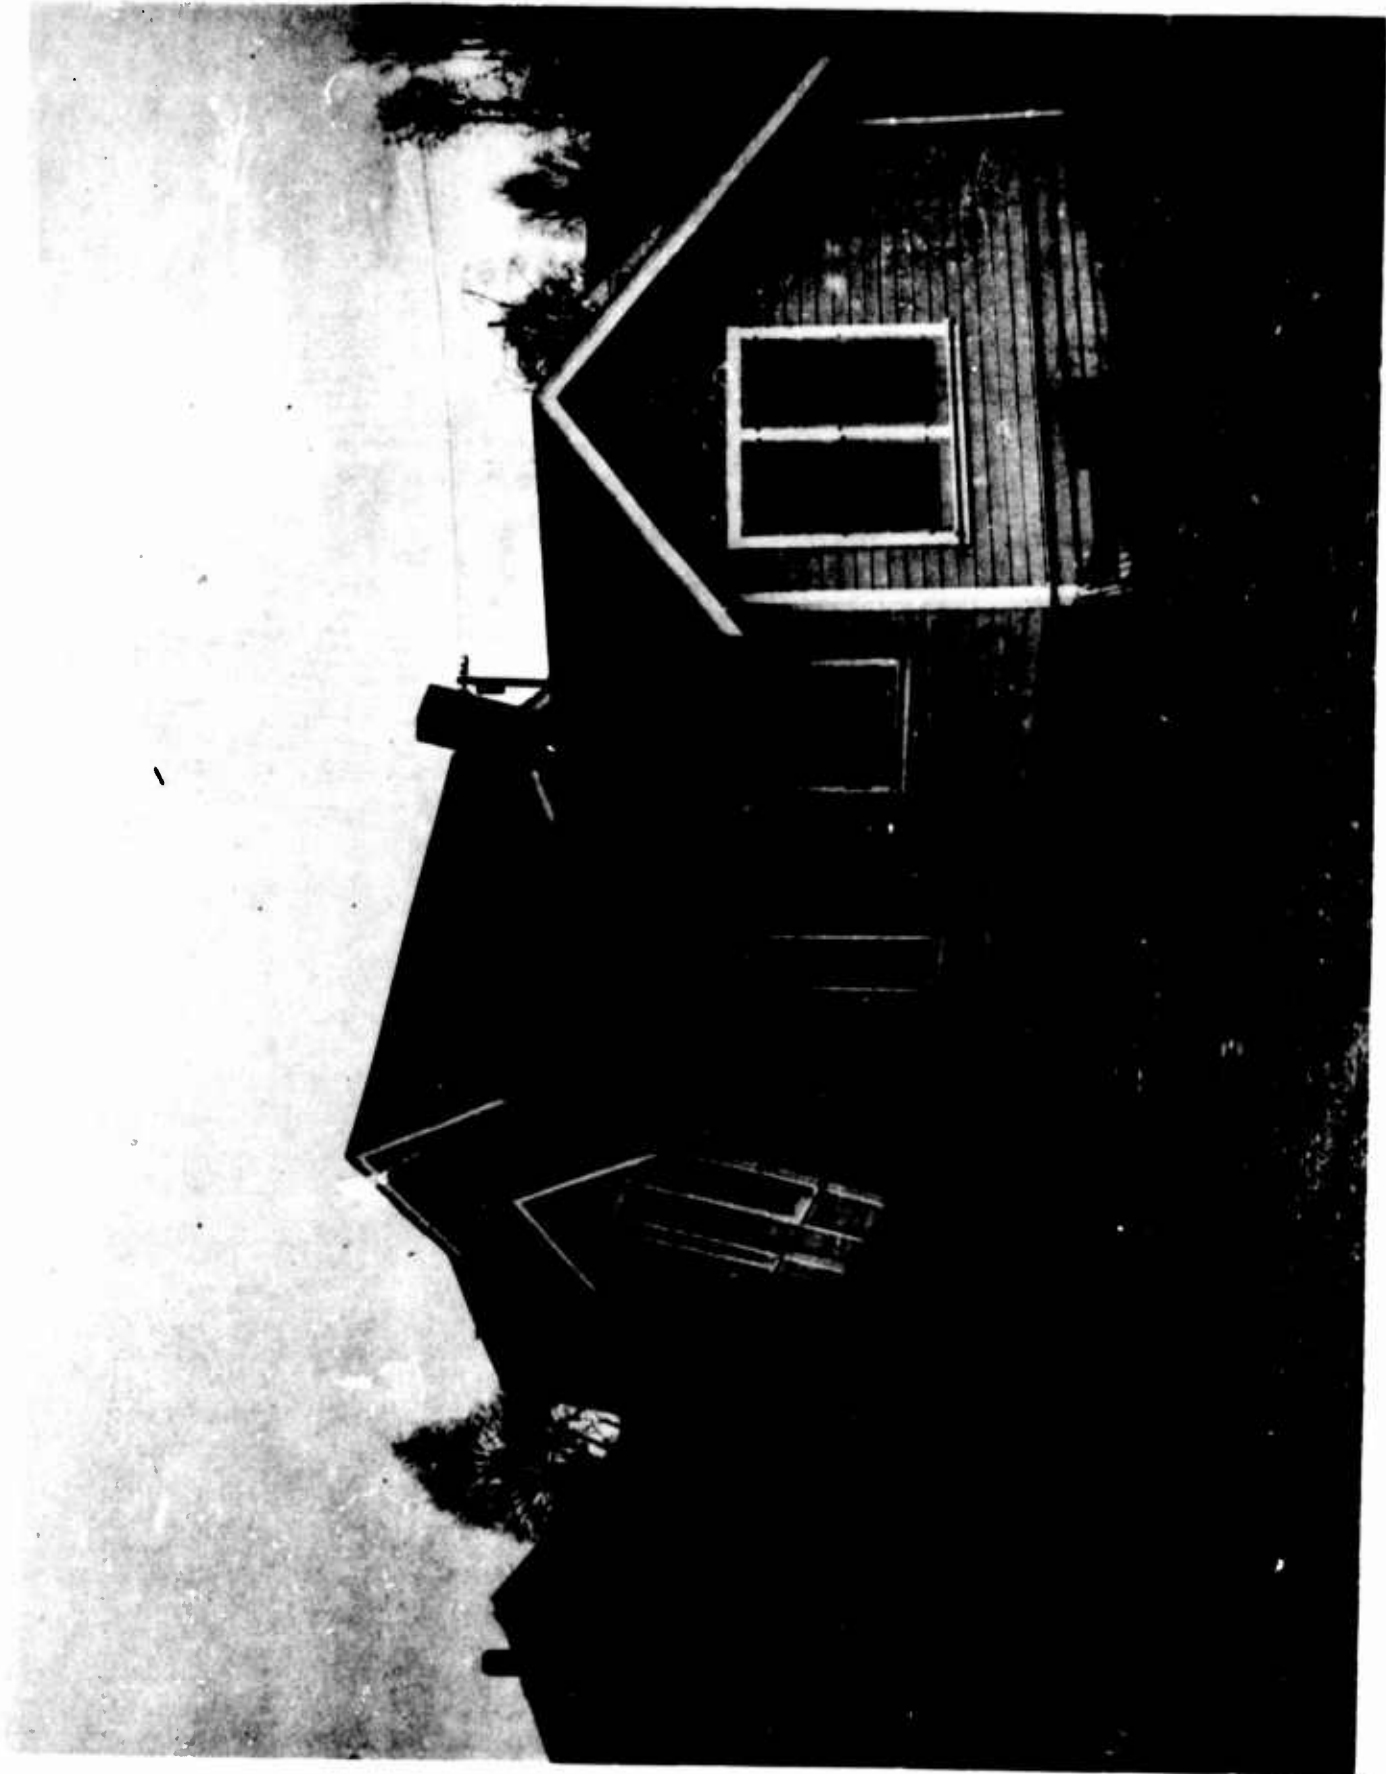
Figure 80. L Street Slide (Residence at Eighth Avenue and N Street)
