THE GREAT ALASKA EARTHQUAKE

Volume II

Illustrations and Maps

TECHNICAL REPORT NO. AFWL-TR-65-92, Vol II

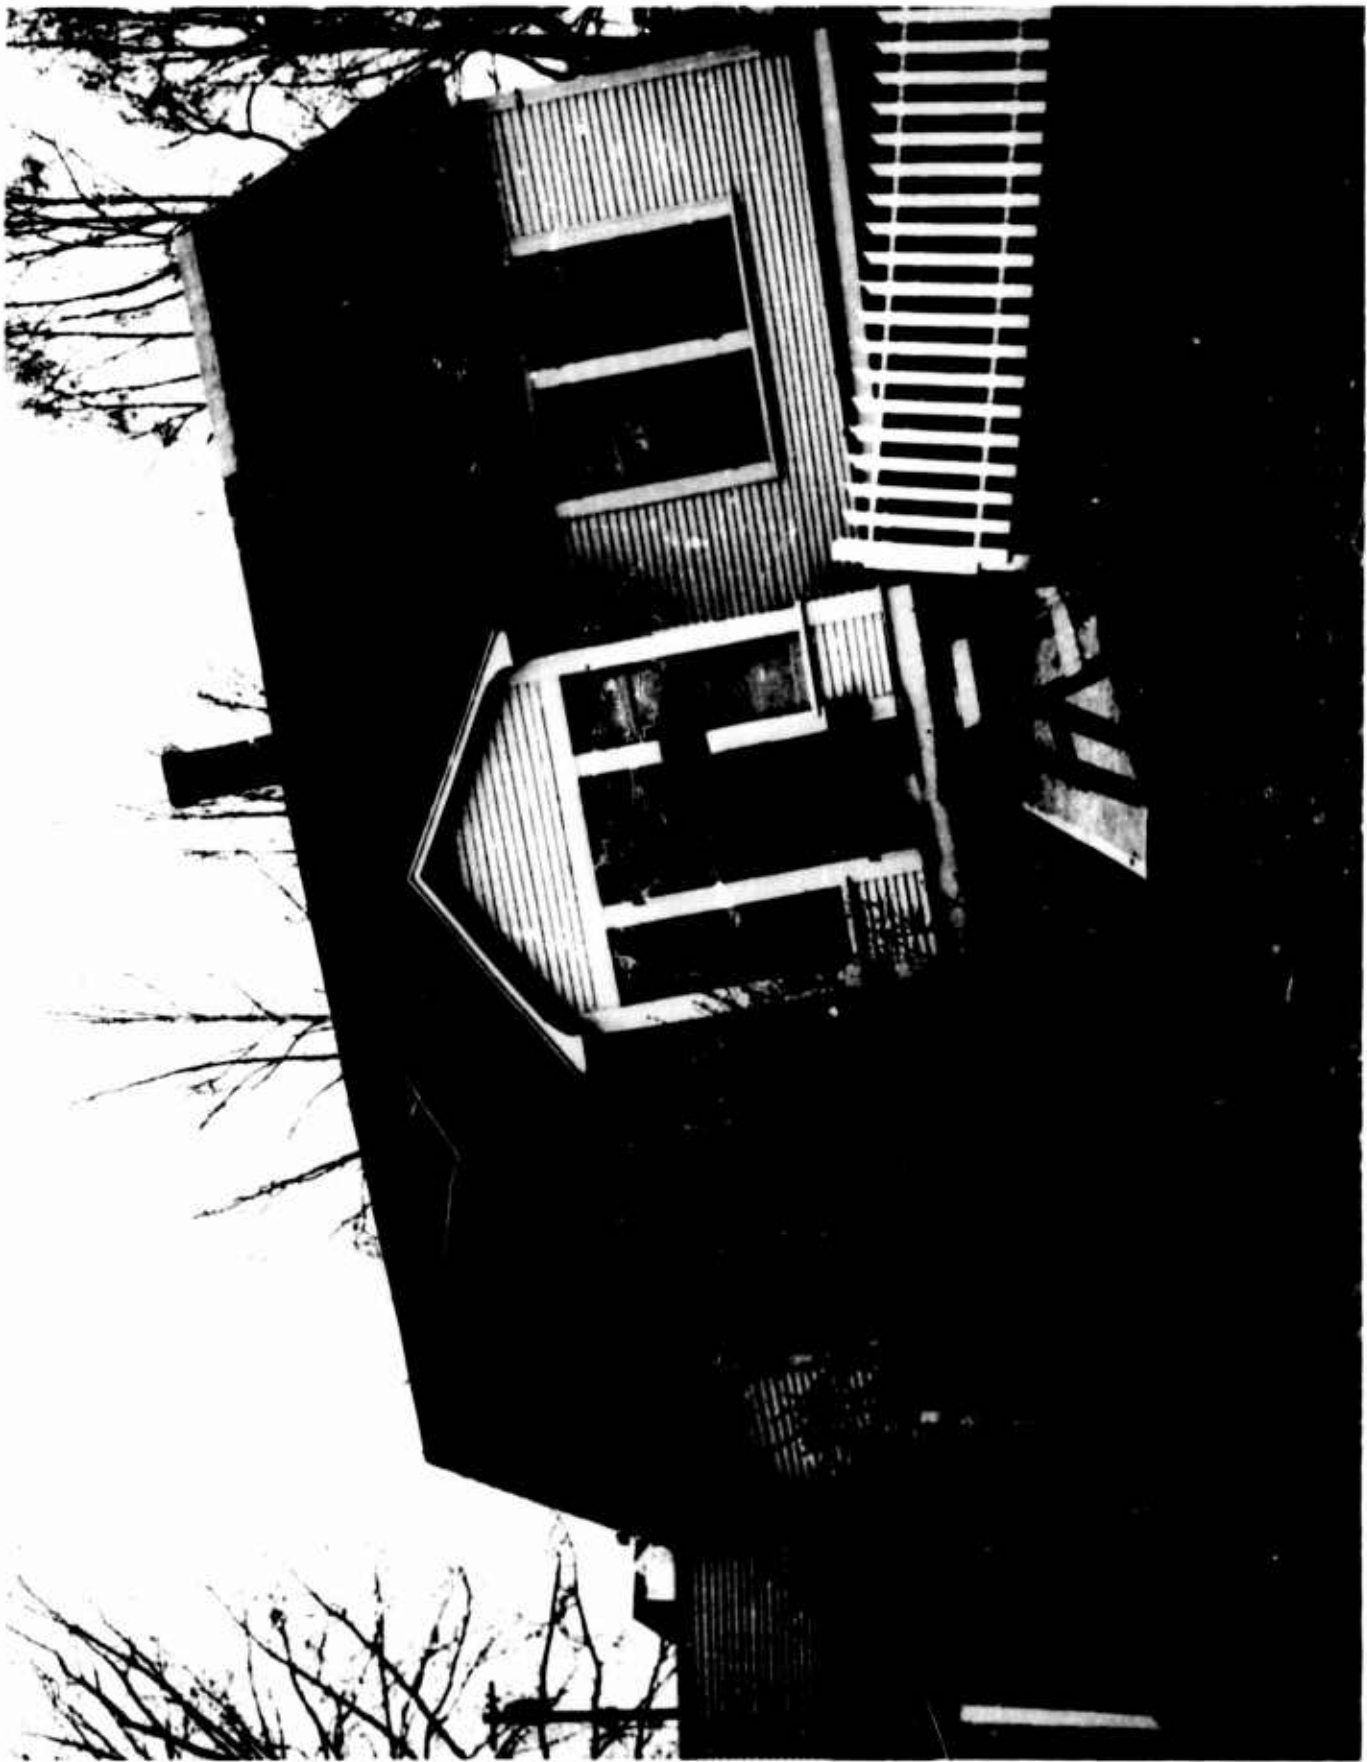
Figure 85. L Street Slide (Residence at Fifth Avenue and K Street)

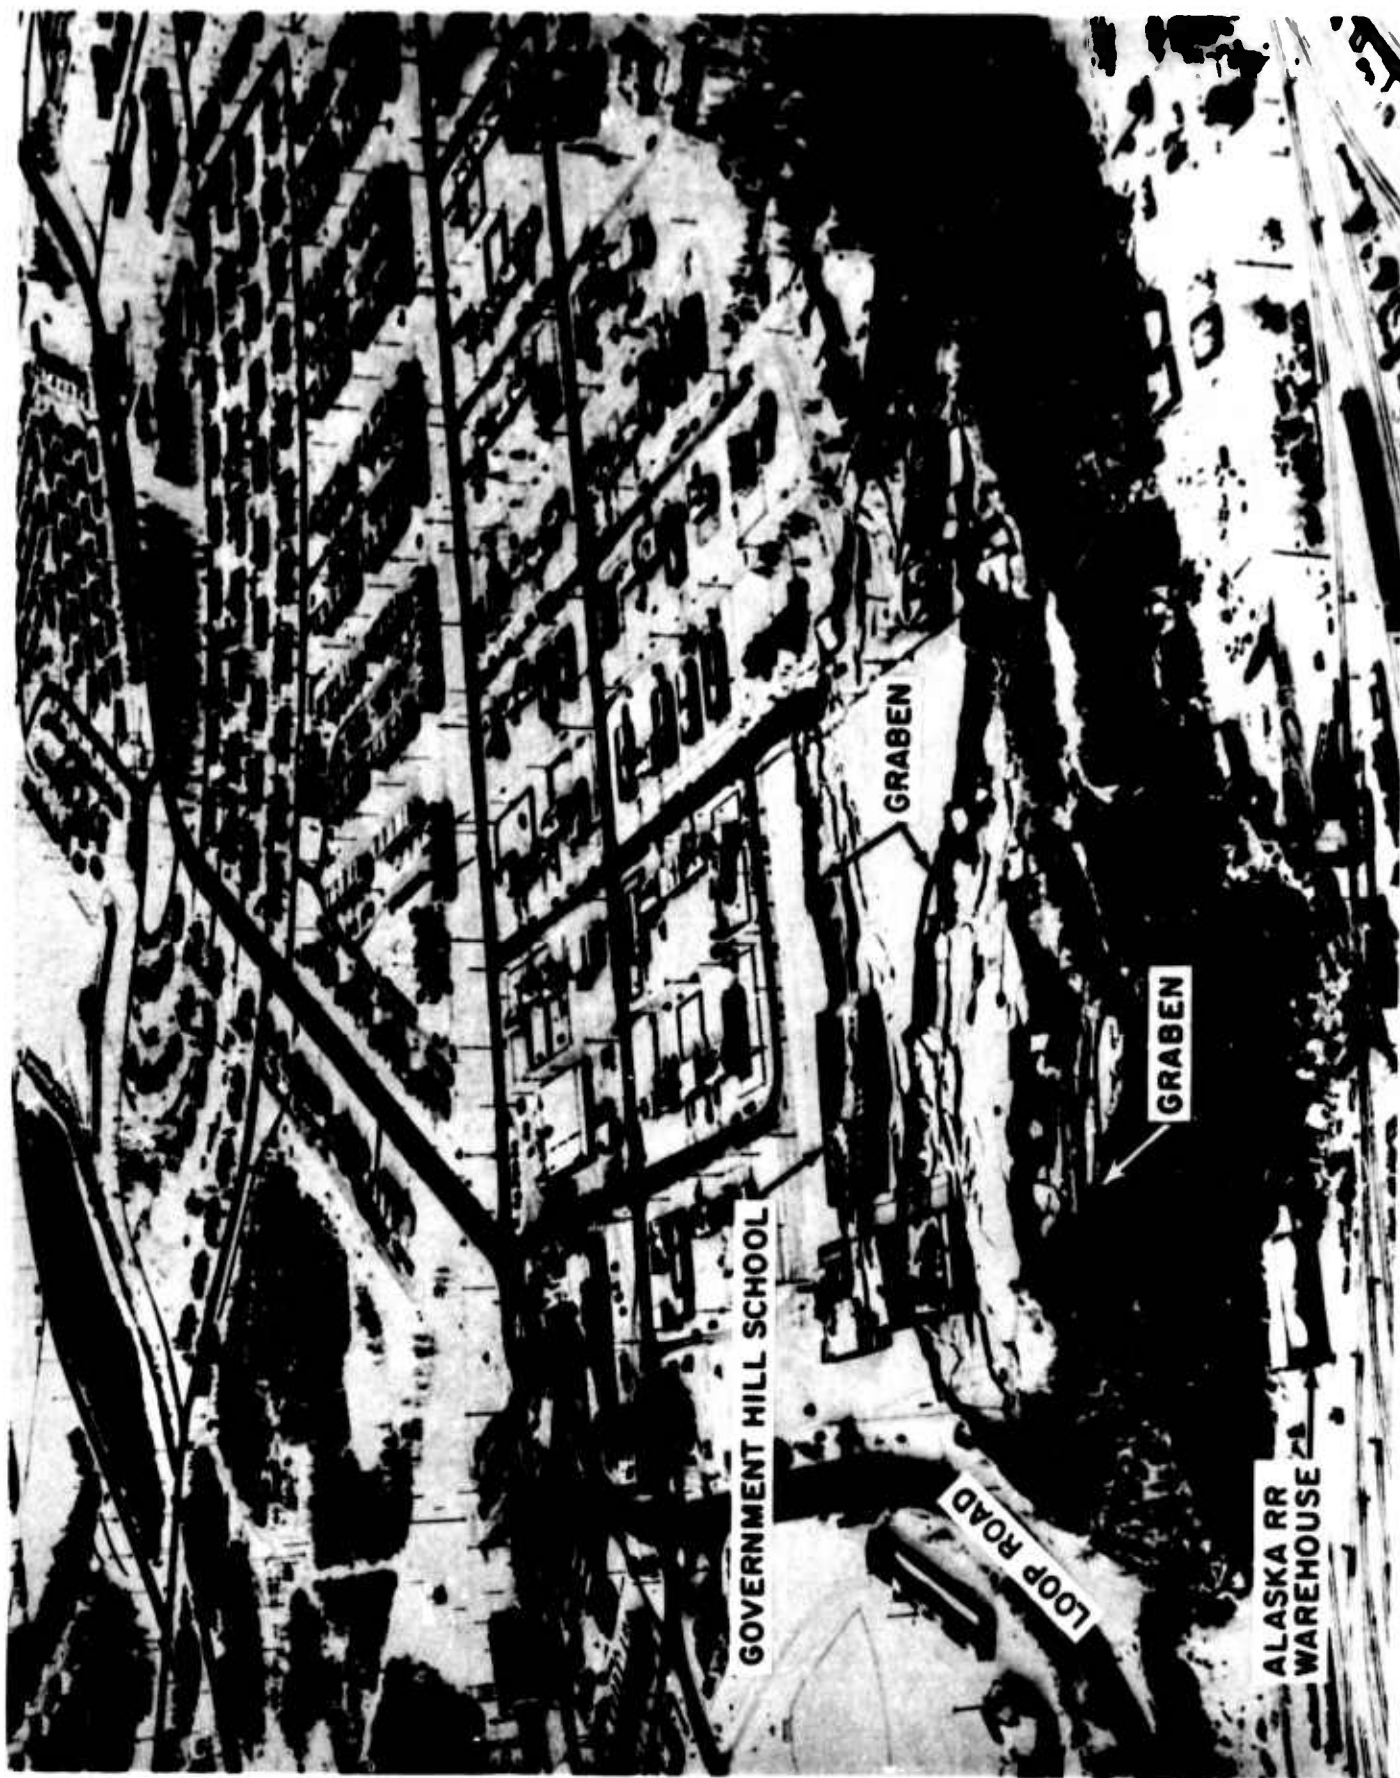
Figure 96. Government Hill Slide (Aerial view of the slide area)

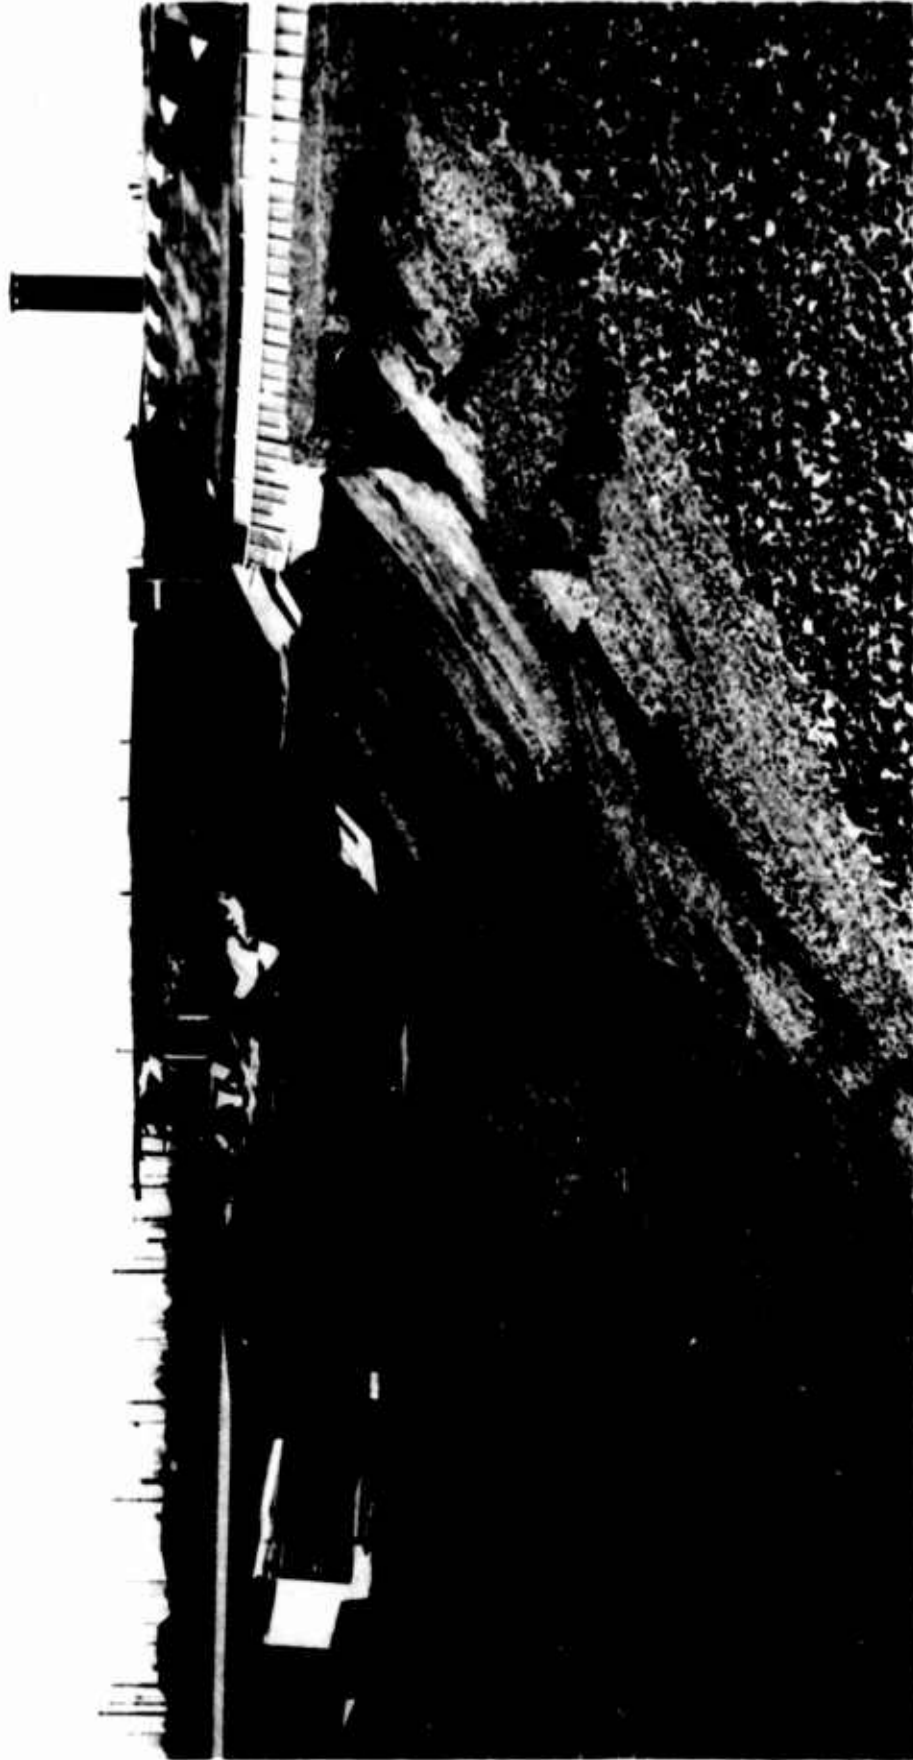
Figure 97. Government Hill Slide (North-south wing of the Government Hill school)

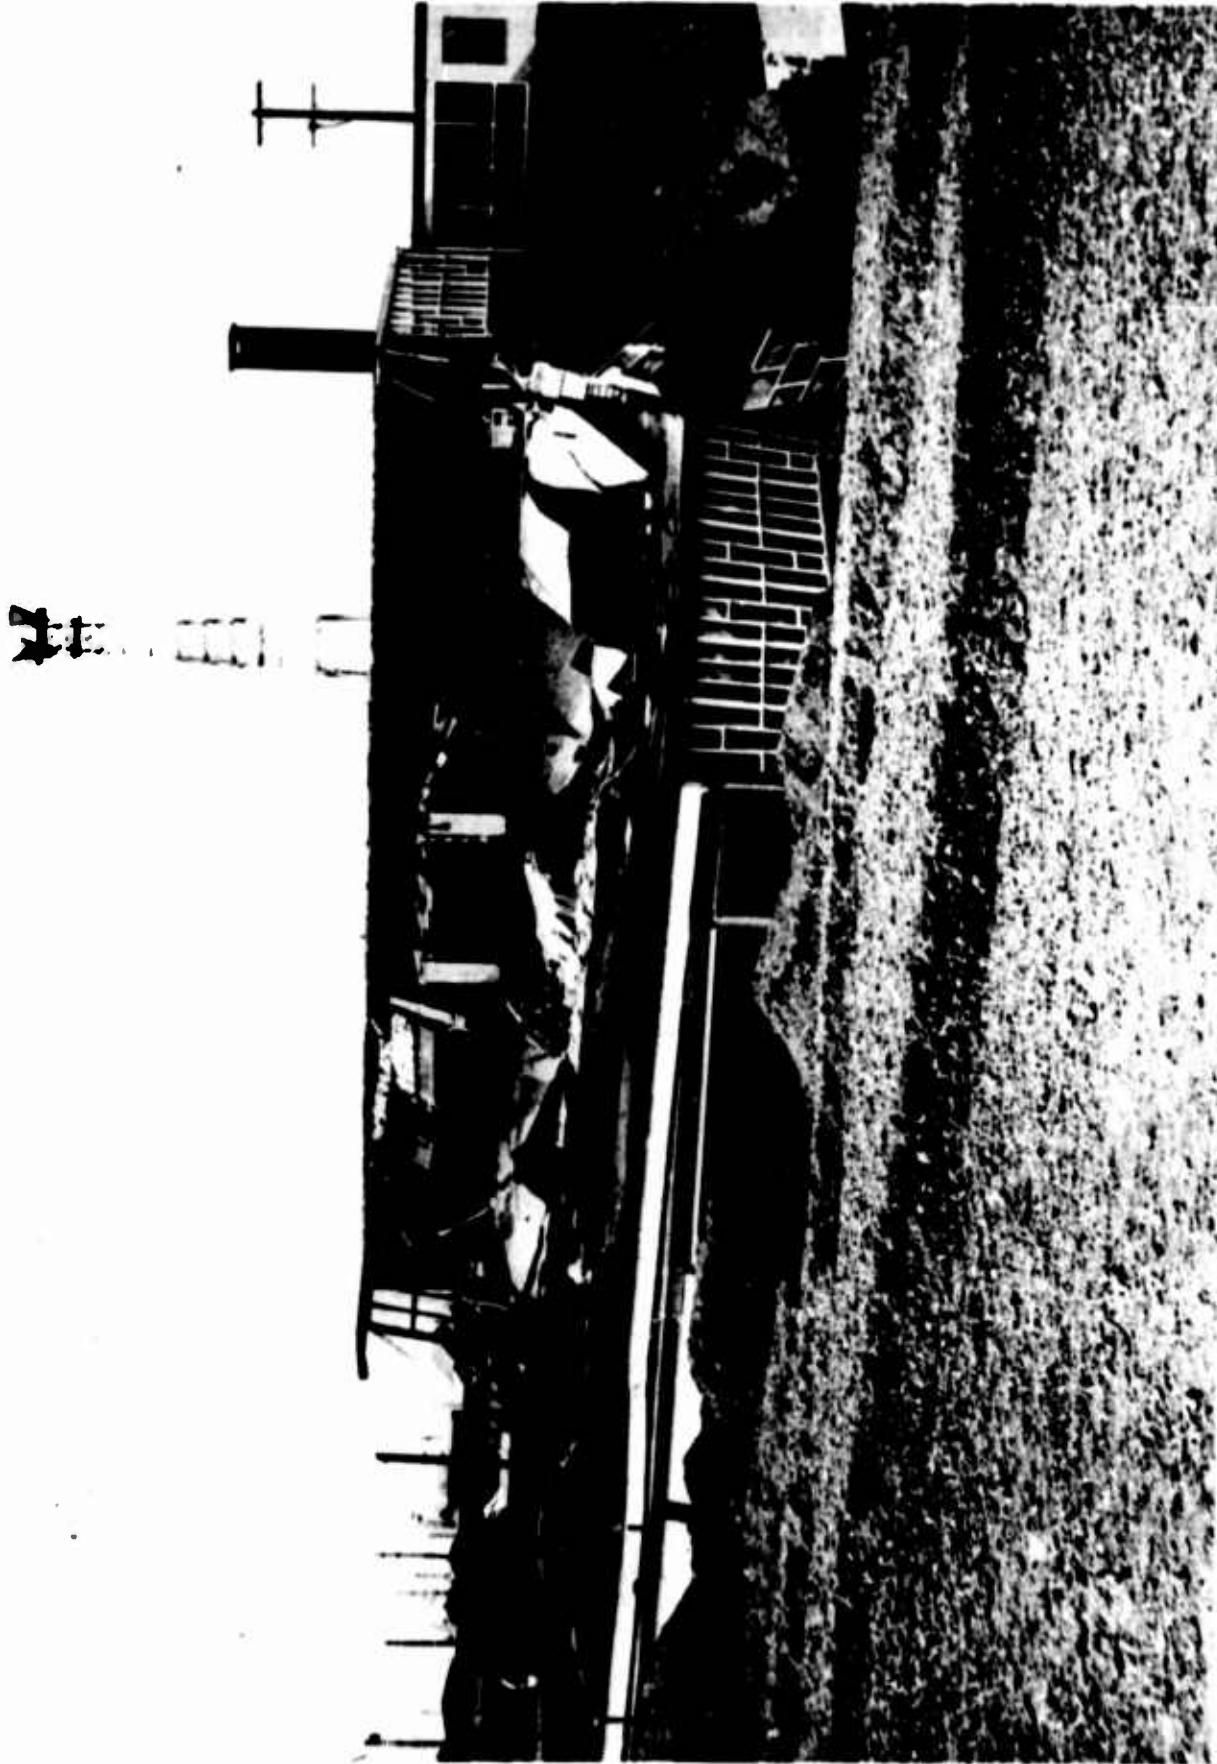
Figure 98. Government Hill Slide (North-south wing of the Government Hill school)

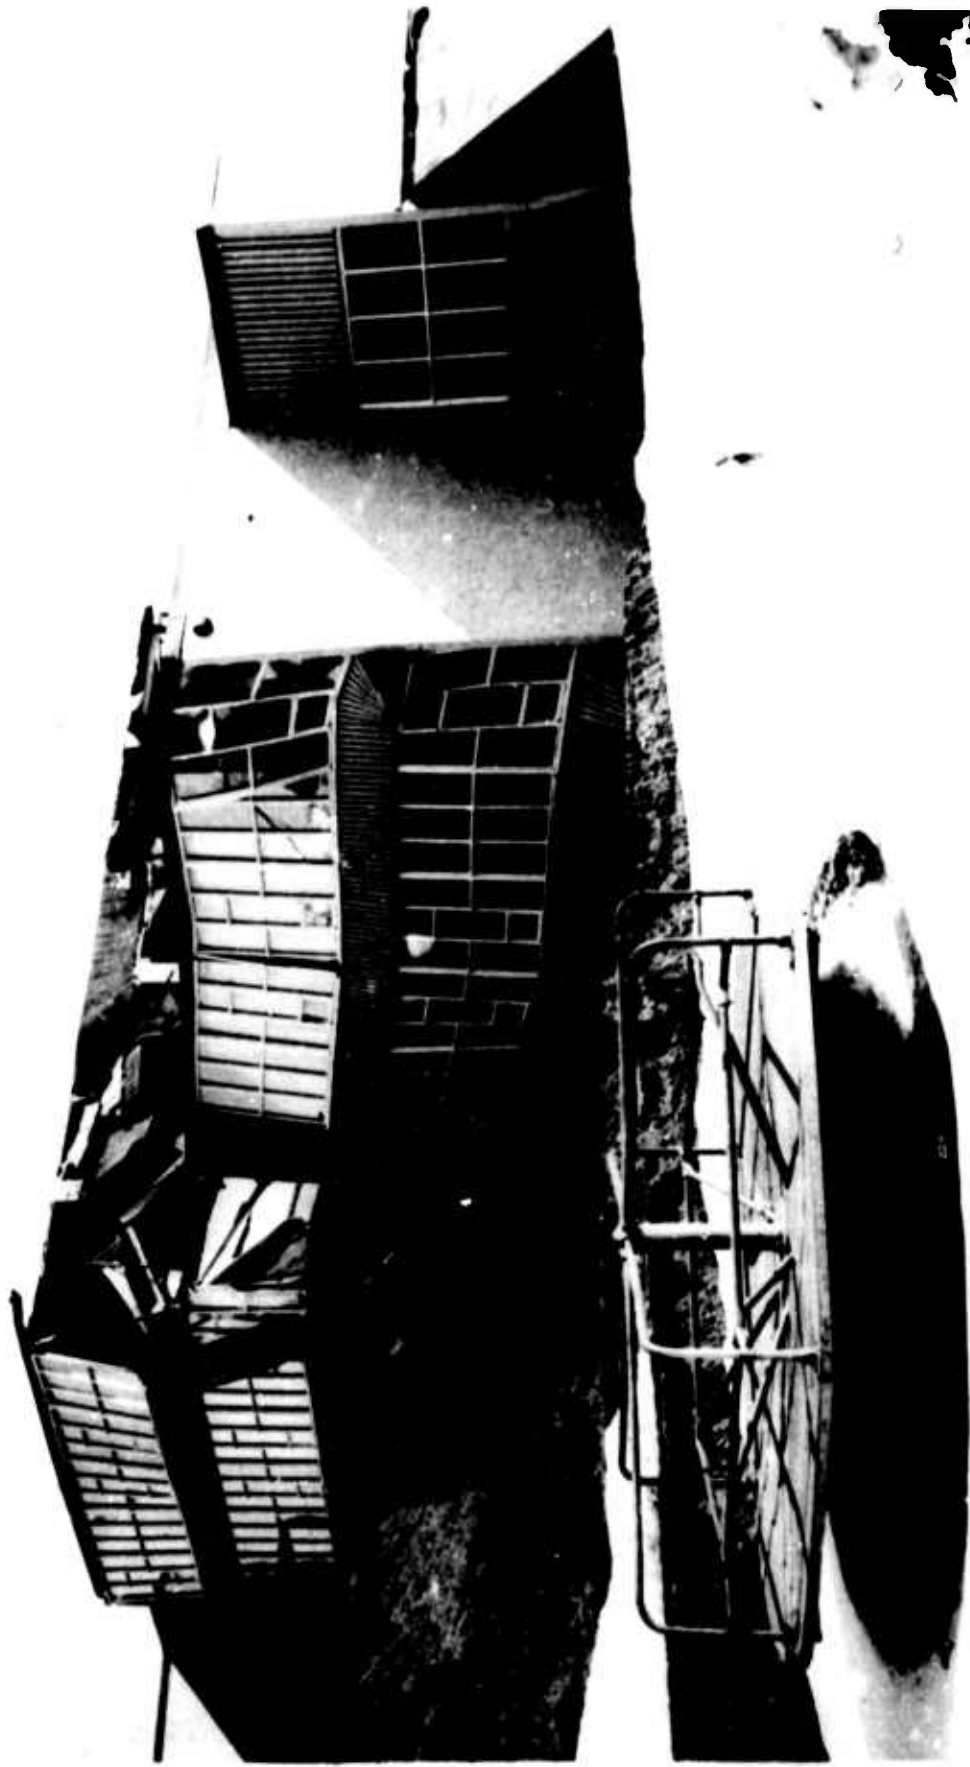
Figure 99. Government Hill Slide (North-south wing of the Government Hill school)

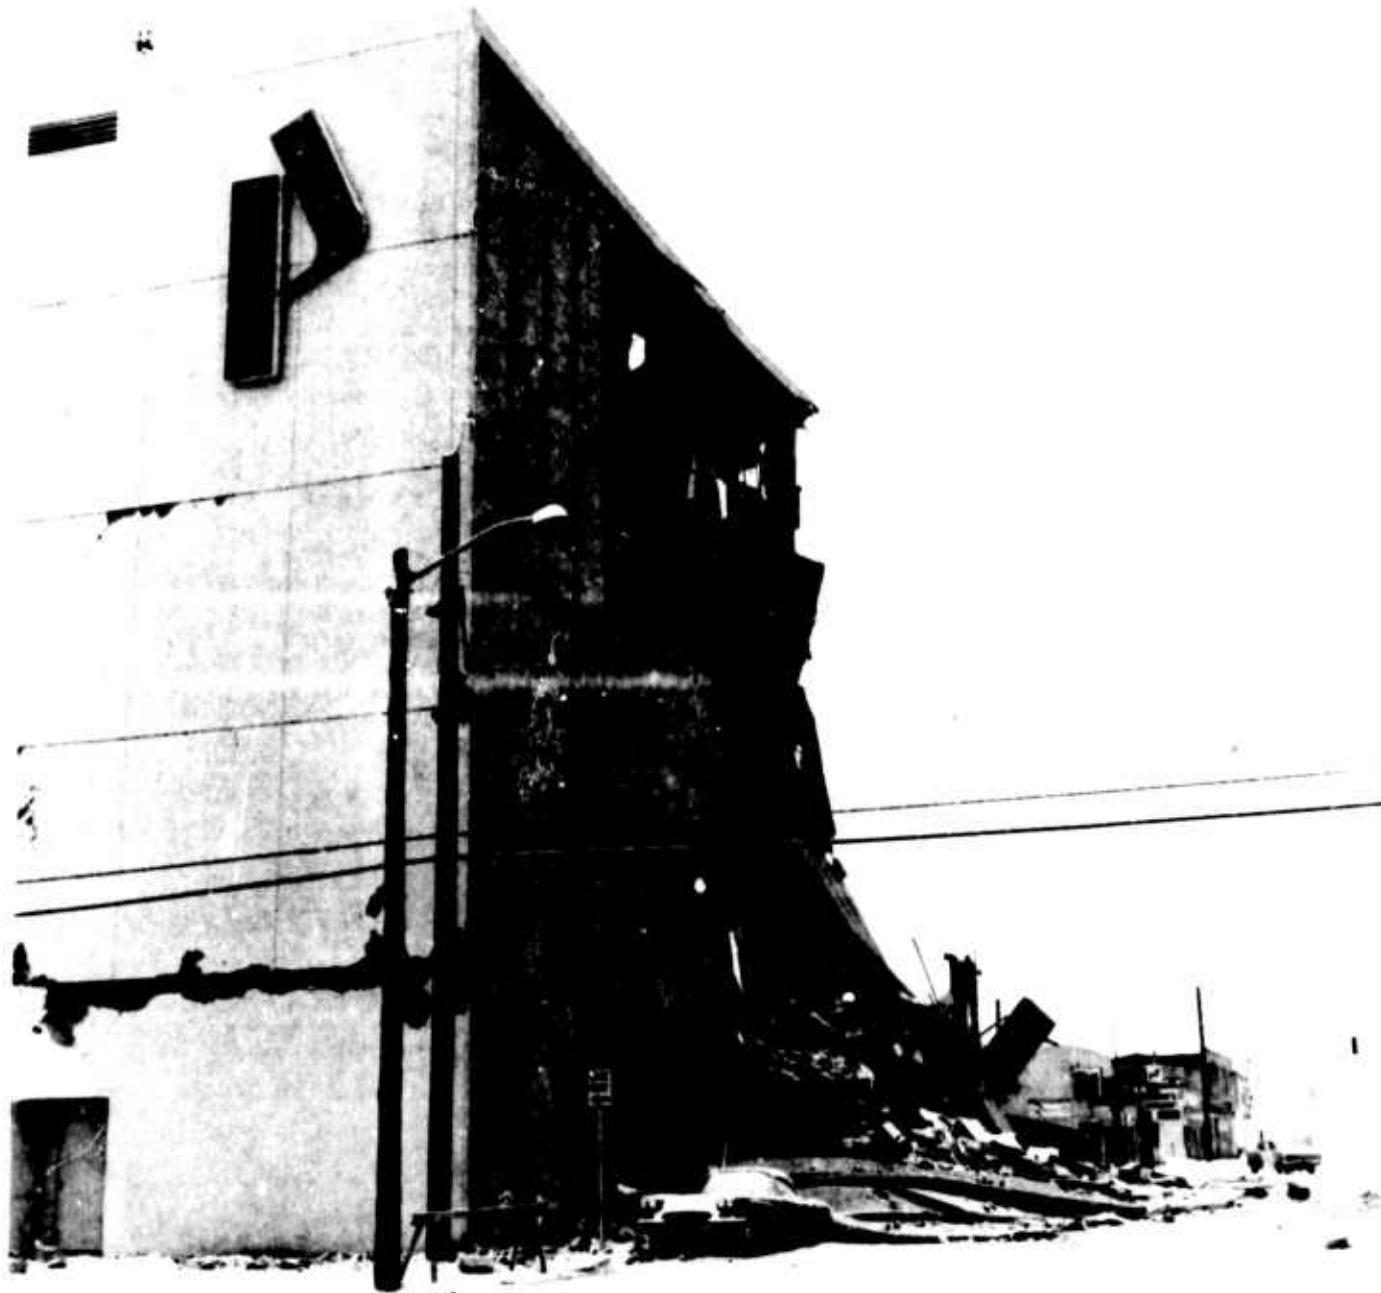
Figure 138. J. C. Penney Building (Unseated shear panels in the east wall. Notice the scalloped bottoms of the shear panels.)

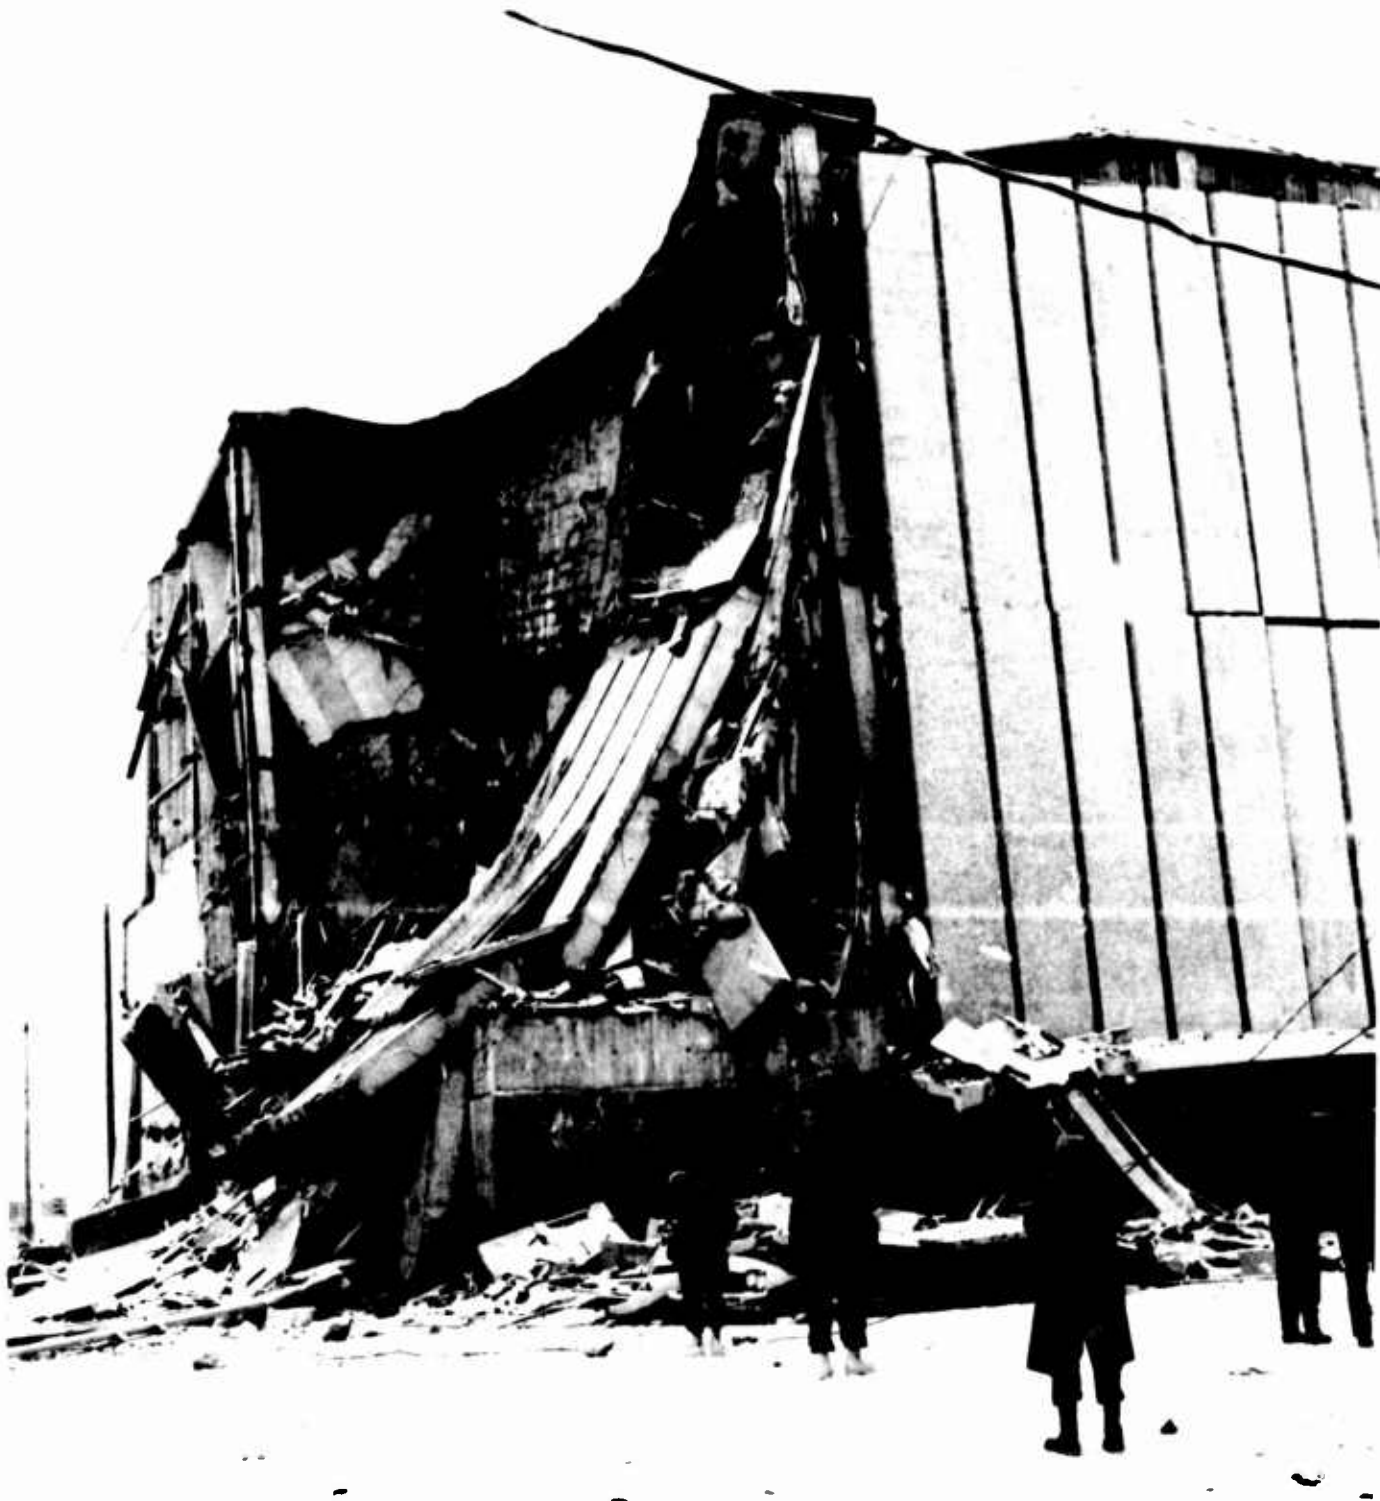
Figure 139. J. C. Penney Building
(Collapsed northeast corner of the structure)

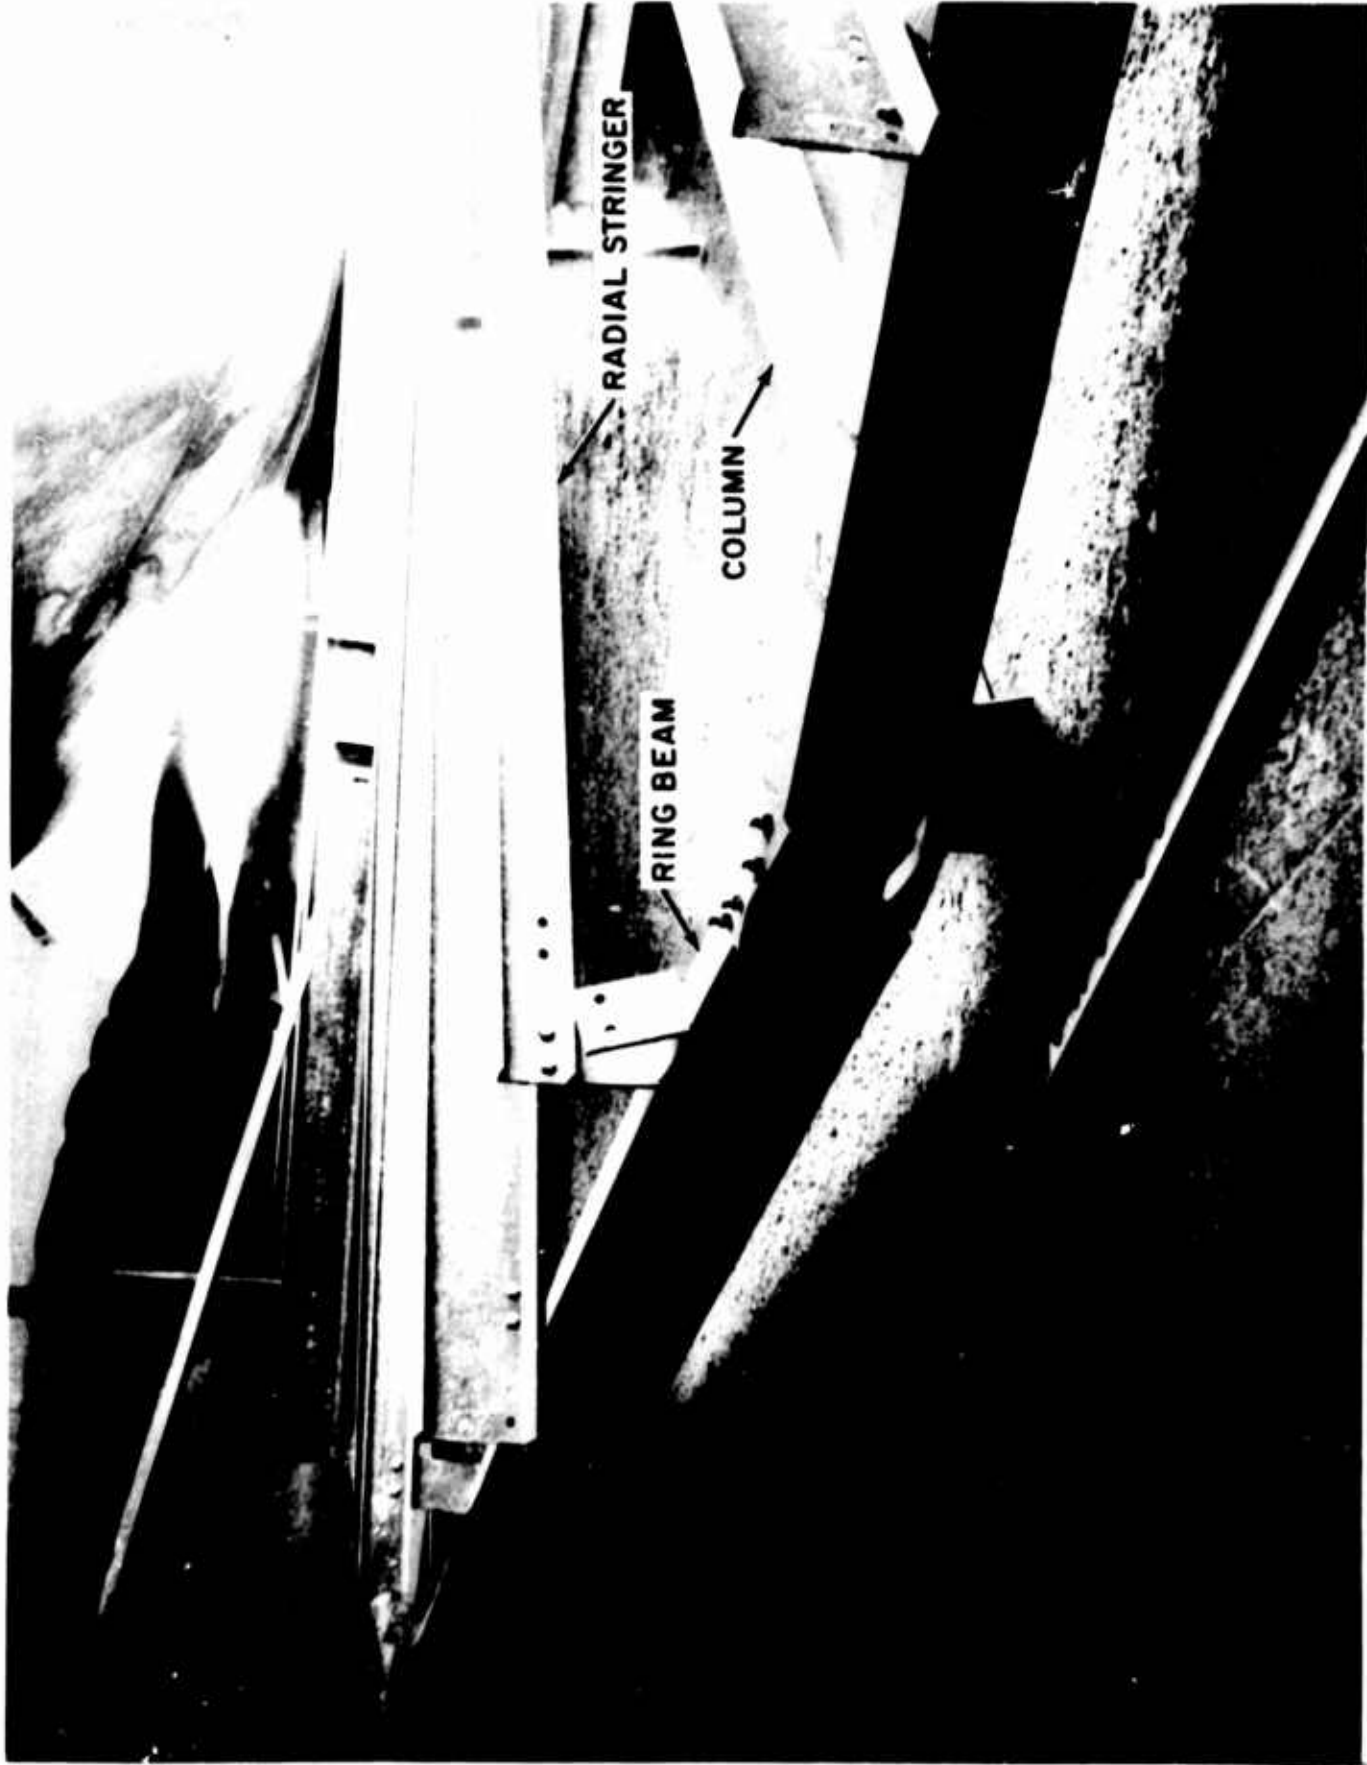
Figure 235. Shell Oil Company Waterfront Storage Tank (Fallen roof ring beam lying on floor of tank)

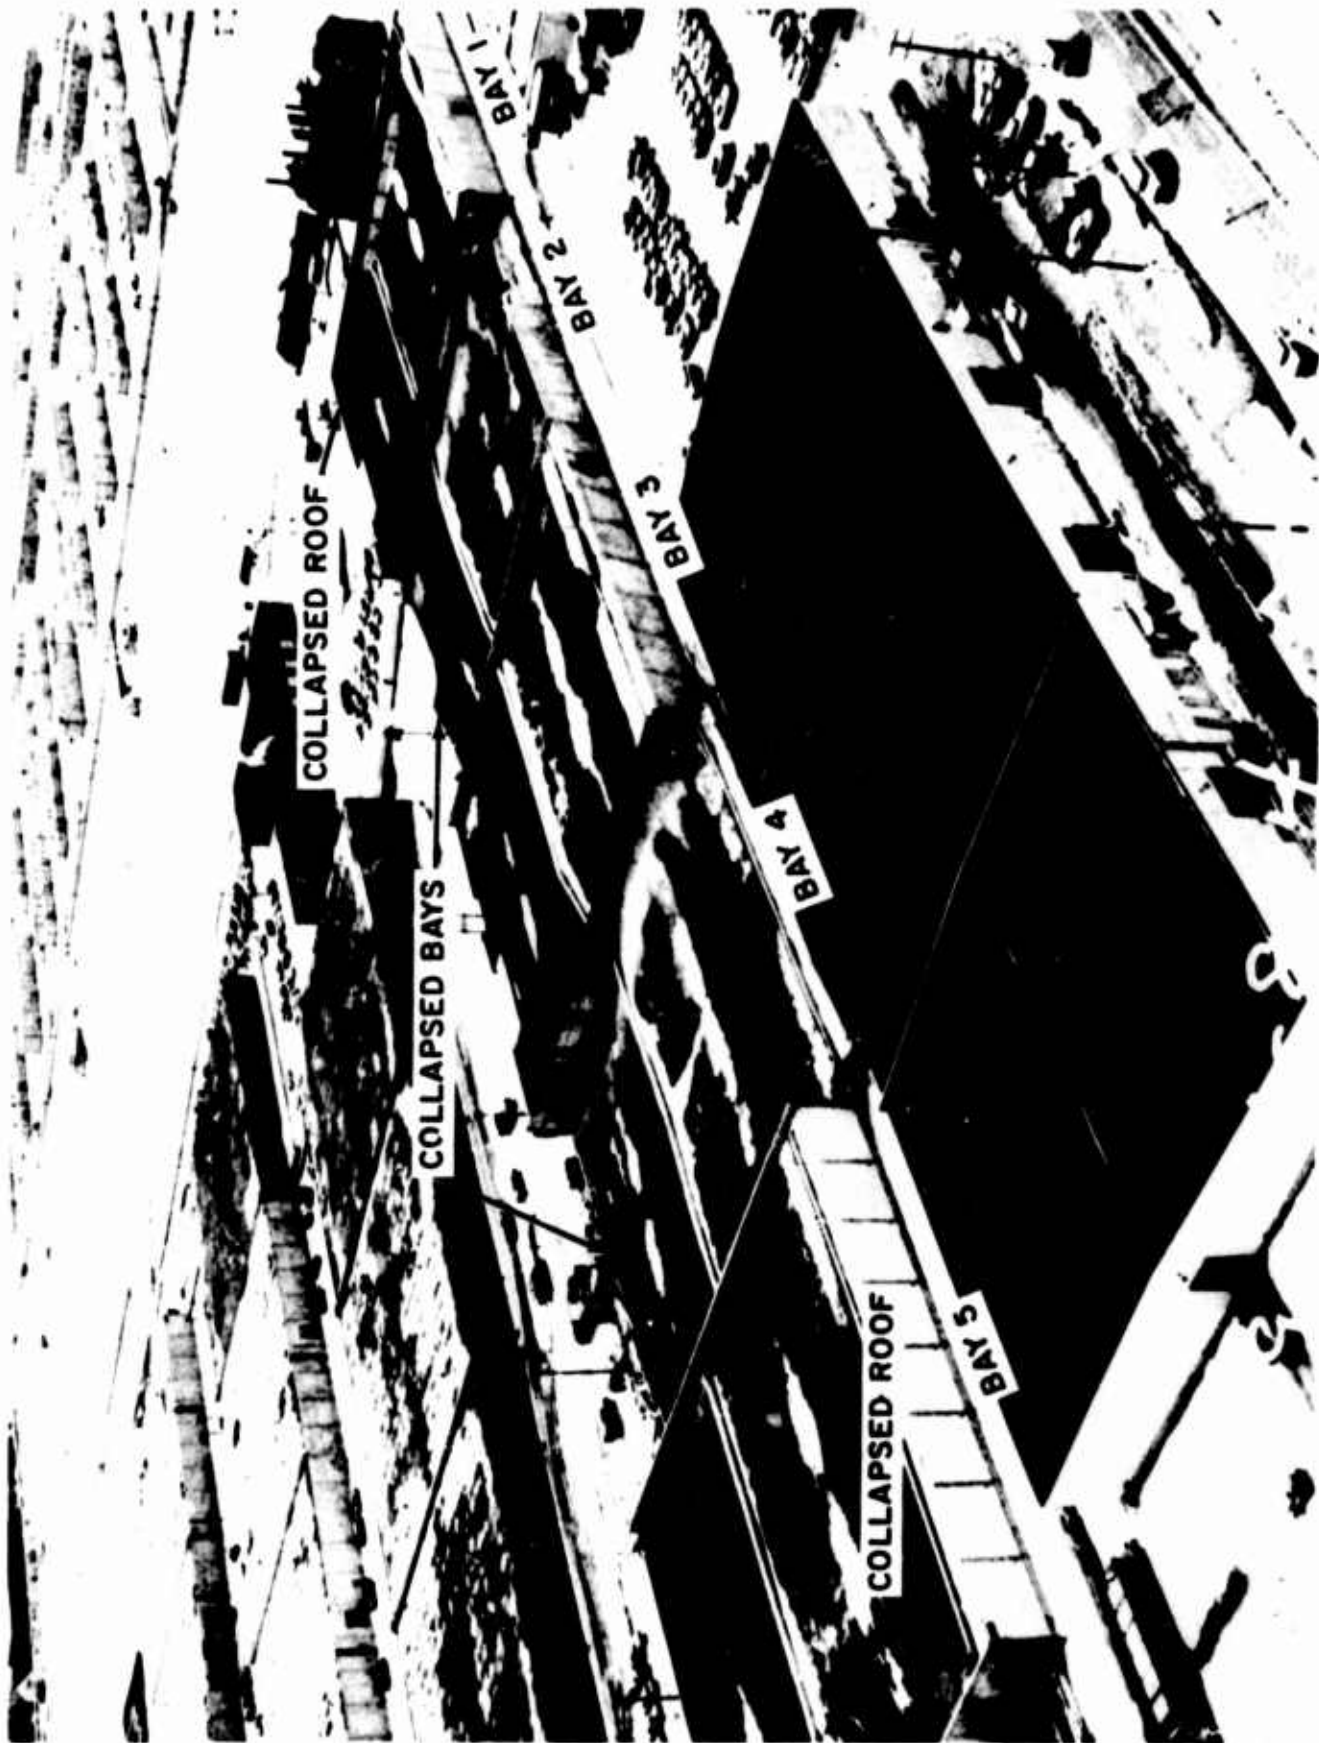
Figure 253. Elmendorf AFB Warehouse (Aerial view of partially collapsed supply warehouse)

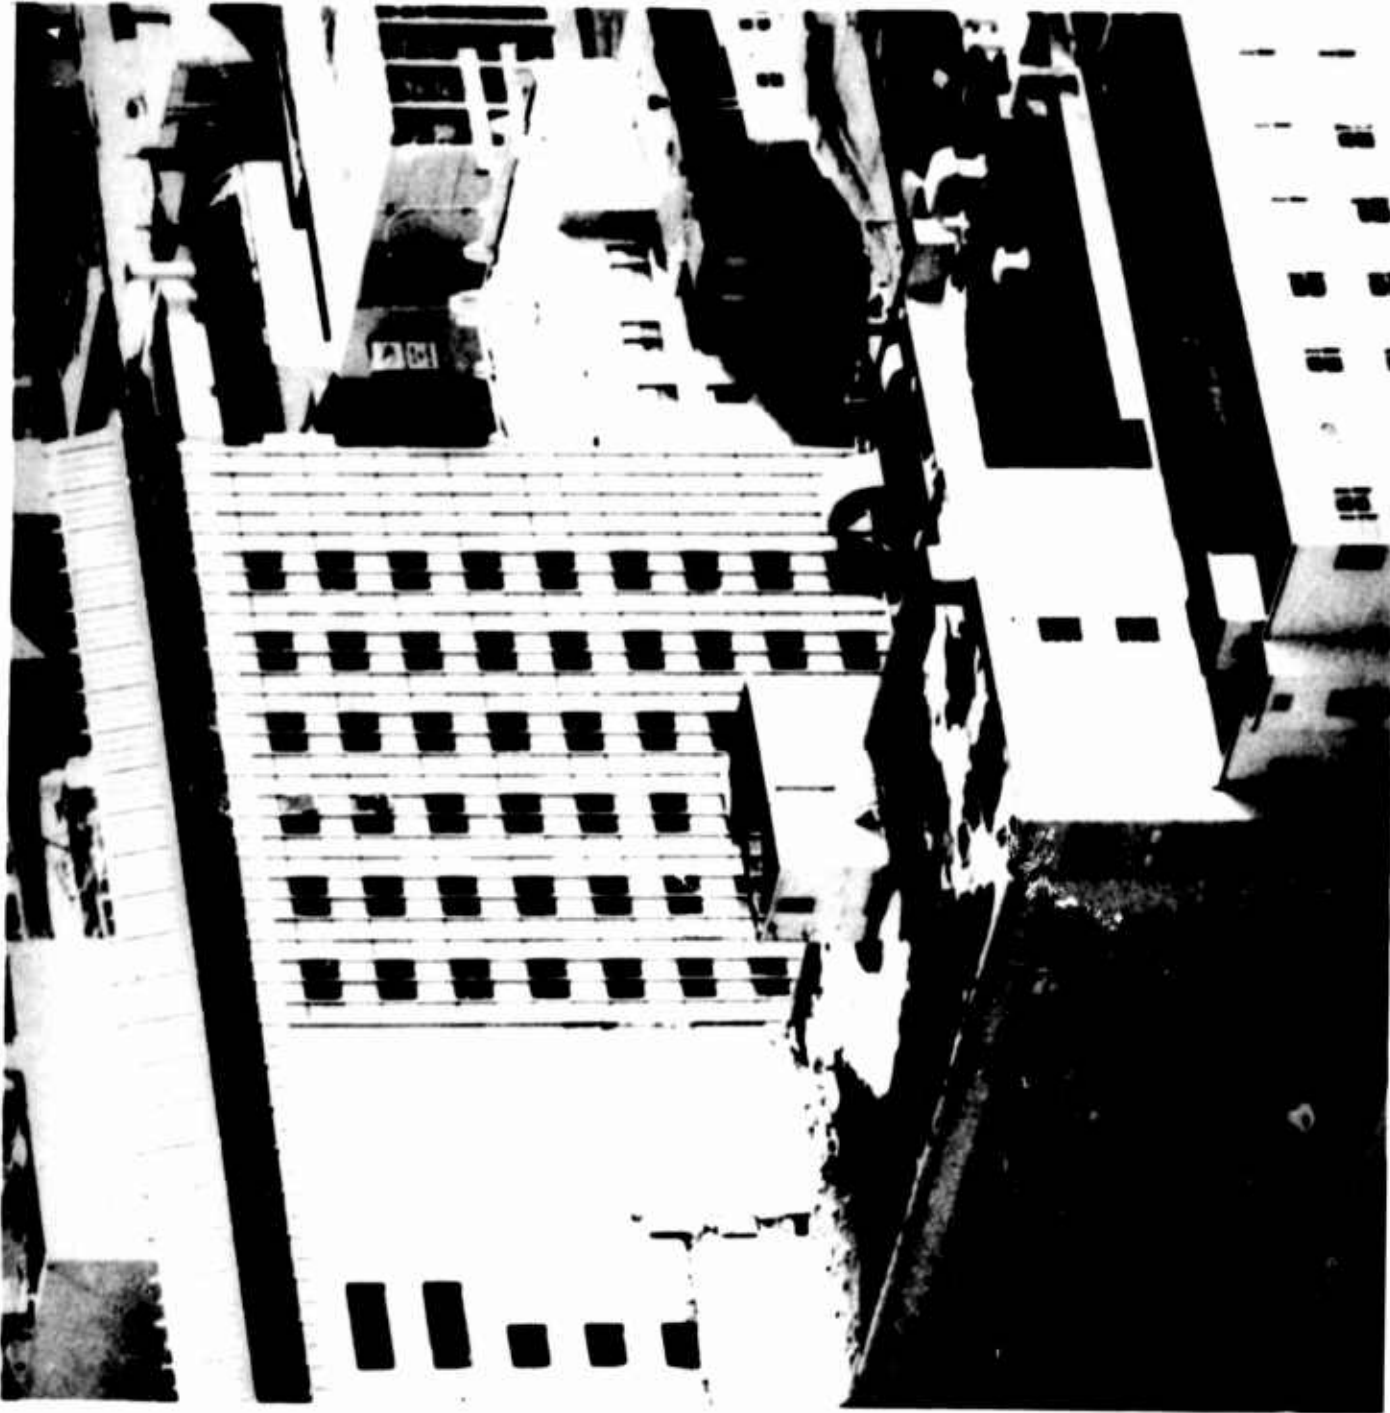
Figure 270. Anchorage Westward Hotel (Aerial view of west side of fourteen-story tower)

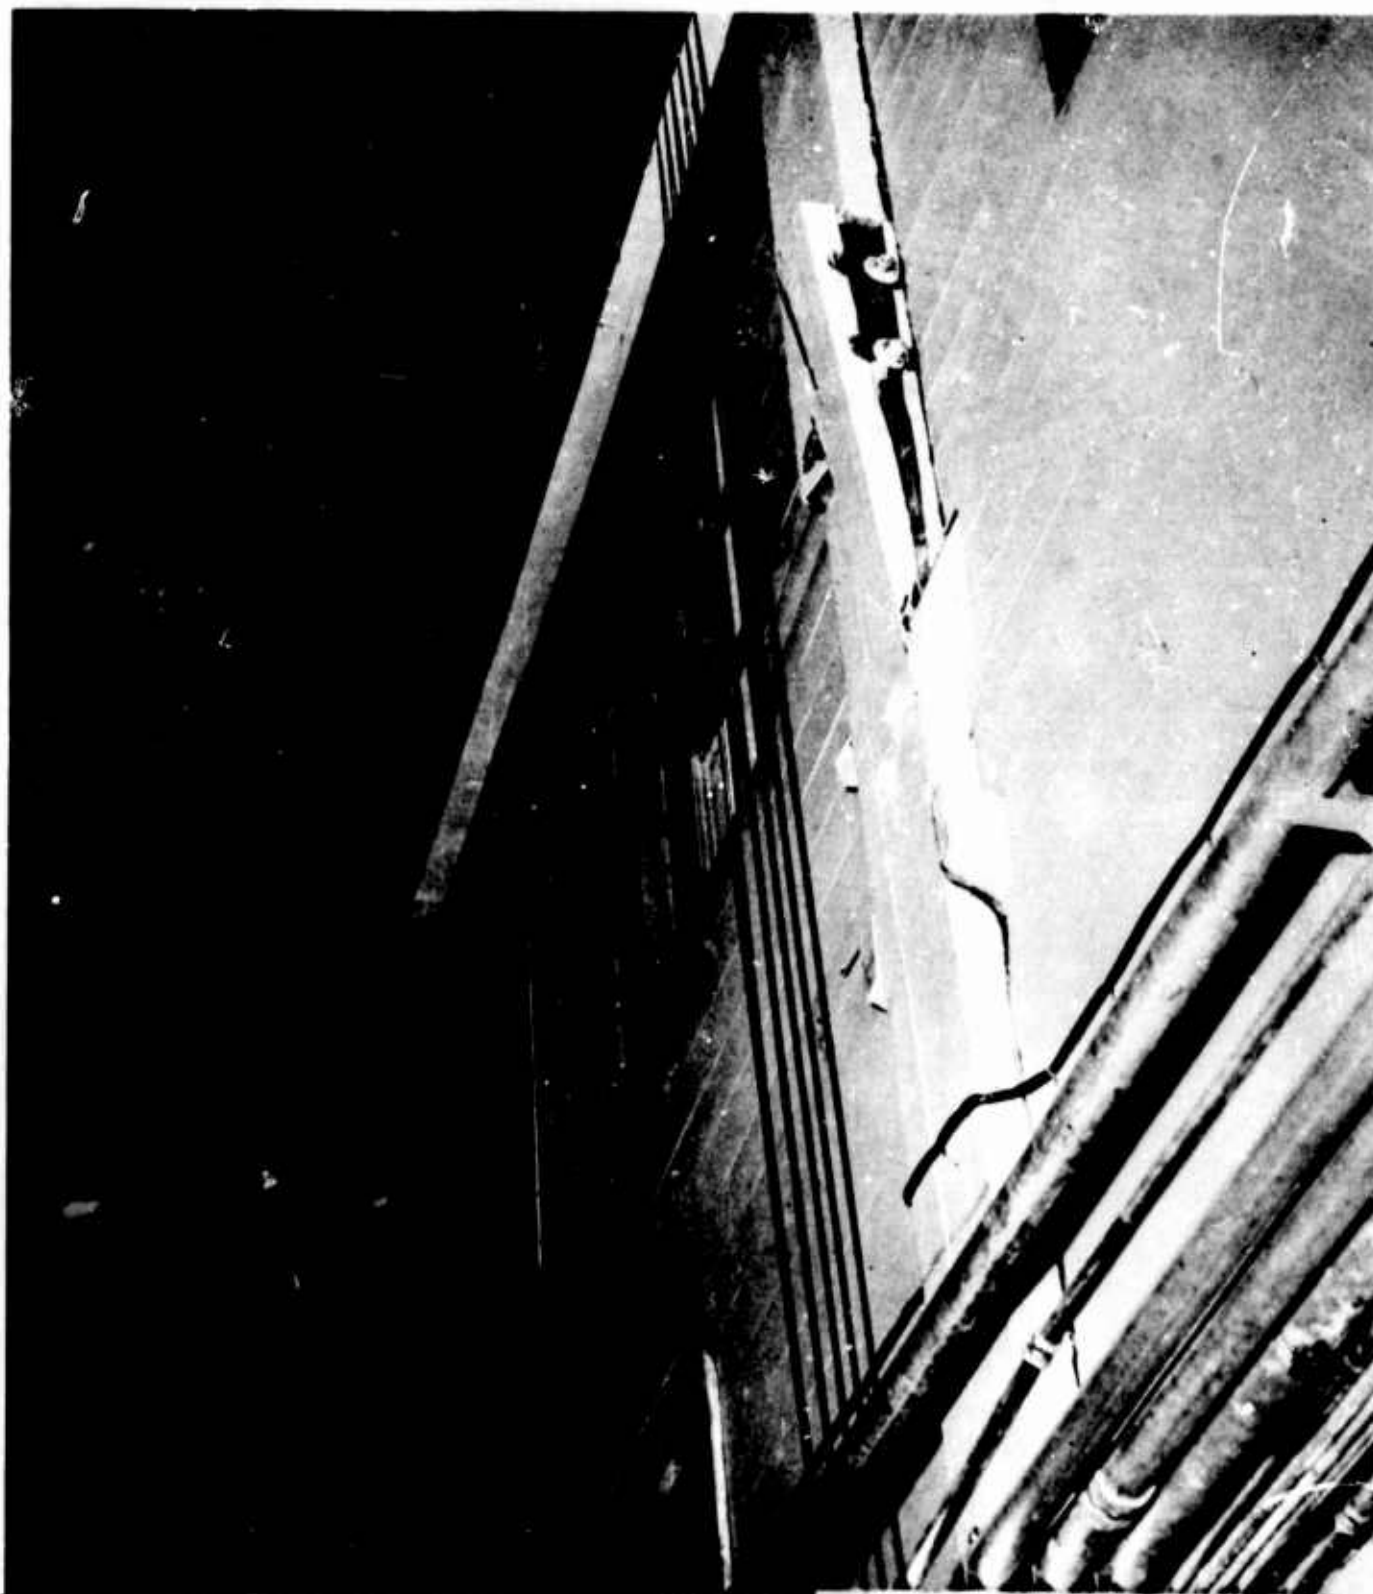
Figure 295. Elmendorf AFB Aircraft Maintenance Hangars
(Closeup of split vertical member at a splice)
