WORLD WAR II GERMAN
FIRE DOCUMENT TRANSLATIONS

WORLD WAR II GERMAN FIRE DOCUMENT TRANSLATIONS

REPORT OF THE REGIMENTAL COMMANDER OF THE
FIRE-PROTECTION POLICE REGIMENT "SAXONY"
ABOUT THE COURSE AND RESULTS OF THE MASSIVE AERIAL ATTACKS
ON ROTTERDAM ON MAY 14, 1940, AND THE EXPERIENCES
DRAWN THEREFROM (by Hans Rumpf) A-1

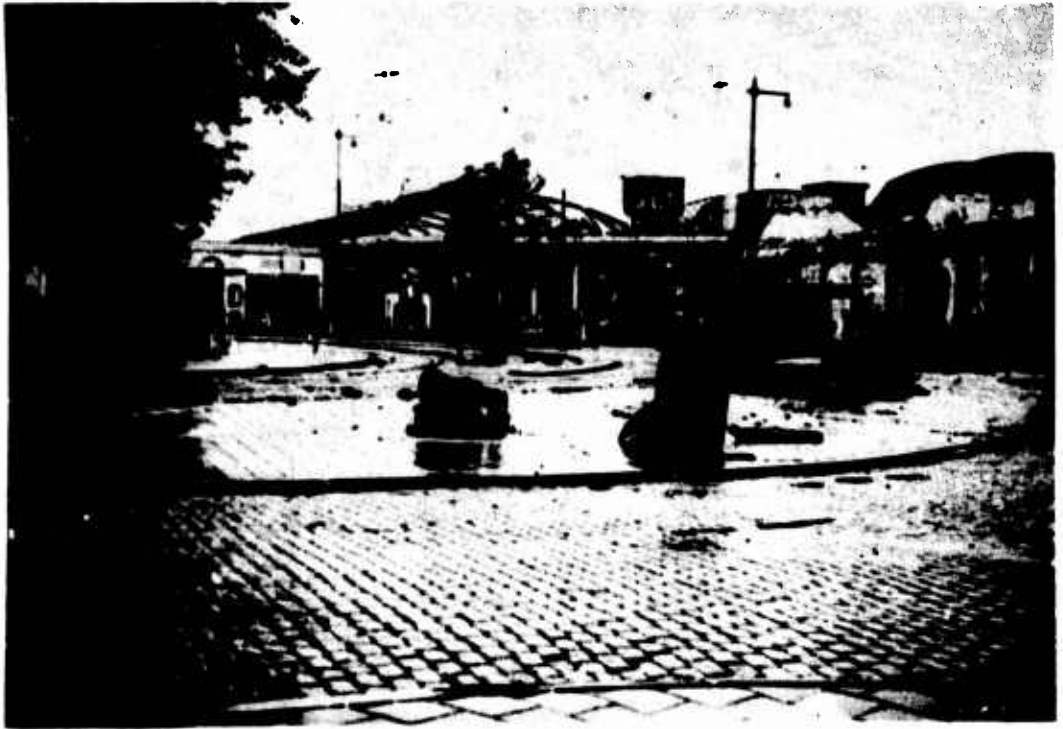
Pictures 21, 22 THE DELFTER POORT RAILROAD STATION

the water works, but there was an unlimited amount of water available from the canal at Stationssingel, directly behind the station (see Pictures 19 to 24).

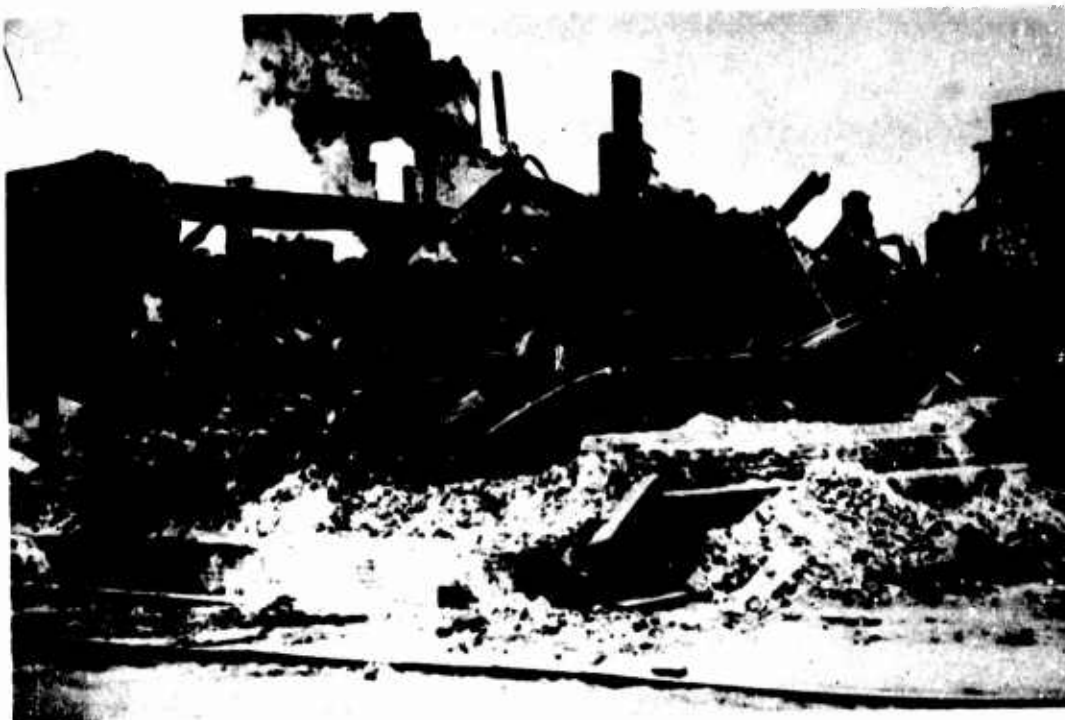
A characteristic of fire ruins is the tangle of twisted metal. With the exception of a few buildings which received a direct hit by a high explosive bomb and were left standing without burning (see Pictures 25 to 30), all parts of the field of ruins show the typical destruction by fire, with the metal supports twisted by heat and fire (see Pictures 33 to 42).

Pictures 35, 36 TWISTED STRUCTURAL STEEL, CHARACTERISTIC OF STRUCTURES DESTROYED BY FIRE

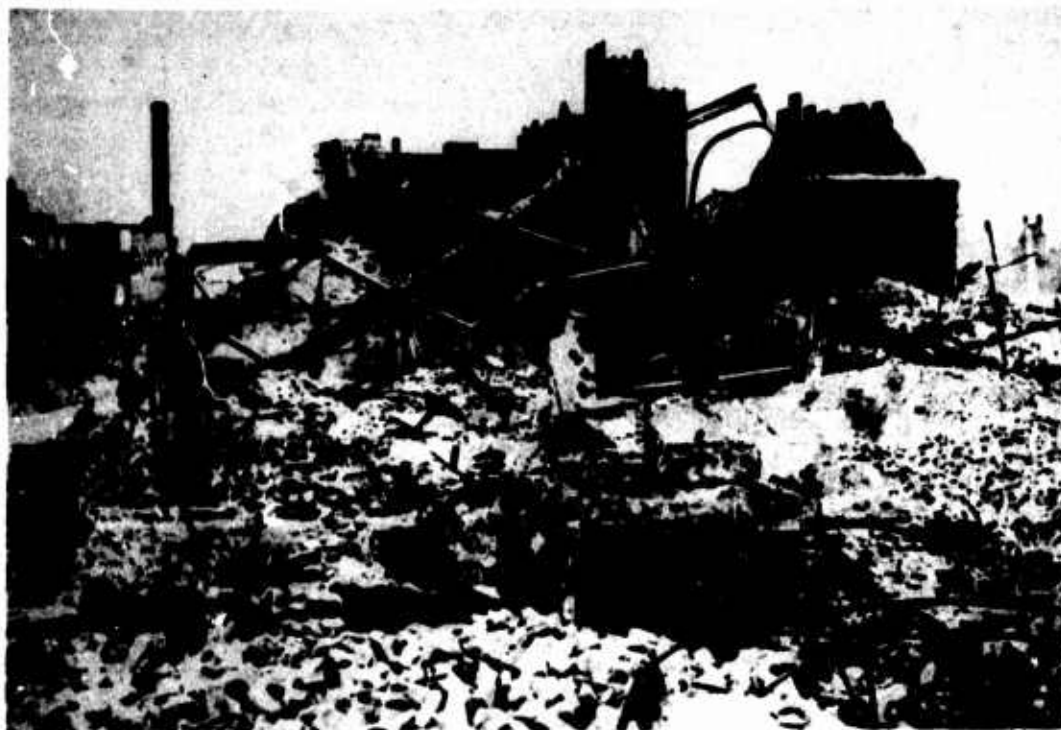
Pictures 37, 38 TWISTED STRUCTURAL STEEL, CHARACTERISTIC OF STRUCTURES DESTROYED BY FIRE

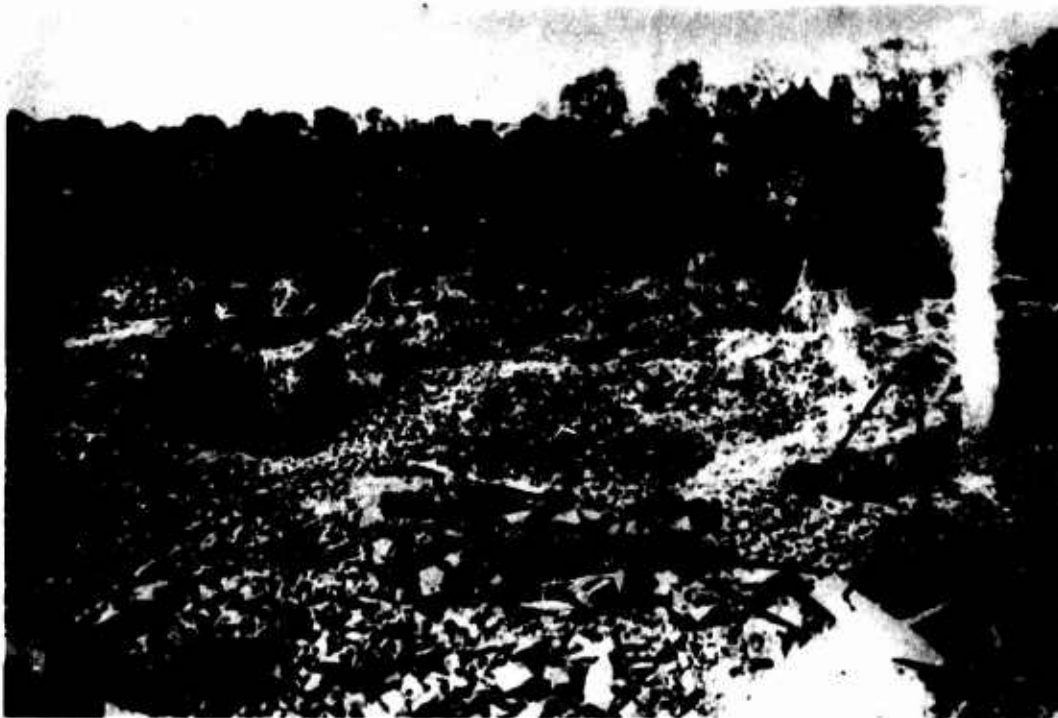
Picture 62 STEEL VAULT IN CENTER OF DESTROYED BUILDING

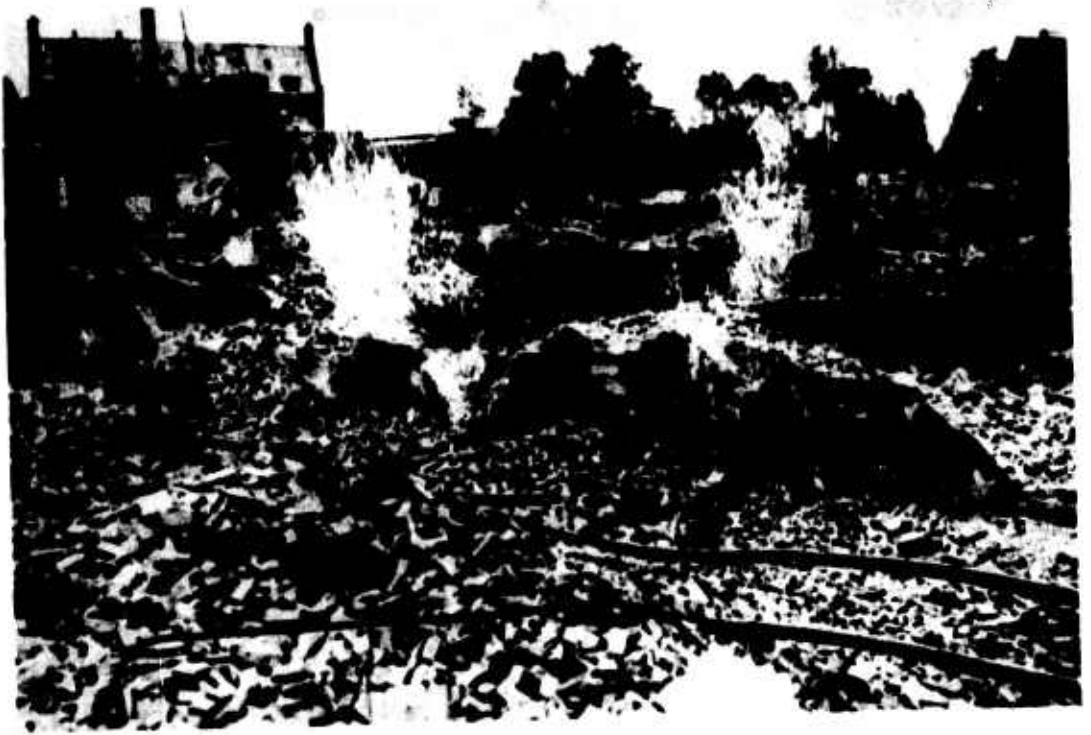
Stands of trees surprisingly often brought the fire to a halt. In many cases, houses or groups of houses situated behind rows of trees or surrounded by trees remained undamaged. It therefore seems that the existence of a great number of trees in a city will have to be taken into consideration when estimating the vulnerability to fires after air attacks (see Pictures 64 to 66).

Picture 64 TREE FIREBREAK

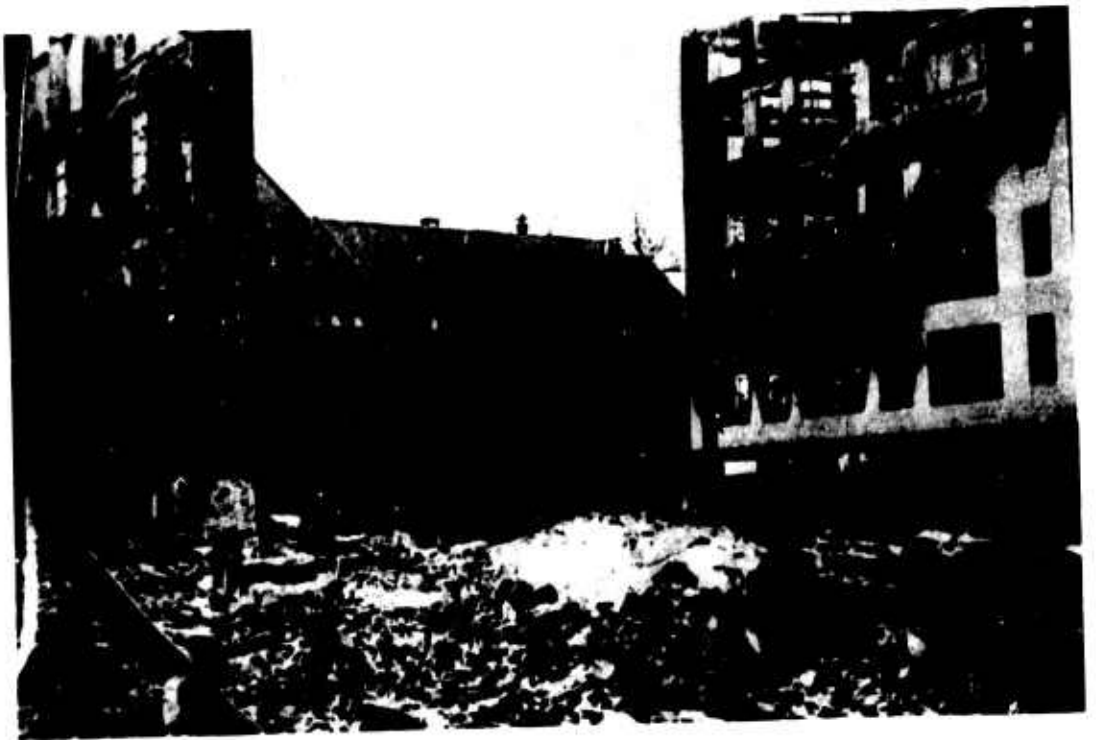
Pictures 65,66 TREE FIREBREAKS

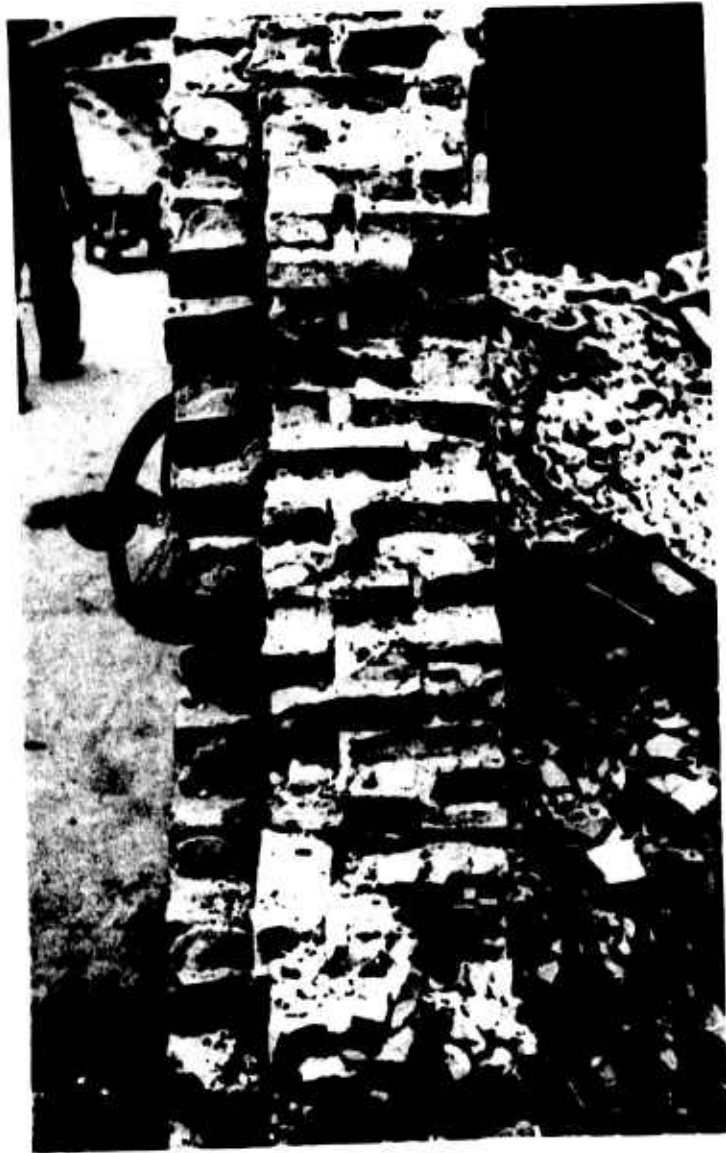
You can see in Picture 75--as hard as this may be to understand for a German--two outer walls of two neighboring buildings, where the left one has the thickness of only 0.5 stone or 8.5 centimeters.

Picture 75 ILLUSTRATION OF DUTCH BRICK WALL CONSTRUCTION
