MISCELLANEOUS PAPER S-69-27

LANDING MAT OVERLAY ON DETERIORATED PAVEMENT

BARE BASE SUPPORT

U. S. Army Engineer Waterways Experiment Station
CORPS OF ENGINEERS
Vicksburg, Mississippi

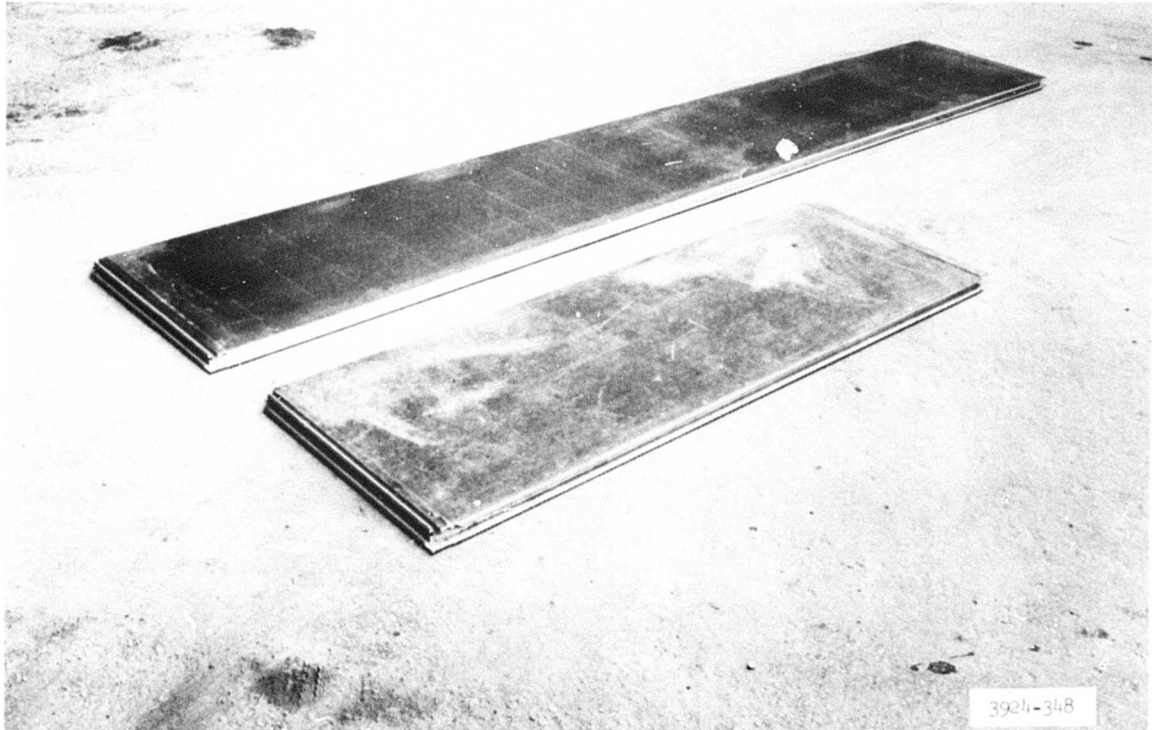
Photograph 1. Full and half planks of XM18

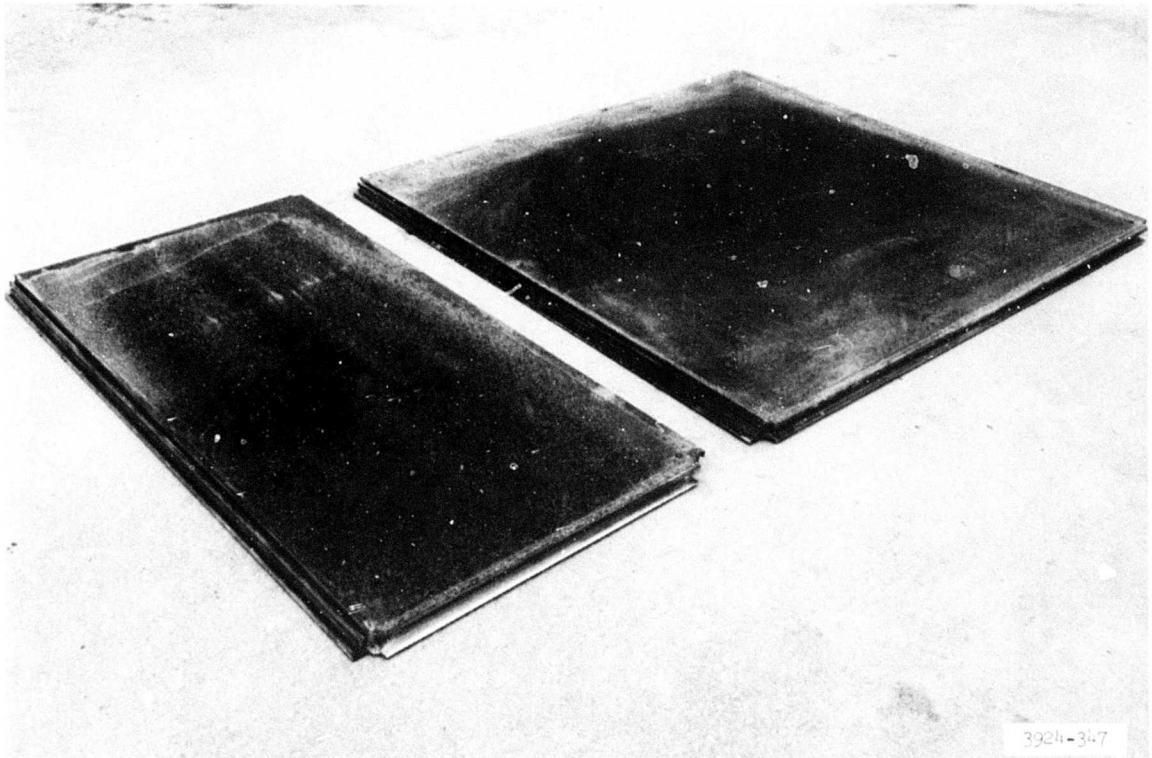
Photograph 2. Full and half panels of XM19

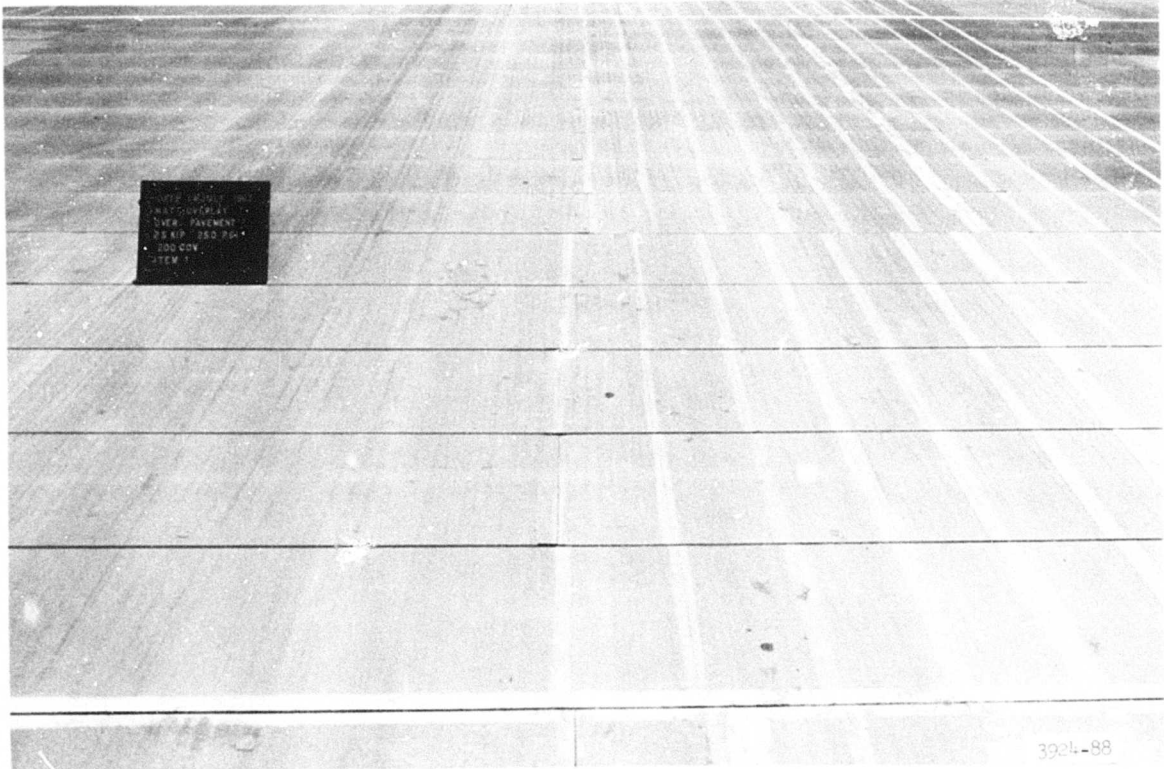
Photograph 17. Item 1 after 120 coverages applied during light rainfall
(200 coverages total)

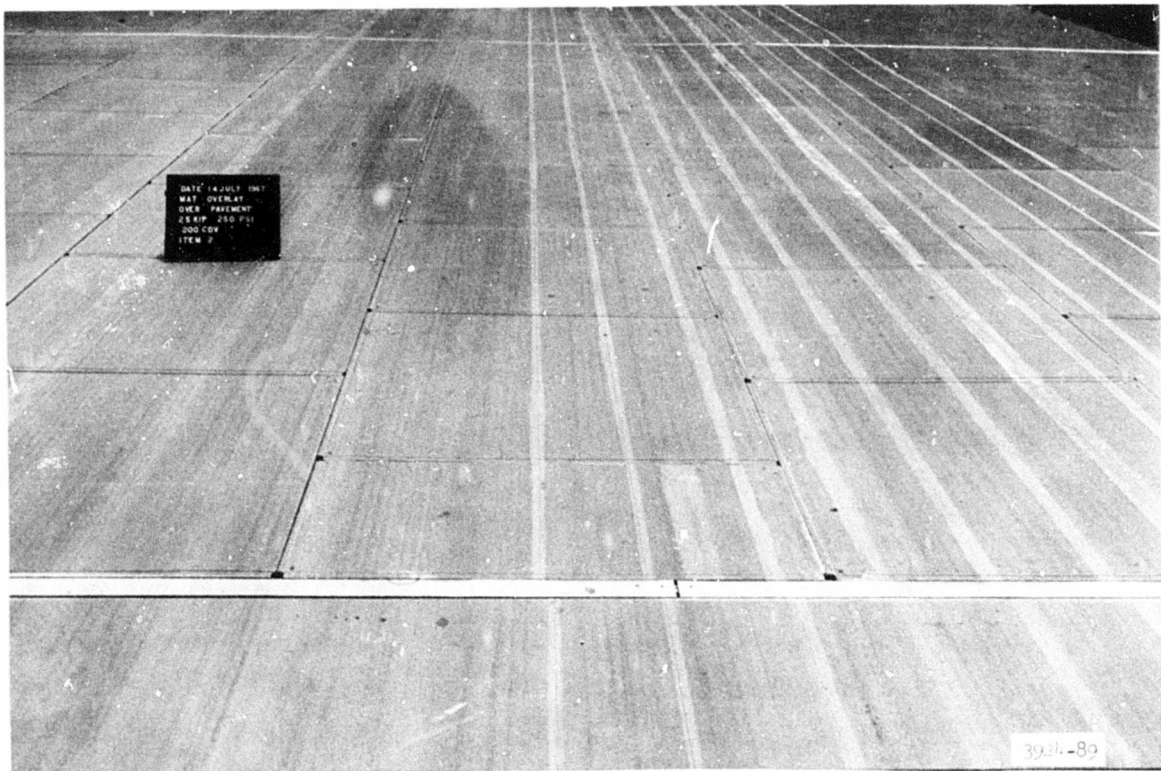
Photograph 18. Item 2 after 120 coverages applied during light rainfall
(200 coverages total)

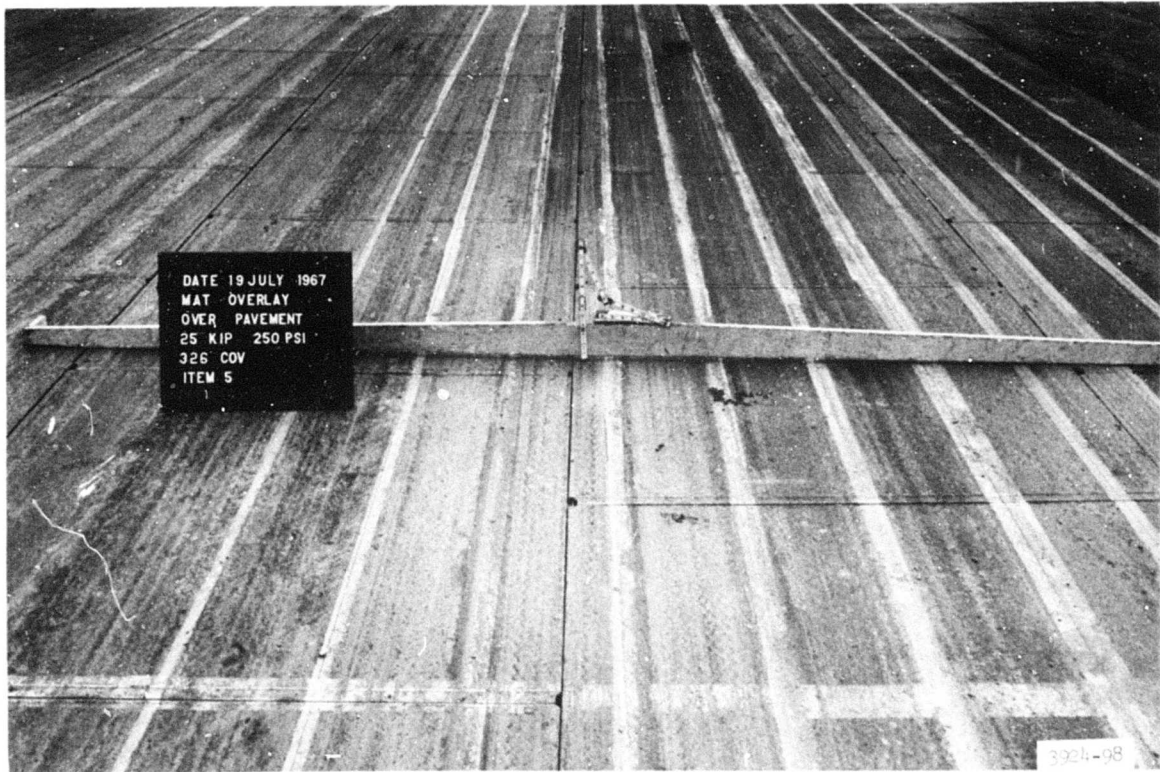
Photograph 27. Item 5 after 26 coverages applied during heavy rainfall (326 coverages total)

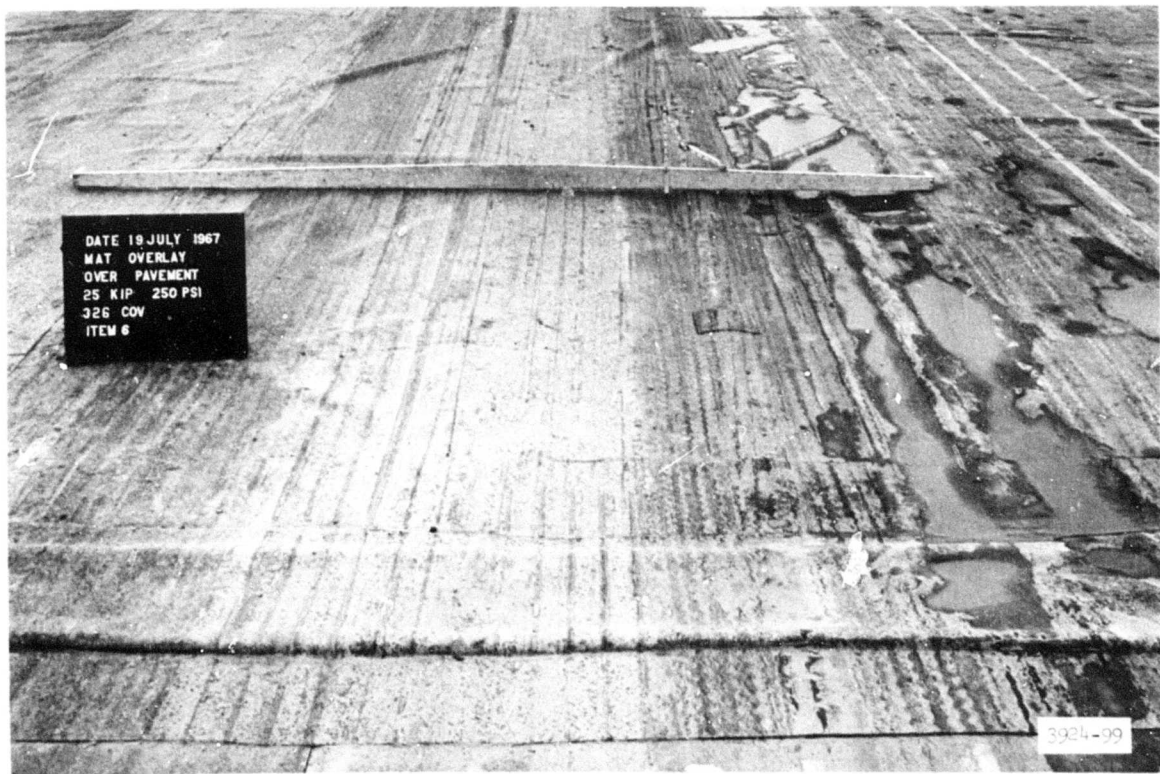
Photograph 28. Item 6 after 26 coverages applied during heavy rainfall (326 coverages total)

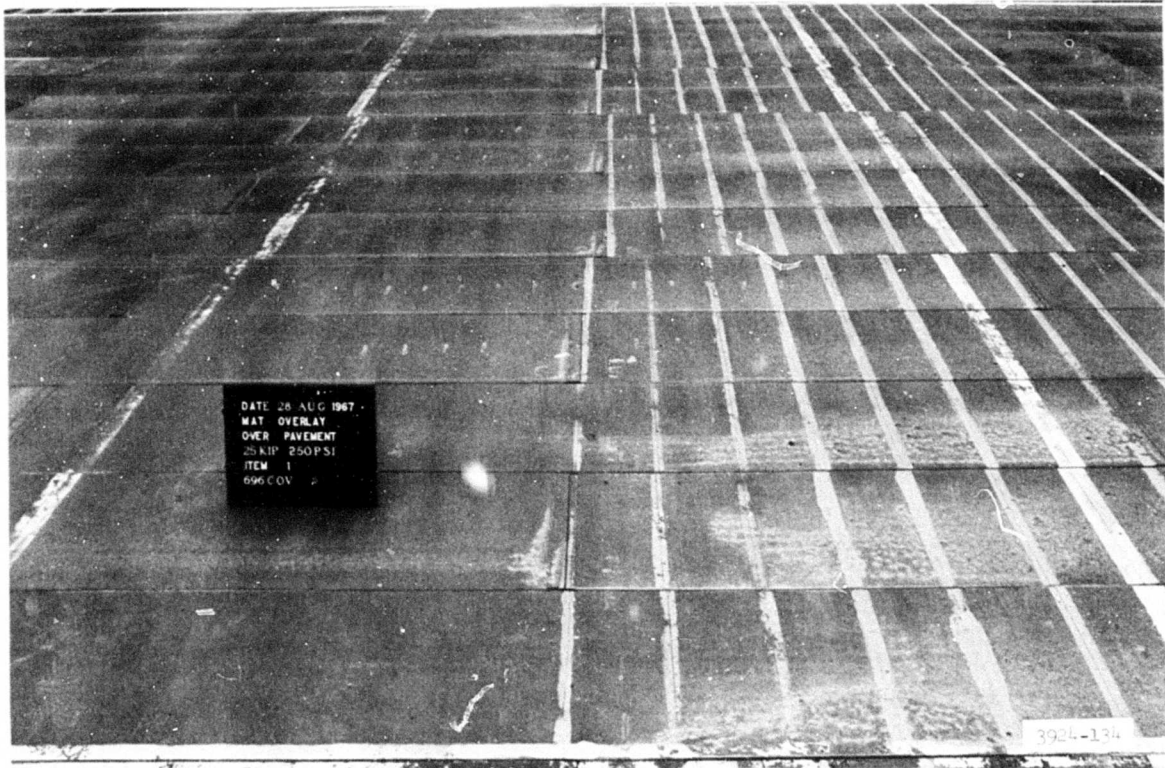
Photograph 37. Item 1 after 696 coverages

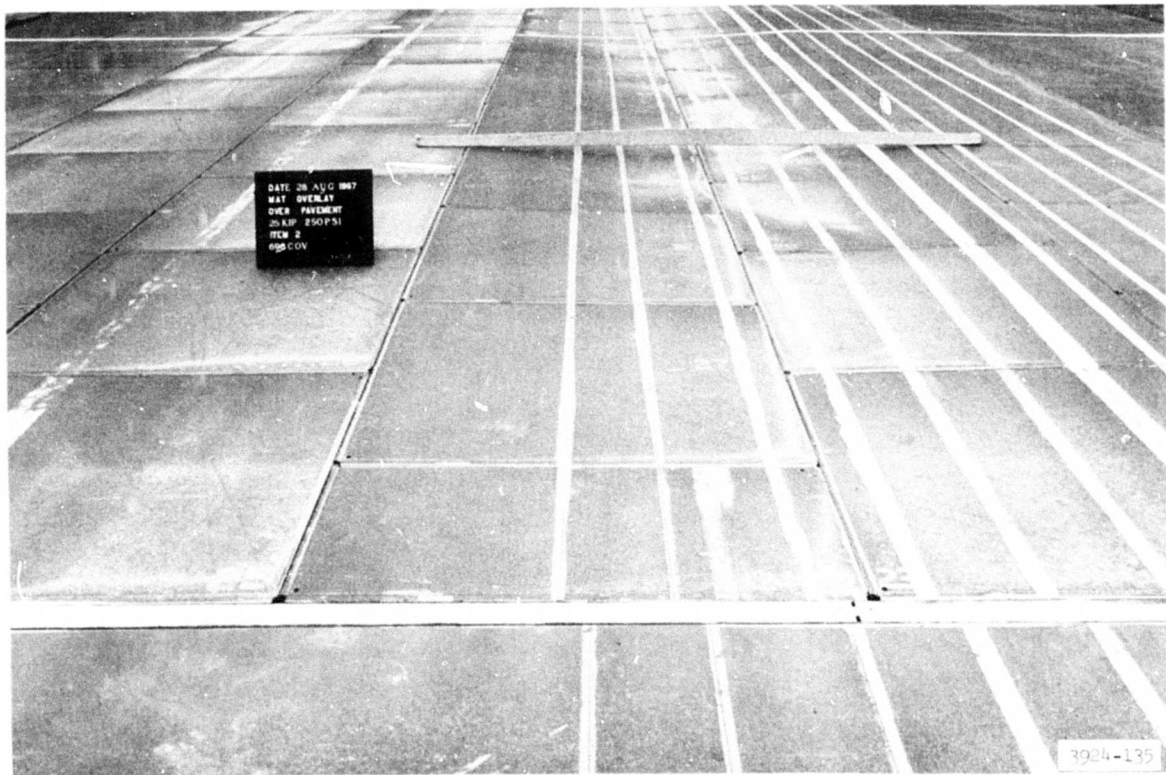
Photograph 38. Item 2 after 696 coverages

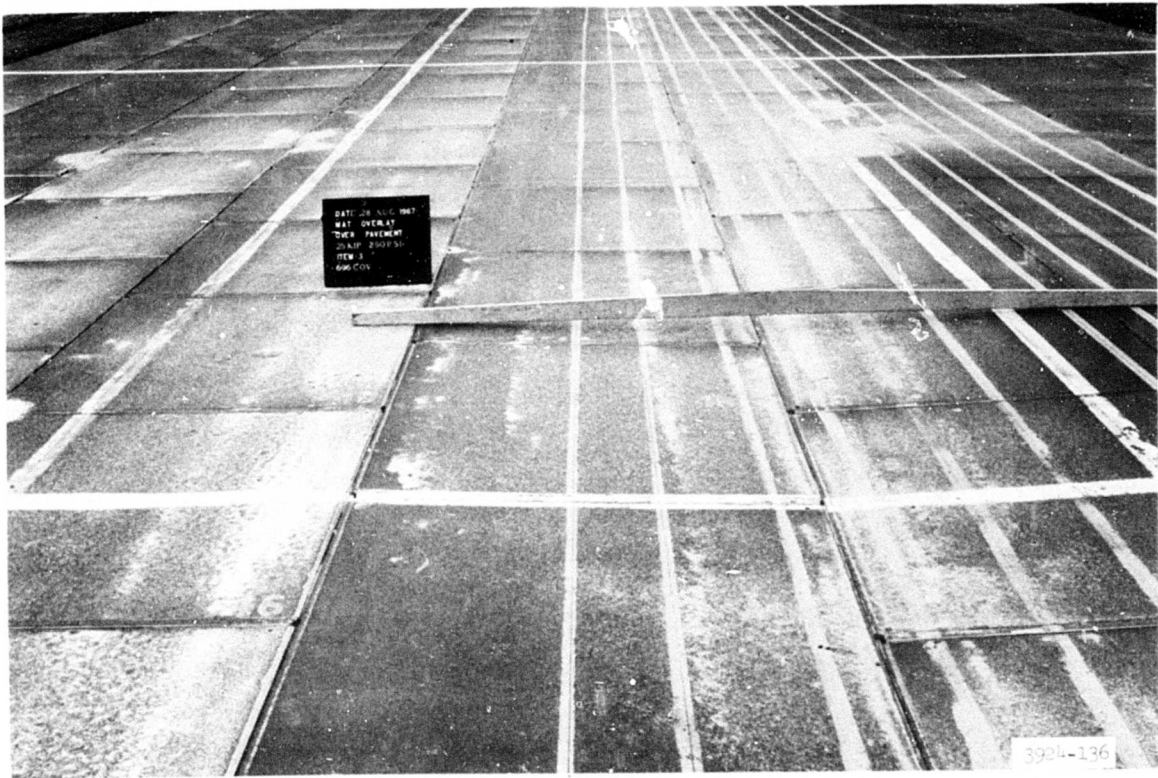
Photograph 39. Item 3 after 696 coverages

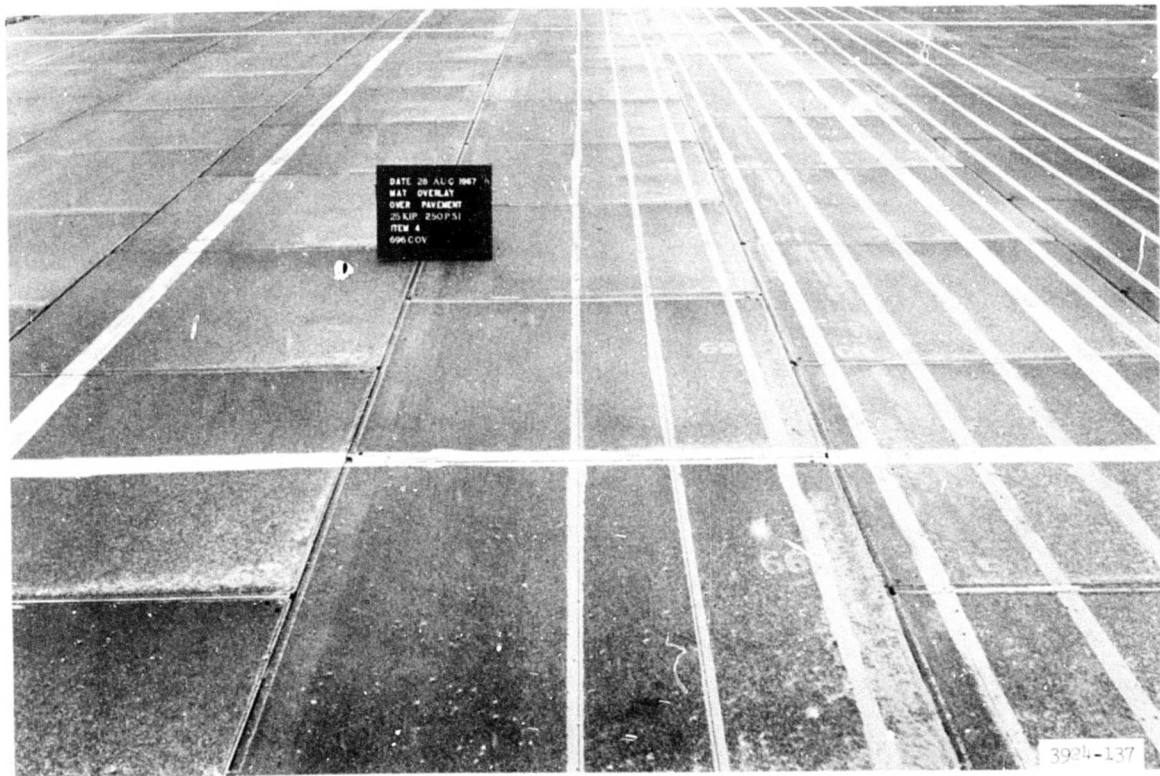
Photograph 40. Item 4 after 696 coverages

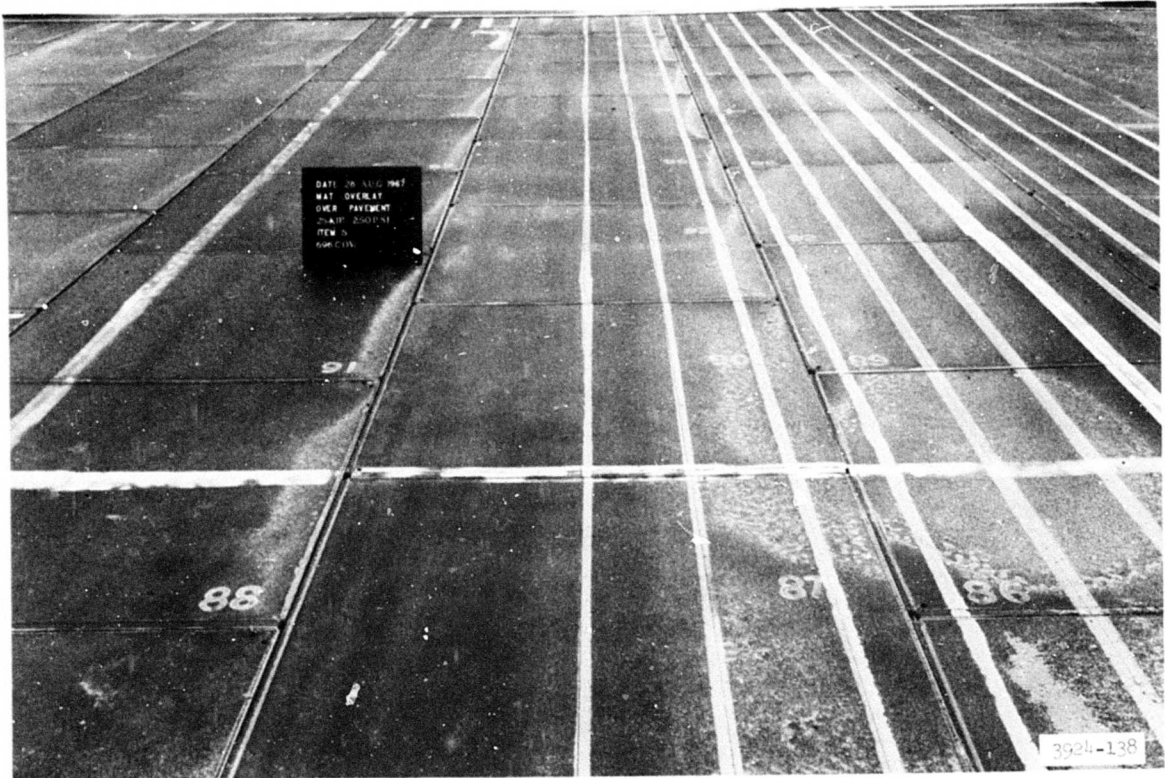
Photograph 41. Item 5 after 696 coverages

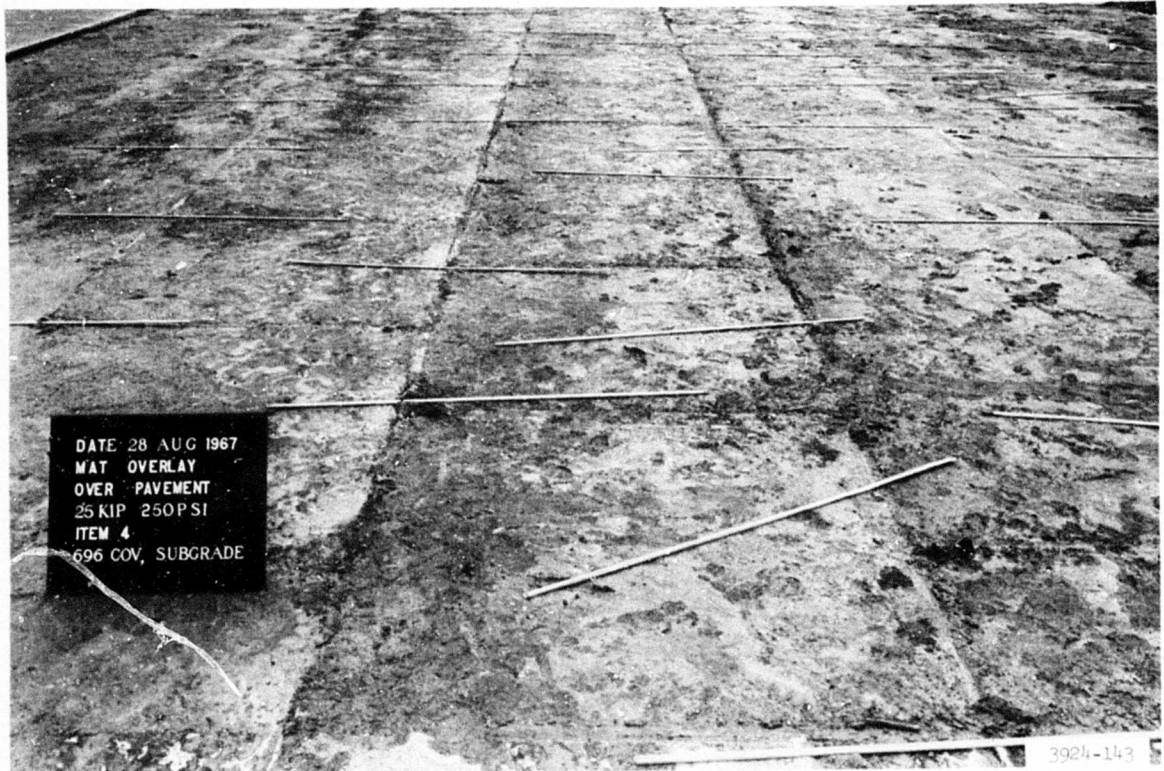
Photograph 45. Condition of clay gravel overlay after stabilization and subsequent 366 coverages (696 total coverages on section)

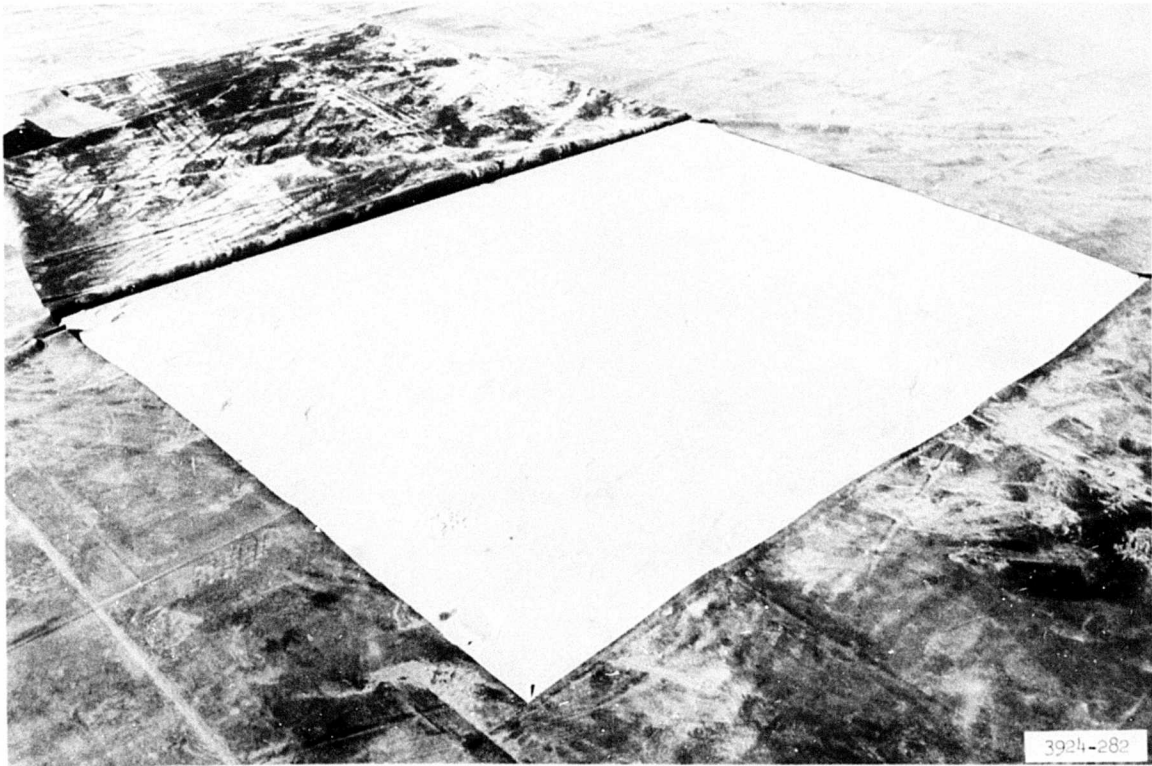
Photograph 59. Condition of sand in item 1 after 2170 coverages

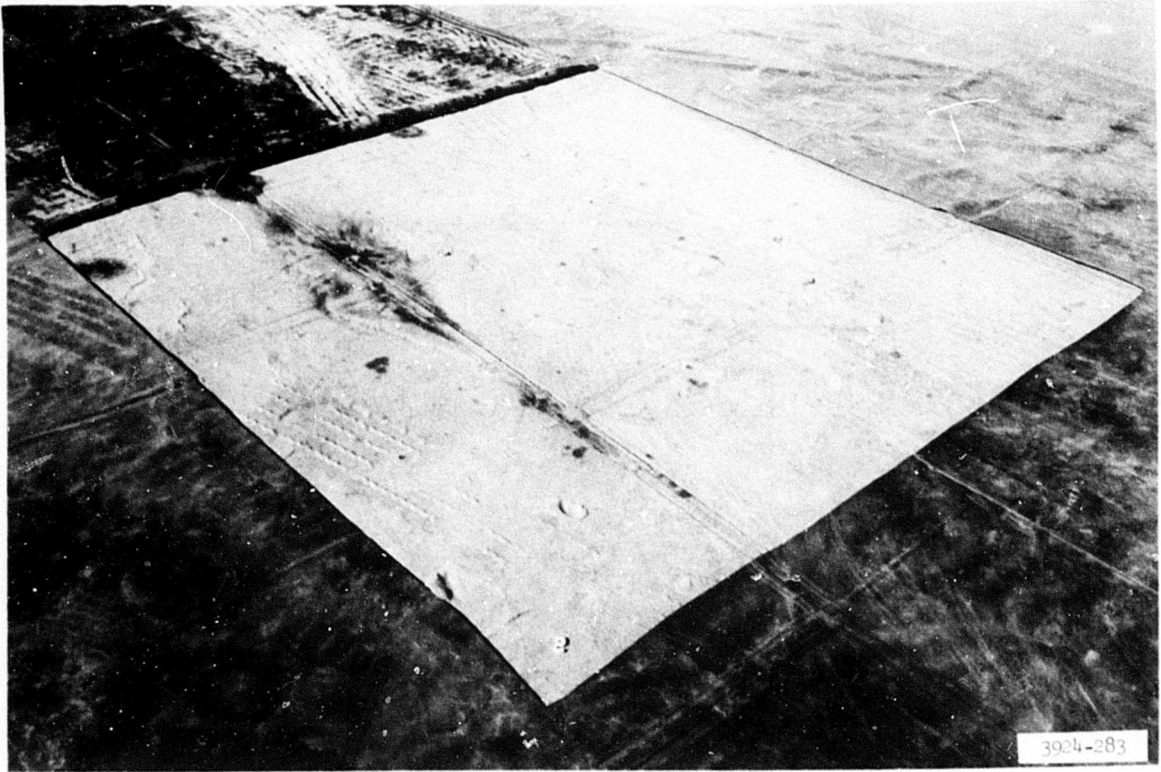
Photograph 60. Condition of sand in item 2 after 2170 coverages

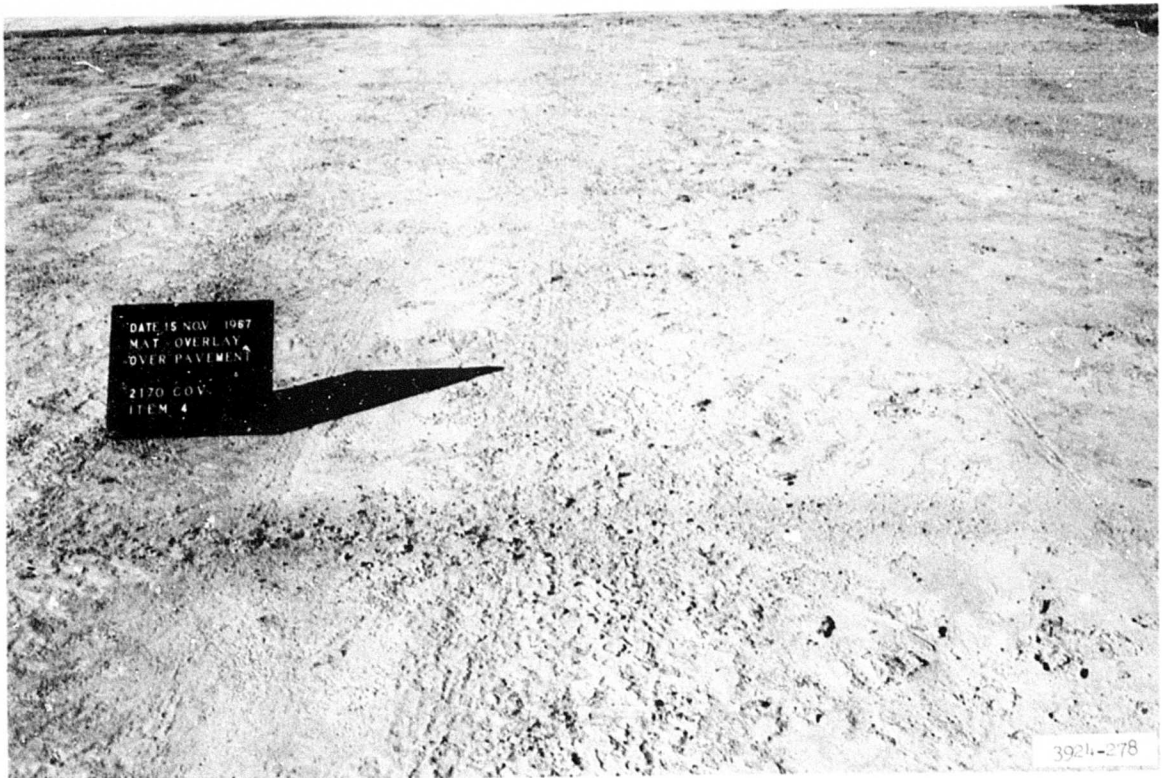
49. The clay gravel in item 4 that had been stabilized with portland cement is shown in photograph 62. The lower part of the photograph actually shows part of the clay gravel leveling course in item 3, which was also stabilized with portland cement. From this photograph, it can be seen that the stabilized clay gravel was still quite stable. Soil tests at this time indicated that the surface strength of the material in item 4 was in excess of 300 CBR.

Photograph 62. Condition of stabilized clay gravel in item 4 after 2170 coverages

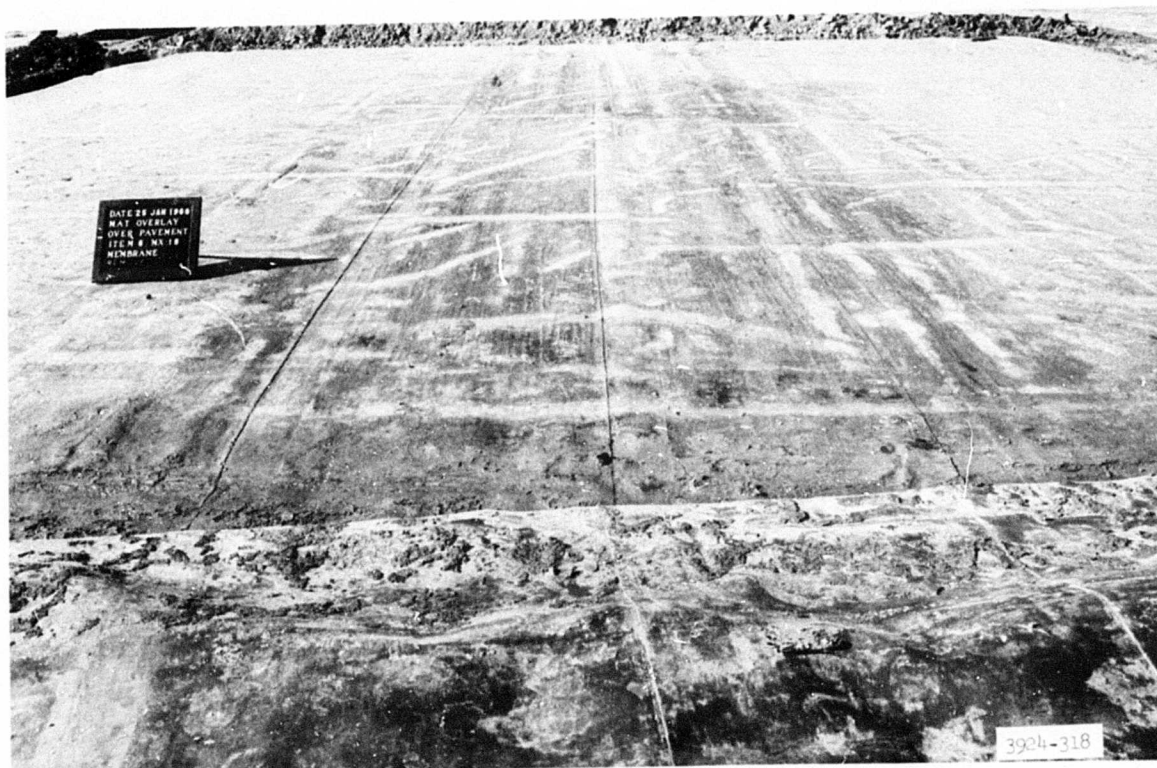
52. The WX18 membrane on item 6 was not removed until all test traffic had been completed, although traffic was stopped on item 6 at 510 coverages. A view of the exposed lean clay after removal of the membrane is shown in photograph 66. The soil was stable, and tests indicated the strength of the lean clay at the surface and 4 in. below the surface to be 94 and 85 CBR, respectively.

Photograph 66. Lean clay in item 6 after removal of membrane
