TECHNICAL REPORT N-70-10

**SURVEY OF GULF COAST
STRUCTURAL DAMAGE RESULTING FROM
HURRICANE CAMILLE, AUGUST 1969**

Final Report

By U. S. Army Engineer Waterways Experiment Station, Vicksburg, Mississippi

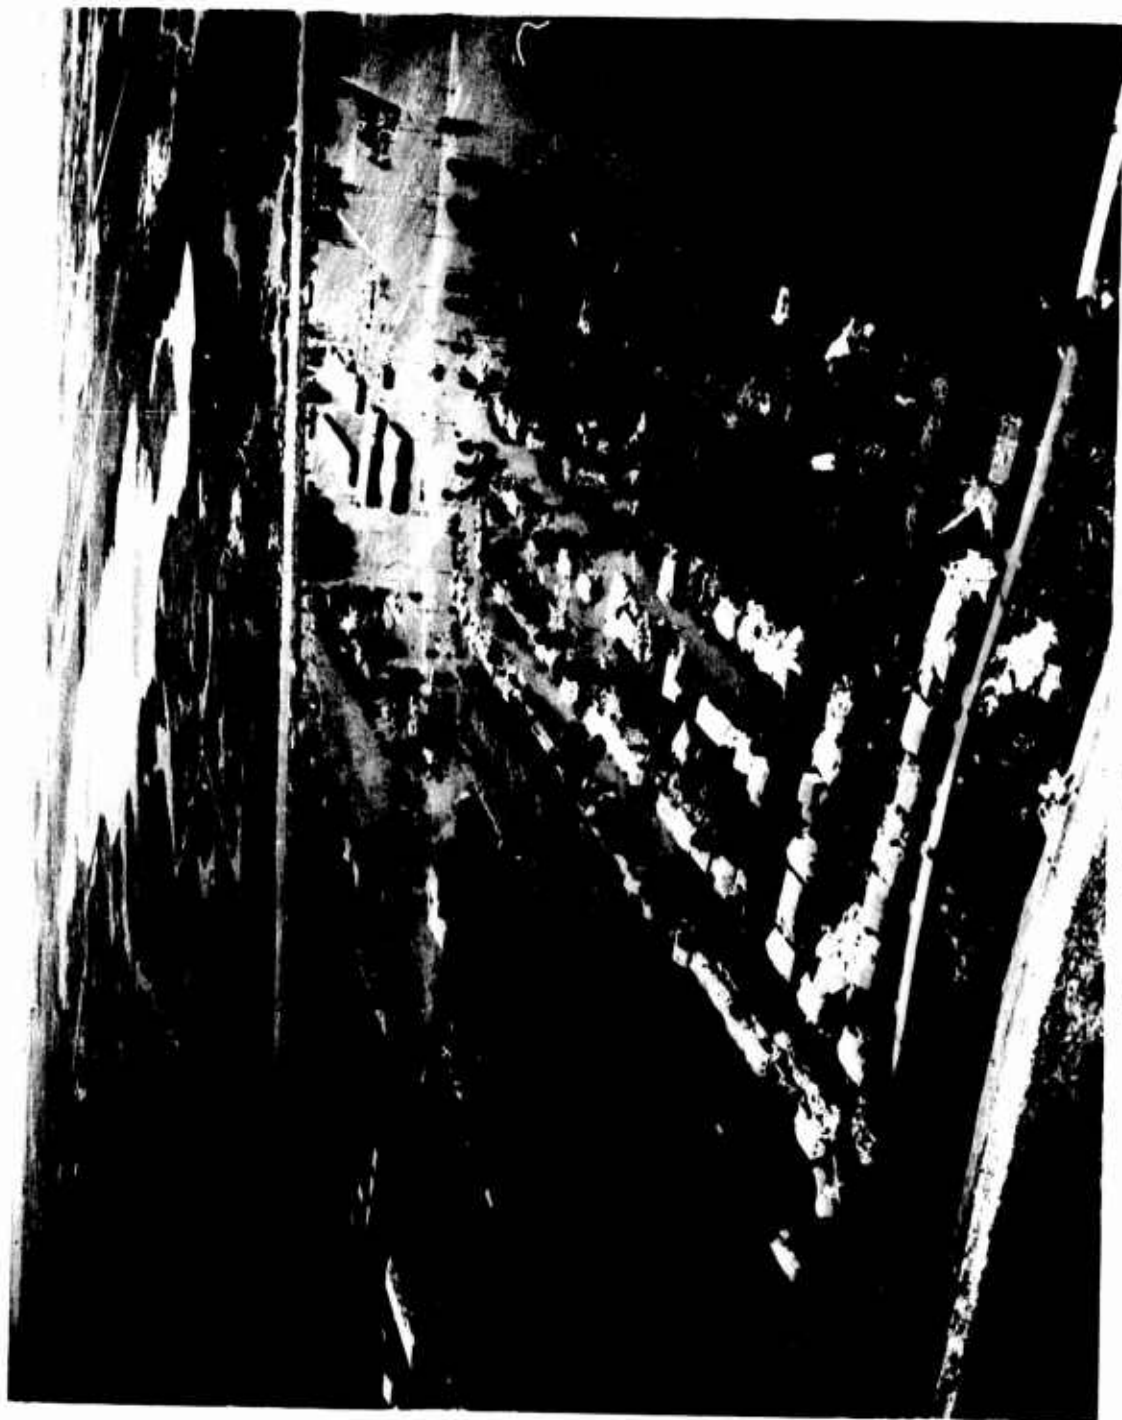
Figure 2.13 Below Buras, Louisiana.

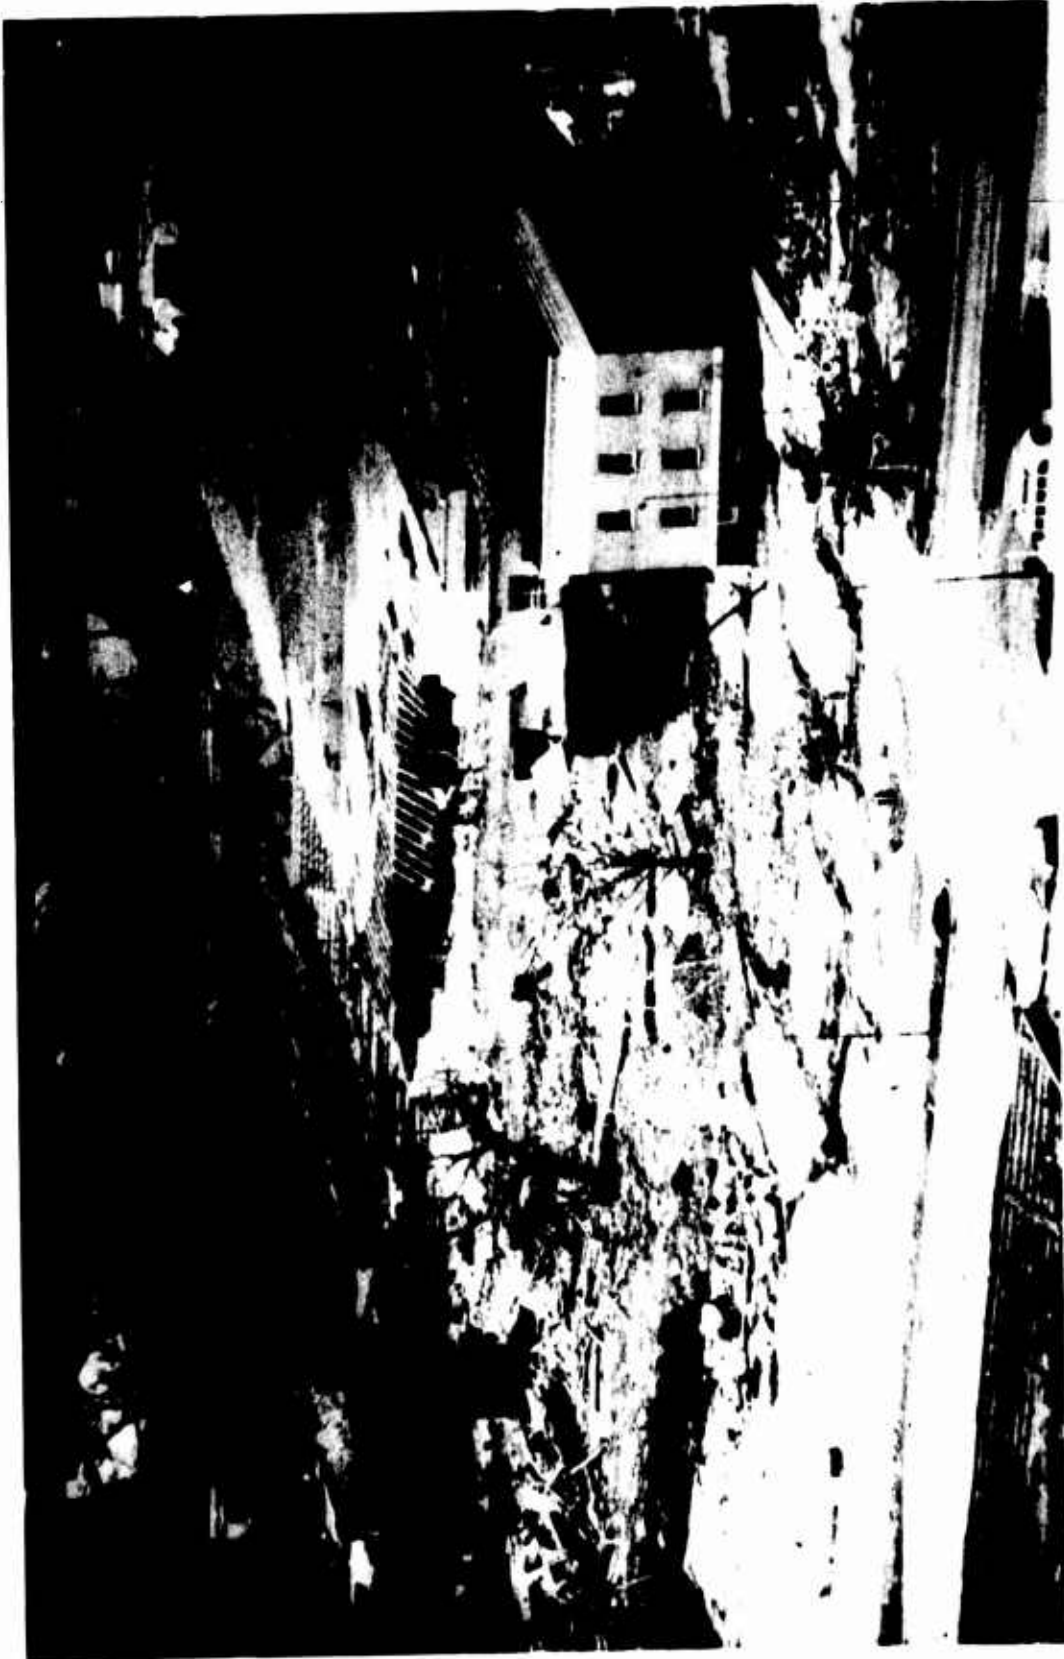
Figure 2.23 Pass Christian, City Hall in foreground.

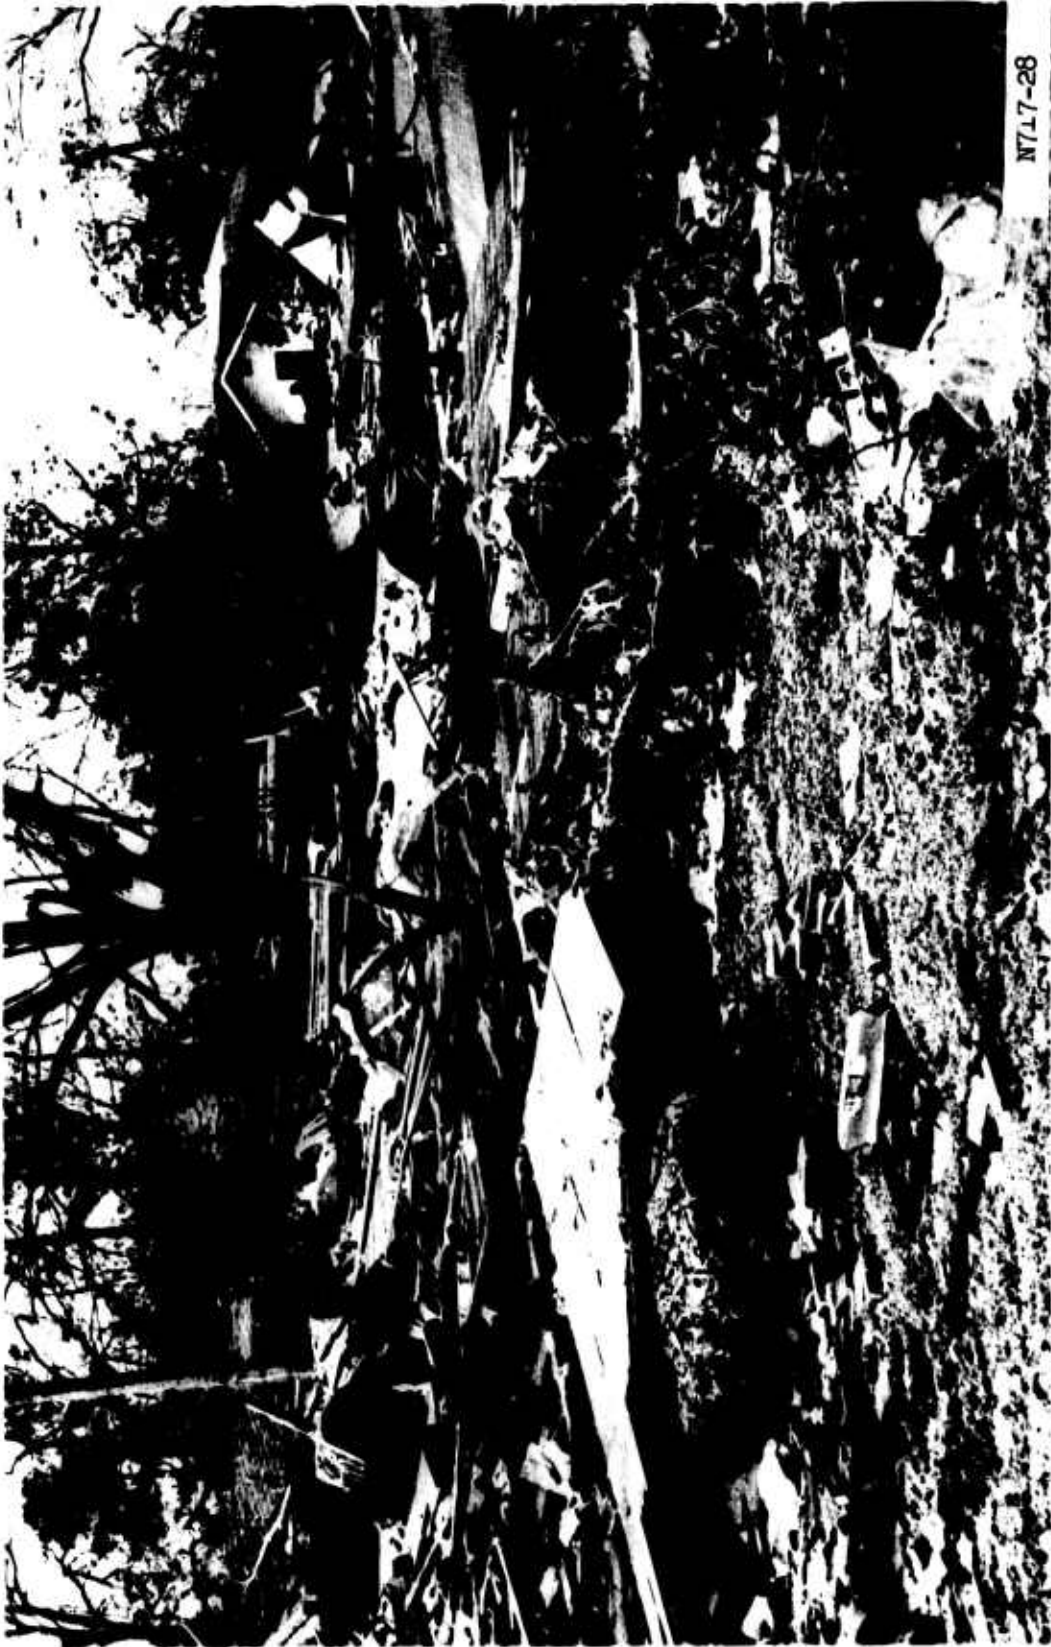
N717-28

Figure 2.29 Debris from residences and Port facilities, west Gulfport, Mississippi.

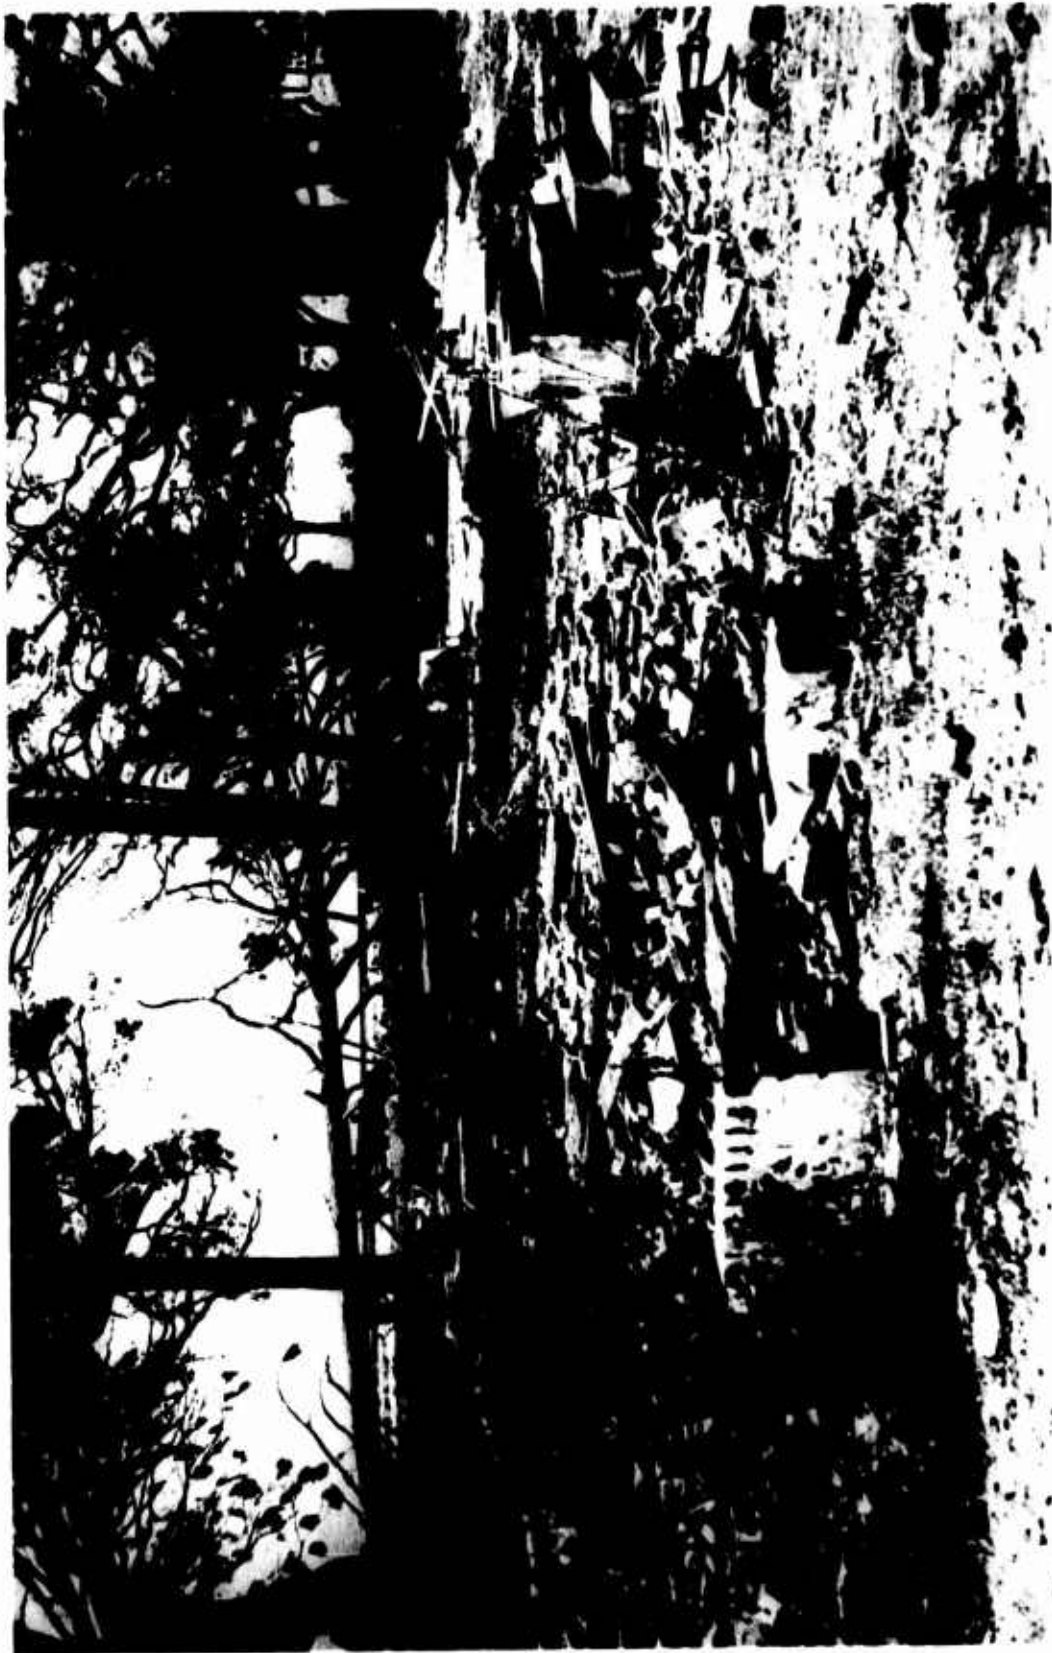
Figure 2.35 Residence near Long Beach, Mississippi.

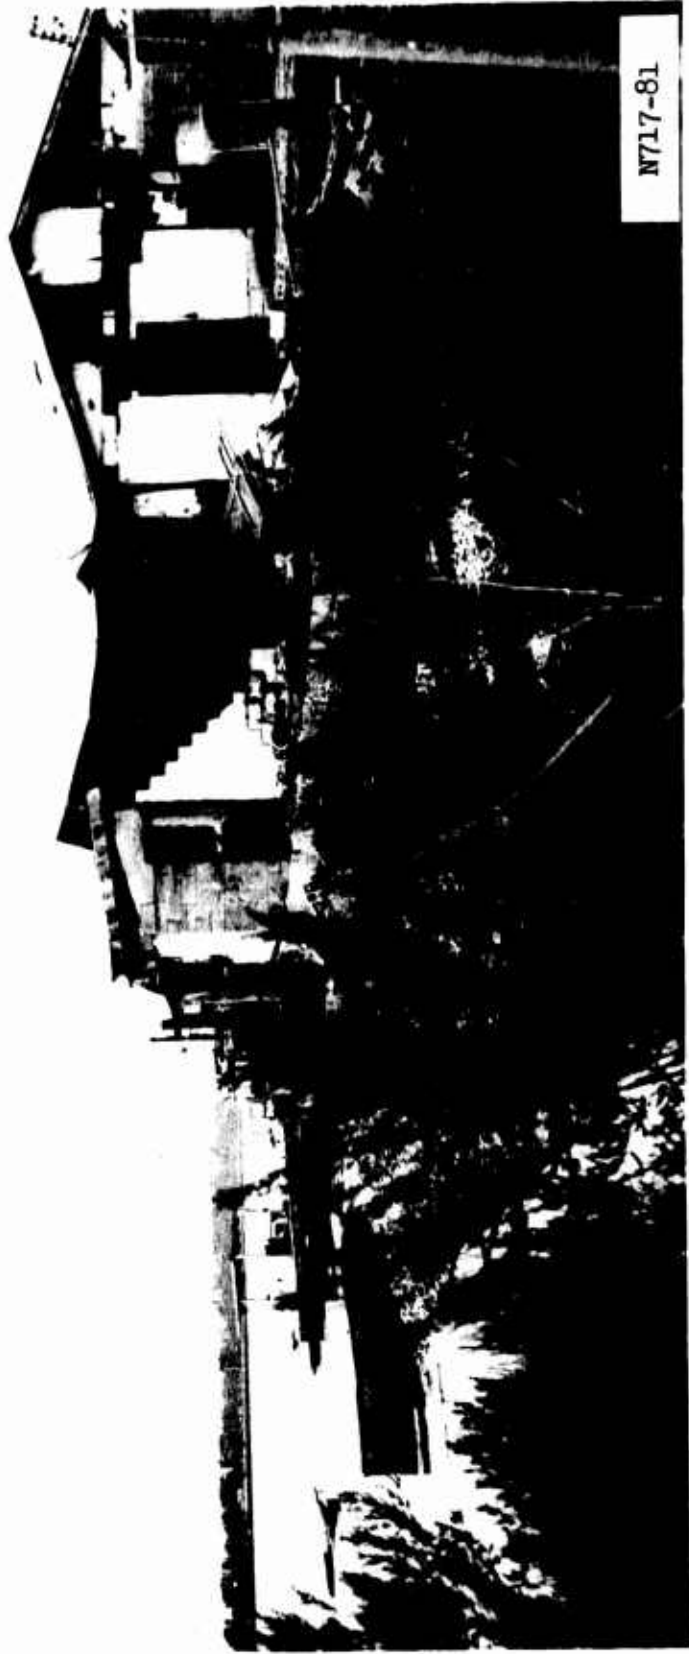
Figure 2.37 Commercial building, Back Bay of Biloxi, Mississippi.

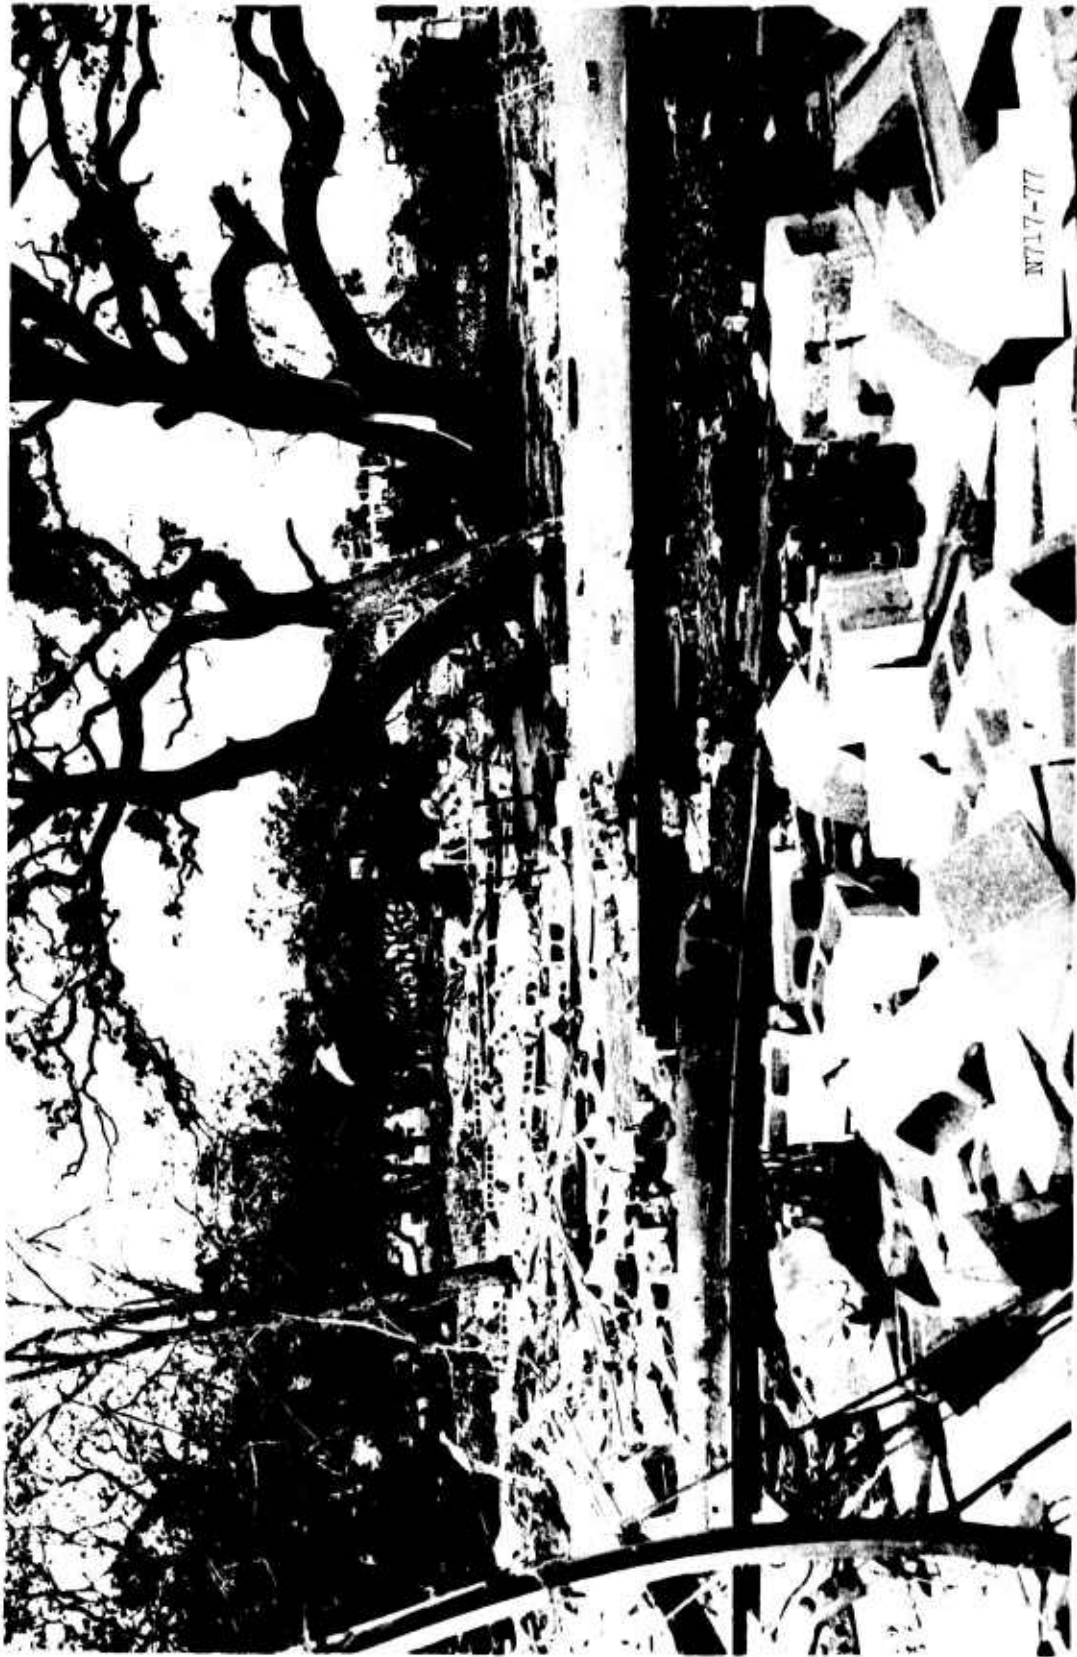
2.3.1 Masonry Block Structures. Many motels, apartments, gasoline stations, and small businesses along the Gulf shoreline were constructed of block and/or brick bearing walls, and these structures generally fared very poorly. An appreciable number collapsed totally with little evidence remaining to indicate how they looked before the storm. Almost all buildings of this type were totally destroyed in the area along the coast from Gulfport to Bay Saint Louis. Figures 2.40 through 2.46 show the remains of some buildings of this type.

Figure 2.41 Motels, west of Biloxi, Mississippi.

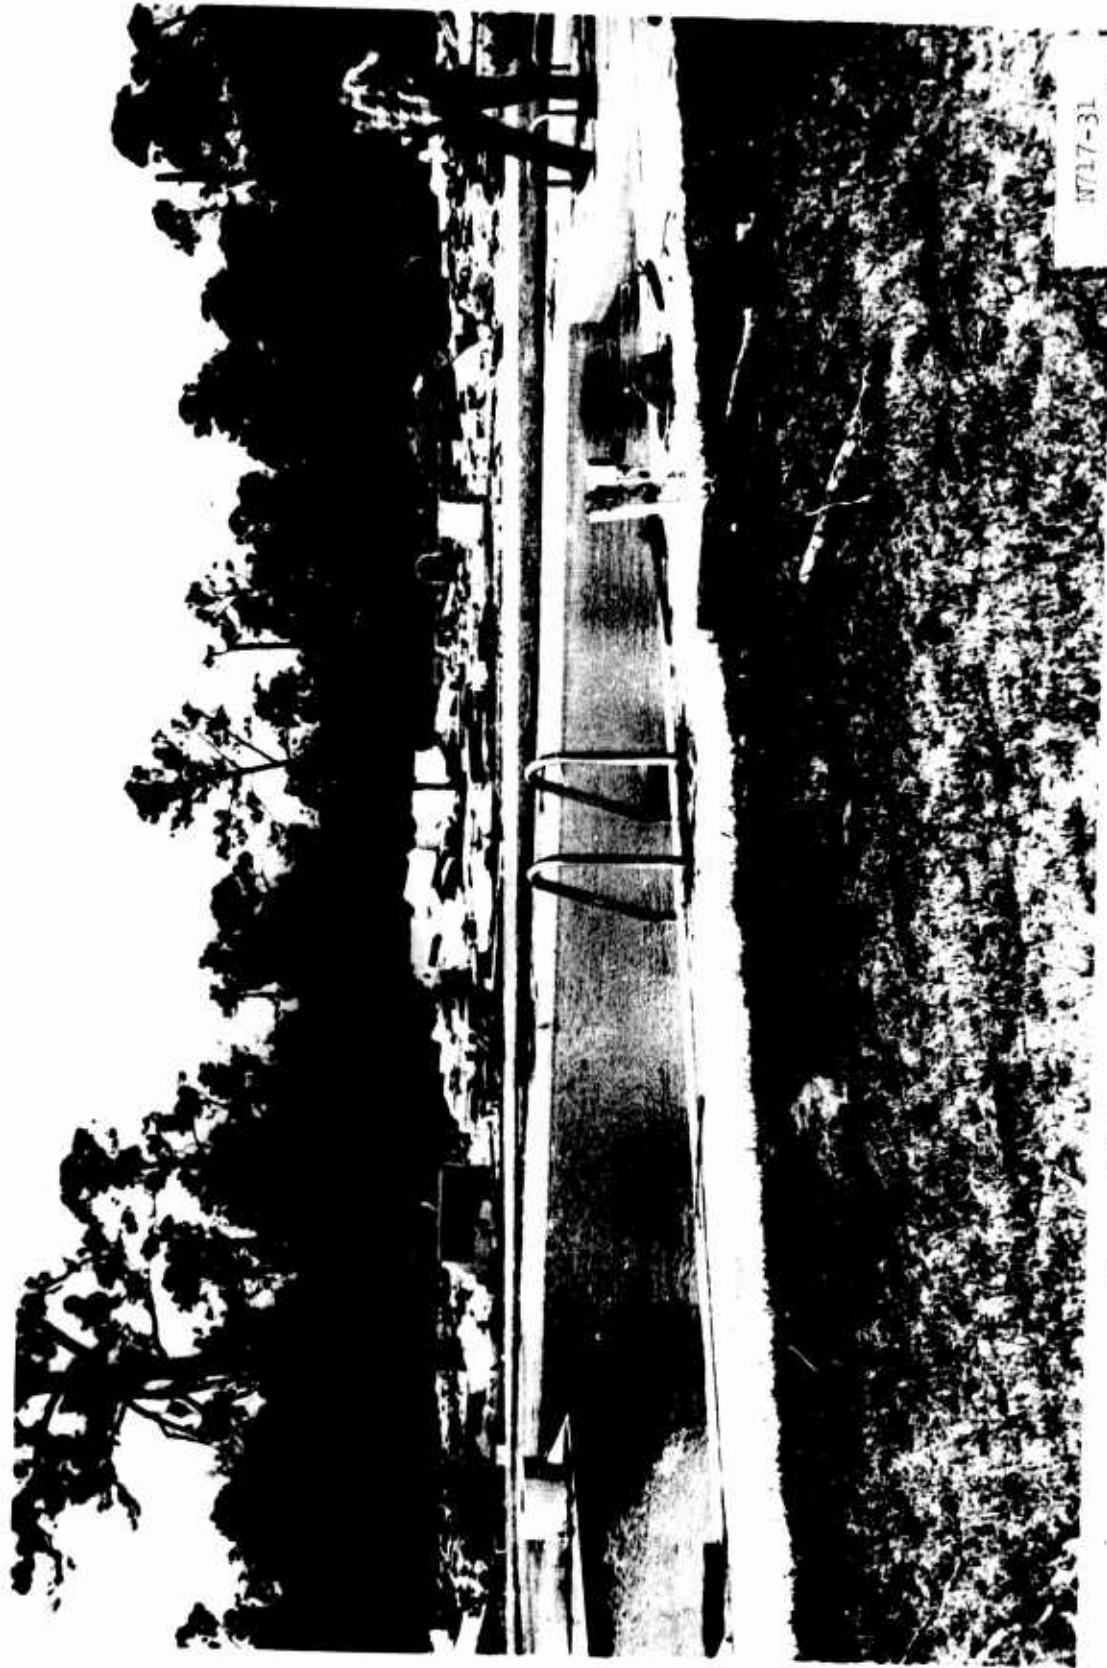
W717-31

Figure 2.42 Motel or apartment house, Long Beach area.

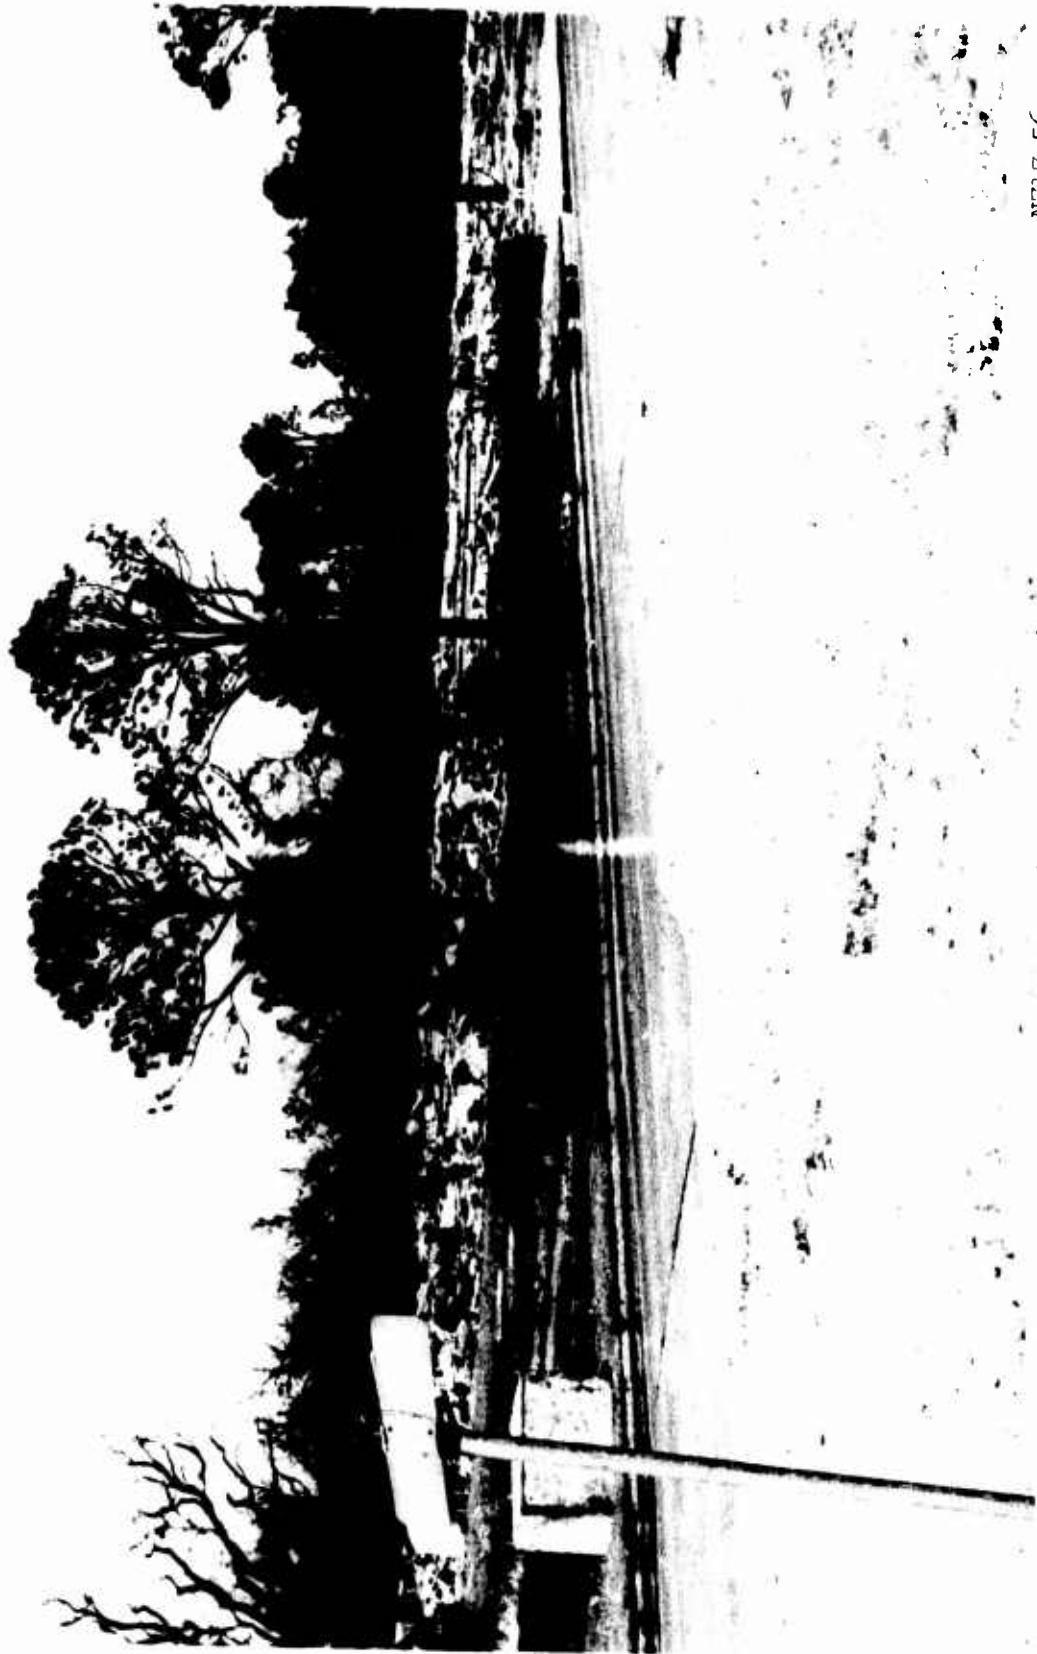
N717-56

Figure 2.43 shows the remains of the Richelieu Apartments, where 23 people died after ignoring repeated warnings by local authorities to vacate the building.

Figure 2.43 Richelieu Apartments (23 dead), Pass Christian, Mississippi.

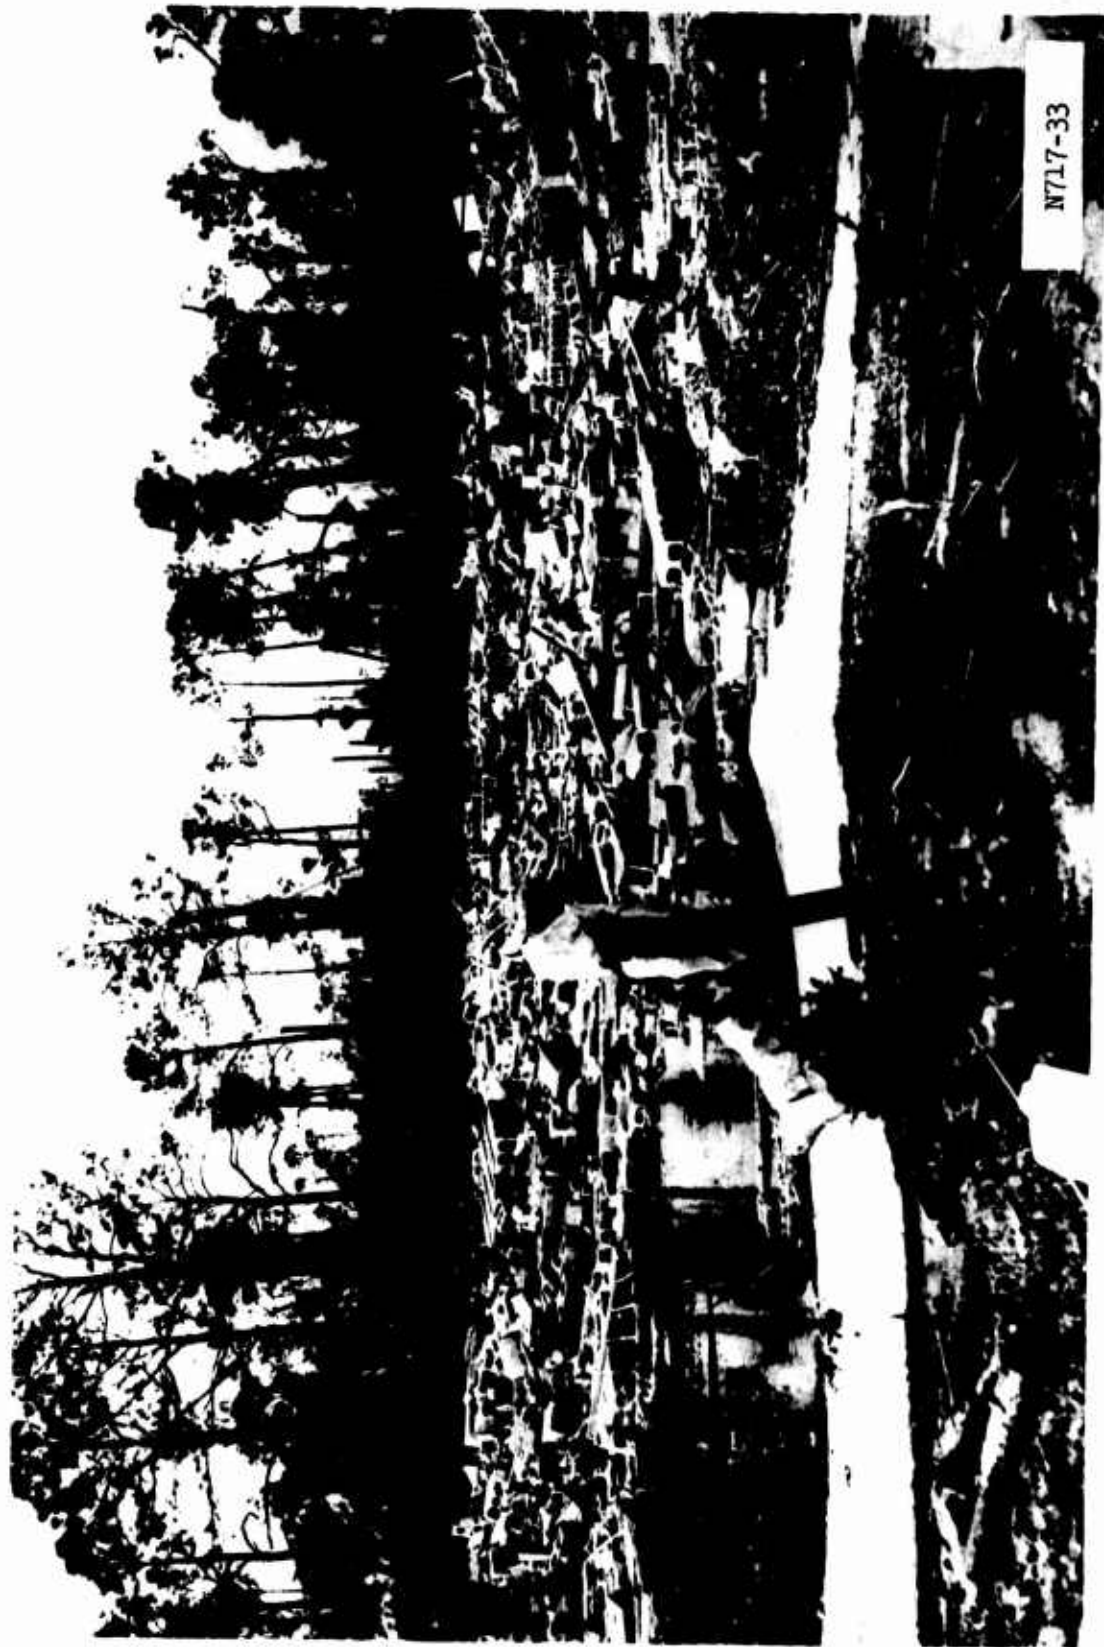
Figure 2.44 Pool area, Gulf Villa Apartments, Long Beach area.

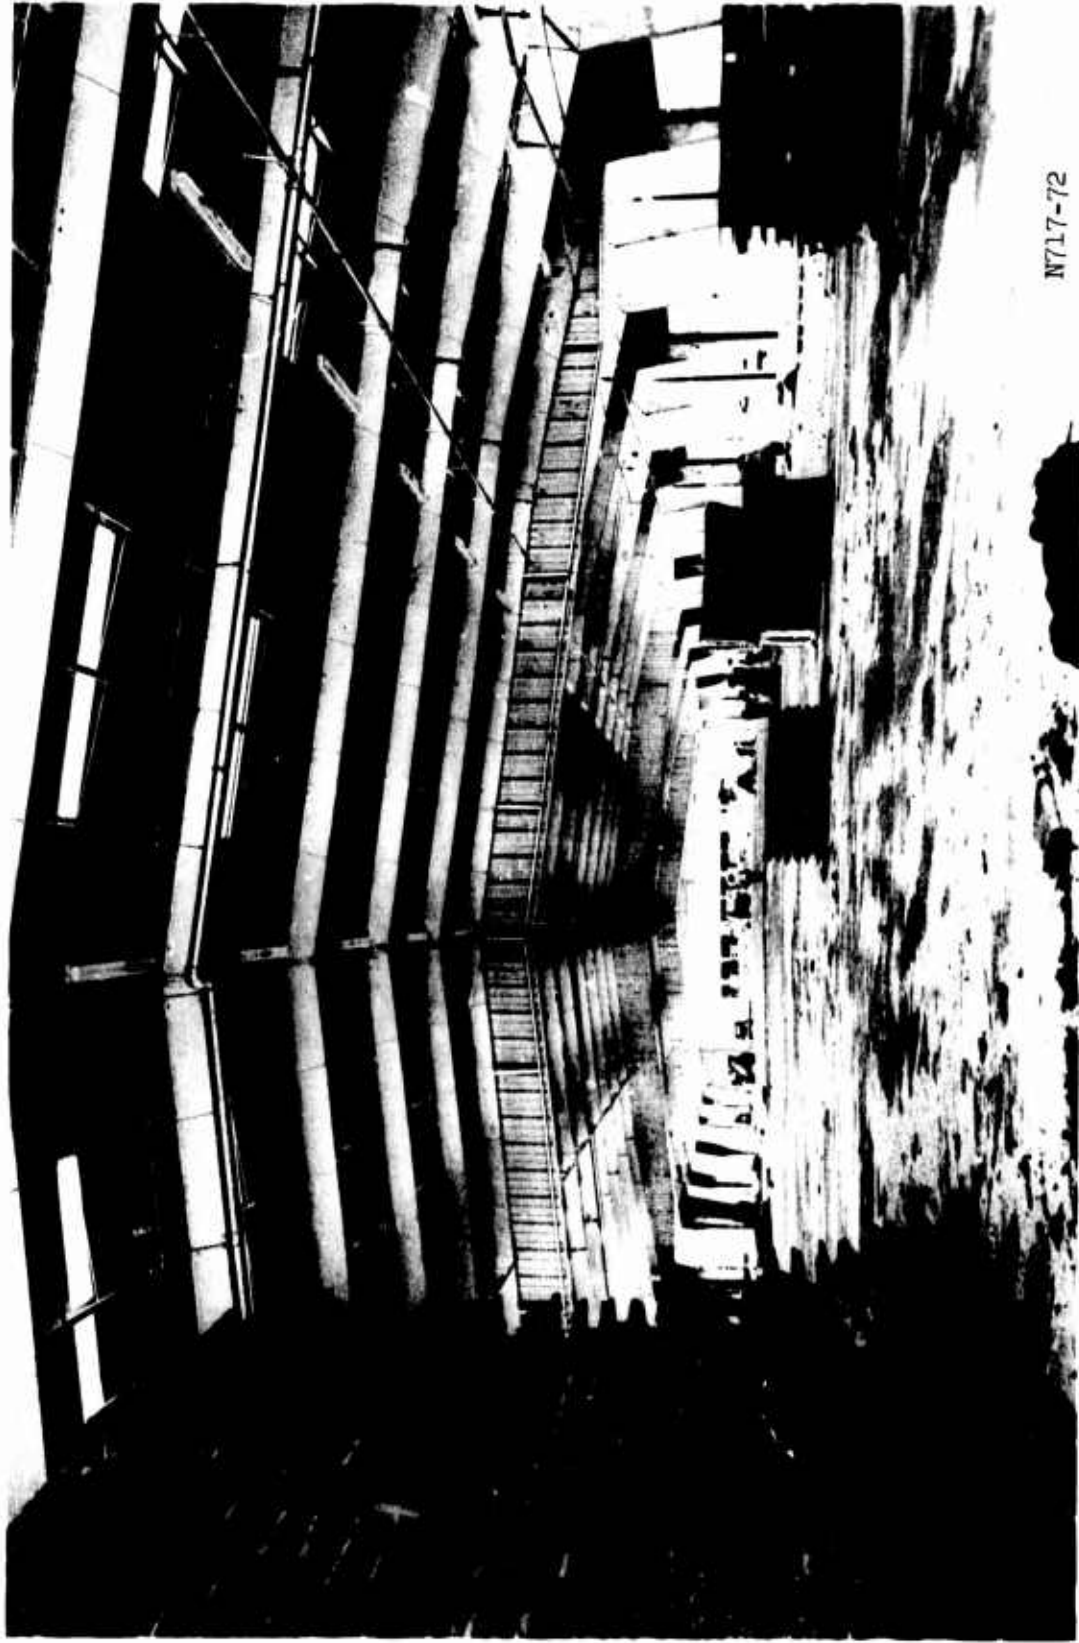
This building is a large clear span (span of about 125 feet) warehouse located at the southern tip of the Port of Gulfport. It is of rigid-frame construction with combination columns (steel sections encased in structural concrete) and with tilt-up concrete wall panels about 20 feet square by 6 inches thick and roll-up doors forming the walls. Light sheet metal purlins run along the length of the building and support a sheet metal roof. The columns appeared to have been cast in two steps, one to encase the steel section and the second to key in the tilt-up walls. The general construction is shown in Figures 3.1 and 3.2.

Figure 3.2 General view of State Dock.

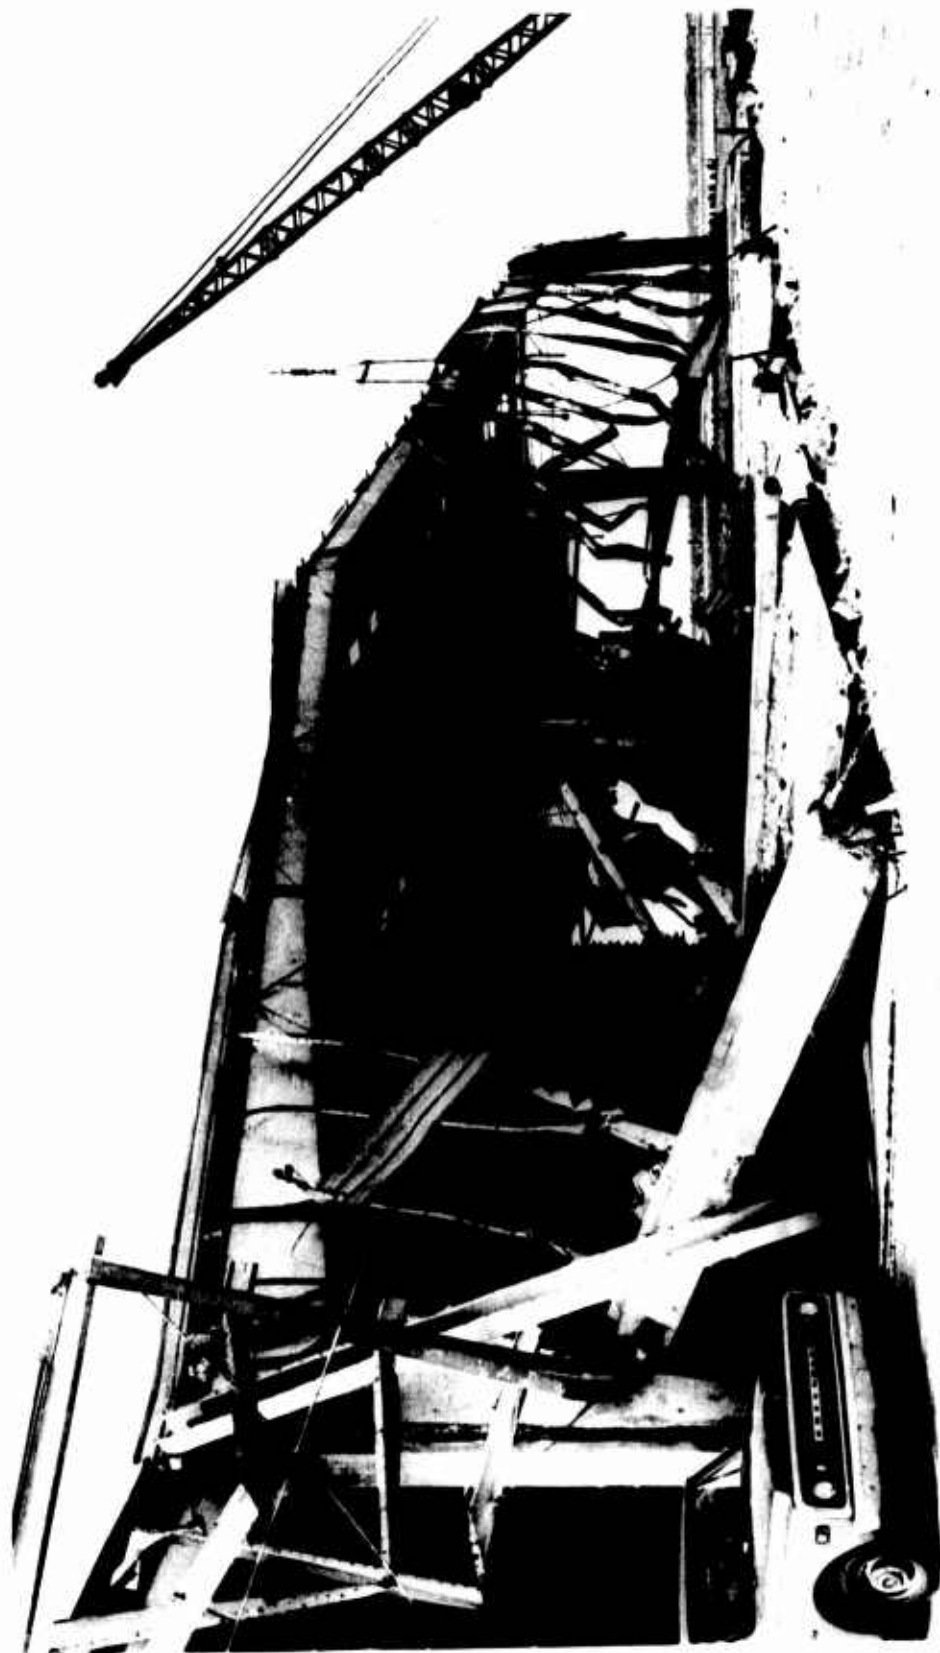
As shown in Figures 3.3 through 3.5, the end facing south-southeast and the first bent collapsed into the building with the tilt-up panels of this end wall falling with the columns. The tilt-up panels along the east side of the building were pushed into the structure, and those along the west side fell away from the structure. Like many other structures along the coast, this building was subjected to loadings far above those probably anticipated in their design.

Figure 3.4 Close-up view of collapsed end wall of State Dock.

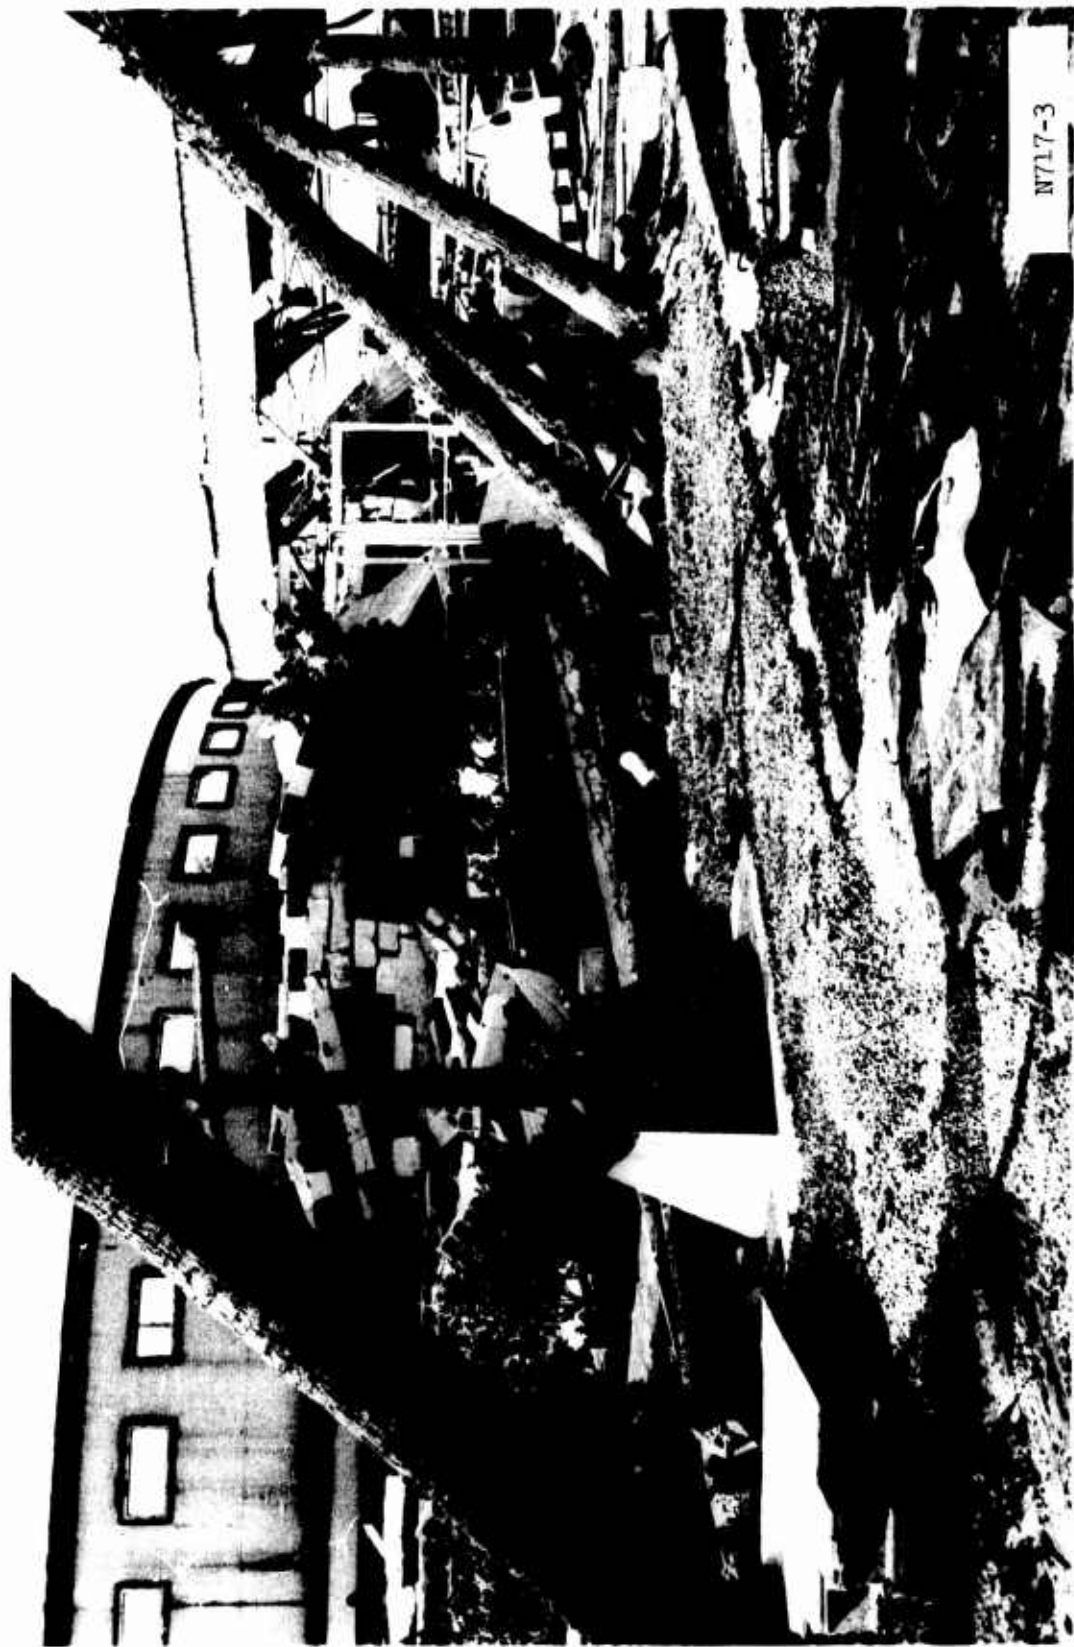
Marine Life consisted of a group of various structures (Figure 3.12). A large steel arch which this team was told was designed for 120-mph winds sheltered a display tank and a concrete seating area. A small (30 to 50 spaces) NFSS shelter was located under this seating area. A concrete floor and block wall structure surrounded the large display tank to the east of the arch.

Figure 3.12 Marine Life Aquarium.

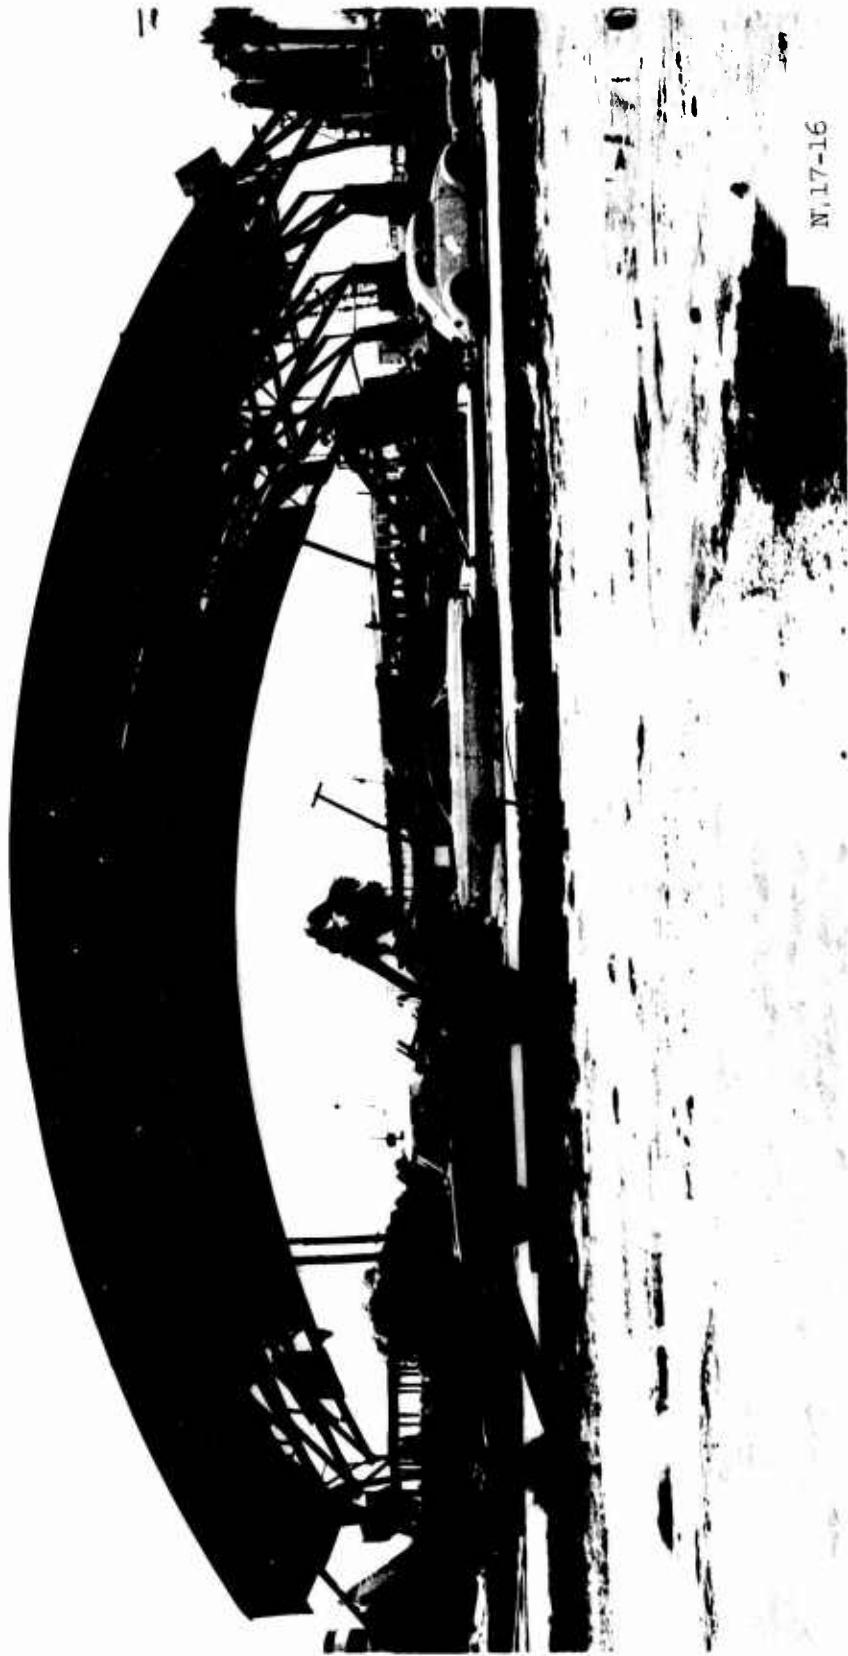
The steel arch remained standing despite the loss of two pipe column supports at the northeast corner (corner nearest the camera and to the left in Figure 3.13) and the dropping of the other three columns on the east side. Some roofing was torn off the west side of the arch (Figure 3.14). The middle pier supporting the west end of the arch was badly damaged

Figure 3.13 Marine Life steel arch.
