TECHNICAL REPORT N-70-10

**SURVEY OF GULF COAST
STRUCTURAL DAMAGE RESULTING FROM
HURRICANE CAMILLE, AUGUST 1969**

Final Report

By U. S. Army Engineer Waterways Experiment Station, Vicksburg, Mississippi

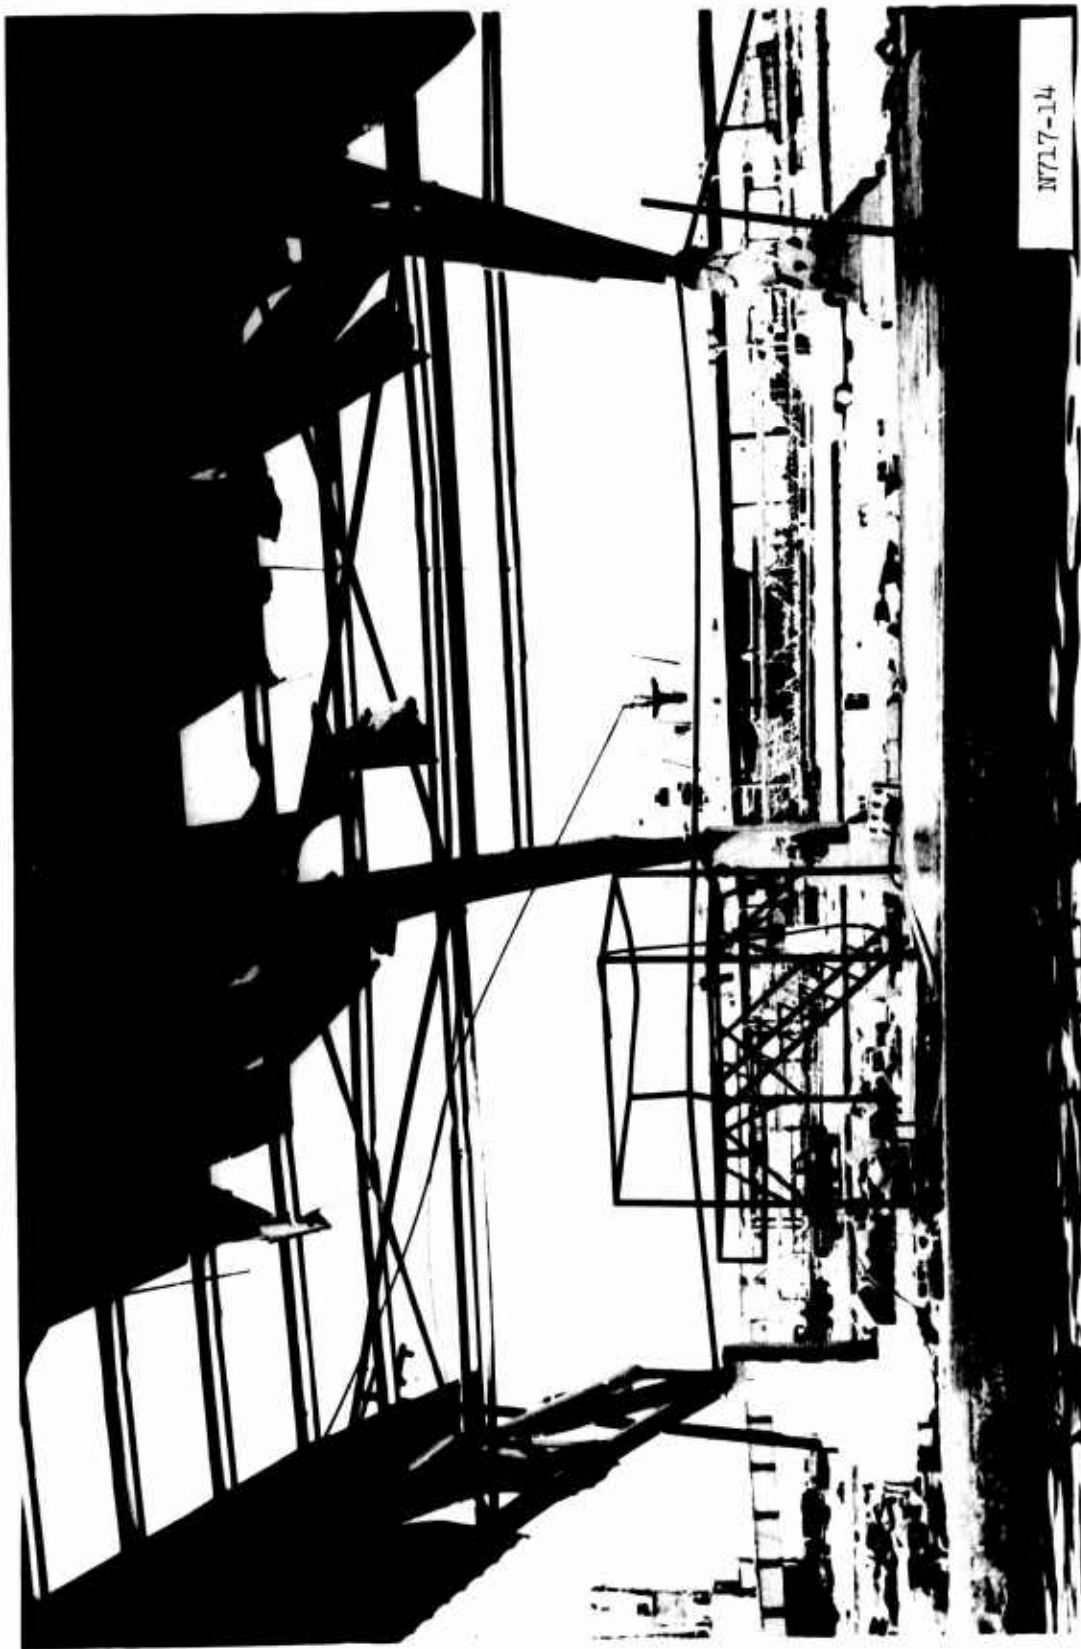
The block wall along the west side of the arch was almost completely destroyed (Figure 3.17).

Figure 3.17 West end of Marine Life arch.

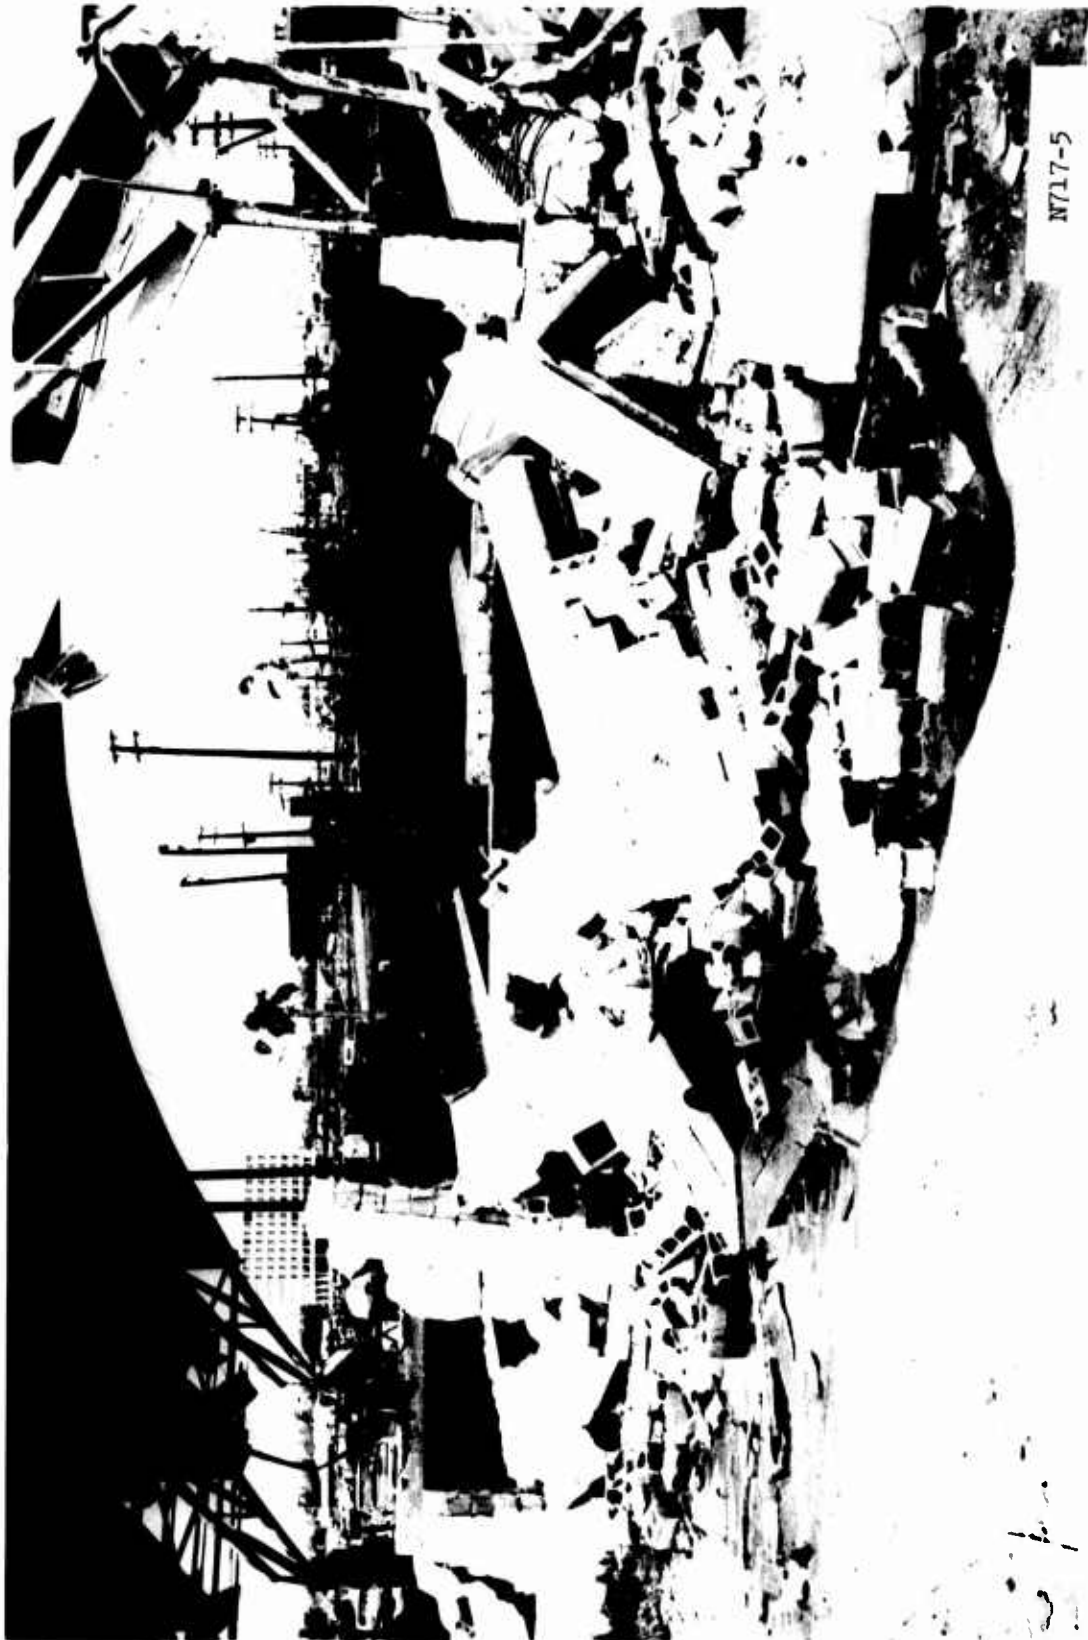
This seating area under the east side of the arch was completely collapsed (Figures 3.18 and 3.19). The seating area appeared to have failed when the water lifted the seating and dropped it onto the walls crushing some block and failing the beams of the seating portion at the supporting walls, thus transforming the beams into essentially simply supported spans which then fell (Figures 3.20 through 3.22). It was not clear whether these beams had been designed for continuity; the steel arrangement, but not the splice length, suggests that they were.

Figure 3.18 Seating area under Marine Life arch.

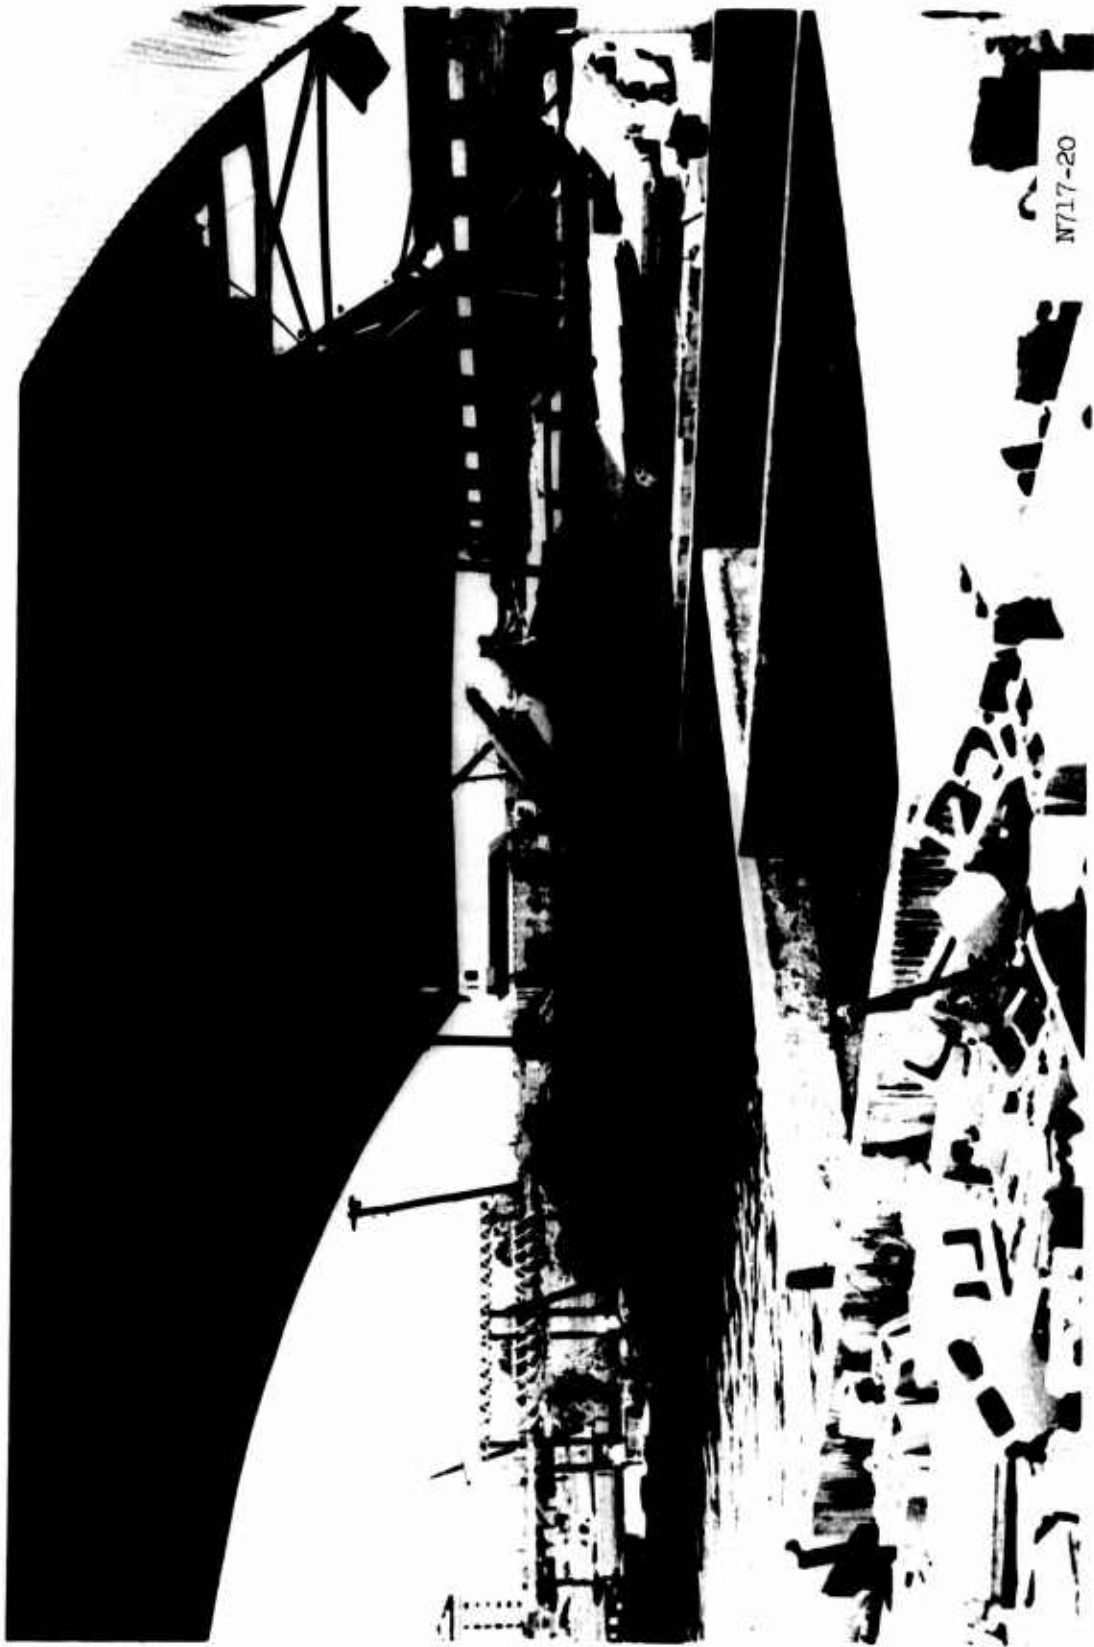
Figure 3.19 Seating area and arch at Marine Life.

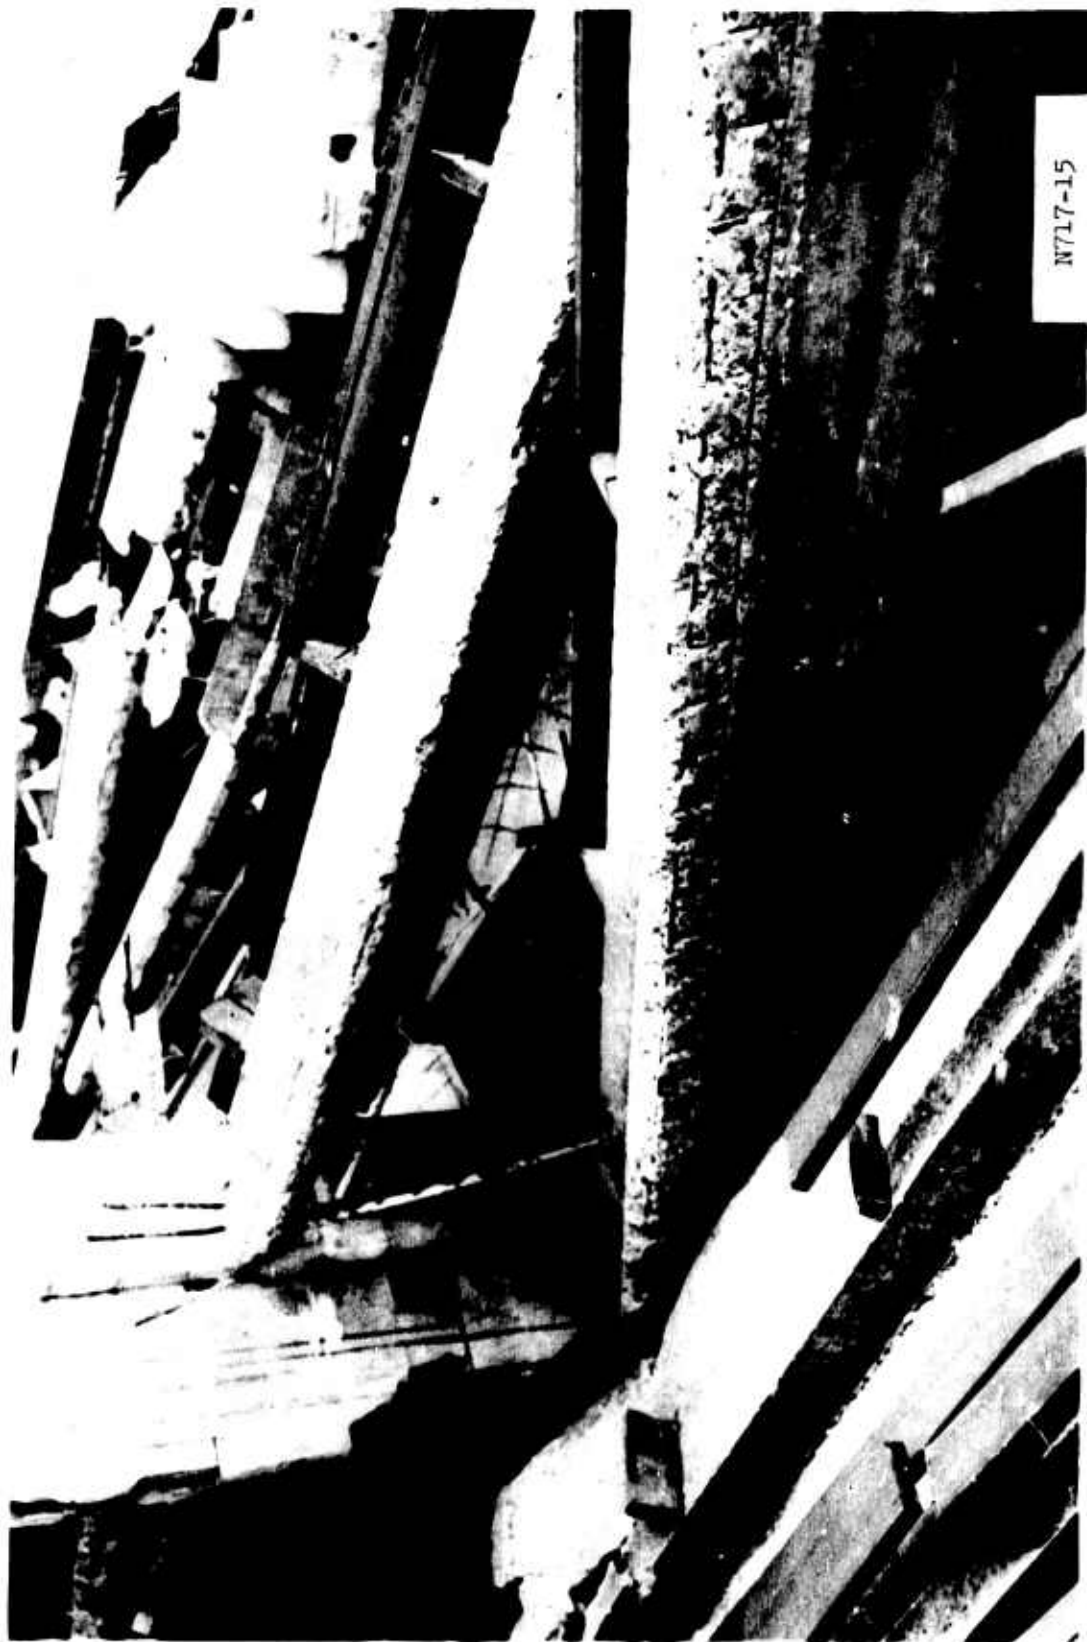
The welded-wire fabric of the seating slab tore out of the beams easily and had little or no cover, as can be seen in the beam shown in the foreground of Figure 3.20 and in Figure 3.25, which shows a beam that ultimately failed in torsion.

Figure 3.20 Close-up of seating area, Marine Life.

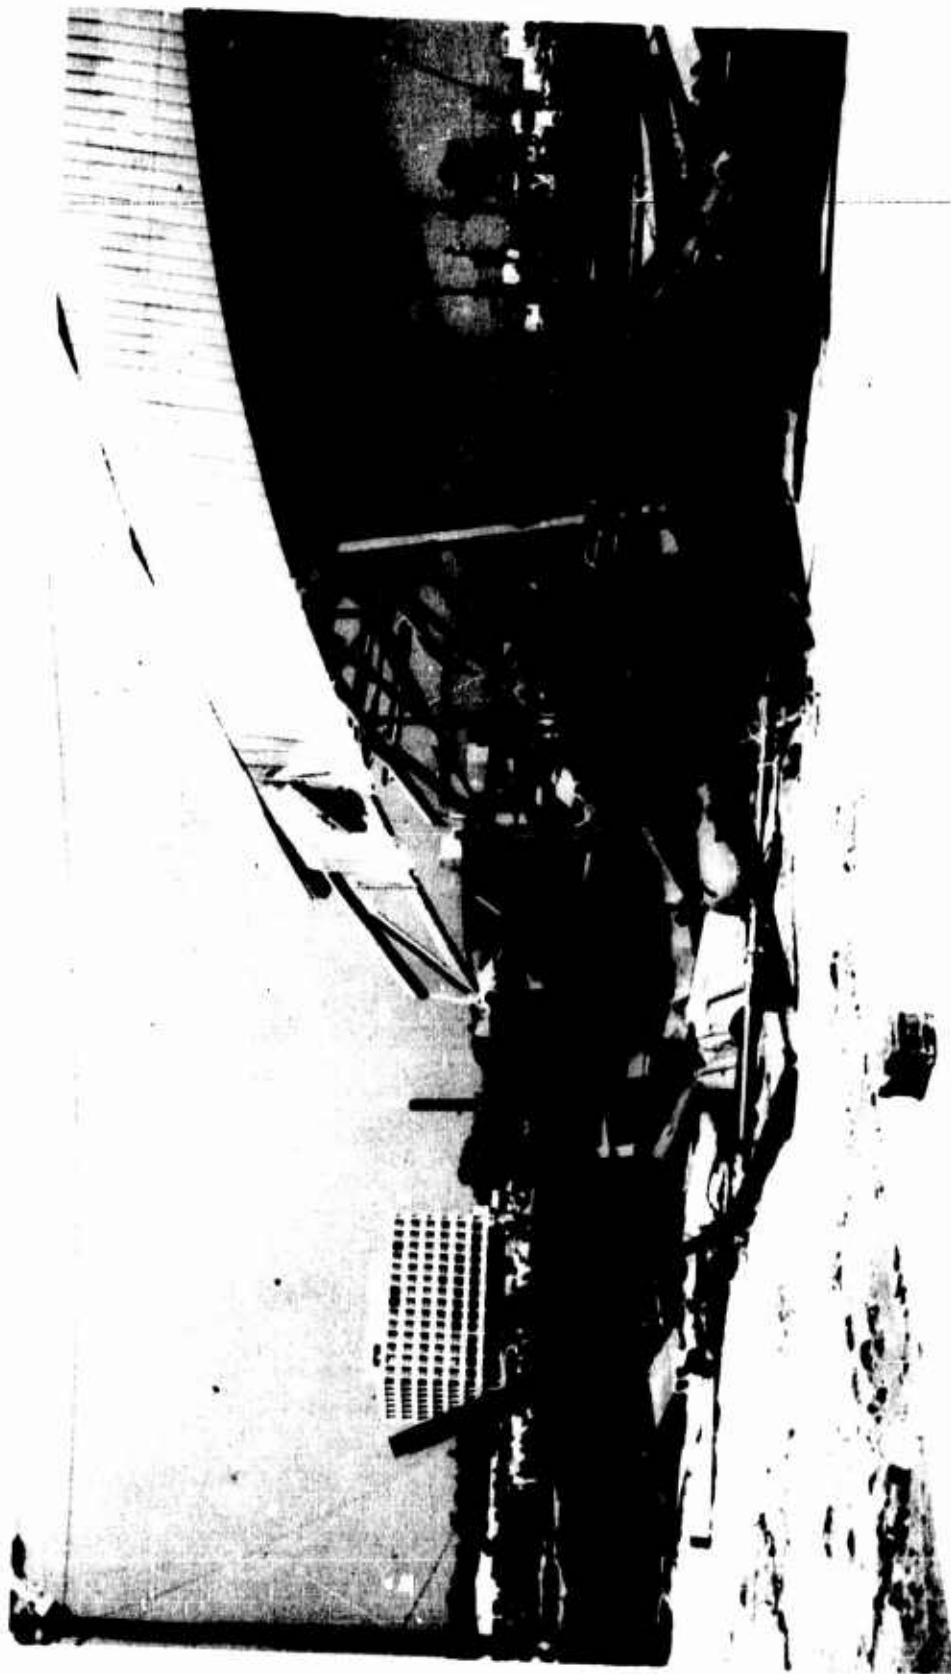
The steel frame ended up in a pile west-northwest of the building slab (Figure 3.28) with one column still tied to the slab (Figure 3.29). The welds at the base plate of another column failed (Figure 3.30).

Figure 3.28 Steel frame of Marine Shop south of Marine Life.

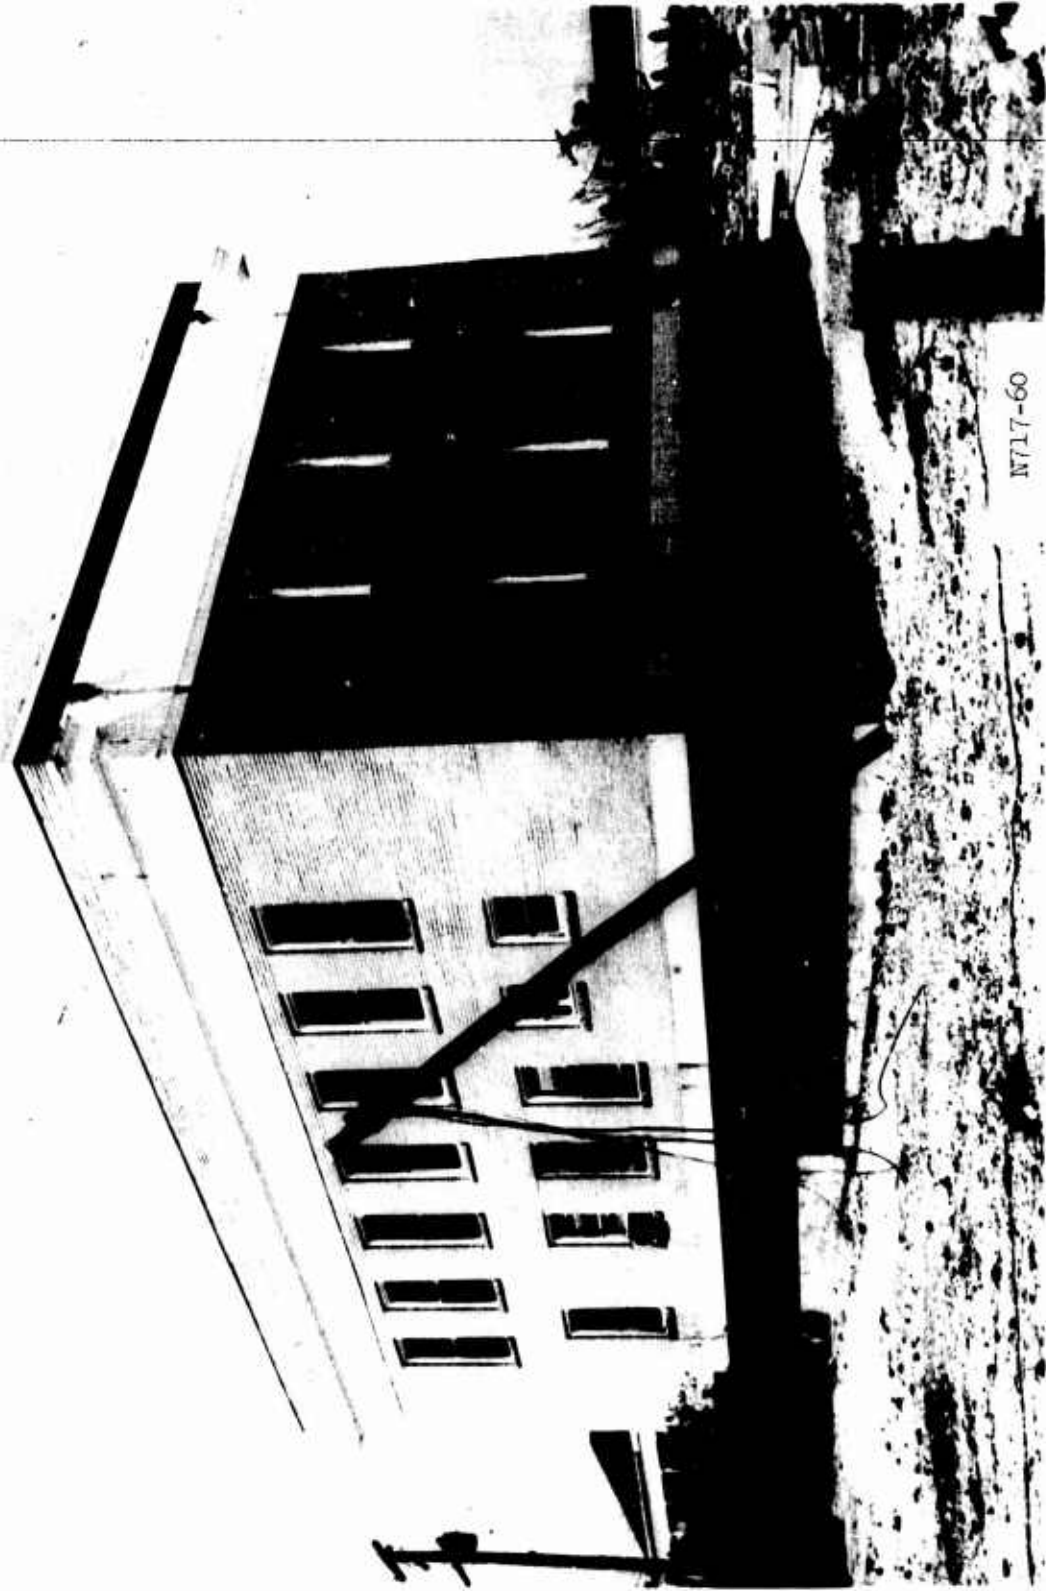
Figure 3.32 Pass Christian City Hall.

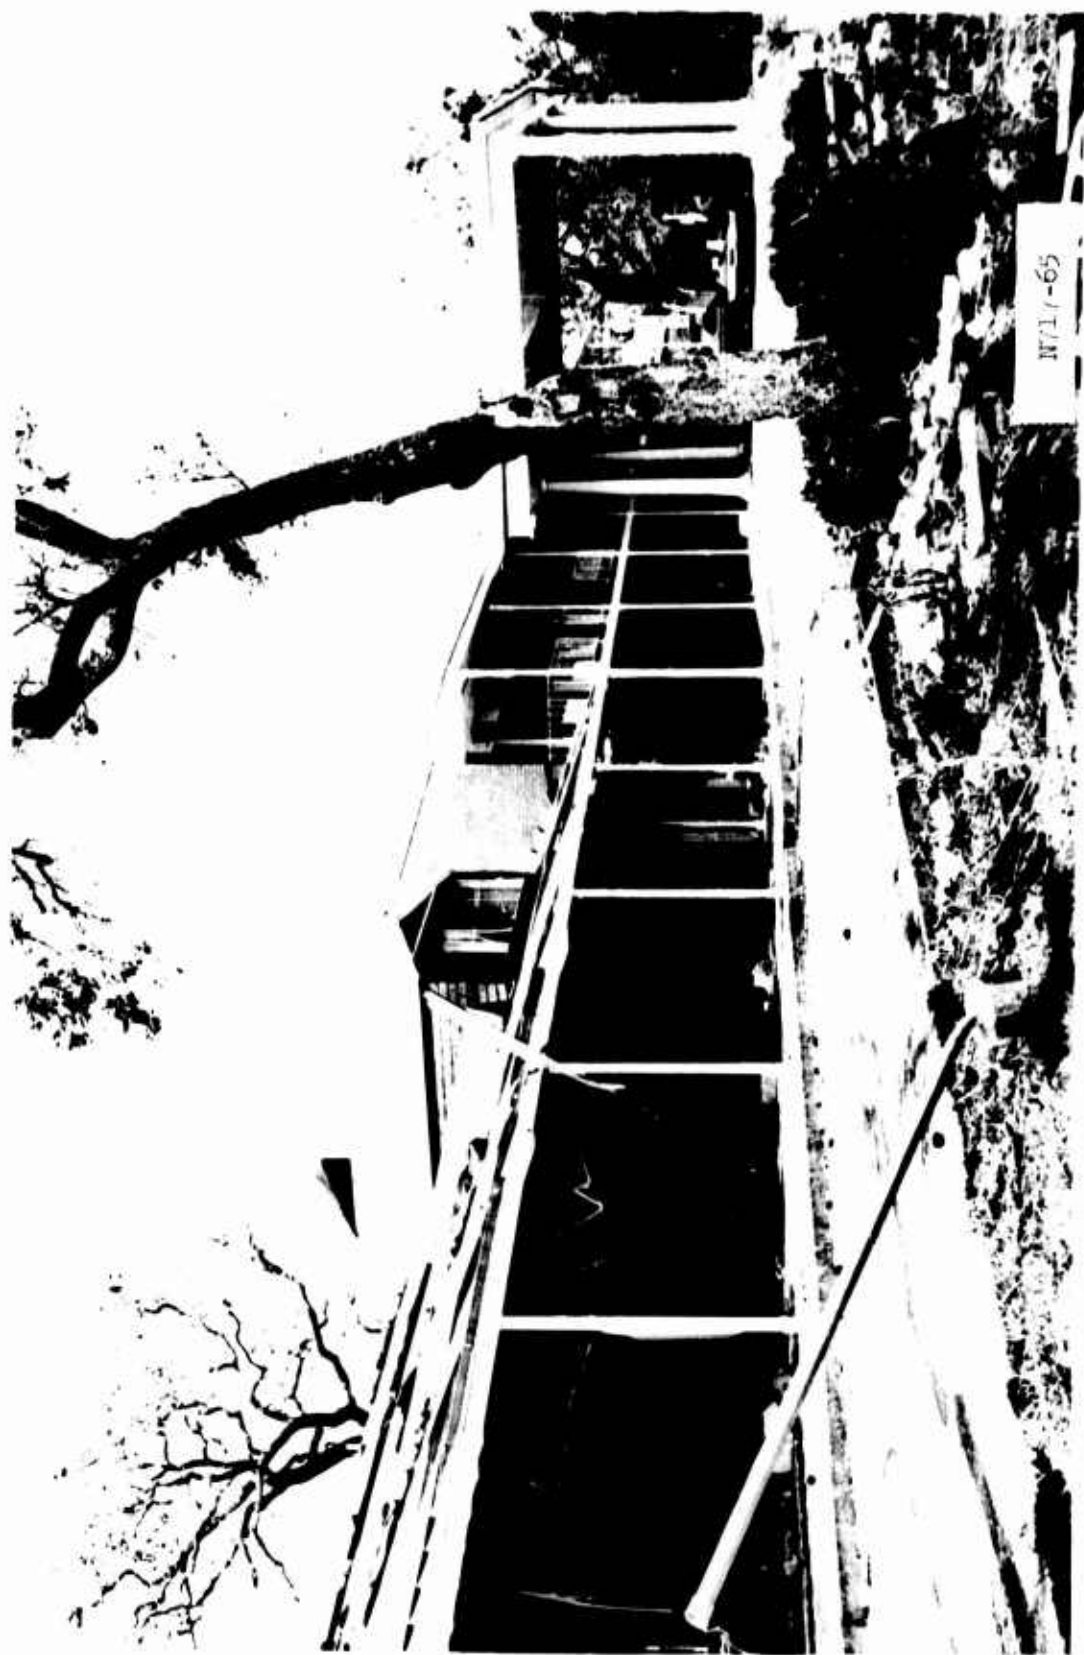
The main building (Figure 3.38) was parallel to the highway. There appeared to be two wings perpendicular to and behind the main building. The east wing was completely leveled and the west wing was relatively undamaged. The east wall of the main building was out (Figure 3.39), and the entire first floor suffered extensive water damage, especially in the dining area (Figure 3.40).

Figure 3.38 Ramada Inn, Long Beach.

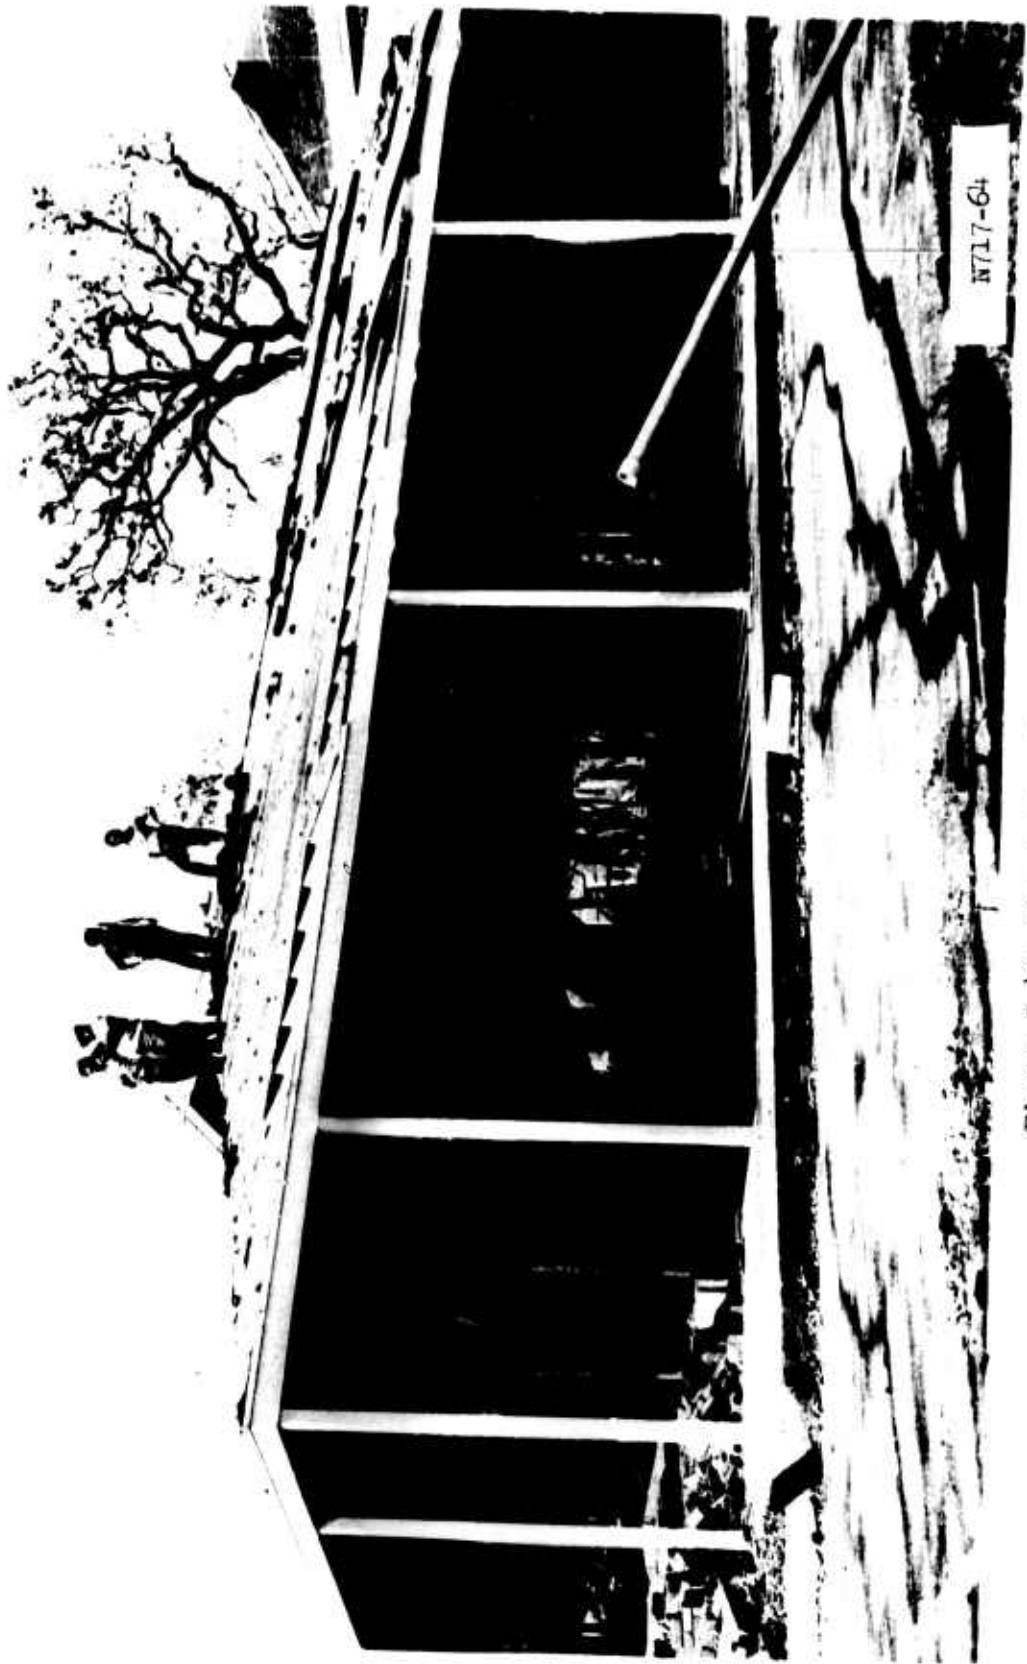
Figure 3.40 Ramada Inn dining area.

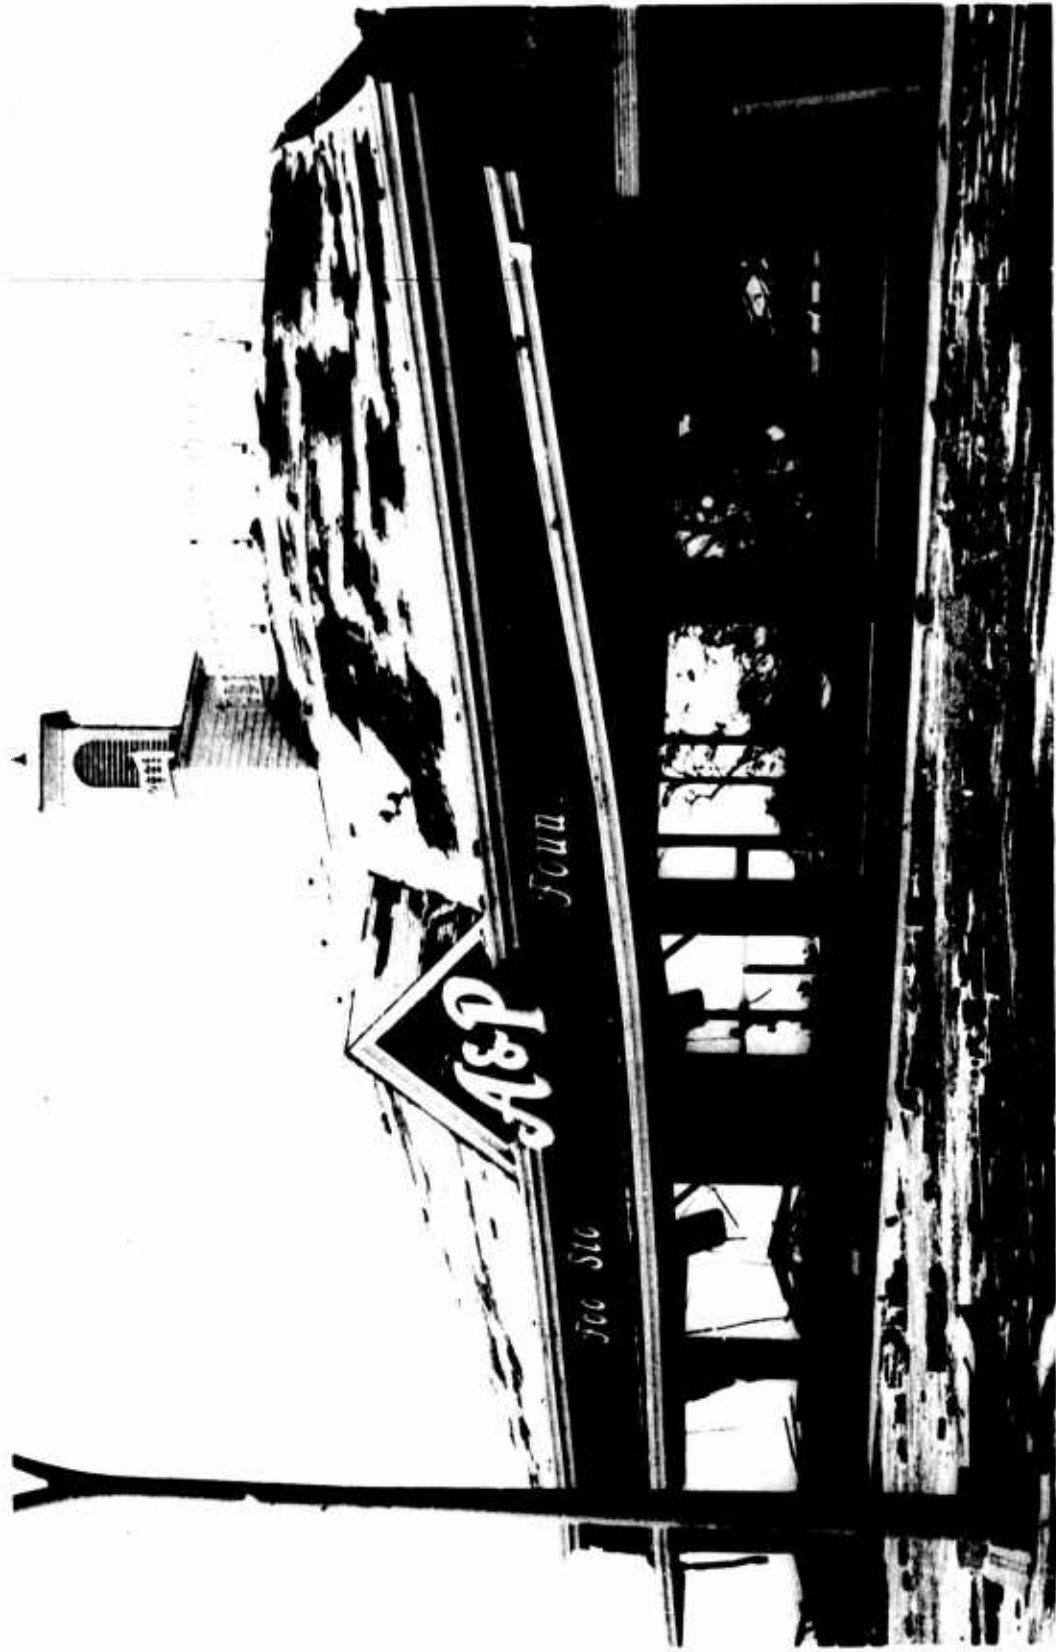
This complex, located several blocks east of the Ramada Inn in Long Beach, was constructed mainly of block walls, steel pipe columns and main beams, and with small angle trusses or bar joists supporting the roof. The front of the A&P store is shown in Figure 3.41.

Figure 3.41 Front of A&P store, Long Beach.

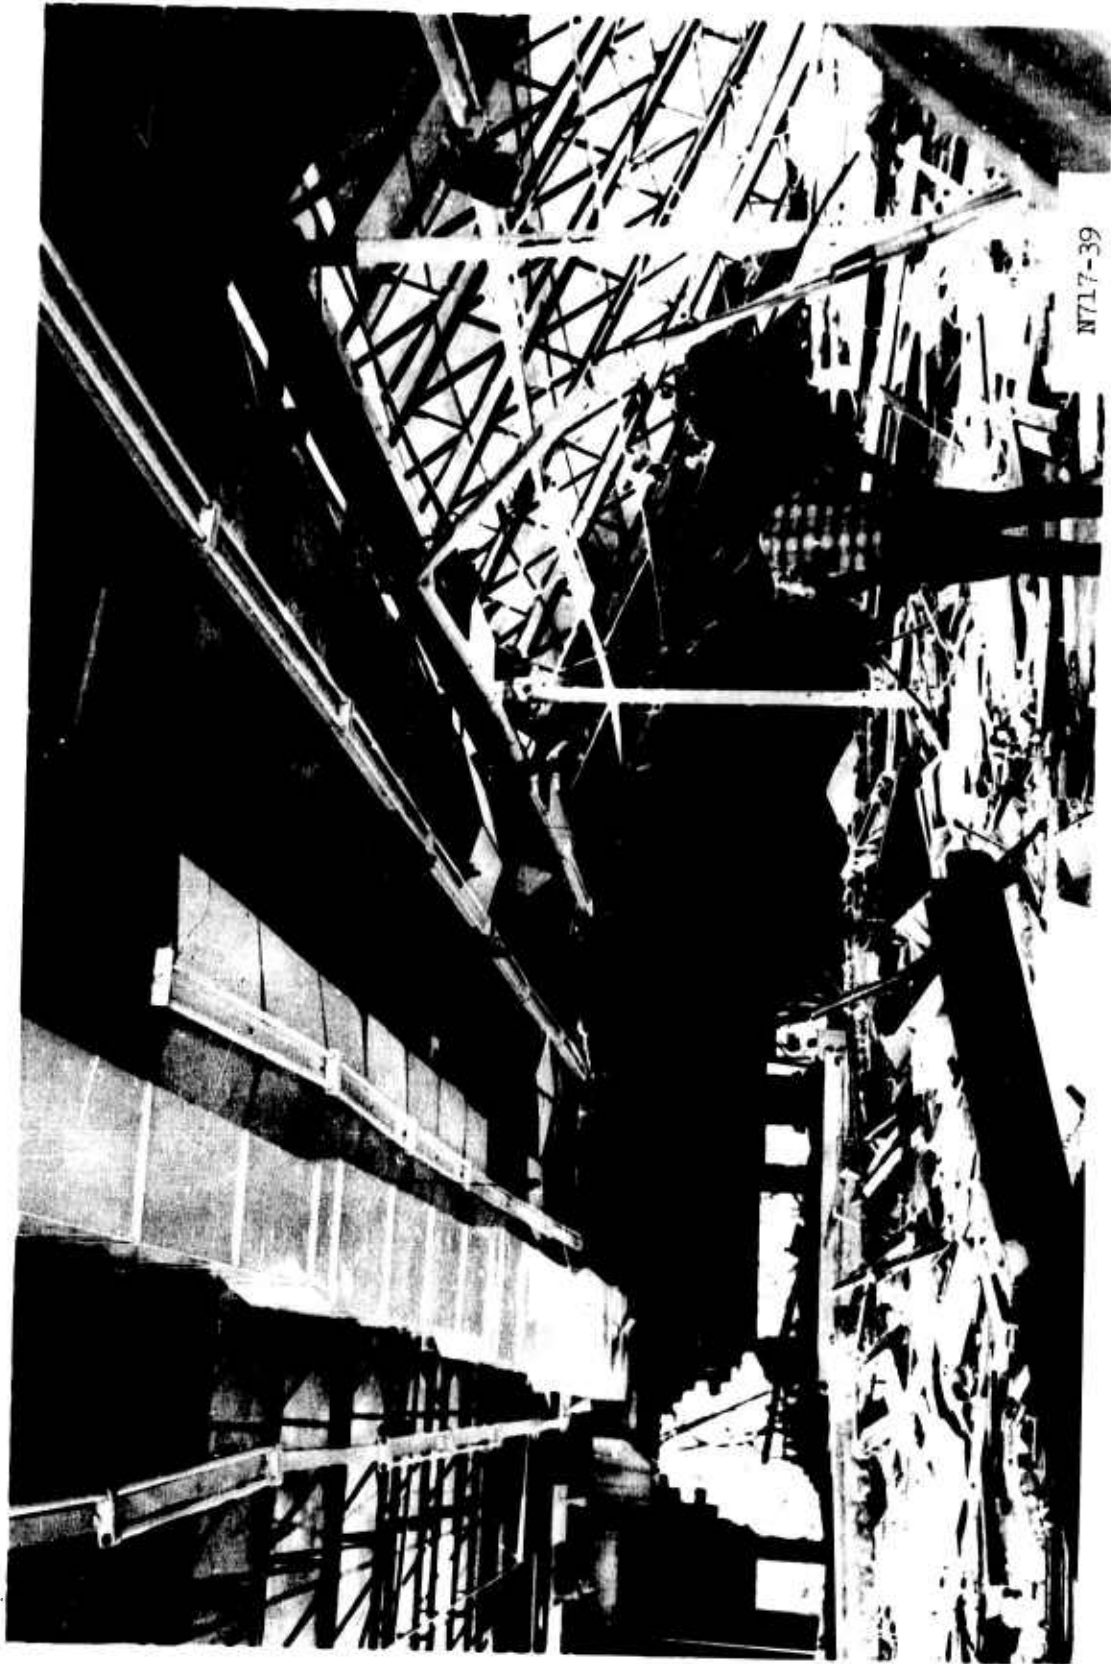
The two side bays of the A&P store collapsed, probably when the walls between this building and the adjoining stores were destroyed. One corner of the wooden truss hip roof at the front of the A&P was left cantilevered over the debris (Figure 3.43). The center bay, supported on steel beams at both ends, did not suffer extensive structural damage (Figure 3.44). The presence of lamps in the fixtures shows that the water did not reach the ceiling level.

Figure 3.44 Central bay of A&P, Long Beach.

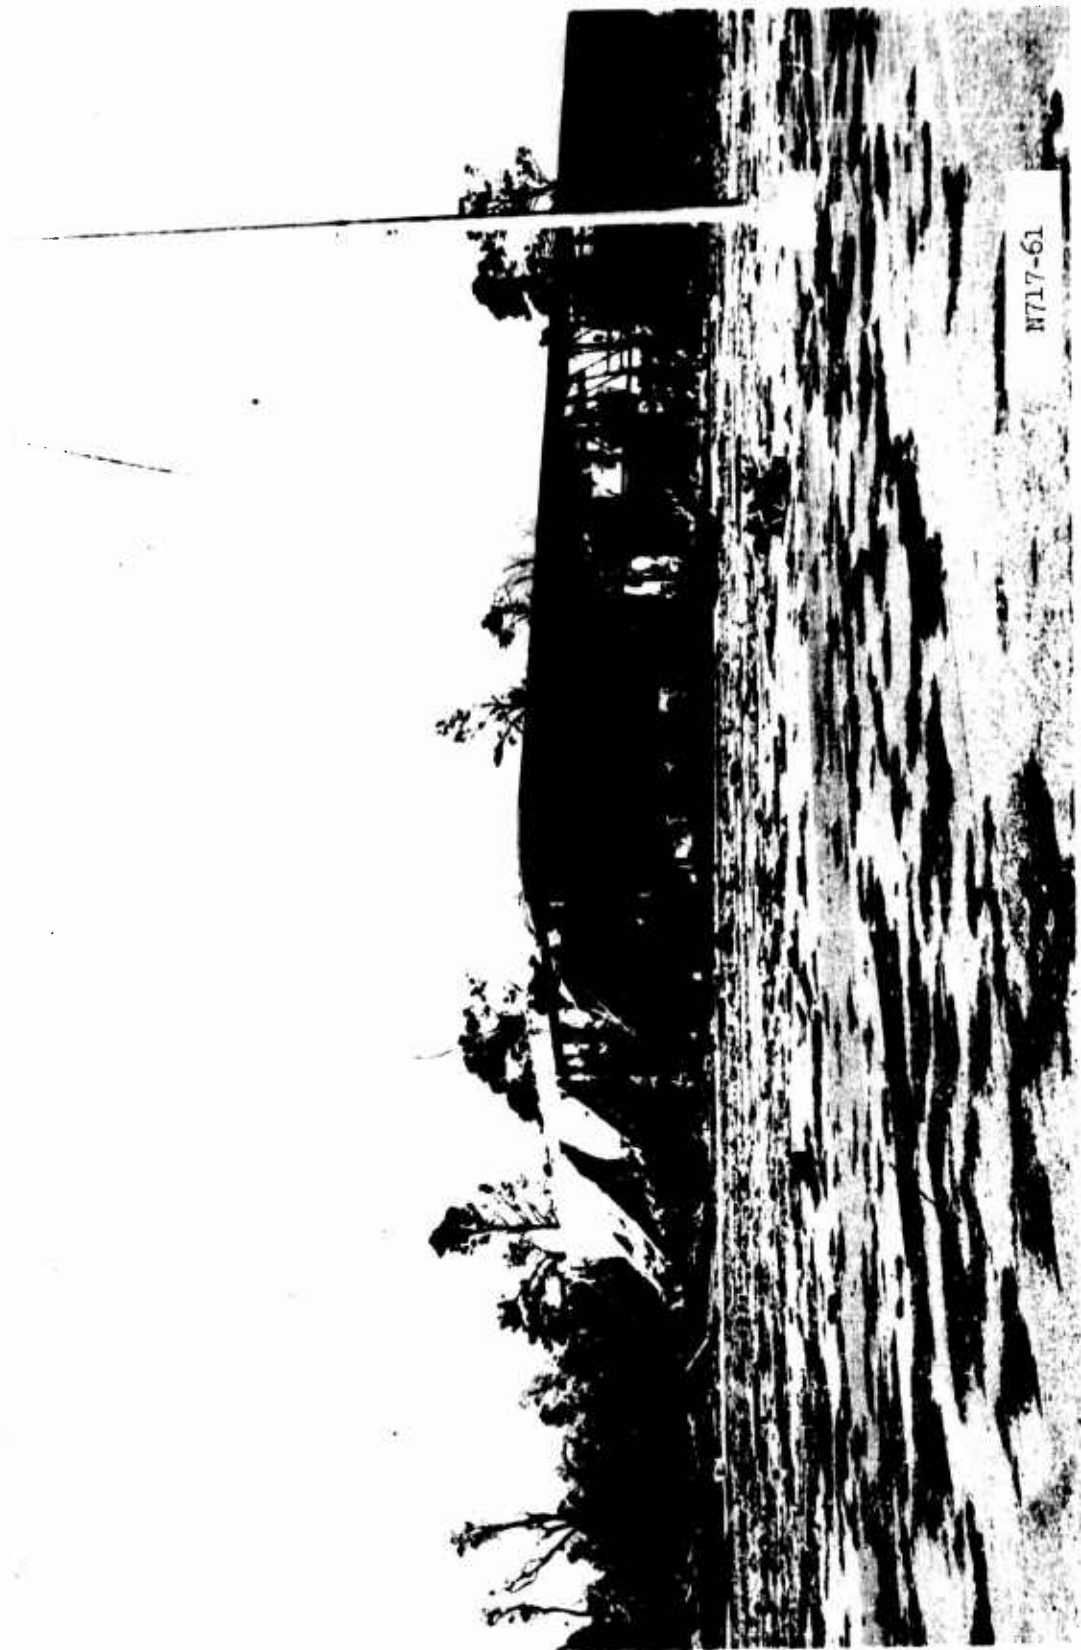
Several stores, including a large discount-type store, were located in Gulf Plaza near the Long Beach-Pass Christian boundary and contained in a large pipe column, beam, and bar joist structure with glass and block walls. As can be seen in Figures 3.46 and 3.47, the exterior walls and store contents were completely washed away, leaving only portions of the building frame. It appeared that only a minimum amount of welding had been used to attach the bar joists to the supporting beams.

Figure 3.46 Gulf Plaza shopping center.

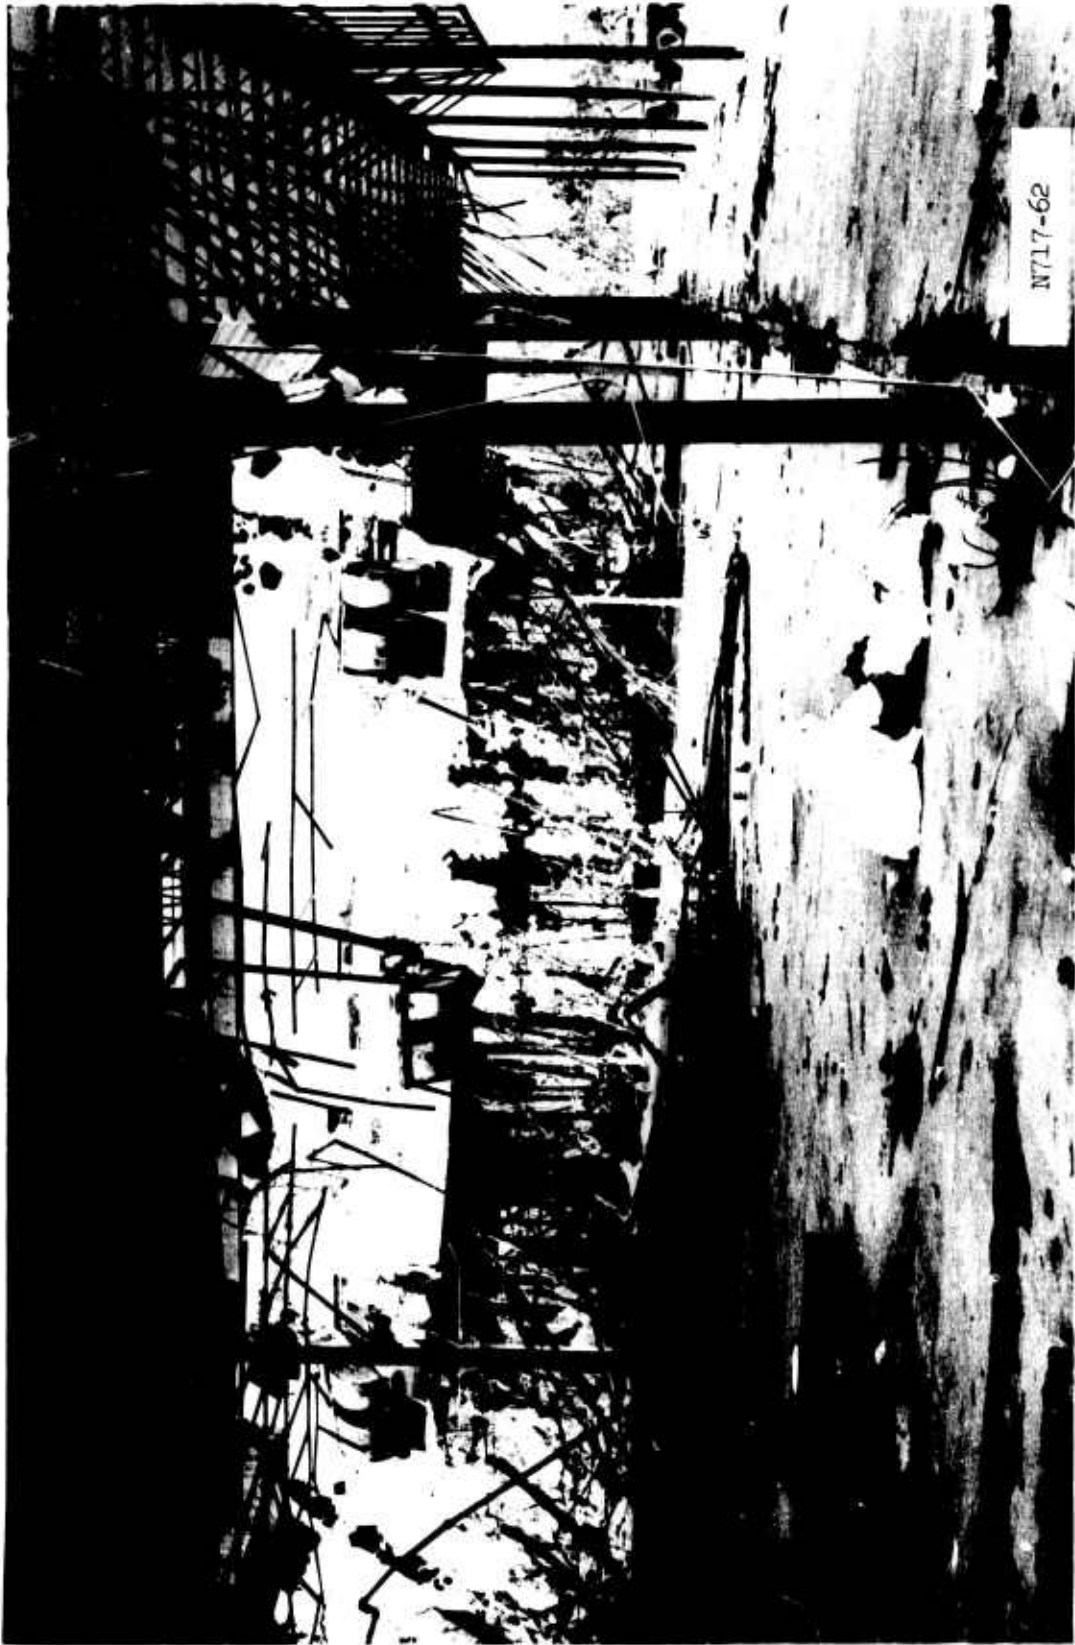
Figure 3.47 Interior of Gulf Plaza shopping center.
