FINAL REPORT  
ON  
SCANNING ELECTRON MICROSCOPY STUDY OF  
6309 SIZE BEARINGS

JANUARY 31, 1971

U.S. Navy Contract: N00014-70-C-0229

SKF Report: AL71C002

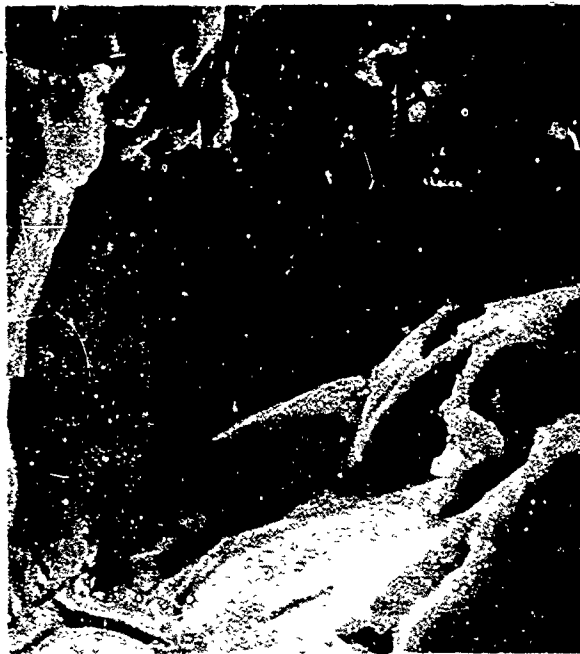
3000X

C. Higher magnification of B.
