THICKNESS REQUIREMENTS FOR SOILS BENEATH  
LANDING MATS; BARE BASE SUPPORT

MISCELLANEOUS PAPER S-71-3

Project 3782-64

Conducted by U. S. Army Engineer Waterways Experiment Station, Vicksburg, Mississippi

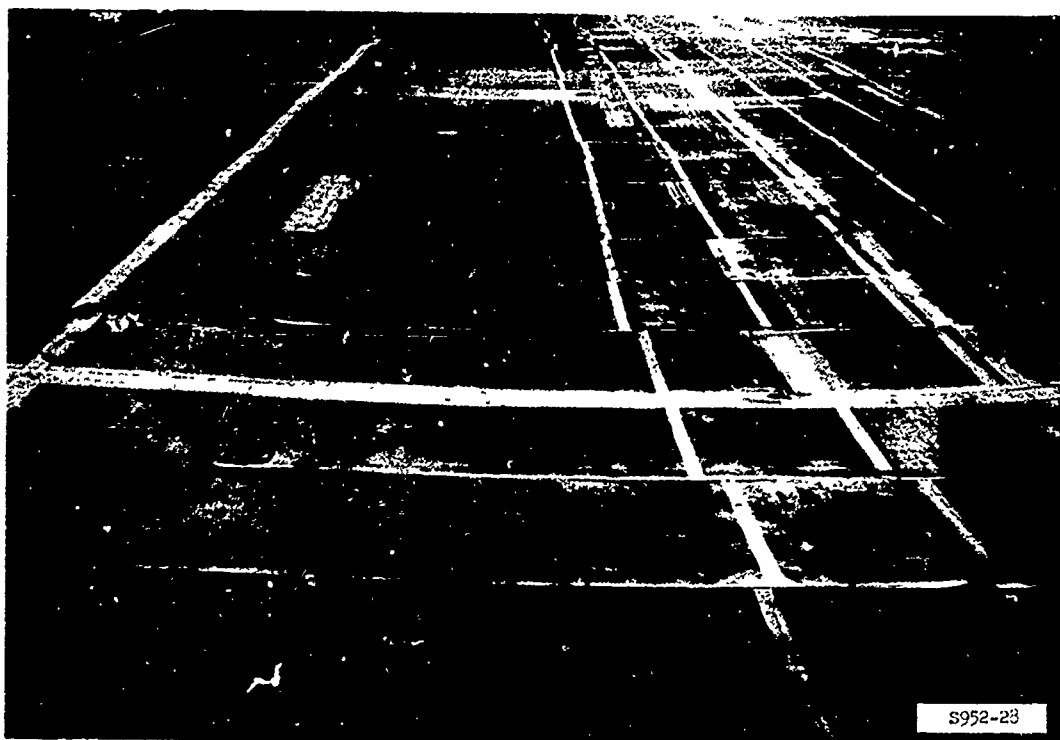
Photograph A67. Test section III, lane 2, item 2,  
after failure at 72 coverages
