OBSERVATIONS
ALONG THE PIPELINE HAUL ROAD
BETWEEN
LIVENGOOD AND THE YUKON RIVER

R. Berg and N. Smith

October 1976

CORPS OF ENGINEERS, U.S. ARMY
COLD REGIONS RESEARCH AND ENGINEERING LABORATORY
HANOVER, NEW HAMPSHIRE

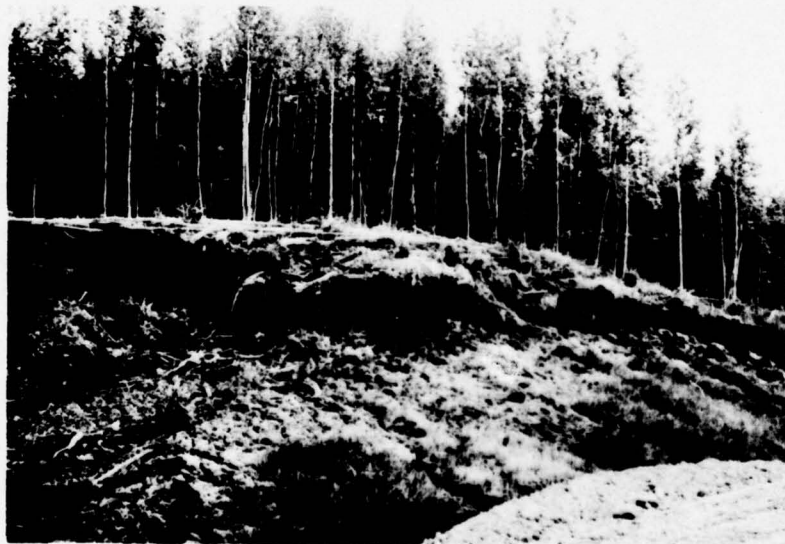
11. Thawing near top of slope; start of grasses,
Mile 4.5 Rt, 11 August 1970.

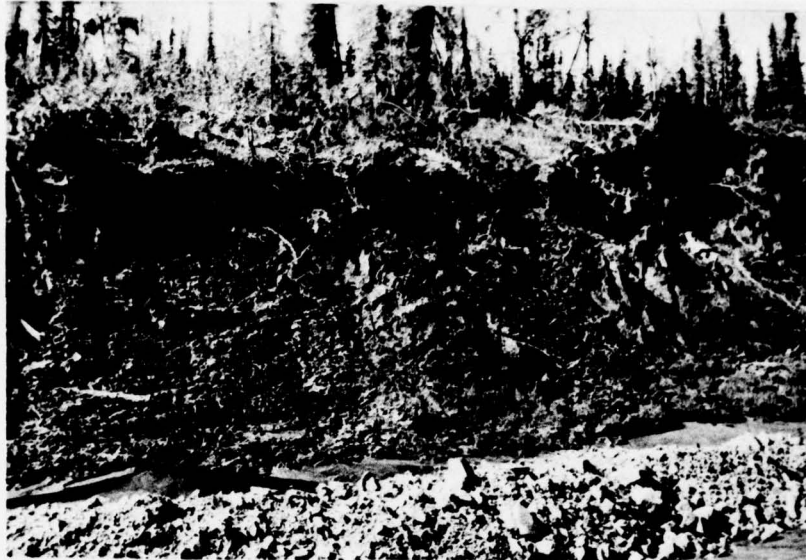
36. Mud flow on thawing backslope, Mile 19.6 Lf,
11 August 1970.

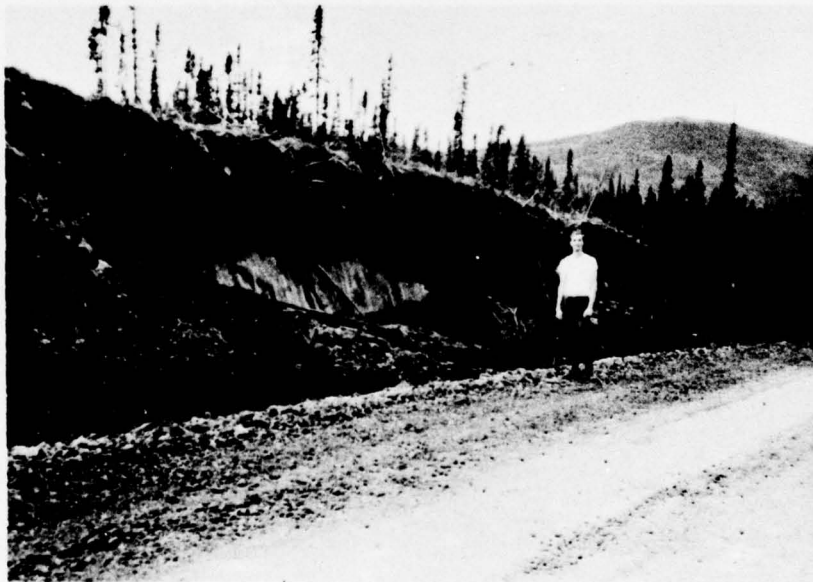
69. Massive ice still visible, Mile 22.9 Lf, 26 June 1970.

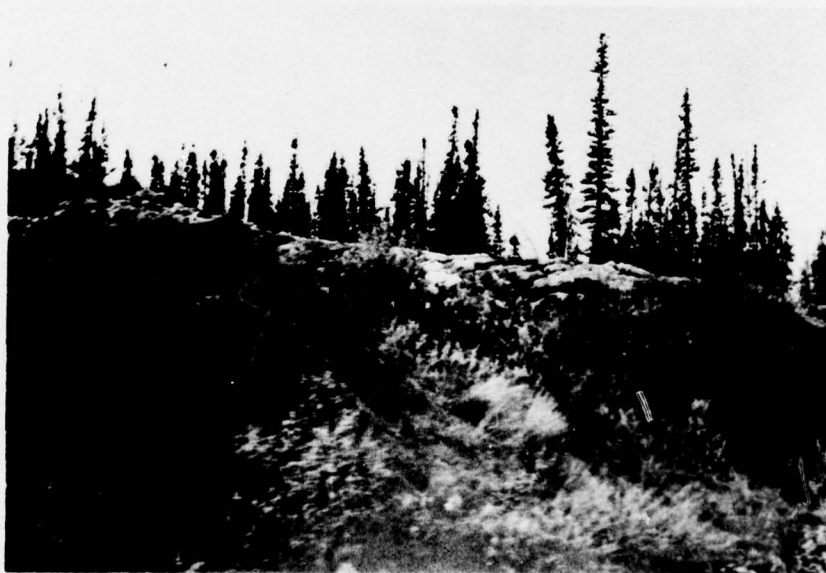
89. Grasses and small trees on backslope, Mile 23.2 Lf, 14 September 1975.

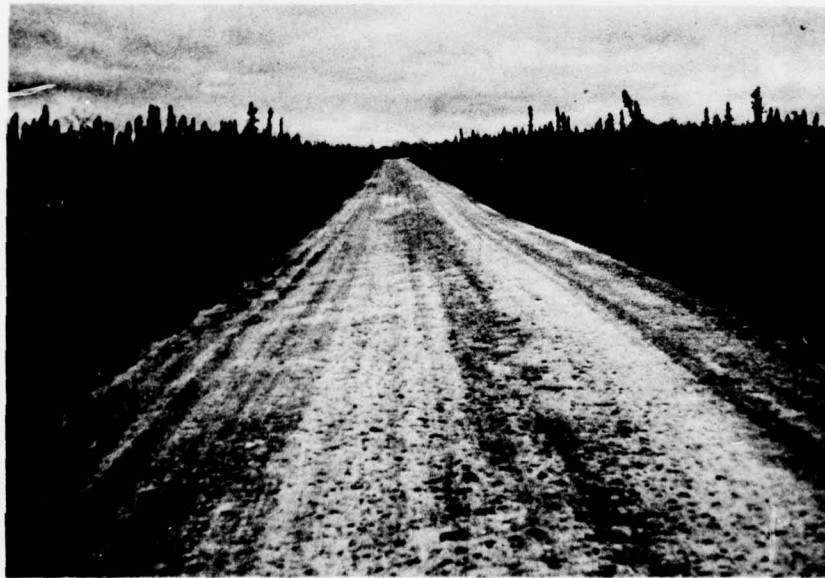
109. Centerline looking north, Mile 16.3, 30 May 1975.
