MISCELLANEOUS PAPER GL-79-4

## EVALUATION OF THE EFFECTIVENESS OF MEMBRANES FOR PREVENTION OF CRACK REFLECTION IN THIN OVERLAYS

March 1979

Interim Report

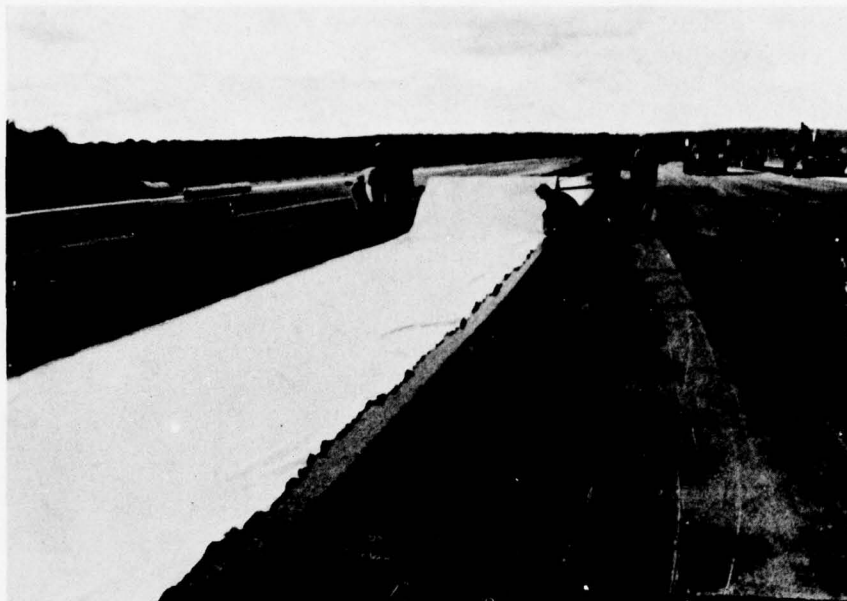
990 ft long, and weighed 535 lb. This size roll was too large and heavy to be handled by hand, so the roll was sawed in half with a chain saw (Photo 3). The fabric was very difficult to place wrinkle free, and the frayed edge caused by the sawing gave the fabric a very ragged appearance when placed (Photos 4 and 5). The AC-10 tack coat was sprayed at a rate of 0.22-0.25 gal/sq yd in a 10-ft width. All joints and overlaps on both fabric sections were sealed with joint seal material to glue the edges. After both fabric sections were placed, the area was rolled with a light pneumatic-tired roller (Photo 6).

Photo 5. Fort Devens--sawed edge of Bidim C-22 gave a ragged appearance; material smoothed out under roller

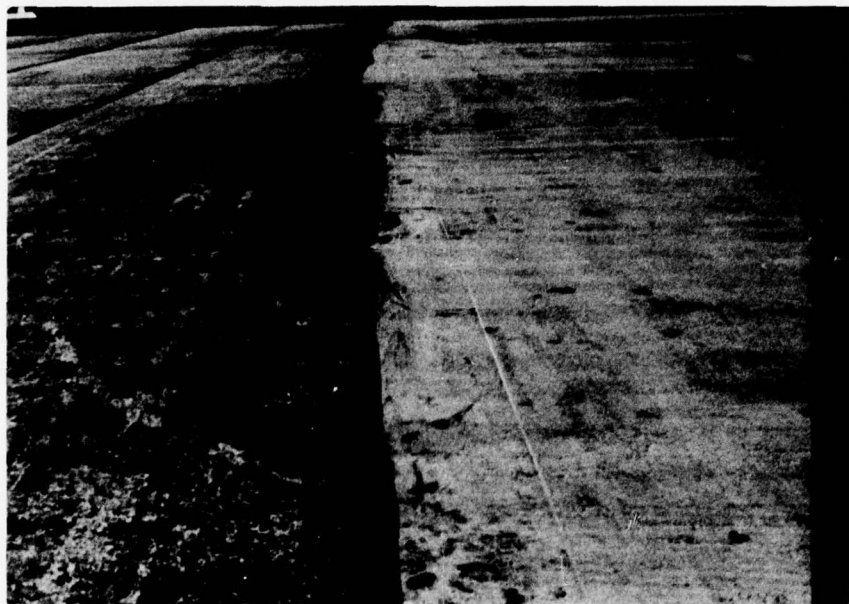
Photo 11. Fort Devens--joints and splices in fabric sections sealed with joint seal material to glue edges to pavement

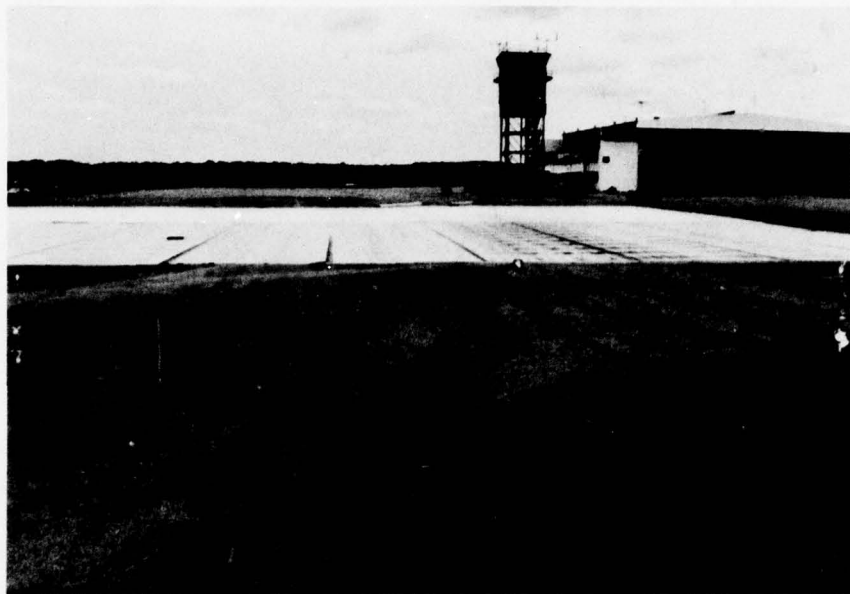
15. On the morning of 8 October 1977, the fabric test sections located on the apron area were placed. The air temperature at the time of placement was 41°F. The AC-10 tack coat was sprayed at temperatures of about 365°F. The cracks in the northern half of the test sections on the apron area were sealed prior to being overlaid and those in the southern half were left unsealed. All cracks were blown free of grass and debris prior to sealing with joint seal material (Photo 7). The Mirafi 140 fabric was placed in the direction of the 200-ft length of the test section in the same manner as had been placed on the NW-SE runway. Due to the cool weather, the light pneumatic-tired roller was placed on the fabric immediately after the 200-ft length was placed (Photos 8 and 9). A different procedure from that used on the runway was tried for placement of the Bidim C-22 fabric. The material was left in a roll 17 ft 5 in. wide and unrolled in an area adjacent to the area that had received the tack coat. The material was laid in the short direction of the test area (84 ft), which was transverse to the Mirafi 140 fabric. Six or eight men would pick the fabric up and place it on the tack coat (Photo 10). This worked reasonably well as there was no wind blowing. The fabric edges were sealed with joint seal material (Photo 11). The unsealed cracks were very evident under the fabric (Photo 12). The completed fabric areas were well bonded to the pavement surface and looked to be in a fairly wrinkle-free condition (Photo 13).

Photo 13. Fort Devens--fabric test sections on apron;  
 Bidim C-22 placed in direction of paving;  
 Mirafi 140 transverse to paving

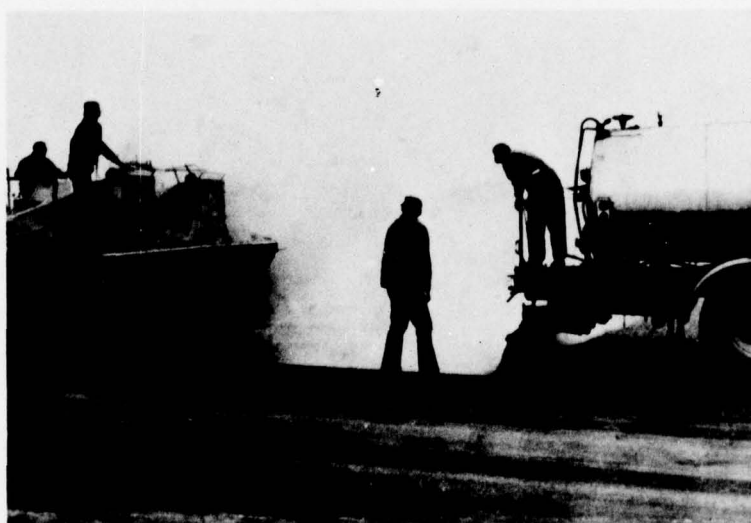
18. Bids were received for the work at Moore AAF to place asphalt rubber not only on the test areas as indicated in Figure 2 but on the entire length of the NW-SE runway and the N-S runway. Arizona Refining Company was the successful bidder, and the U. S. Rubber asphalt-rubber mixture was placed on the runways and on the test sections. The Sahuaro asphalt-rubber mixture was only placed on the test sections. Arizona Refining started loading the blended rubber, which was stacked in 50-lb bags alongside the runway, into distributor trucks on the morning of 12 October 1978. The AC-10 asphalt was shipped from Exxon in Everett, Massachusetts, and transferred to the distributor trucks. Two percent extender oil, Califlux GP, was added to the asphalt in the distributor. The rubber was hand loaded on a screw conveyor that dumped it into the top of the truck (Photo 14). An air hose from a small air compressor, which was parked alongside the truck, was used to inject air into the mixture while the rubber was added. This was to aid in coating the rubber with asphalt. After mixing the rubber and asphalt, the temperature in the truck was raised to 400-425°F prior to spraying. Technical specifications used for placement of the asphalt-rubber mixtures are given in Appendix B. Prior to application of the asphalt rubber, the aggregate spreader, trucks, and rollers were lined up behind the distributor truck, to avoid a delay in placement of cover aggregate or rolling after placement of asphalt rubber (Photo 15). The asphalt-rubber mixture was applied at the rate of 0.7 gal/sq yd, and considerable smoke was evident when spraying the hot mixture (Photo 16). The hot, crushed aggregate was

Photo 16. Fort Devens--considerable smoke from hot asphalt rubber

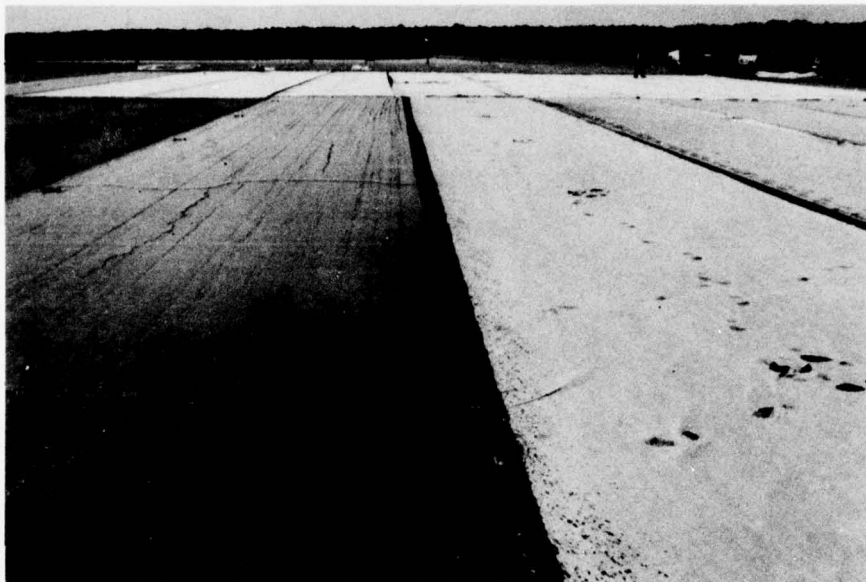
Photo 21. Fort Stewart--overlap of about 9 in. at joint;  
note no wrinkling of Bidim C-22 fabric

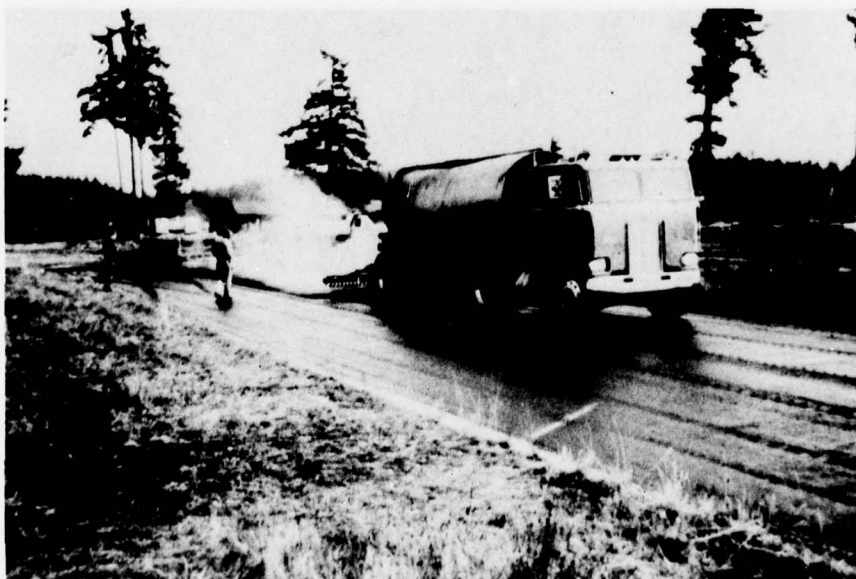
Photo 34. Fort Lewis--application of Sahuaro asphalt-rubber mixture on Faith Avenue

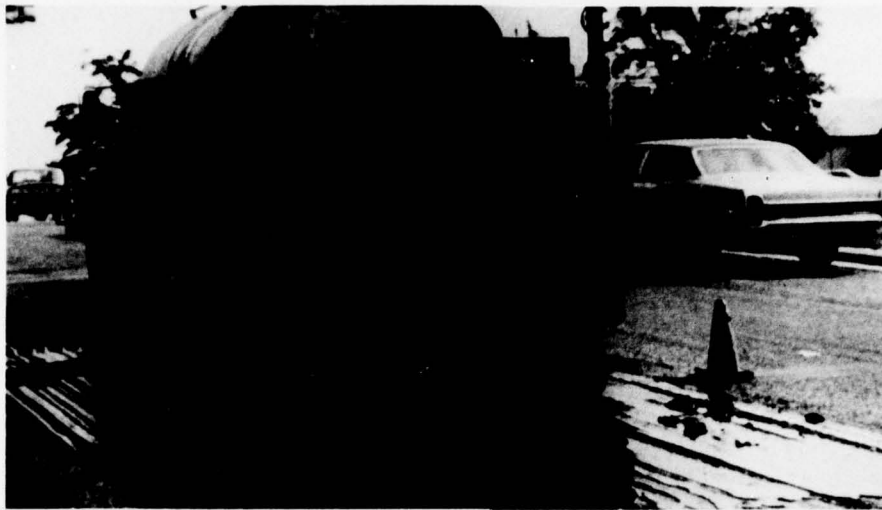
36. The weather was quite cool and wet during the period of work on Louisiana Avenue. The asphalt tack material used for placement of the Petromat fabric was AC-20 paving grade asphalt. Approximately 0.25-gal/sq-yd tack was to be placed prior to placement of fabric, but as shown in Photo 41, the asphalt distributor did not spray a uniform tack coat as specified. The fabric was placed with a small tractor, equipped with special attachments to lay fabric (Photo 42). The tractor operator was inexperienced in this work and did not lay a wrinkle-free

Photo 41. Fort Polk--spraying of tack for fabric  
very poor; nonuniform spray application

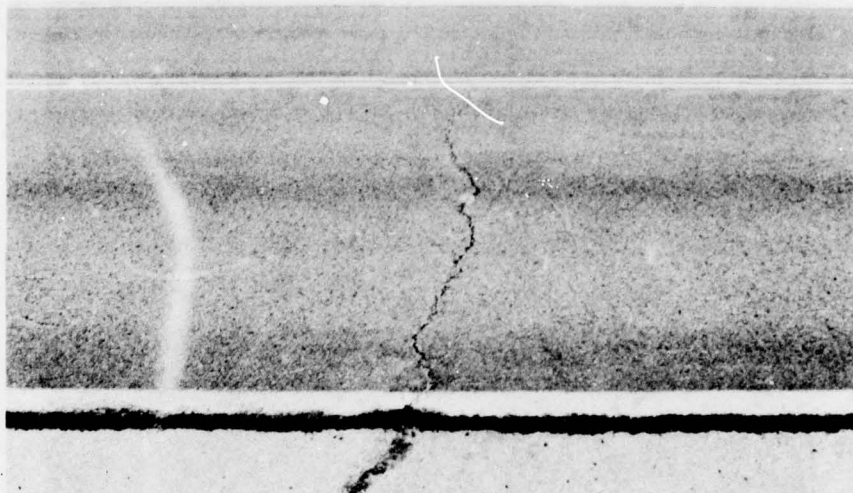
49. The survey to monitor the performance of the various test sections at Fort Devens was made on 7 June 1978. It was reported that the 1977-78 winter was one of the coldest this area has experienced in the past 50 years. Photos 91-107 indicate the crack pattern that existed in the selected photographic areas on the airfield prior to placement of overlay and 6 months after the placement of the overlay. No cracking was noted in the selected areas for the 6-month survey. A total of five transverse cracks in the entire length of the NW-SE runway were observed to have reflected for the area treated with the U. S. Rubber asphalt-rubber membrane (Photo 108). On the NW-SE runway (Photo 109), five transverse cracks were observed in the two 200-ft-long control sections. The small gouged area on the N-S runway (Photo 110), in the Mirafi 140 test area, apparently was caused by a locked wheel turn of an aircraft. The overlay slipped on the fabric and formed the resulting depression. Photos 111-115 indicate the cracking pattern for Barnum Road; and as noted, no cracks have reflected in the selected areas. Some cracking was found in the overlay surface of Barnum Road outside of the test areas (Photo 116).

Photo 116. Fort Devens--reflected crack  
in Barnum Road outside of test areas
