NEW YORK STATE DEPT OF ENVIRONMENTAL CONSERVATION ALBANY F/G 13/2  
NATIONAL DAM SAFETY PROGRAM. LOCK 3 DAM AT MECHANICVILLE (INVEN--ETC(U)  
JUN 79 G KOCH DACW51-79-C-0001

REPORT DOCUMENTATION PAGE		READ INSTRUCTIONS BEFORE COMPLETING FORM
1. REPORT NUMBER	2. GOVT ACCESSION NO.	3. RECIPIENT'S CATALOG NUMBER
4. TITLE (and Subtitle) Phase I Inspection Report Lock 3 Dam at Mechanicville Upper Hudson River Basin Rensselaer-Saratoga Co. Inventory No. NY 215		5. TYPE OF REPORT & PERIOD COVERED Phase I Inspection Report National Dam Safety Program

PHASE 1 INSPECTION REPORT  
NATIONAL DAM SAFETY PROGRAM  
LOCK 3 DAM @ MECHANICVILLE  
I.D. No. NY - 215  
(#119 - UH)  
UPPER HUDSON RIVER BASIN  
RENSSELAER - SARATOGA COUNTY, NEW YORK

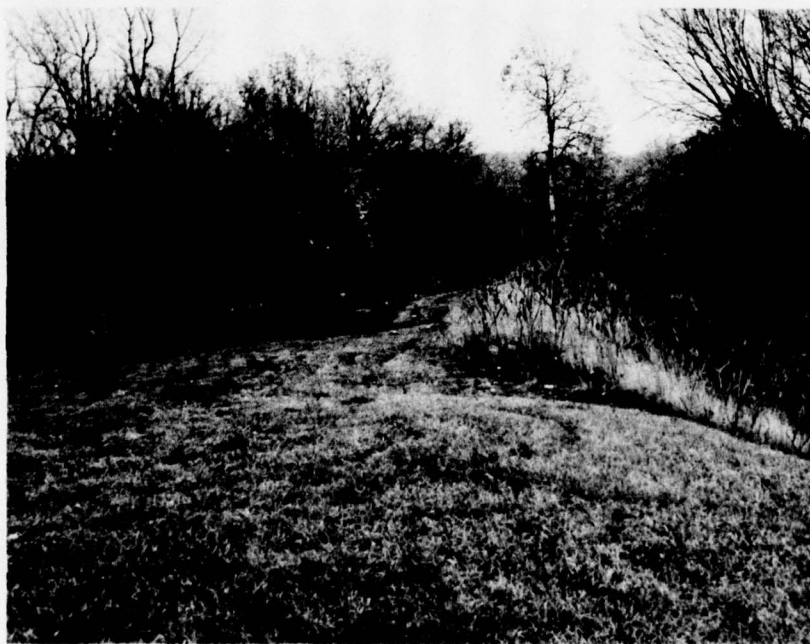
2. The concrete facing on the dike embankment's upstream slope protection was cracked.
3. The vertical alignment of the crest was somewhat irregular sloping downward in the upstream direction; a vehicle path existed on the top of the dike.
4. Several large trees existed on the top of the embankment.
5. Small trees and brush existed on the downstream slope of the embankment.

(UPSTREAM)

EARTH DIKE
