ROYAL AIRCRAFT ESTABLISHMENT FARNBOROUGH (ENGLAND)
HOLOGRAPHIC INTERFEROMETRY OF CFRP WING TIPS. (U)
AUG 78 M MARCHANT
RAE-TR-78105

Technical Report 78105

**HOLOGRAPHIC INTERFEROMETRY
OF CFRP WING TIPS**

M. Marchant

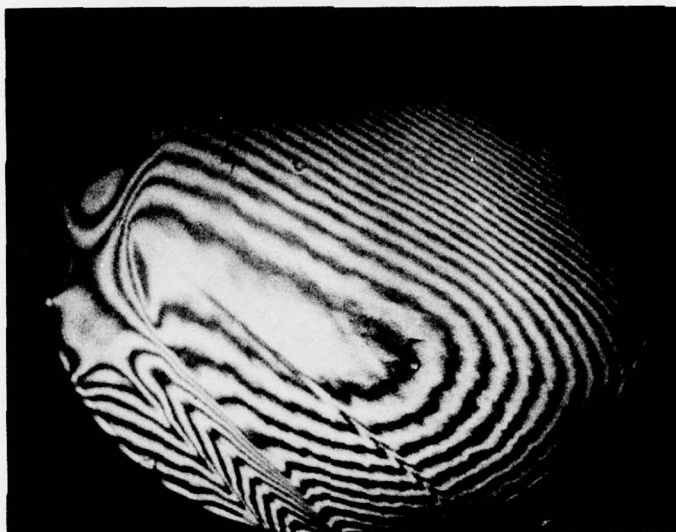
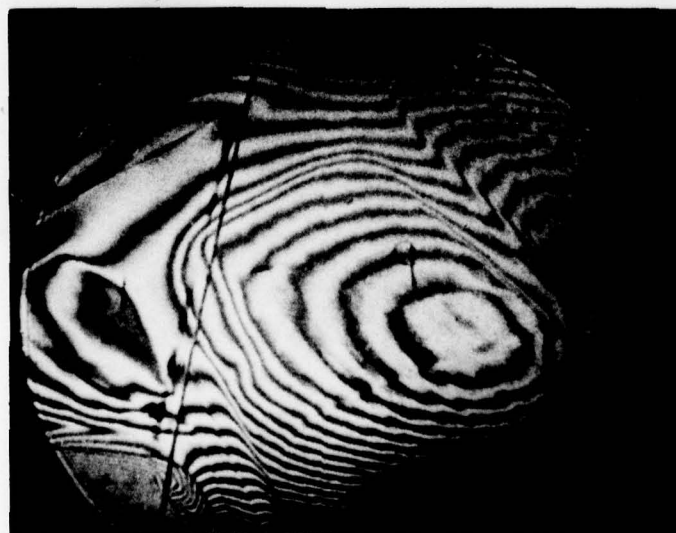
Fig A14a-c Wing tip 12 - top

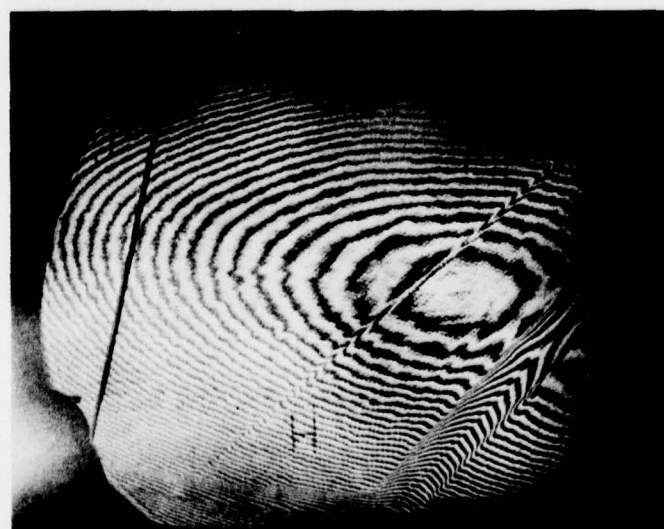
Fig A15a-c Wing tip 12 - bottom

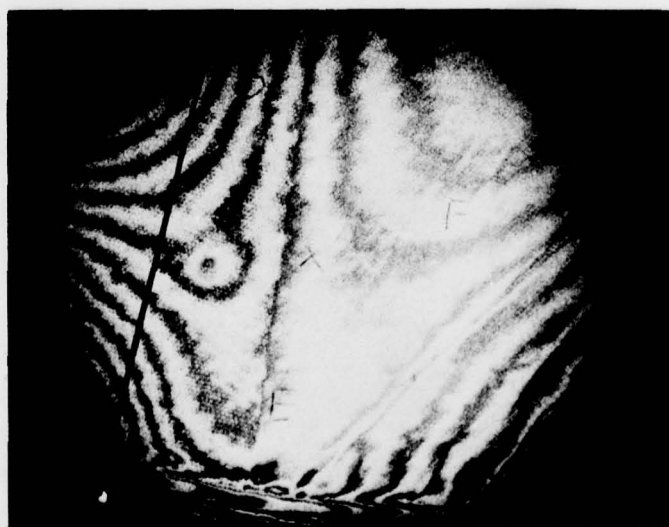
Fig A18a-c Wing tip 13 - bottom

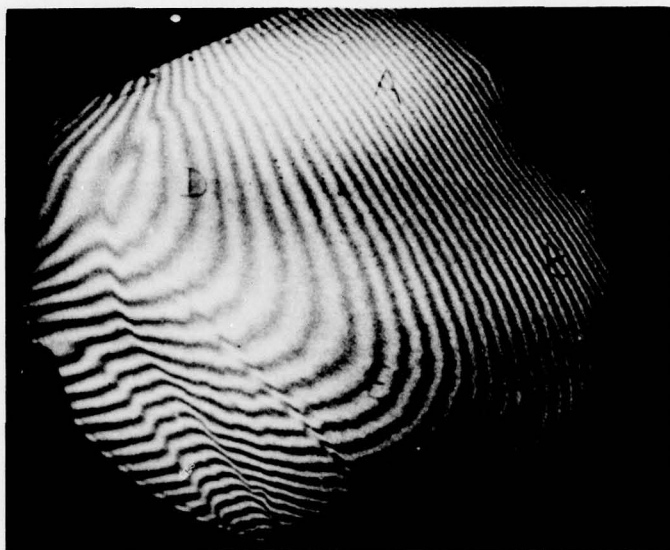
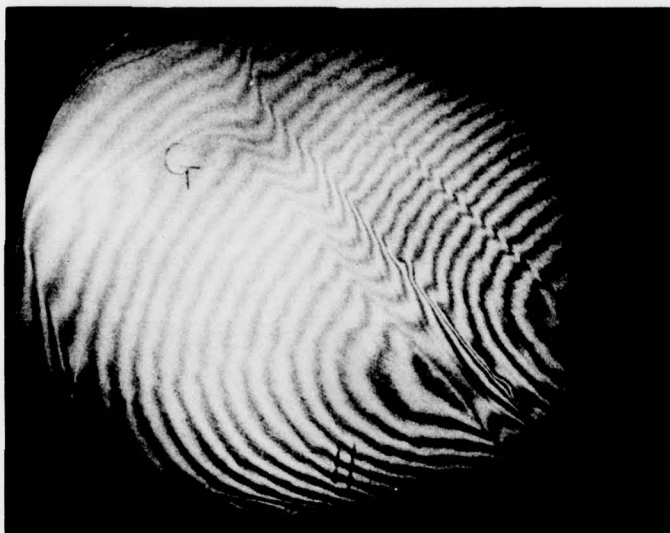
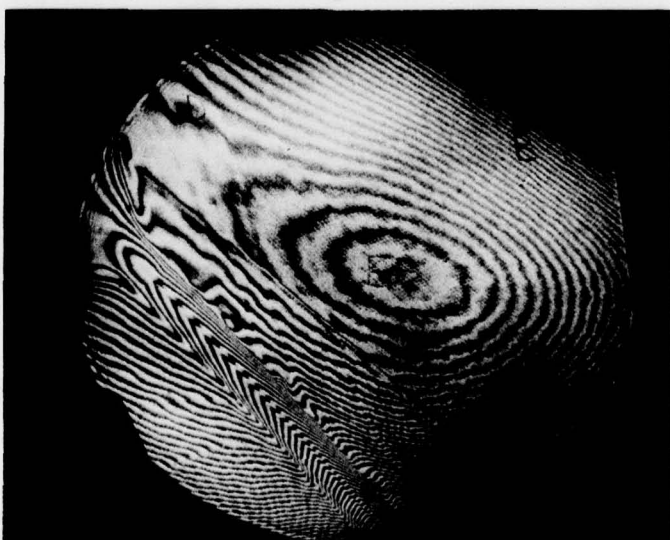
Fig A20a-c Wing tip 14 - top

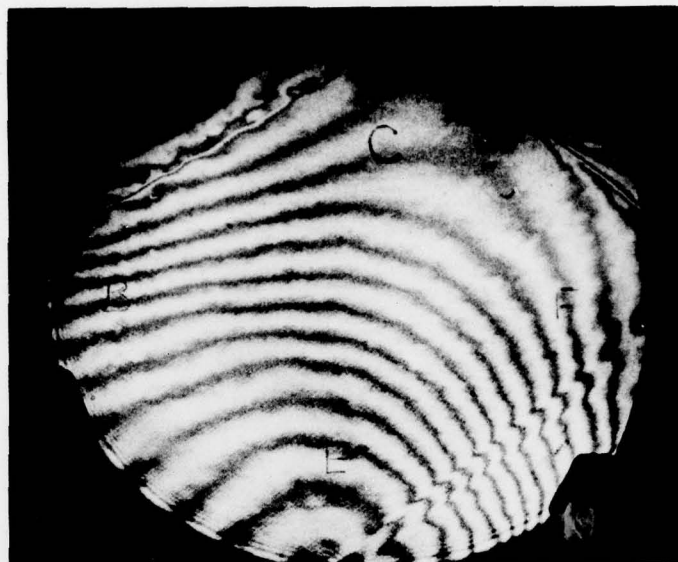
Fig A21a&b Wing tip 14 - bottom
