| REPORT DOCUMENTATION PAGE | | READ INSTRUCTIONS<br>BEFORE COMPLETING FORM |
|---|---|---|
| 4. TITLE (and Subtitle)<br>Phase I Inspection Report<br>Ischua Creek Watershed Project Site 6A<br>Allegheny River Basin, Cattaraugus County, NY<br>Inventory No. 571 | | 5. TYPE OF REPORT & PERIOD COVERED<br>Phase I Inspection Report<br>National Dam Safety Program |
| 14. MONITORING AGENCY NAME & ADDRESS (if different from Controlling Office)<br>Department of the Army<br>26 Federal Plaza New York District, CofE<br>New York, NY 10287 | | 12. REPORT DATE<br>10 September 1980 |

PHASE I INSPECTION REPORT  
NATIONAL DAM SAFETY PROGRAM  
ISCHUA CREEK WATERSHED PROJECT  
SITE 6A  
I. D. No. NY. 571  
ALLECHENY RIVER BASIN  
CATTARAUGUS COUNTY, NEW YORK

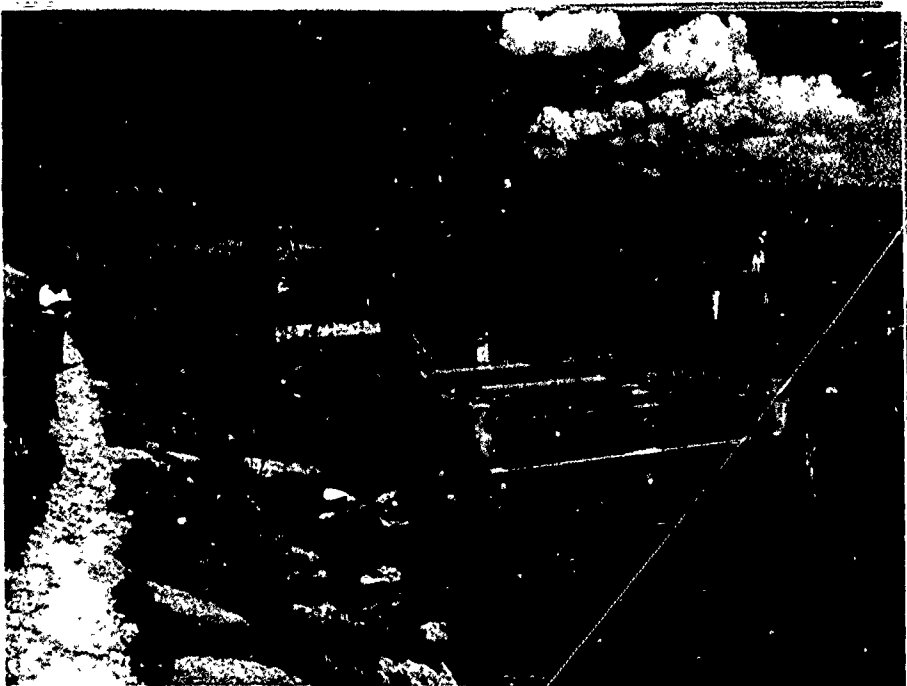
View of intake structures.
