MISCELLANEOUS PAPER GL-81-8

# EVALUATION OF MEMBRANE INTERLAYERS FOR PREVENTION OF CRACK REFLECTION IN THIN OVERLAYS

Philip J. Vedros, Jr.

October 1981

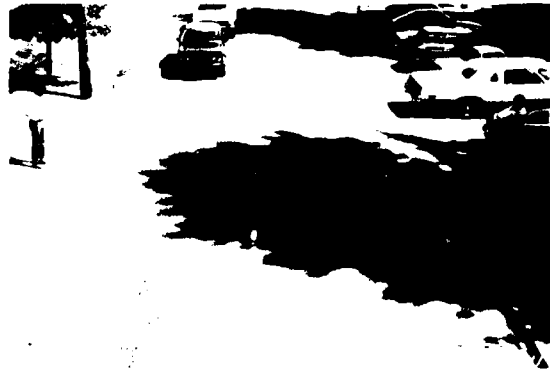
Photo 6. Control section (1-in. standard overlay),  
Second Division Drive

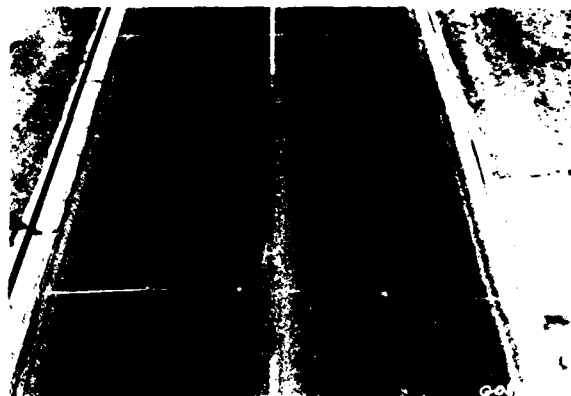
Photo 7. Sahuaro rubber section (uncoated chips),  
Second Division Drive

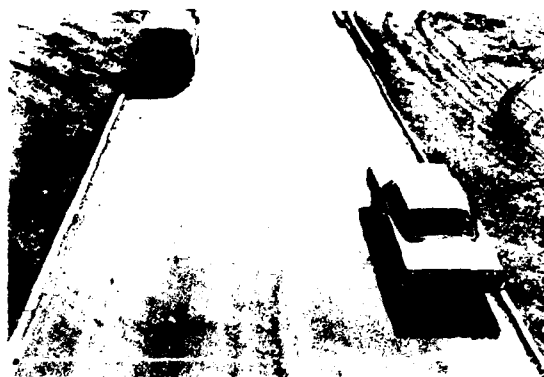
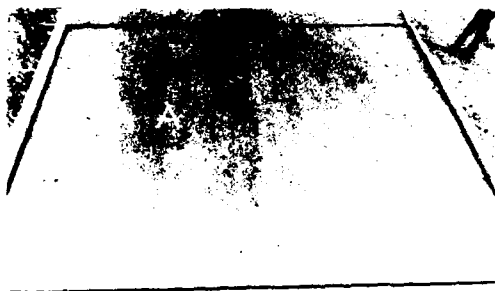
Photo 9. Bidim C-22 fabric section, south side of Faith Avenue

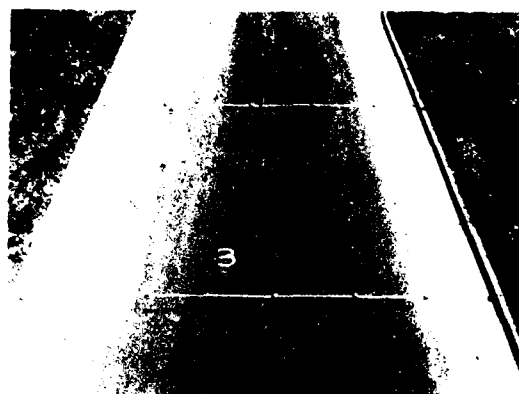
Photo 11. Control section, south side of Faith Avenue

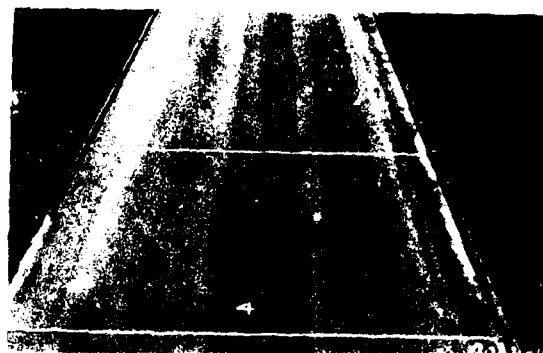
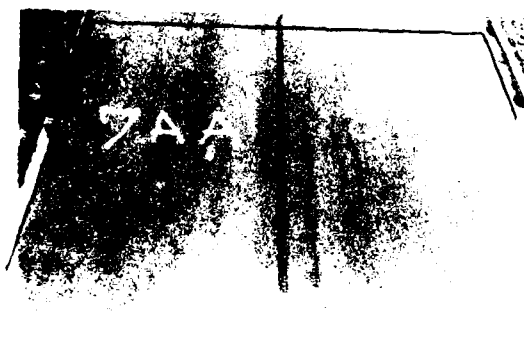
Photo 12. U. S. Rubber section, south side of Faith Avenue

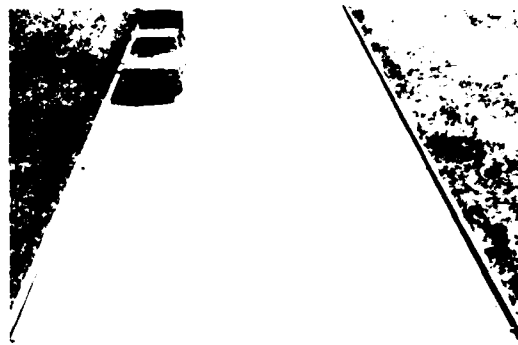
Photo 15. Mirafi 140 fabric section, north side of Faith Avenue

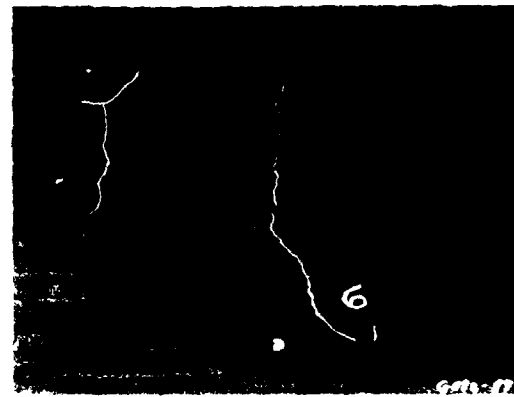
Photo 26. Sahuaro rubber section, NW-SE runway

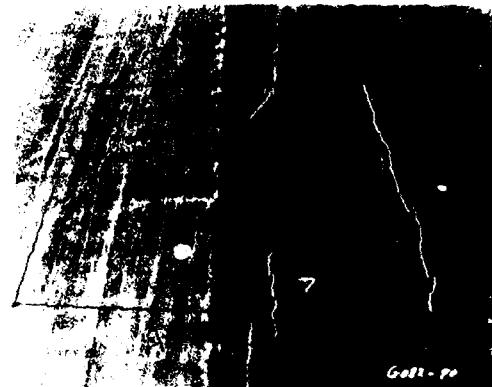
13. The cracking in the pavement surface on this runway was not as severe and numerous as on the NW-SE runway. The cracks were generally about 1/4-in. in width and had never been sealed. Sections numbered 7 through 12 are located on this runway. Photos 27 through 32 indicate the crack pattern that existed in the selected photographic areas before placement of the test materials and the progression of reflection cracking with time. Table 2 indicates the percentage of cracking for Sections 7 through 12, and Table 3 summarizes the data for each facility. As noted in Table 3, the control section indicated the lowest crack reflection at 53.3 percent, and the Mirafi 140 fabric the highest at 97.0 percent.

Photo 27. Sahuaro rubber section, N-S runway

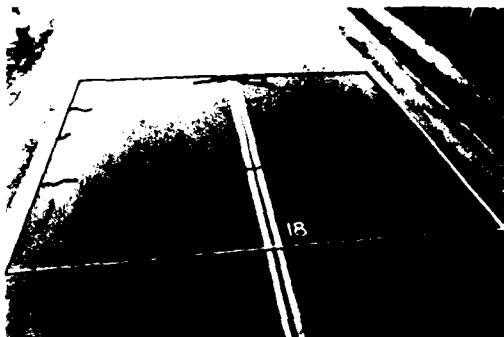
Photo 38. Sahuaro rubber section, Barnum Road

15. The cracking pattern in the pavement surface on Barnum Road was different from that found on the airfield, probably due to the difference in base material. The base material on Barnum Road consisted of a 5- to 7-in. layer of 3-in. maximum size asphalt stabilized crushed rock. The few cracks in the test areas had been sealed sometime prior to this test program. As shown in Figure 2, there were five test sections placed on Barnum Road. Photos 38 through 42 indicate the crack pattern that existed in the selected photographic areas before placement of test materials and the progression of reflection cracking through these materials to the end of the last inspection in June 1981. Table 2 indicates the percentage of cracking for Sections 18 through 22, and Table 3 summarizes the data for each facility. As noted in Table 3, the Sahuaro rubber section indicated the lowest crack reflection at 8.9 percent, and the Mirafi 140 fabric the highest at 60.4 percent.

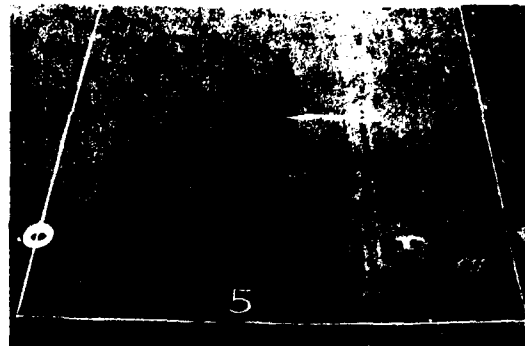
Photo 47. Bidim C-22 fabric section, north end of west apron

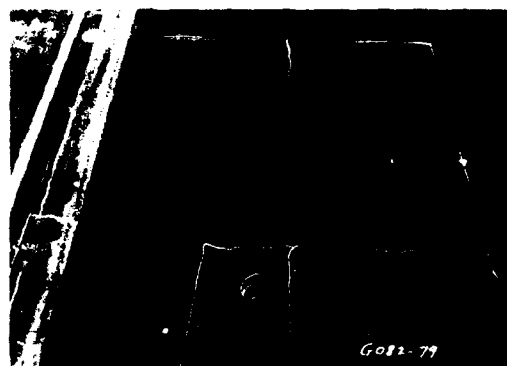
Photo 48. Bidim C-22 fabric section, south end of west apron

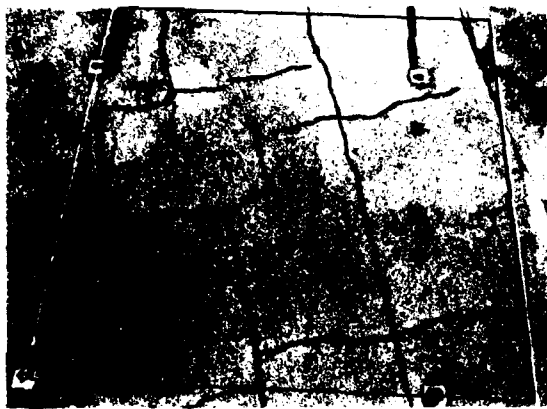
Photo 51. Control section, south end of west apron

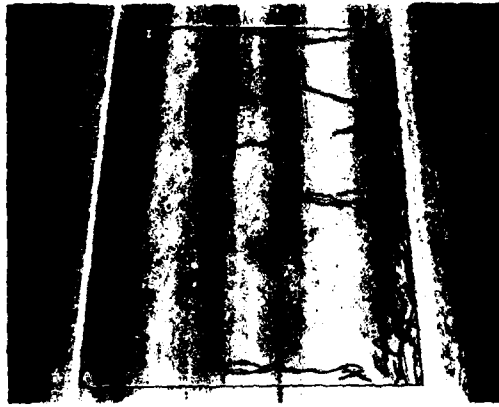
Photo 58. Mirafi 140 fabric section, south end of Wilderness Road

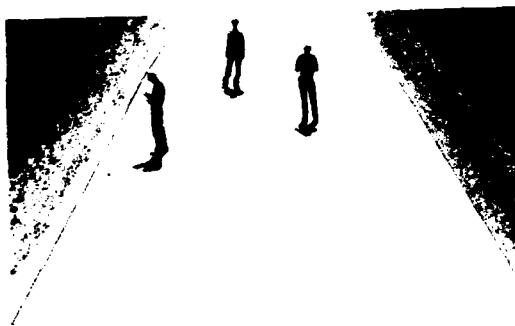
Photo 65. Mirafi 140 fabric section, north end of Wilderness Road

24. The test materials have been in place on Wilderness Road for a period of almost 3 years. As indicated in the photographs, not much crack reflection has occurred in any of the sections. The alligator-type cracking along the roadway edge is starting to reflect in most of the areas where this type of cracking was noted in the original survey. The alligator pattern of cracking usually indicates a structural deficiency in the pavement, and if this is the case, it is doubtful that the presence of the fabric or asphalt-rubber membrane will do much to correct the condition. Widening the roadway should keep the loads away from the pavement's edges and help to prevent the failures in this area.

- b. Use of a very firm fabric, such as Mirafi 140, will cause problems under thin overlays from wrinkles, if permitted during placement. The wrinkles in the softer fabrics, such as Bidim and Petromat, did not affect the performance of the materials under a thin overlay.
