EVALUATION OF MEMBRANE-TYPE MATERIALS FOR STREAMBANK EROSION PROTECTION

MISCELLANEOUS PAPER GL-81-4

Dewey W. White, Jr.

August 1981

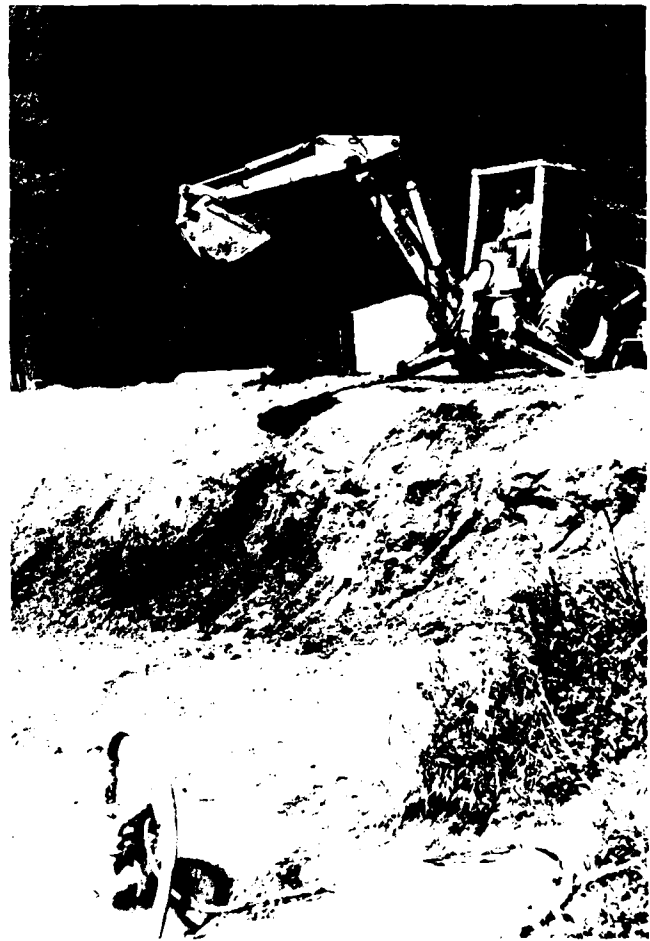
Photo 12. View of backhoe used to remove soil from bank where soil was caving vertically

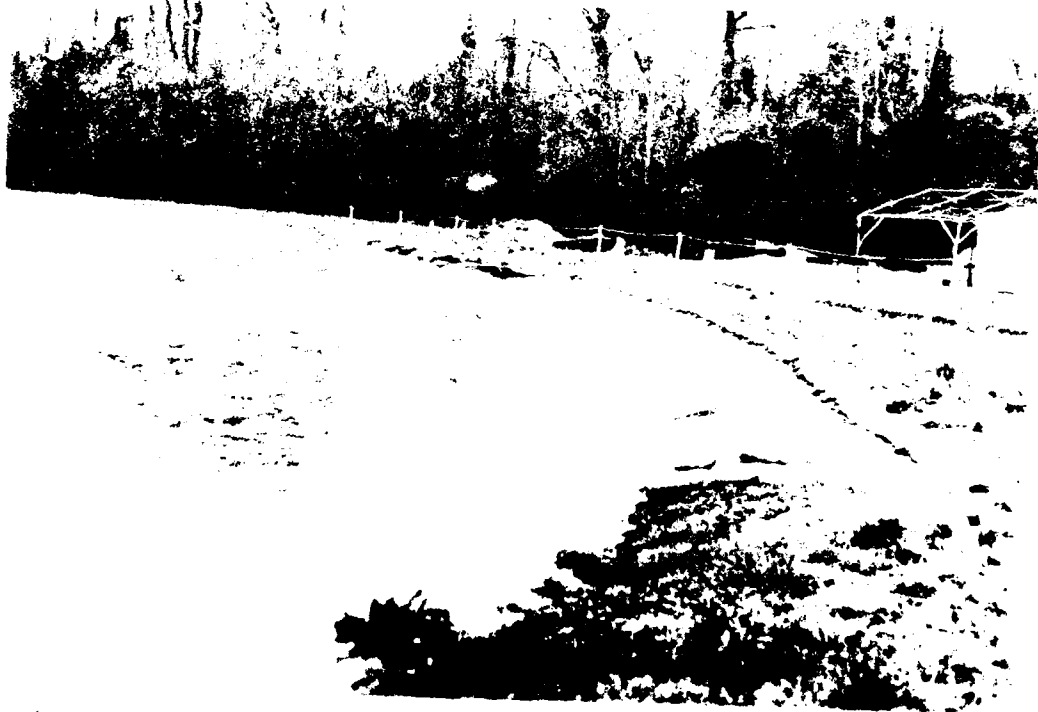
Photo 34. View (looking downstream) of test area during high water.

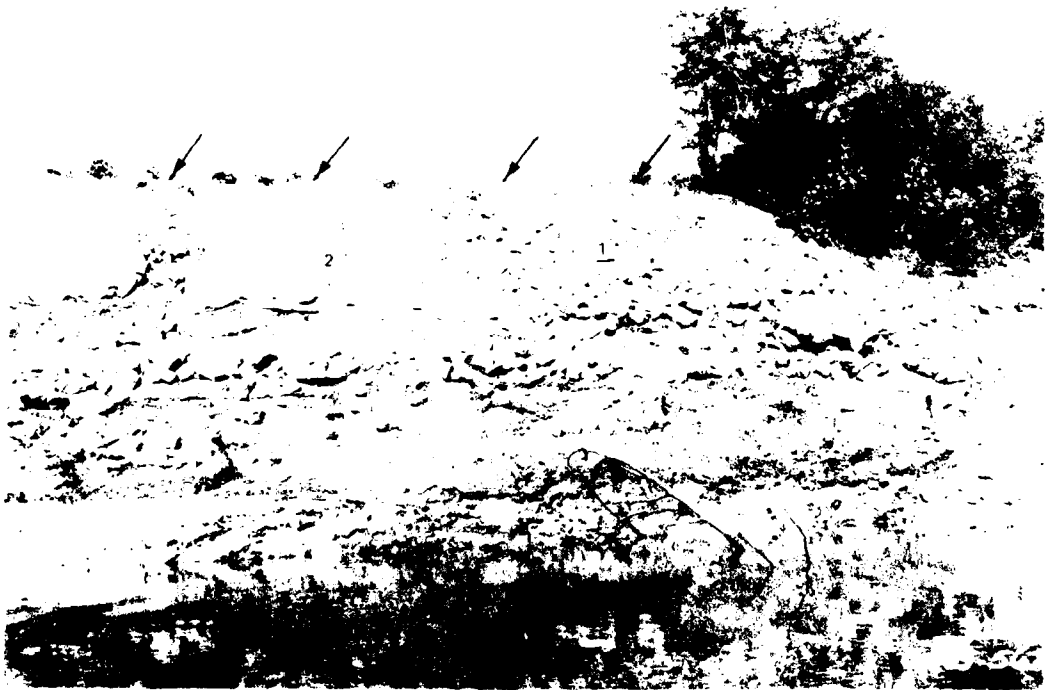
Photo 80. Close-up of Items 1 and 2, July 1980

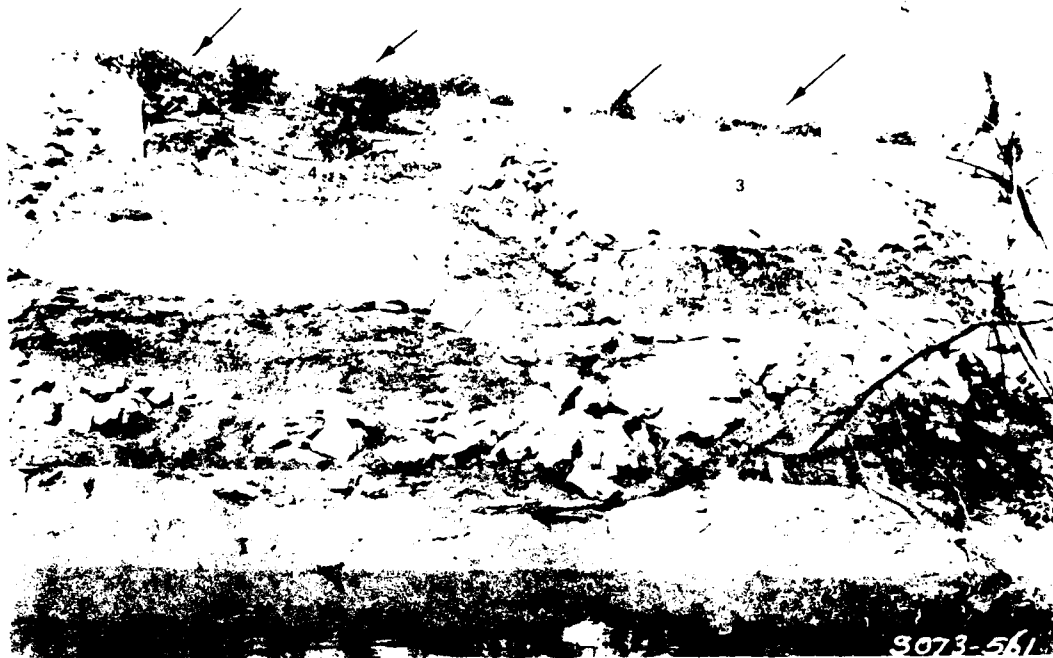
Photo 81. Close-up of Items 3 and 4, July 1980

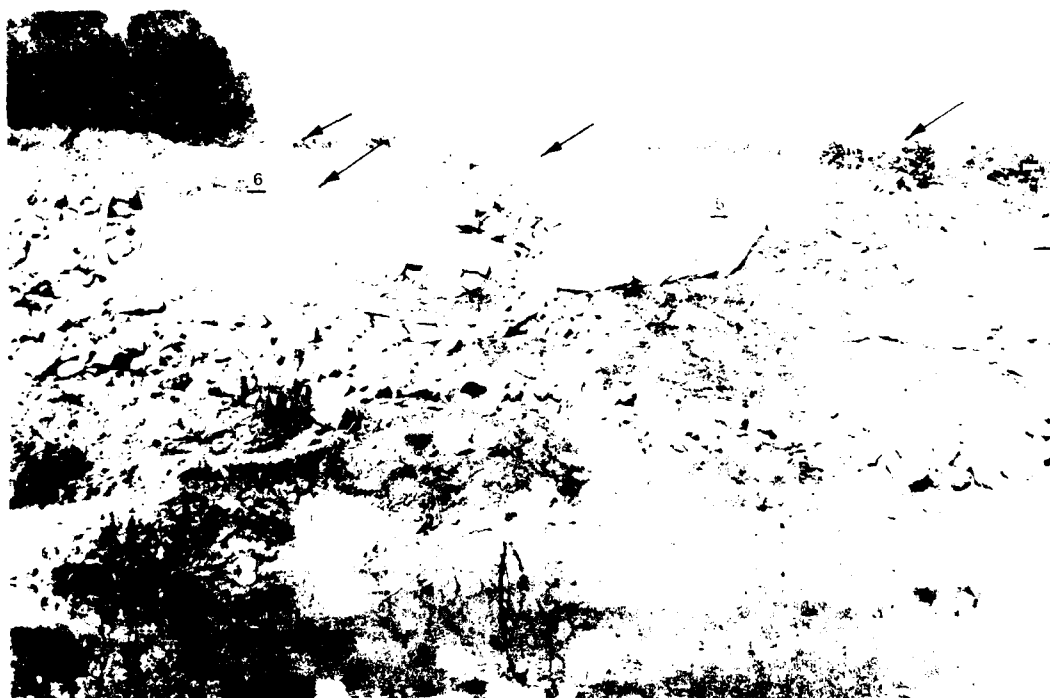
Photo 82. Close-up of Items 5 and 6, July 1980

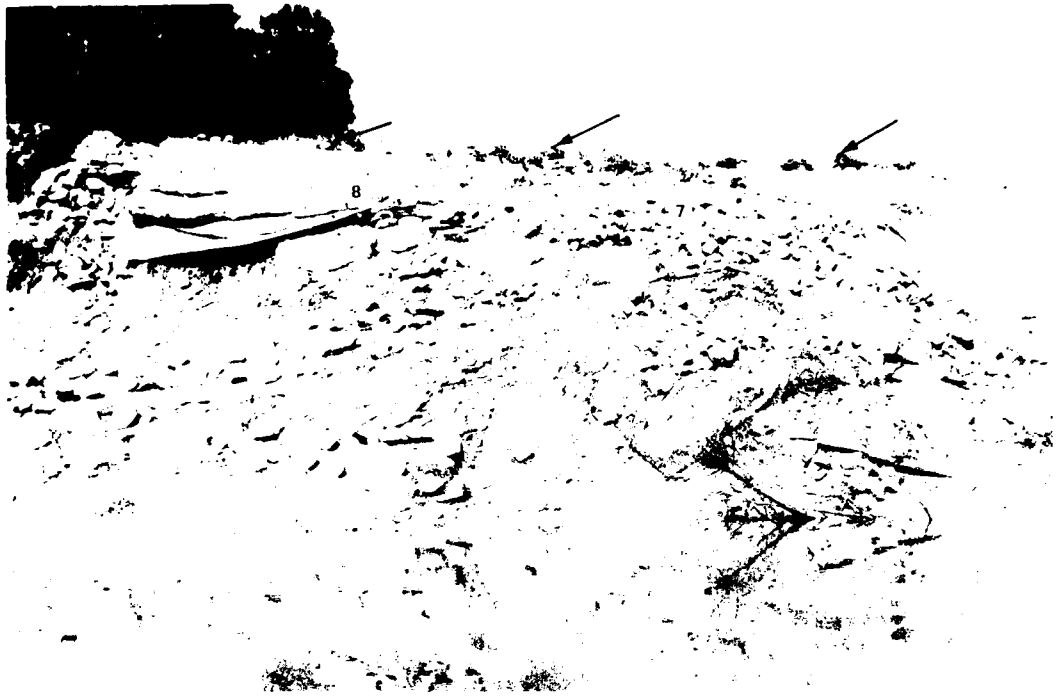
Photo 83. Close-up of Items 7 and 8, July 1980
