| REPORT DOCUMENTATION PAGE | | READ INSTRUCTIONS<br>BEFORE COMPLETING FORM |
|---|---|---|
| 4. TITLE (and Subtitle) National Program of Inspection of Non-Federal Dams, TN. Spring Lake Dam (Candlewood II) Old Hickory Dam (Candlewood III) (Inventory Number TN 06930) (Inventory Number TN06926) near Saulsbury, Tennessee, Hardeman County, TN, Hatchie River Basin | | 5. TYPE OF REPORT & PERIOD COVERED<br>Phase 1 Investigation Report |

Based upon the inspection and subsequent evaluation, Spring Lake and Old Hickory Dams are classified as deficient due to minor erosion that is occurring on the embankments and in the emergency spillways, and some seepage present on the downstream toes of the dams.

PHASE I INSPECTION REPORT  
NATIONAL DAM SAFETY PROGRAM

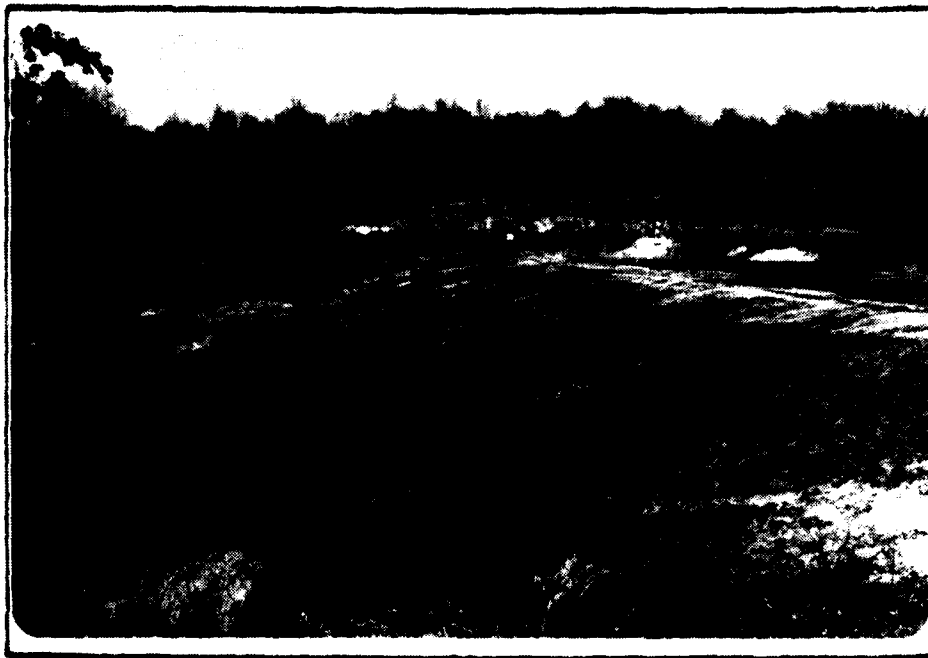
PHOTO NO. 3

Photo No. 3 - The downstream slope from the left abutment.

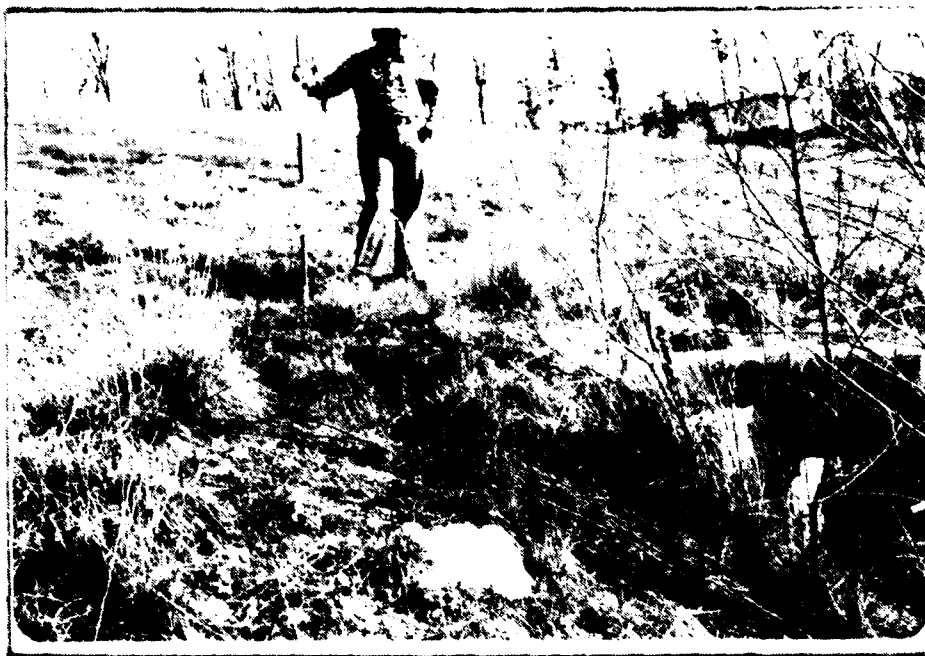
PHOTO NO. 9

Photo No. 9 - A depression occurring in the fill above the service spillway pipe near the toe.

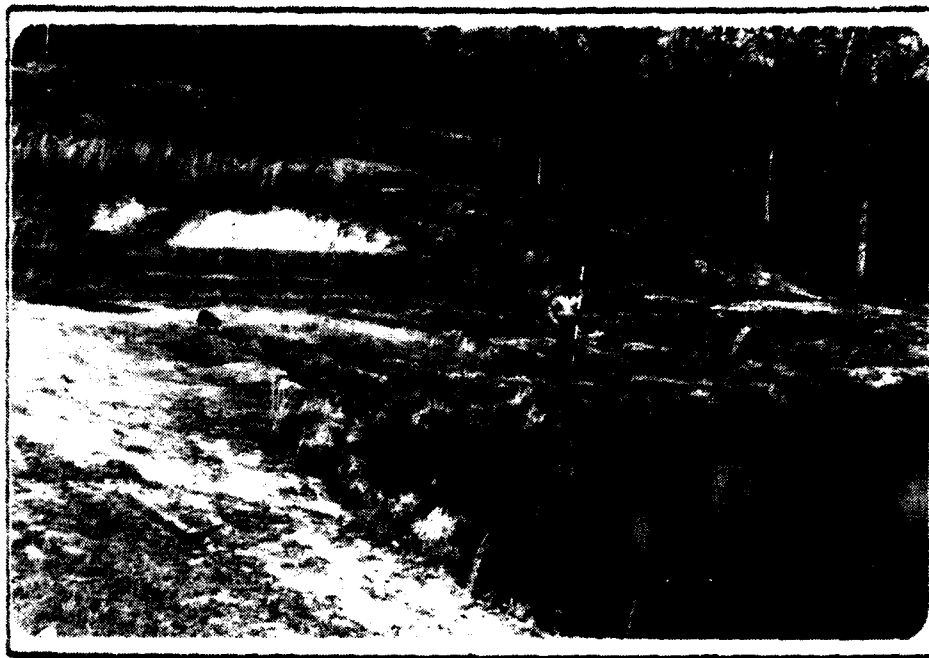
PHOTO NO. 15

3.1.4 The right side of the emergency spillway control section is formed by embankment fill material. The fill has a narrow crest (15') and would probably erode rapidly under high stage flows (photo no. 15).

Photo No. 15 - The entrance channel of the emergency spillway.

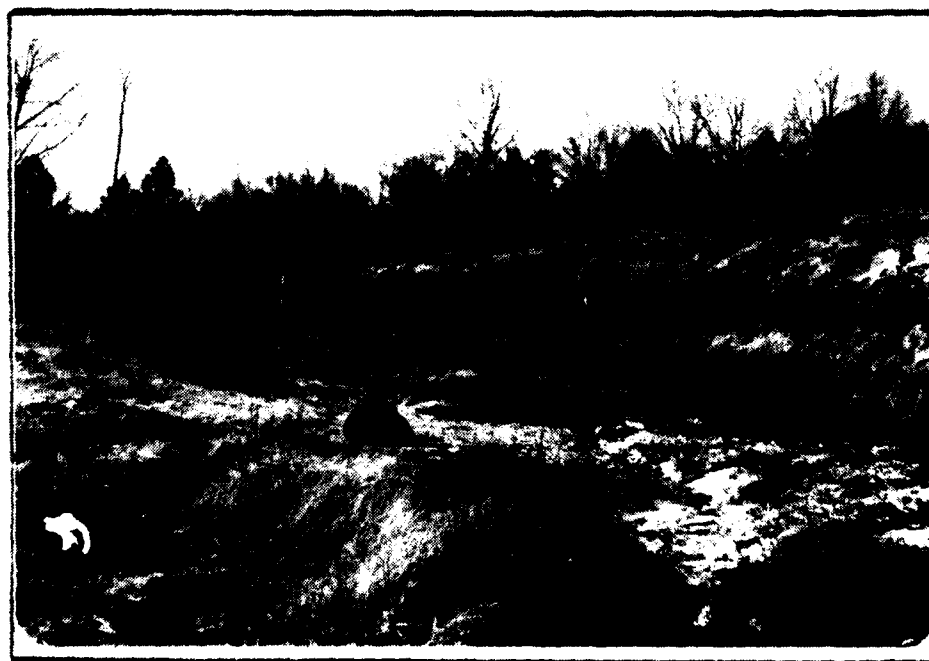
PHOTO NO. 16

Photo No. 16 - The control section of the emergency spillway. Note erosion of the right side slope.

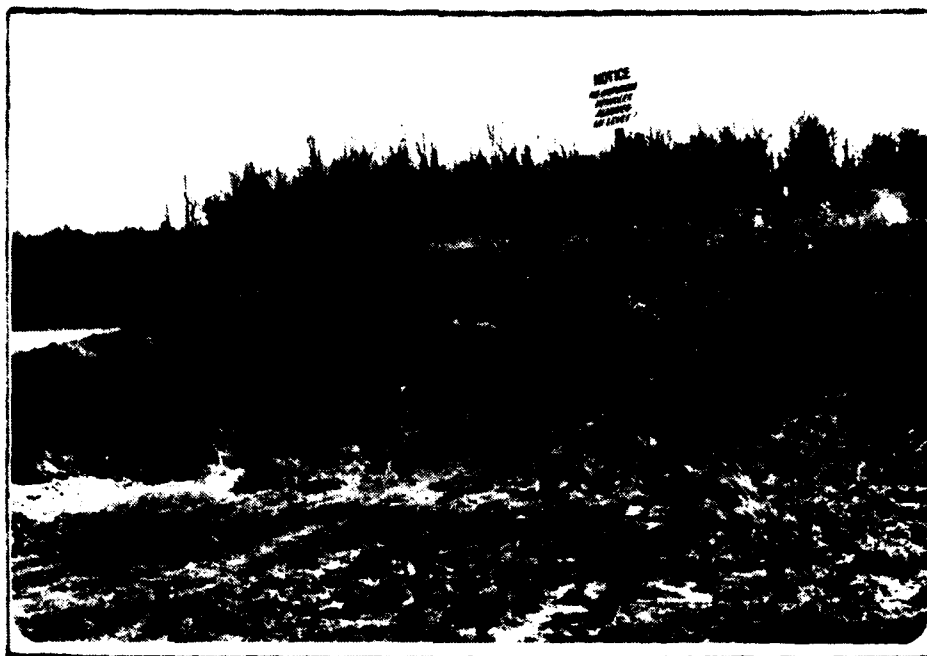
PHOTO NO. 17

Photo No. 17 - Erosion on the left side slope of the emergency spillway.

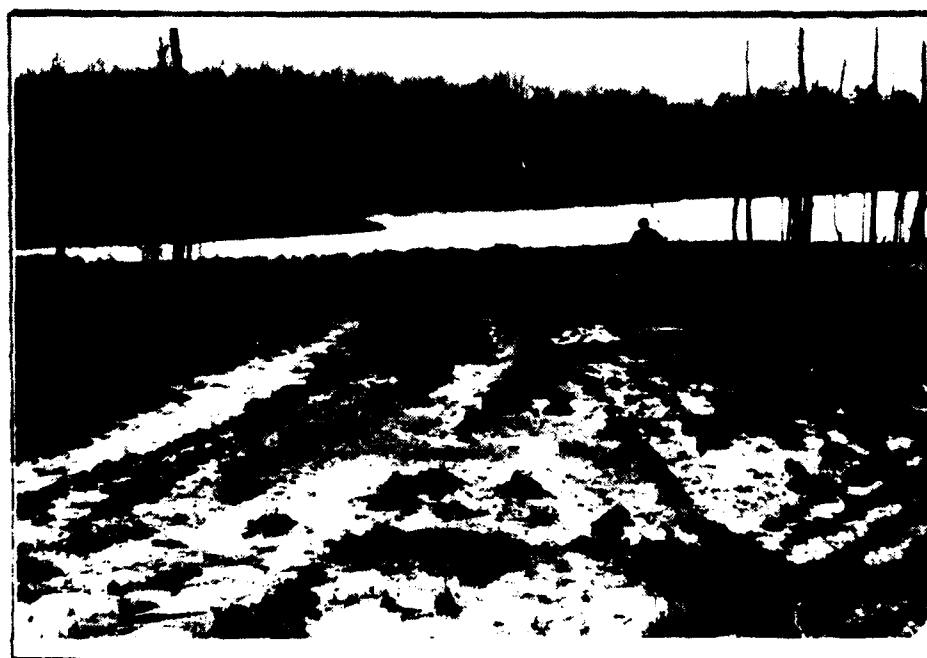
PHOTO NO. 18

Photo No. 18 - The exit channel of the emergency spillway.
