CAESAR CREEK LAKE  
LITTLE MIAMI RIVER BASIN  
OHIO

EMBANKMENT CRITERIA AND  
PERFORMANCE REPORT

PREPARED BY  
U.S. ARMY ENGINEER DISTRICT, LOUISVILLE  
CORPS OF ENGINEERS

SEPTEMBER 1982

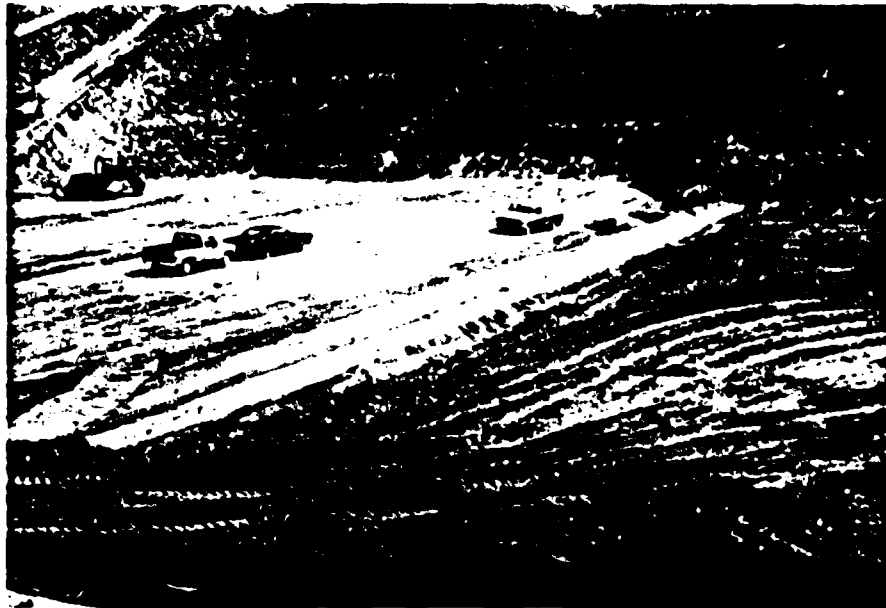
| STATION | DEPTH | SOIL | REMARKS |
|---|---|---|---|
| 105 | 0.00 | SAND | |

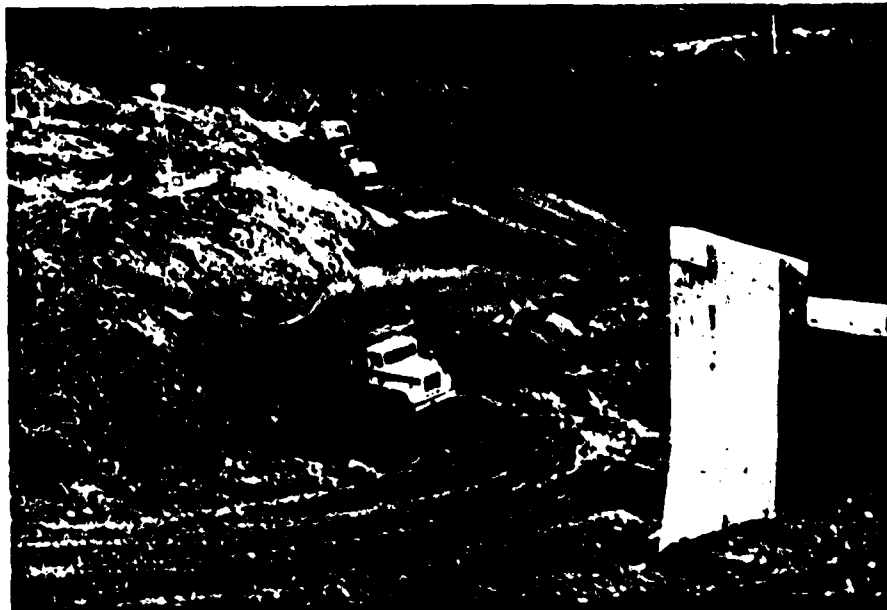
| STATION | DEPTH | SOIL | REMARKS |
|---|---|---|---|
| 107 | 0.00 | SAND | |

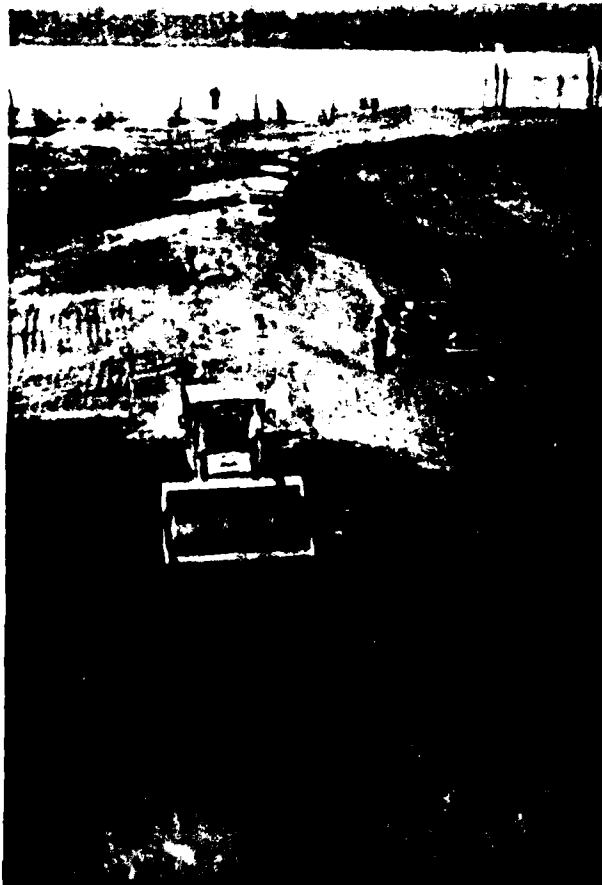
| STATION | DEPTH | SOIL | REMARKS |
|---|---|---|---|
| 109 | 0.00 | SAND | |
