# CONSTRUCTION FOUNDATION REPORT

**SOUTH PLATTE RIVER BASIN  
BEAR CREEK LAKE, COLORADO**

**VOLUME I  
TEXT AND PHOTOS**

**US Army Corps  
of Engineers**  
Omaha District

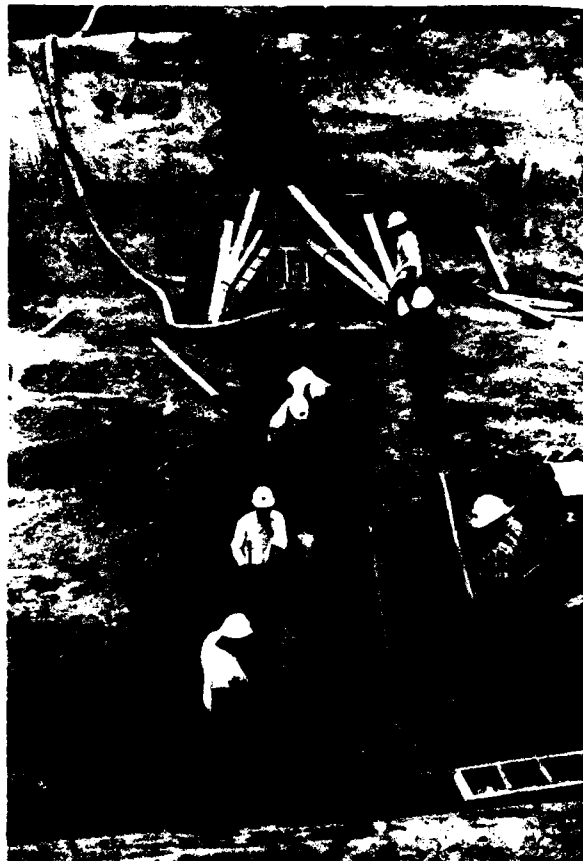
3.7.3.1. South Embankment Inspection Trench: Two shear zones were observed in the trench; one near Station 9+00 (Photo No. 41) and the other near Station 1+00. The shear zone near Station 9+00 had a strike of N. 46°W. and a dip of 74°NE, the same attitude as bedding in bedrock. Material in this shear zone was made up of alternating thin fractured stringers of ironstone, shale, and clay, with a total width of about 2 feet. On the downstream face five ironstone stringers were noted 1/2 to 6 inches thick. The ironstone stringers were highly fractured and water ran freely through these fractures on this side of the trench. A probable source of the water was a nearby irrigation canal. This shear zone was dental treated with lean concrete for an area of 5 feet wide and 5 feet deep to eliminate the possibility of piping through the impervious section of the embankment. A fault was observed near Station 1+00. It had 1 to 2-1/2 inches of clay gouge on the fault plane. A number of thin ironstone stringers appeared above the fault plane but not below, indicating displacement of at least 10 feet. On the downstream face the fault plane is curved, with a strike of N. 25°W. and a dip of 15°SW a few feet above the floor. On the upstream face, the fault dips 3° NE with the same strike as on the downstream face. Since this fault was near the end of the trench in the right abutment, it was felt that it would not affect the integrity of the foundation of the south embankment. If the water in the lake should ever rise to elevation 5673, the upstream side

PHOTO NO. 41. Dental cleaning of  
shear zone across south embank-  
ment trench Sta. 9+03  
Looking northwest. 9/16/75.

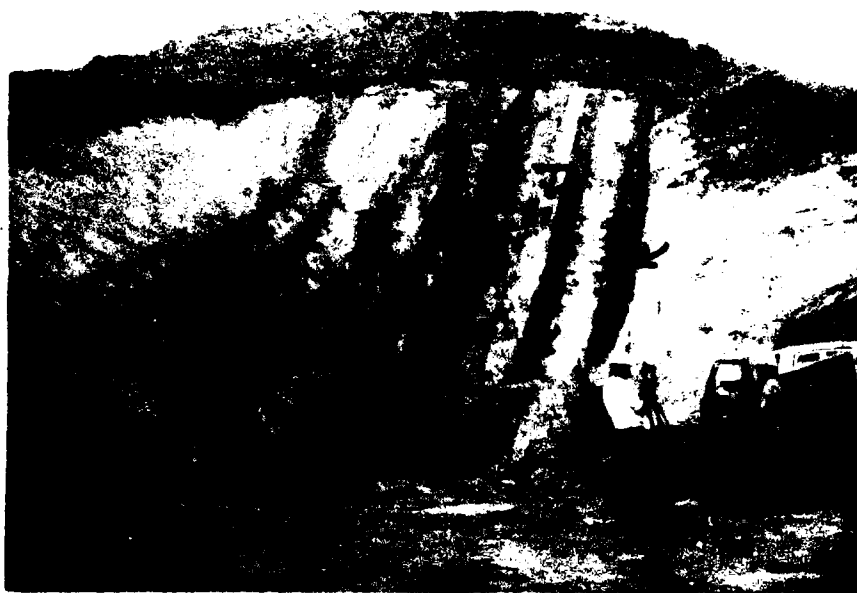
PHOTO NO. 74. Cleaning and keying Mine #3 for concrete cap placement. Looking north. 3/7/77.

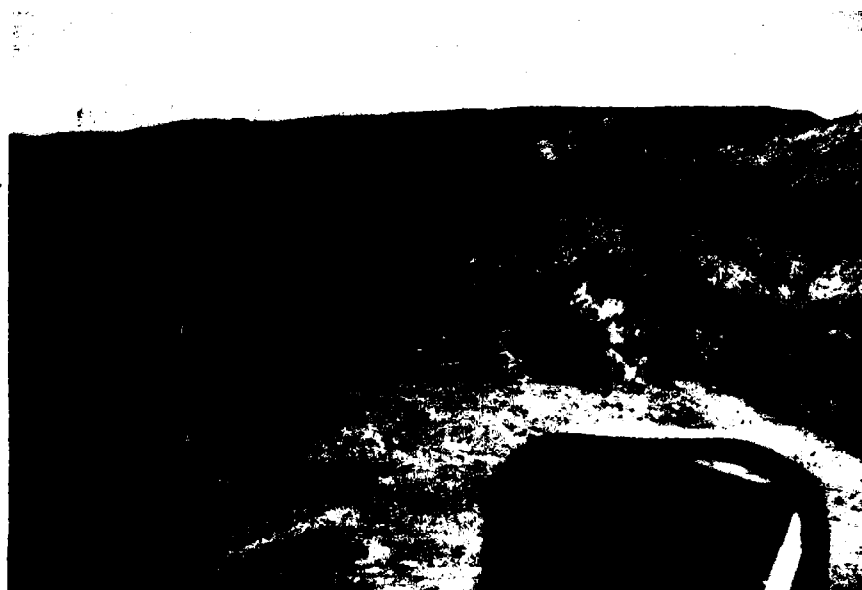
PHOTO NO. 77. Mine #4, completed lean concrete  
pour on bottom two levels.  
Looking south. 10/20/77.

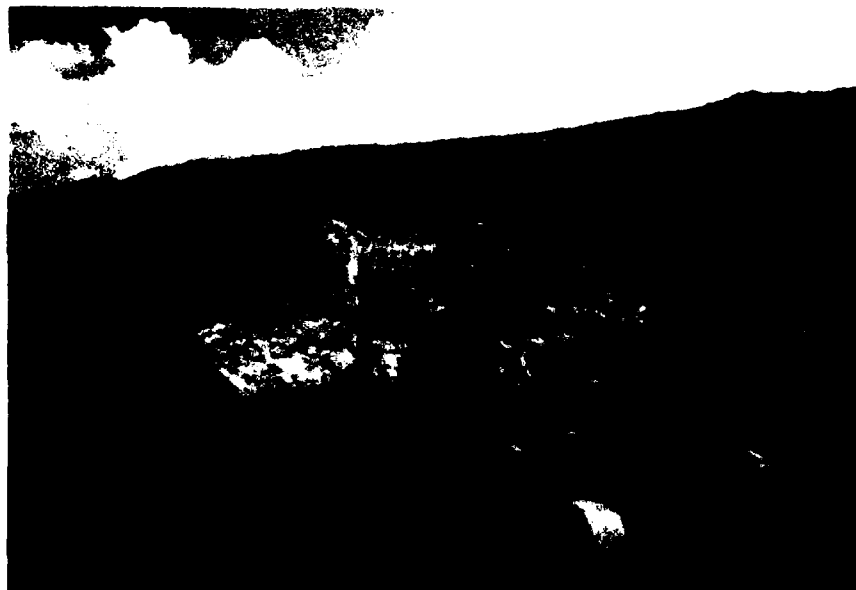
PHOTO NO. 78. Main embankment inspection trench  
from Sta. 42+00 to 35+75, ready for  
clay placement. Looking south.  
6/9/77.
