**UNDERWATER FACILITIES  
INSPECTION AND ASSESSMENT  
AT**

**MAGNETIC SILENCING FACILITIES  
NAVAL STATION  
CHARLESTON, SOUTH CAROLINA**

**FPO-1-84(39)**

**NOVEMBER 1984**

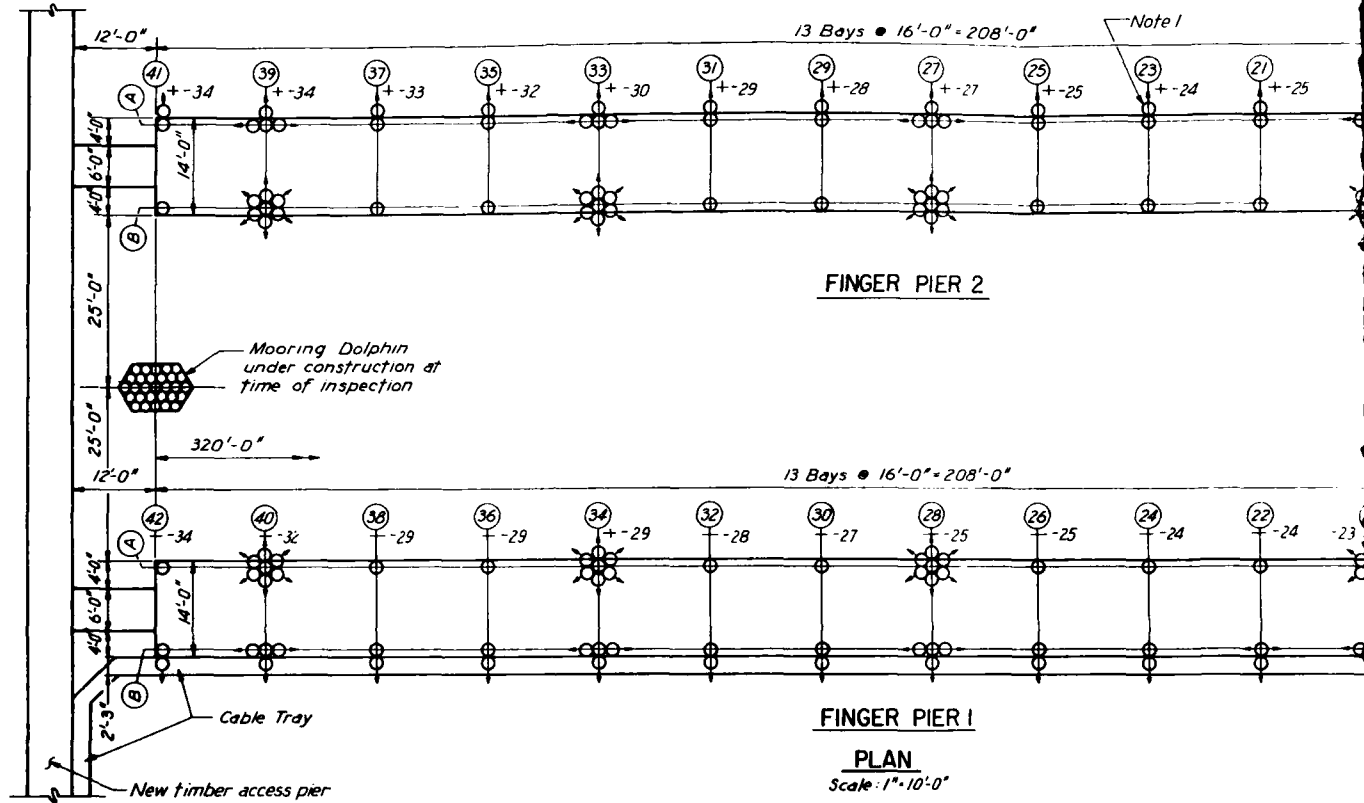
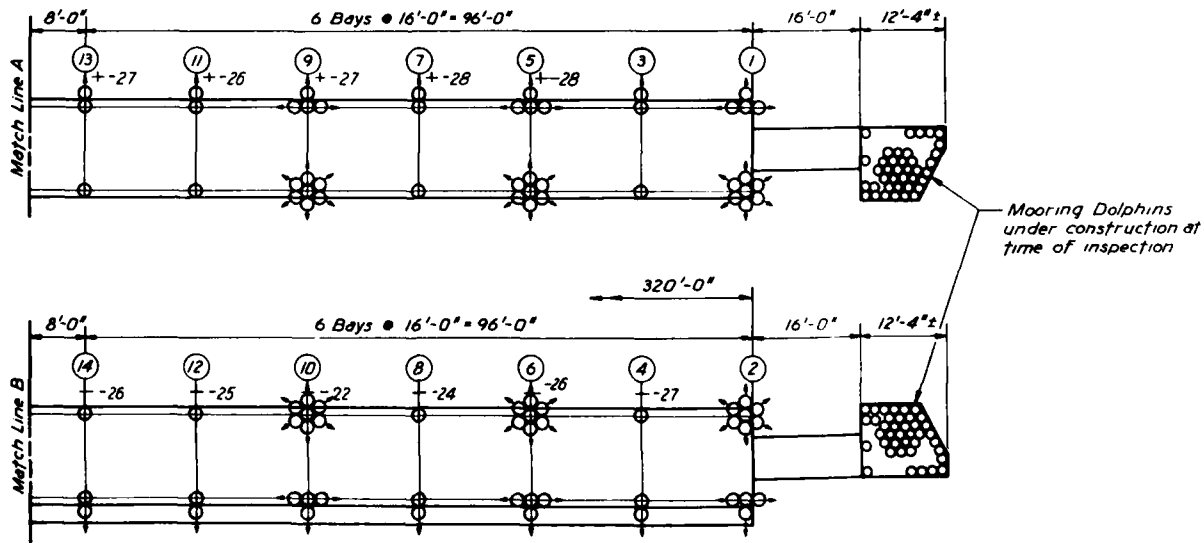
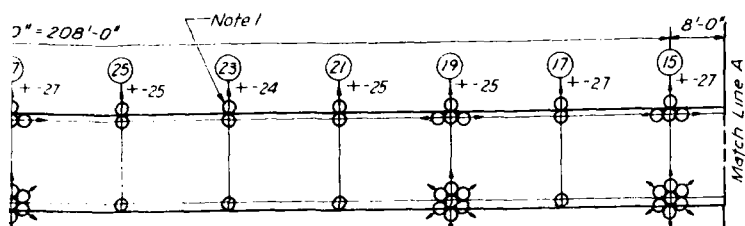
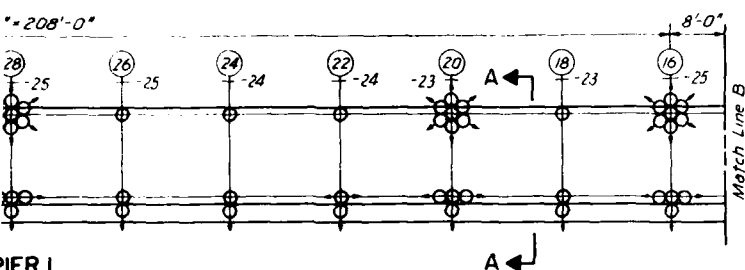
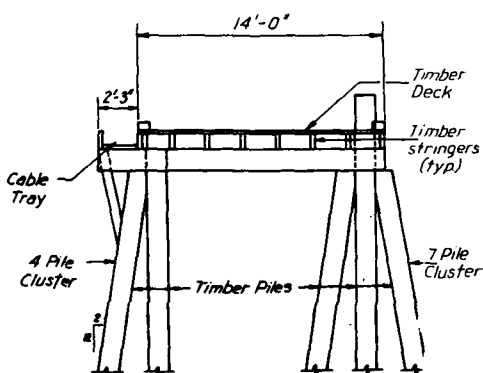
CHESAPEAKE DIVISION  
NAVAL FACILITIES ENGINEERING COMMAND  
WASHINGTON, D.C.  
NAVAL STATION CHARLESTON, S.C. FIG. NO.  
PIER YANKEE  
**FINGER PIERS 1 & 2**  
CONTRACT No. N82477-93-D-3387

This drawing was developed in part from NAVFAC Drawg. Nos. 5095582 & 5095583. All piles were given a Level I inspection. All piles were found to be in good condition. Piles are shown oversized for clarity. + Channel bottom elevations Datum M.L.W. El. 0.0

1. North and South horizontal braces broken at water line.

| Facility | Year Built/<br>Reconstructed | No. of<br>Piles | Facility Size<br>Length by Width | Structure Type | Recommendations* | Estimated Cost<br>of<br>Recommendations |
|---|---|---|---|---|---|---|
| Finger Pier 2 | 1984 | 127 | 208'-0" x 14'-0" | 14" Timber piles | Repair bracing at Bent 23 | Contractor's responsibility (\$1,000) |
