POTABLE WATER STORAGE FACILITIES INSPECTIONS AND ASSESSMENTS

NAVAL AMPHIBIOUS BASE
LITTLE CREEK
NORFOLK, VIRGINIA

FPO-1-84(41) OCTOBER 1984

19. ABSTRACT (Continue on reverse if necessary & identify by block number)
In October of 1984, an underwater inspection was conducted at the Naval
Amphibious Base, Little Creek, Norfolk, Virginia to assess the condition of
seven potable water storage facilities.

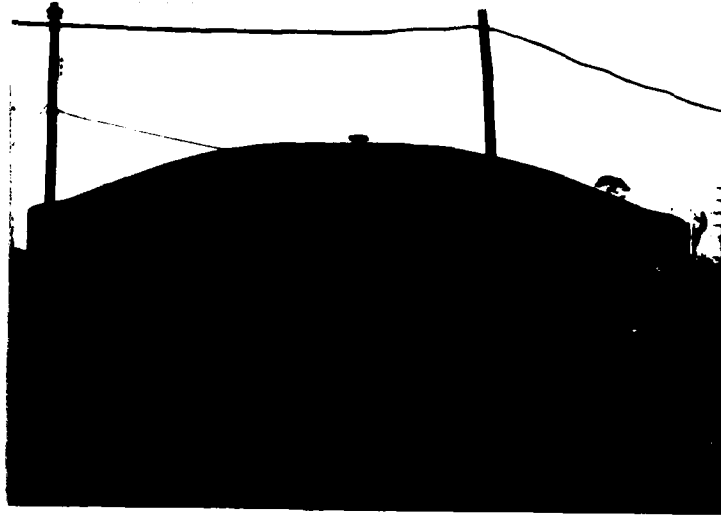
PHOTOGRAPH 4.6-1
Overall View of Facility NAB 753.

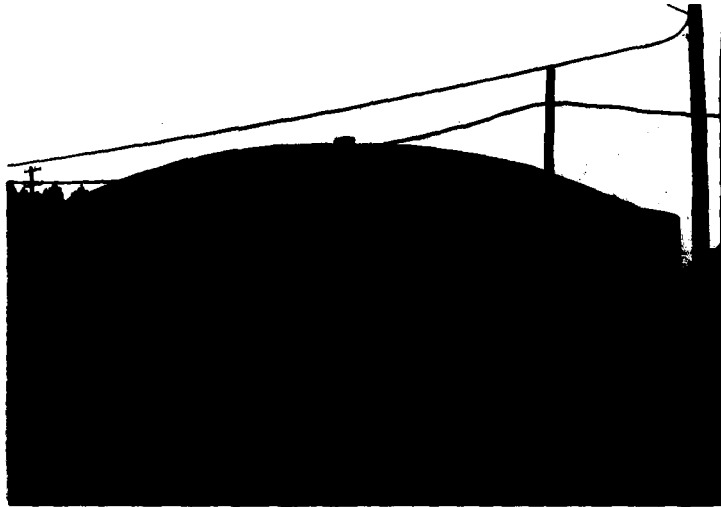
PHOTOGRAPH 4.7-1
Overall view of Facility NAB 754.
