TECHNICAL REPORT CERC-88-4

# EFFECTIVENESS OF EXPEDIENT LEVEE-RAISING STRUCTURES

Experimental Model Investigation

April 1988

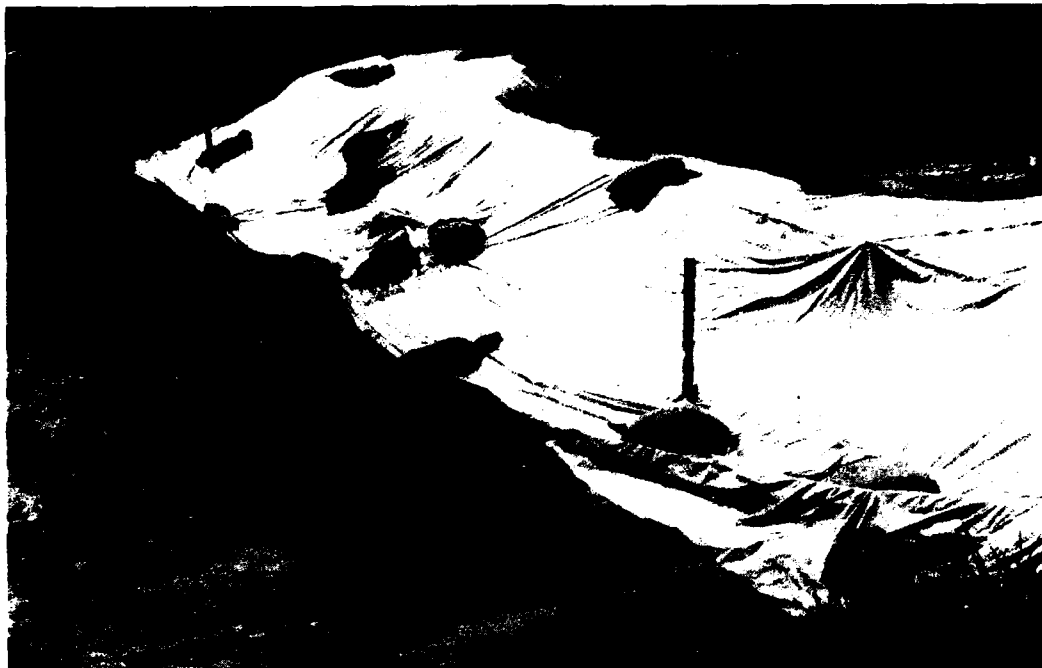
Photo 21. Riverside view of Section 2-2 before testing

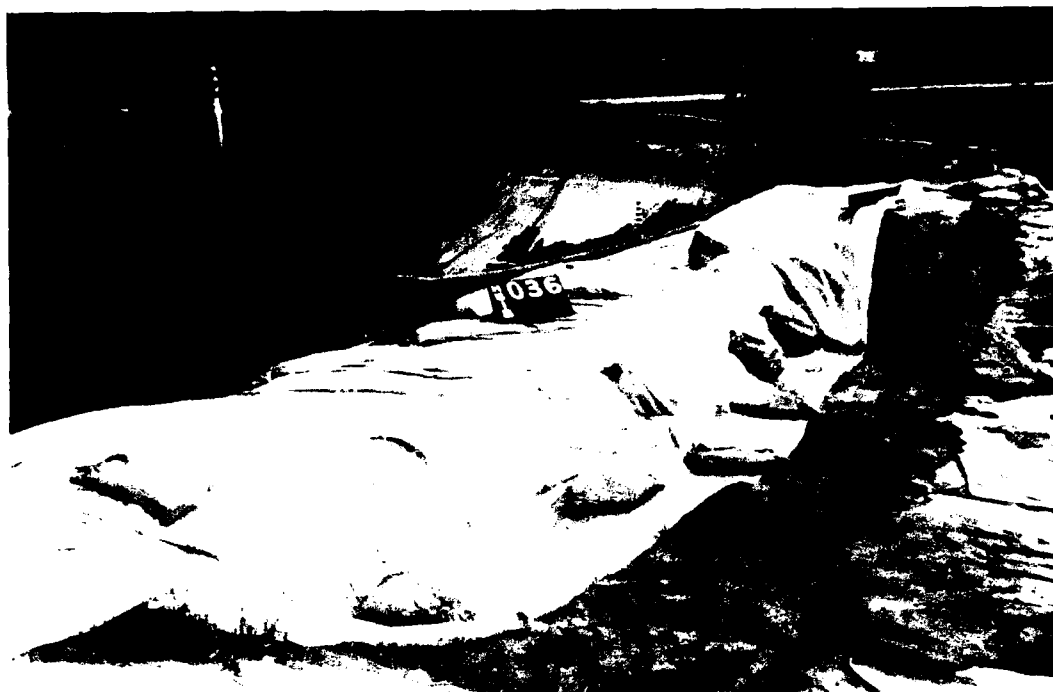
Photo 31. Landside view of Section 2-2 after 34.5 hr of wave action  
at the 1.0-ft water level

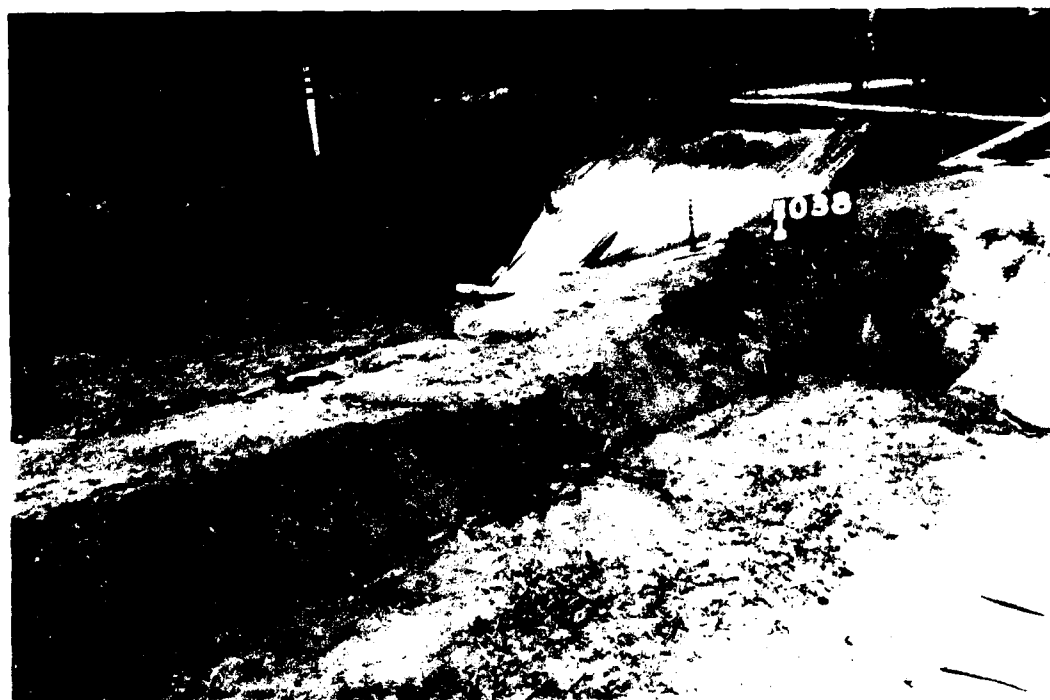
Photo 32. Landside view of Section 2-2 after 34.5 hr of wave action  
at the 1.0-ft water level (poly covering removed)

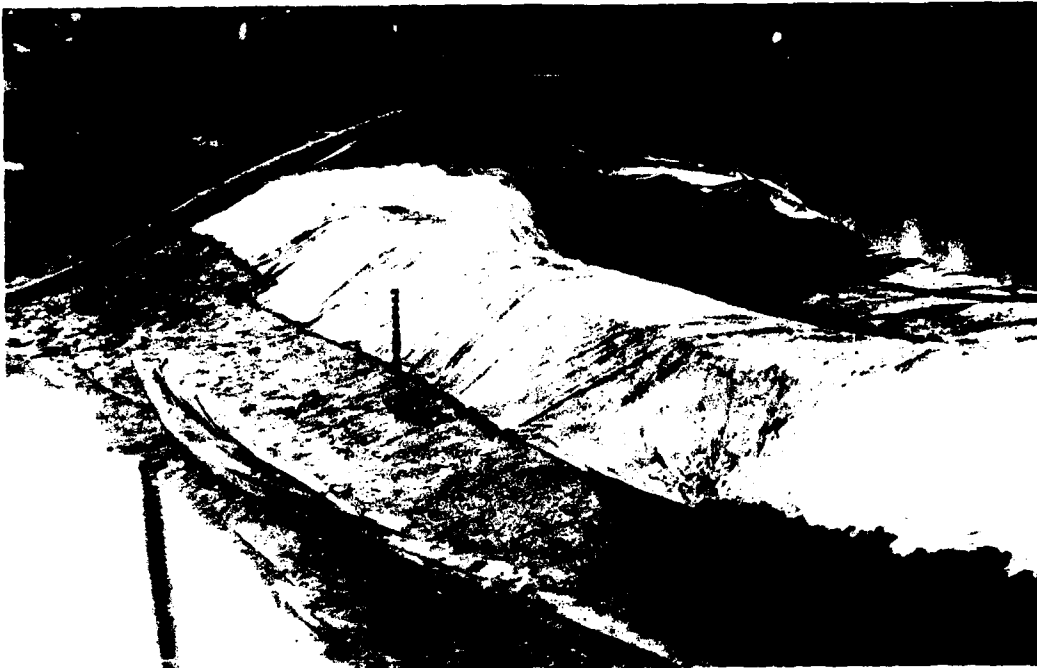
23. Section 2-4. Section 2-4 (Plate 12 and Photos 47 and 48) was a new design submitted by and tested at the request of CELMK. The structure consisted of a 2-ft-high compacted clayey silt potato ridge encased in 6-mil opaque polyethylene. In lieu of scarifying the surface of the existing levee, a seepage key was incorporated into the design to deter piping of water underneath the structure. Unlike Section 2-2, only one sheet of poly was used; therefore, the lap joint at adjoining sections of poly was not reproduced for this test. It should be noted that a poor lap joint construction could result in instability that was not observed during this test. In-place moisture content (17.2 percent dry weight, average) and soil densities (average wet density = 100.5 pcf; average dry density = 85.7 pcf) measurements were taken when the structure was approximately two-thirds complete. At the request of CELMK, this clayey silt structure was not as thoroughly compacted as previously tested clayey silt structures.

Photo 47. Riverside view of Section 2-4 before testing

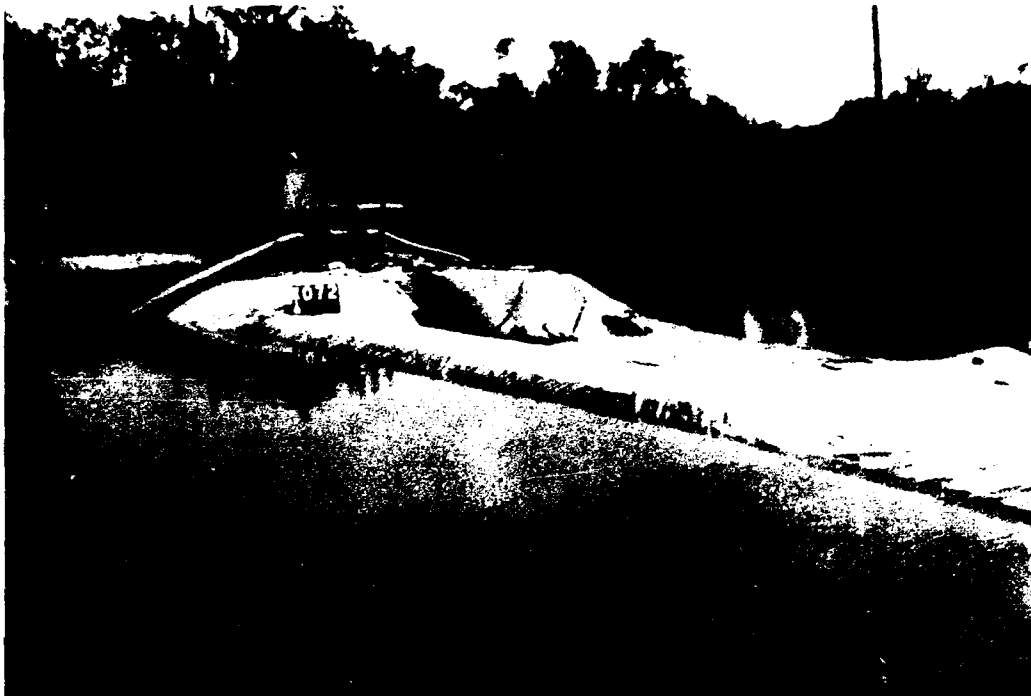
24. Section 2-4 was exposed to 24, 95, and 24.5 hr of 0.5-, 1.0-, and 1.5-ft static differential heads, respectively, and no significant seepage or stability problems were observed (Photos 49 and 50). By the end of the static head tests, the test section was spongy. As in Section 2-2, the poly trapped the moisture that would have otherwise dissipated through evaporation. Without evaporation, the structure became saturated with water that entered

Photo 49. Riverside view of Section 2-4 after testing 0.5-, 1.0-, and 1.5-ft static differential heads

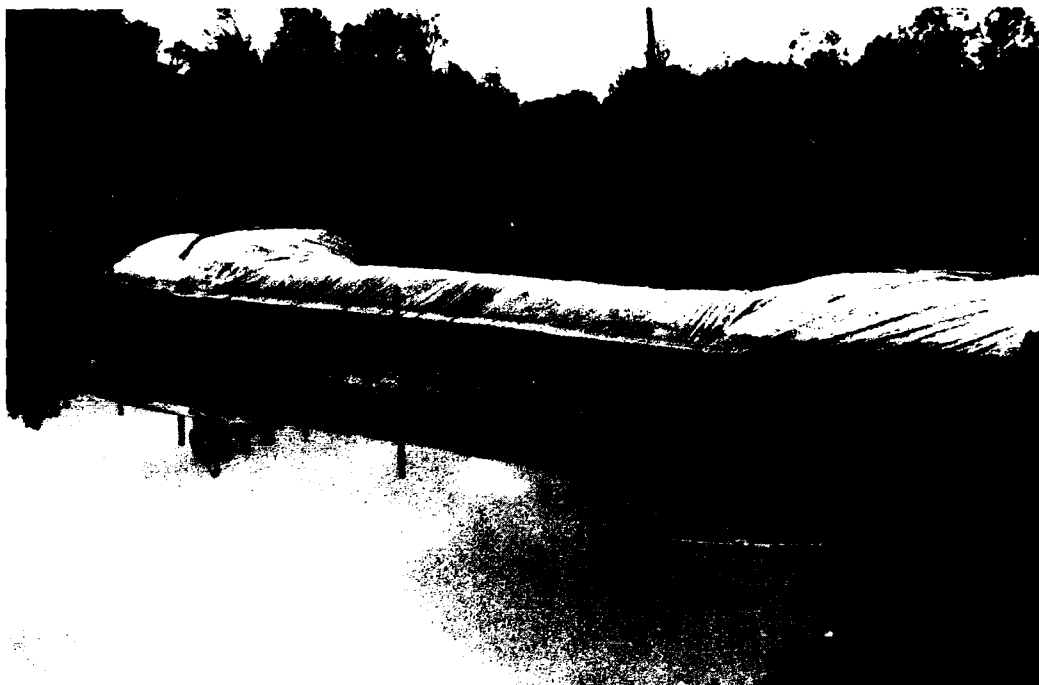
25. Following the static head tests, the water level in the small basin was lowered to 1.0 ft, and the structure was exposed to 19 hr of wave action over a period of 266.5 hr. Erosion of the soil in the wave action zone beneath the poly started immediately. The erosion rate slowed as the test progressed and had all but stopped by the 19th hour of wave action. The small basin was drained to document the condition of the test section (Plate 13 and Photos 51 and 52). The eroded material was contained by the poly but had produced a large bulge on the riverside toe and had stretched the poly very tight. Tension cracks were appearing along the crown of the structure, and the riverside of the crown was being vertically compressed due to forces being applied by the stretched poly covering. The poly had not torn loose on the landside toe, but it was showing signs of stretching and tearing at the points where the anchor pins projected through the poly. It was noted throughout wave action at the 1.0-ft water level that minor amounts of material were being pumped out of the structure through 2 or 3 small holes (diameters equal to approximately 1/4 in.) in the poly on the lower riverside slope. This material loss was insignificant, but it did show that material could be pumped through the holes by wave action; and if the holes were large enough, the material loss could have been significant. It is surmised that large losses of material would have eliminated the bulge that occurred on the riverside toe and would have kept the poly from stretching tight. Thus the protection provided by the bulge and tight poly covering would have been reduced, and the erosion action would have been more rapid and extensive resulting from large amounts of wave energy reaching the uneroded portions of the structure.

Photo 51. Riverside view of Section 2-4 after 19 hr of wave action  
at the 1.0-ft water level

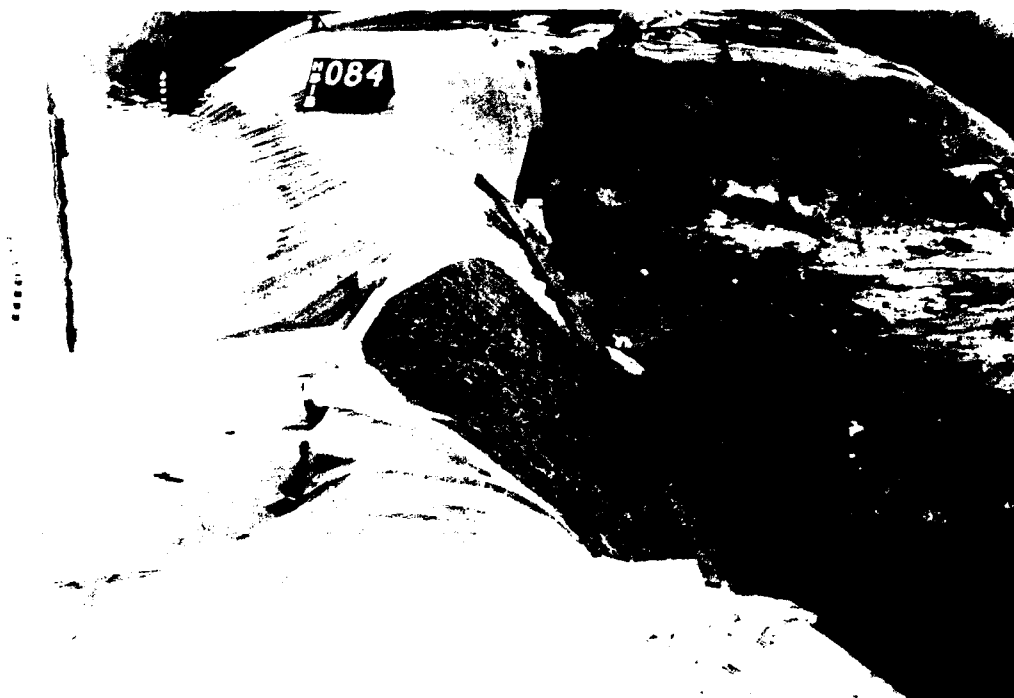
Photo 54. Side view of Section 2-4 after 18 hr of wave action  
at the 1.3-ft water level

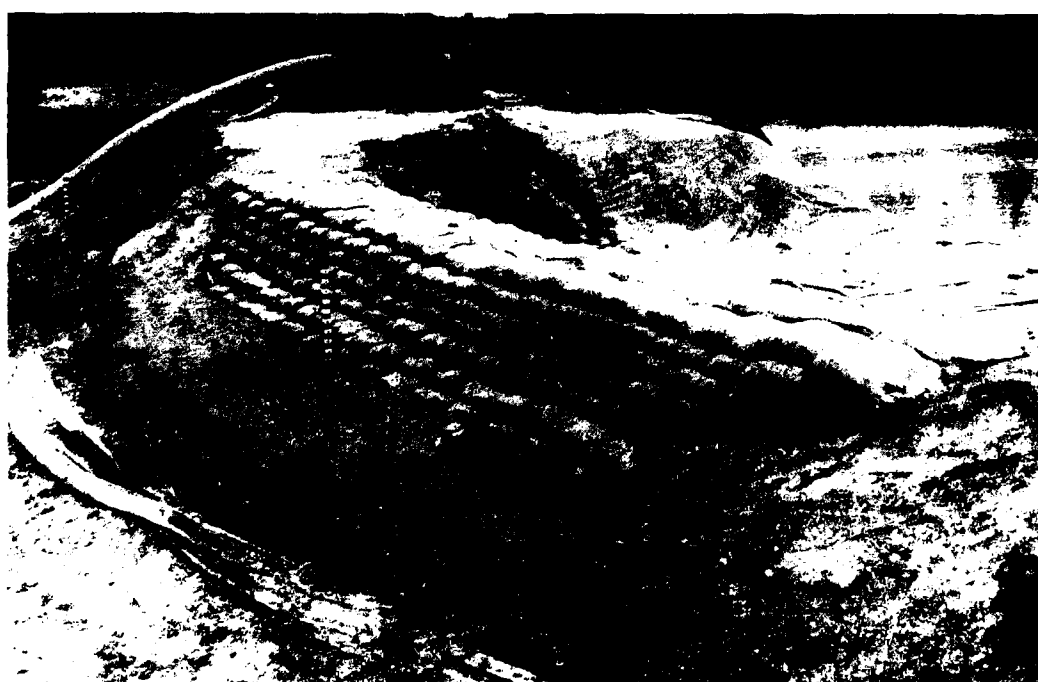
28. Section 2-5 (Plate 15 and Photos 58 and 59) was a 2-ft-high structure constructed of earth-filled sacks. The structure was constructed using the design and construction techniques outlined in the CELMK "Flood Emergency Handbook" (1975). The structure was 6 ft wide at the base, 2.5 ft wide at the crown, and set back 1.0 ft from the riverside edge of the existing levee. Prototype construction guidance recommends removal of sod from the area where the sandbag structure will rest. No sod existed on the test levee, but the area was cut down to a depth of approximately 0.2 ft to simulate removal of sod, and the bottom layer of sandbags was placed in this cut. This cut aided in bonding the sandbags to the existing levee and helped prevent piping of water underneath the structure. Seams of adjacent rows and layers were offset to break seepage lines. The sacks were one-half to two-thirds full and were not tied shut. The untied end was folded back, and the closed end of the next sack was placed over the fold. The sacks were tamped into place by walking

Photo 58. Riverside view of Section 2-5 before testing

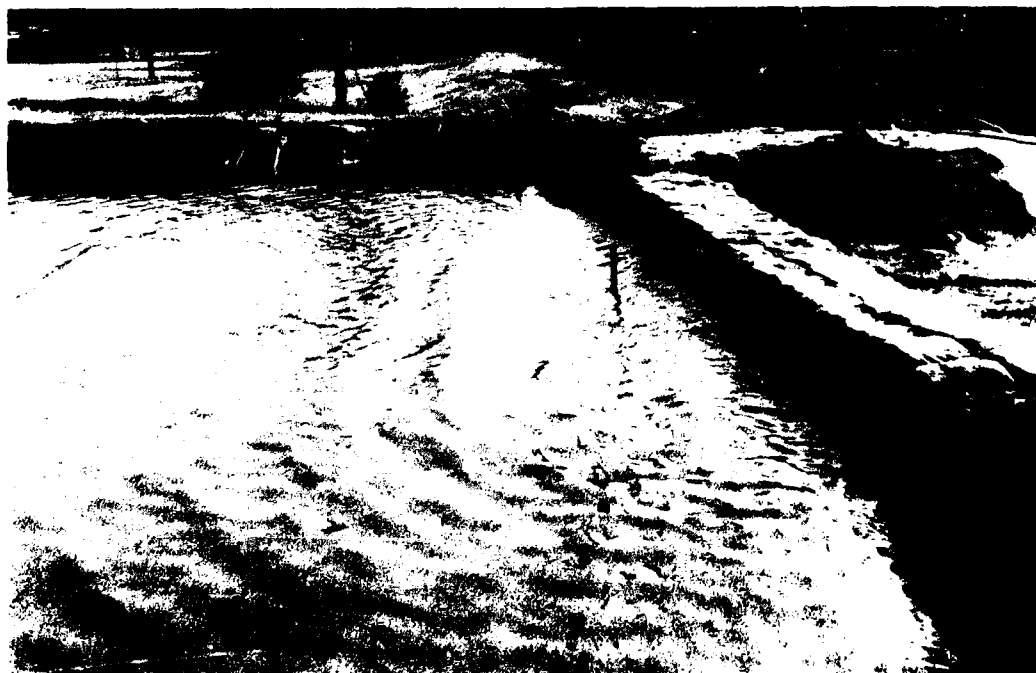
30. Following the static head tests, the structure was exposed to 19 hr of wave action over a period of 191 hr at the 1.0-ft water level (Photo 60). Emptying of the clayey silt-filled bags in the wave action zone started immediately and progressed at a rather rapid rate for the first 3 to 4 hr of wave action. The clay gravel-filled sacks showed some emptying, but it was at a slower rate and to a lesser degree. During the 19th hour of wave action, all noticeable leaching of fill material had stopped, and the small basin was drained. Photos 61 and 62 and cross-sectional soundings (Plate 16) show the condition of Section 2-5 after 19 hr of wave attack. The clayey silt-filled sacks had eroded back and formed a vertical face at the riverside of the structure crown. The clay gravel-filled sacks showed some emptying, but it was to a much smaller degree than that of the clayey silt-filled bags.

Photo 60. Wave action on Section 2-5 (water level = 1.0 ft)

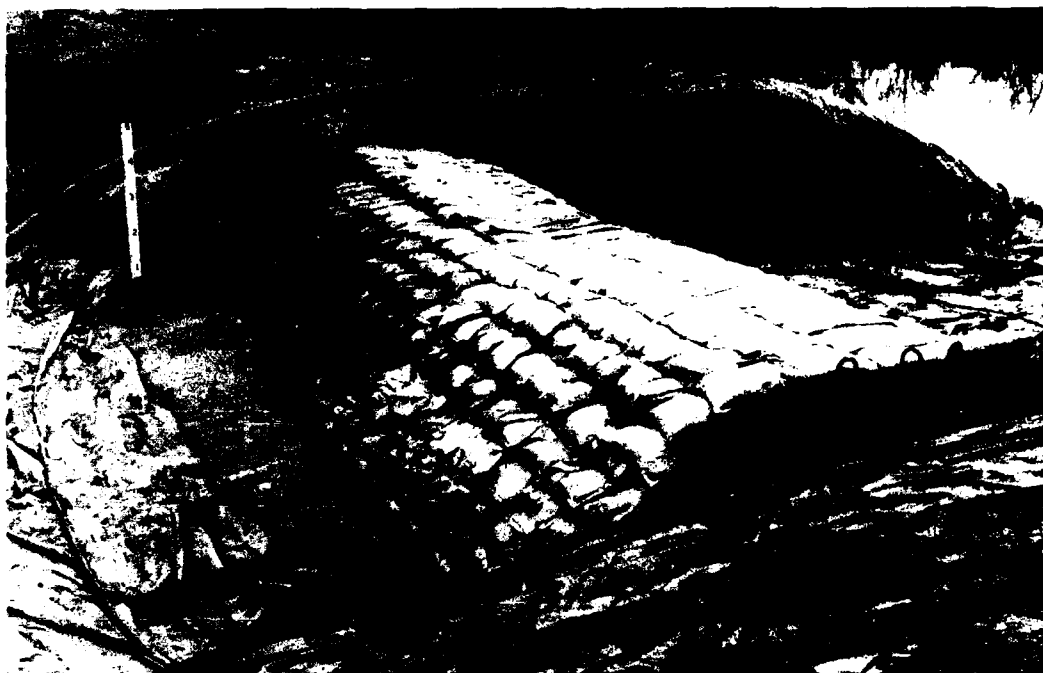
Photo 73. Riverside view of Section 4-1 after 19 hr of wave action at the 1.0-ft water level

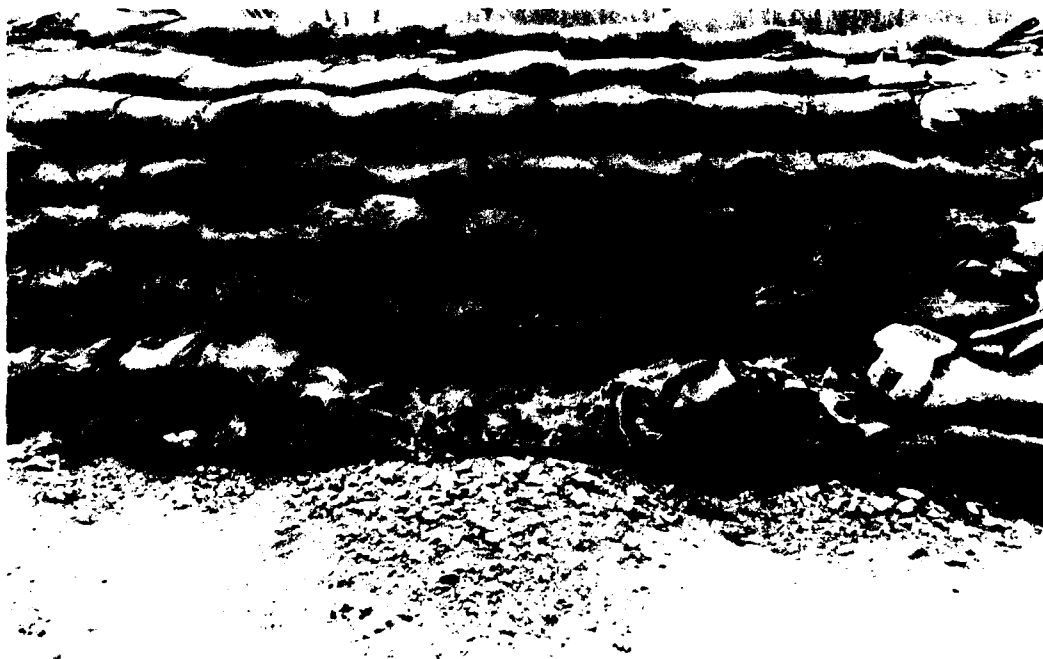
Photo 74. Riverside view of burlap sacks on Section 4-1 after 19 hr of wave action at the 1.0-ft water level

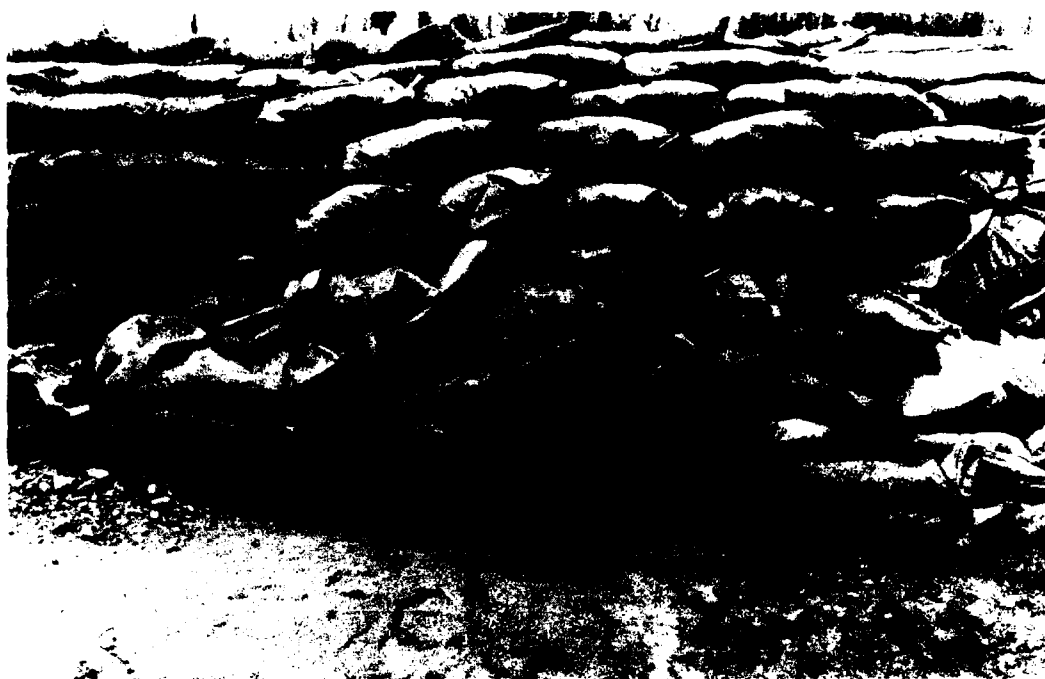
Photo 75. Riverside view of spun woven polypropylene sacks on Section 4-1 after 19 hr of wave action at the 1.0-ft water level

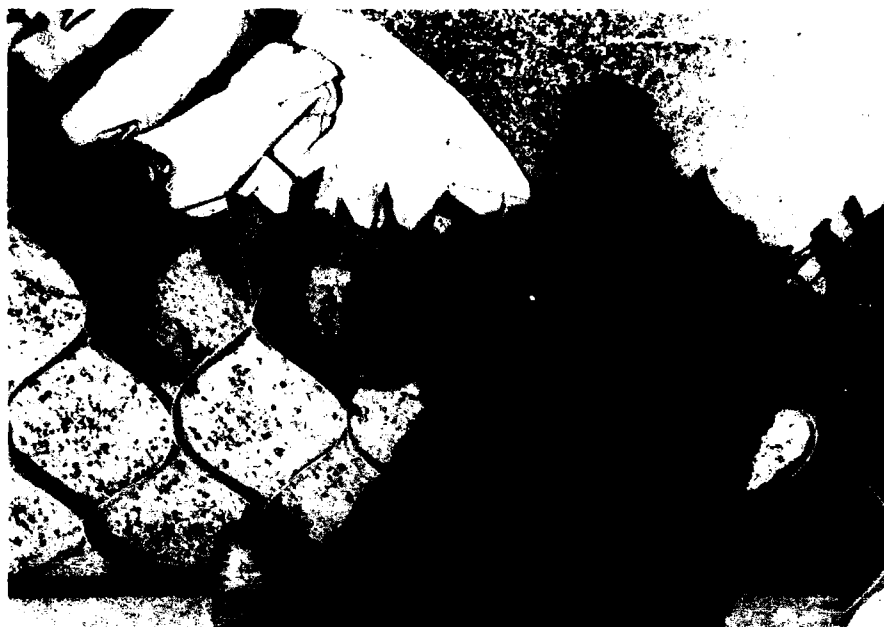
Photo 109. Closeup top view of empty cells on the river-side of the burlap filtered portion of Section 4-2 after 19 hr of wave action at the 1.0-ft water level

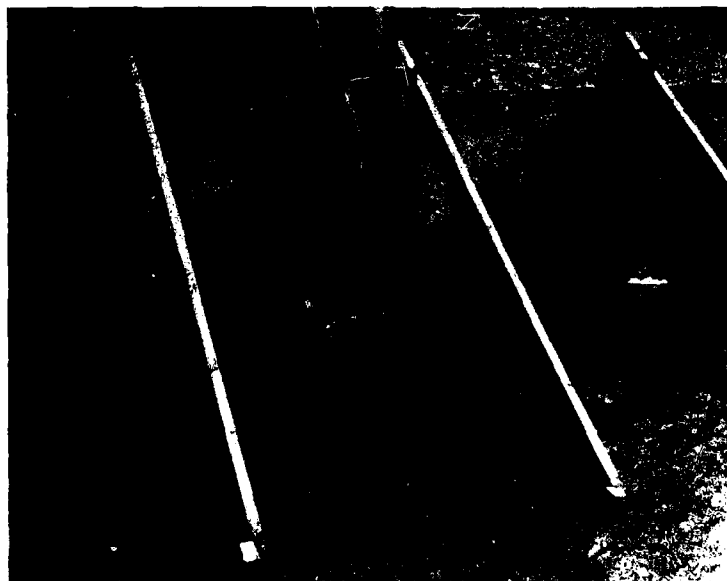
Photo 128. Landside view of Section 4-3 showing flow under Section 4-3 just prior to stopping the 1.0-ft static differential head test

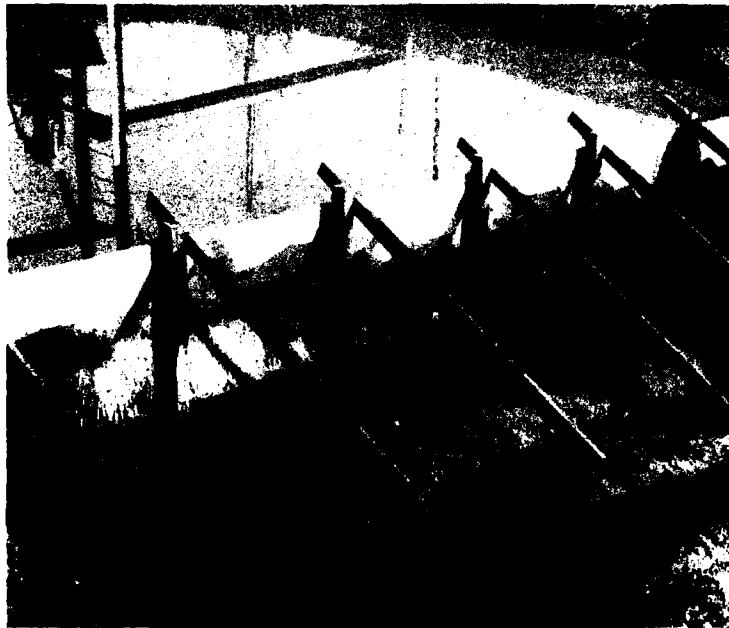
seepage could be seen exiting from beneath the asphalt; but the water was clear (Photo 170). The static head was increased to 1.5 ft and maintained for 24 hr. During this period heavy rains occurred. The seepage increased slightly, but the structure was still functioning very well (Photo 171). The static head was increased to 2.0 ft, and a slight increase in the seepage rate was noted; but the quantity of seepage was still minor. After 24 hr of 2.0-ft static head, the structure was still in good condition. However, it had become obvious that the majority of seepage was coming from around a support post. This became apparent when a prominent bulge appeared in the asphalt coating around the post (Photo 172). The seepage around this post became significant and began moving material when the static head was increased to 2.5 ft. After 2.0 hr the water broke through the asphalt and began free flowing under the plywood flashboard (Photo 173). Photo 174 shows where the asphalt coating and compacted earth-filled trench failed around one of the center support posts.

Photo 170. Landside view of Section 4-3-D at  
the end of the 1.0-ft static differential  
head test

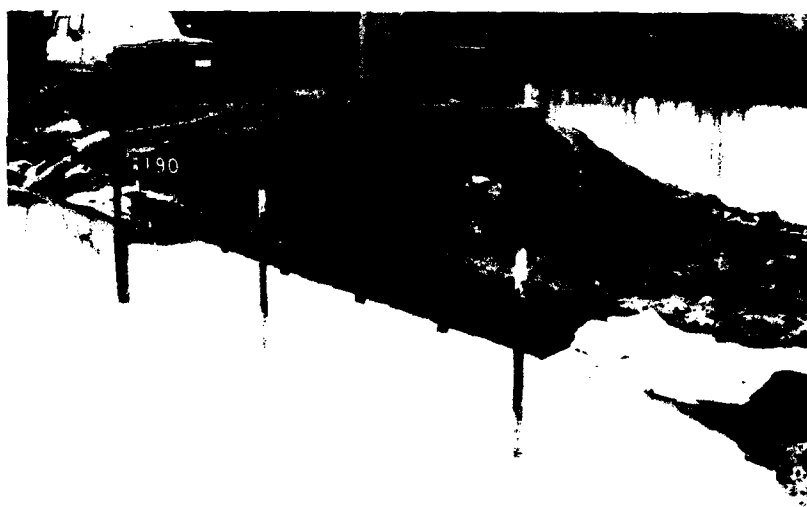
57. Section 4-4 was exposed to static differential heads of 1.0, 2.0, and 2.5 ft for periods of 24 hr each, and no measurable seepage was noted at any time. During this period, the section was exposed to 3 to 5 in. of rain which saturated the earth backing. By the end of the 2.5-ft static differential head test, the crown of the earth backing had consolidated about 2 in., and the flashboard had developed a 2- to 3-deg lean toward the riverside in some areas (Photos 180 and 181). Following the static head tests, the water level was lowered to 1.0 ft, and the structure was exposed to 19 hr of wave attack over a period of 192 hr (Photo 182). Saturation of the earth backing by heavy rains and the pumping action of the waves resulted in an increase in the riverward lean of the flashboard and additional consolidation of the earth fill. The top of the flashboard had leaned as much as 4 in. riverward in some areas. Some areas of the earth fill crown were lowered as much as 8 in. No obvious seepage was noted, and the structure was in good condition at the end of wave attack at the 1.0-ft water level (Photos 183 and 184).

Photo 180. Riverside view of Section 4-4 at the end of the 2.5-ft static differential head test

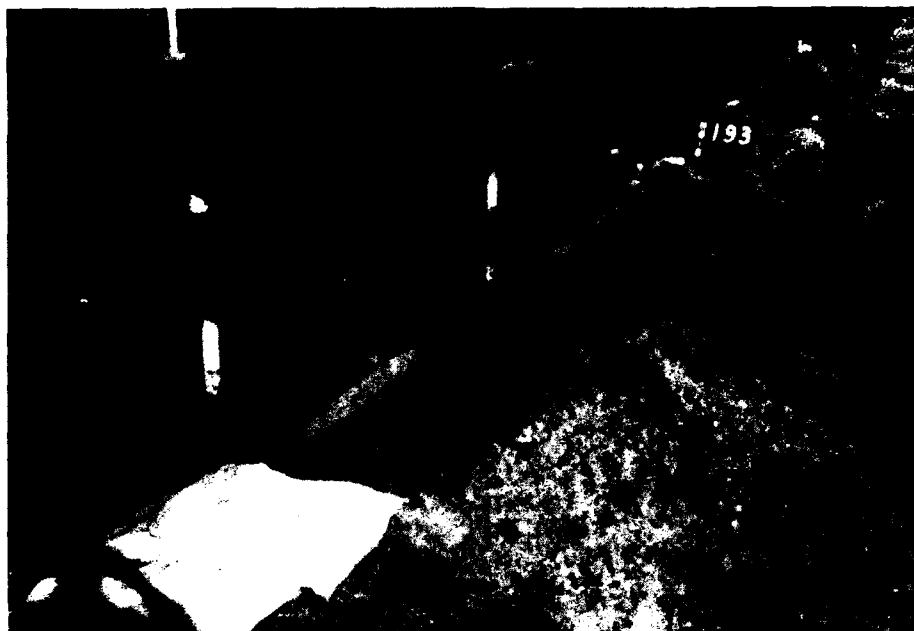
crown lowering. The test section was in good condition and did not appear to be accruing any additional damage, and no measurable seepage was observed (Photos 186 and 187). Wave attack at the 2.5-ft water level produced severe and continuous overtopping (Photo 188). The overtopping water produced very rapid erosion of the earth backing (Photos 189-192). After approximately 2.5 hr of wave attack, the structure showed major deterioration. The 6-mil poly backing had torn loose from the flashboard, and the crown and slope of the earth backing showed major erosion. When the poly tore loose, it was noted that overlap joints showed minor seepage; but scab joints showed no seepage. The pump was kept running in order to replace water being lost from the small basin by wave overtopping.

Photo 187. Landside view of Section 4-4 after 8.5 hr of wave attack at the 2.0-ft water level

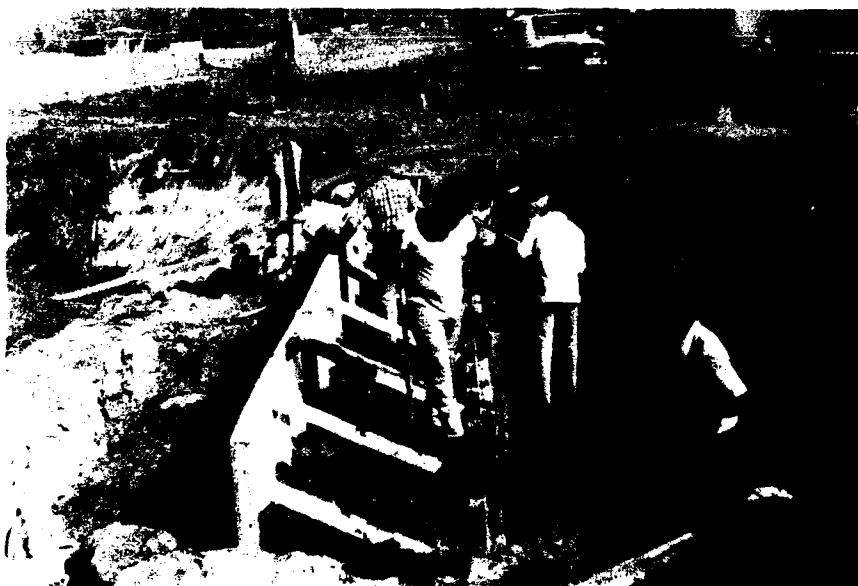
Photo 202. Side view of Section 4-5 during placement of fill

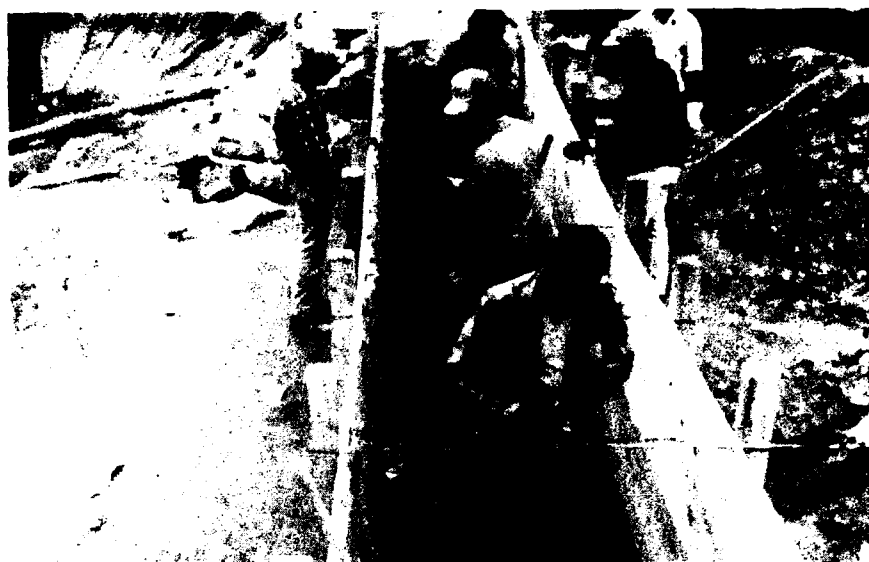
Photo 217. Side view of Section 4-6 during placement of wire ties

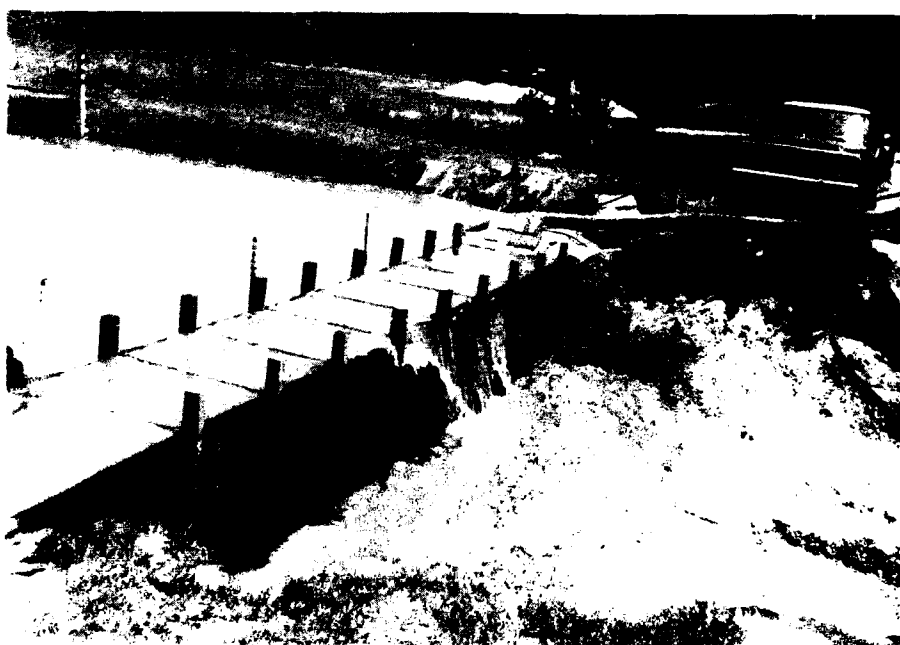
Photo 222. Landside view of wave action on Section 4-6  
at the 3.0-ft water level

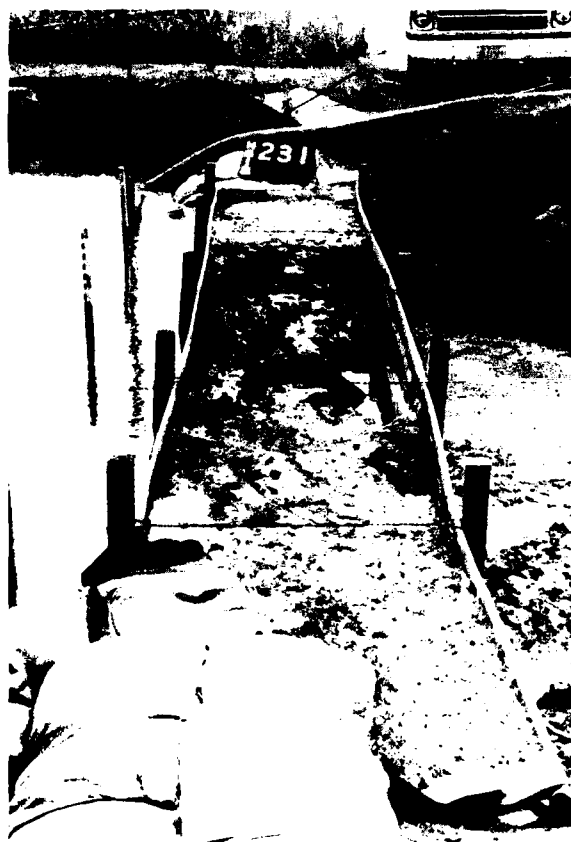
67. Section 4-6-A. Section 4-6 was a very rigid structure with support posts being placed on 3.0-ft centers. It was a very labor-intensive structure to build. In an effort to reduce construction requirements and reduce cost, Section 4-6-A was tested to see what effect the removal of every other support post would have on overall stability of the test section. Tie wires were removed, support posts were cut off at ground level, and the earth fill was repaired (Plate 28 and Photos 226 and 227) prior to exposing the structure to static differential heads of 3.0 and 3.5 ft. Each of the static head conditions were maintained for 24 hr, and the structure showed only minor seepage at the 3.5-ft level (Photo 228). The water level was lowered to 3.0 ft, and the structure was exposed to 6.5 hr of wave action over a period of 24 hr. In the early stages of this test, damage to Section 4-6-A proceeded much like it

had on Section 4-6 when exposed to overtopping wave conditions. Water ponded on top of the earth fill and began to pipe down through the earth and out the landside toe. As earth fill began to leach out of the structure toe, it was noted that riverside planking began to flex with incident wave attack, and landside planking began to bulge out where the support posts had been removed. This occurrence resulted in a free flow of water and suspended earth fill through gaps between the flexing boards (Photo 229). Thus, it could be seen that increasing spacing between support posts from 3.0 to 6.0 ft had an adverse effect on the structure's stability when exposed to moderate overtopping wave conditions. Photo 230 shows the condition of Section 4-6-A at the end of the test.

Photo 230. Side view of Section 4-6-A at the end of the wave action tests

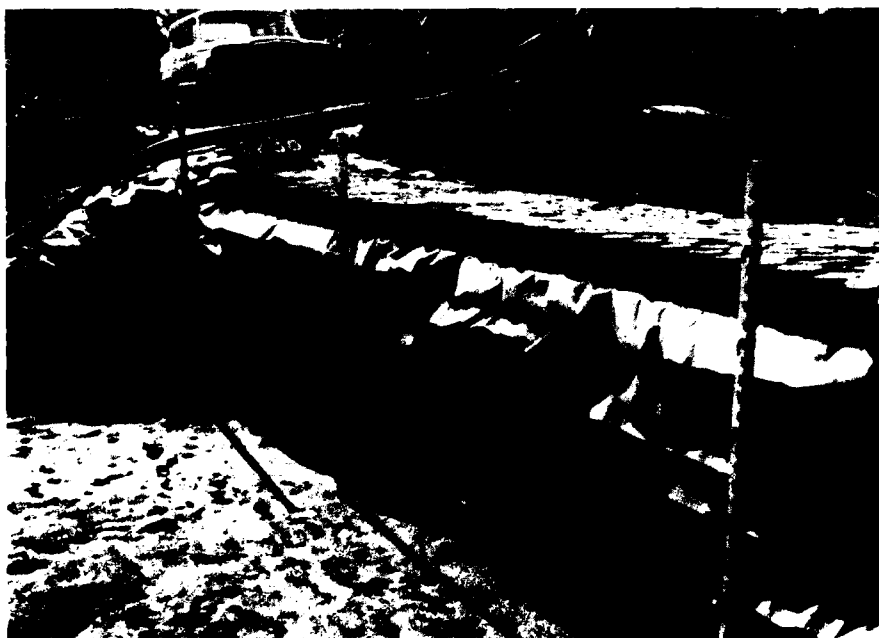
Photo 238. Riverside view of Section 6-1 at the end of the static differential head tests

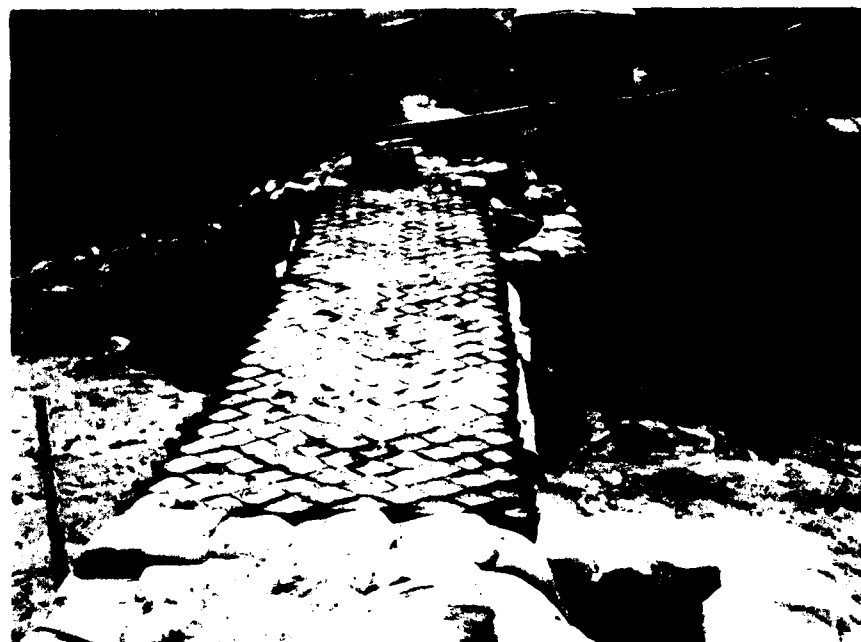
Photo 240. End view of Section 6-1 at the end of the  
static differential head tests

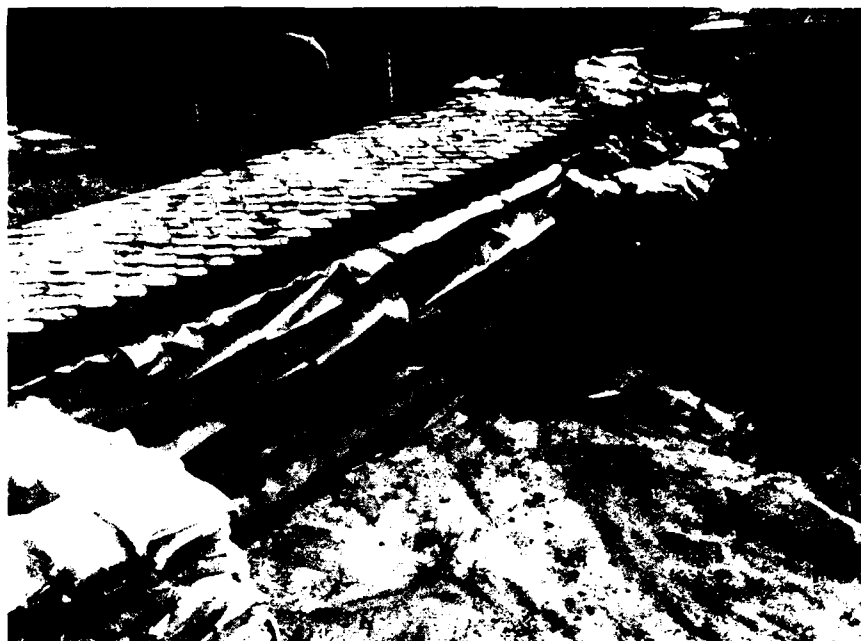
Photo 241. Landside view of Section 6-1 at the end of the static differential head tests

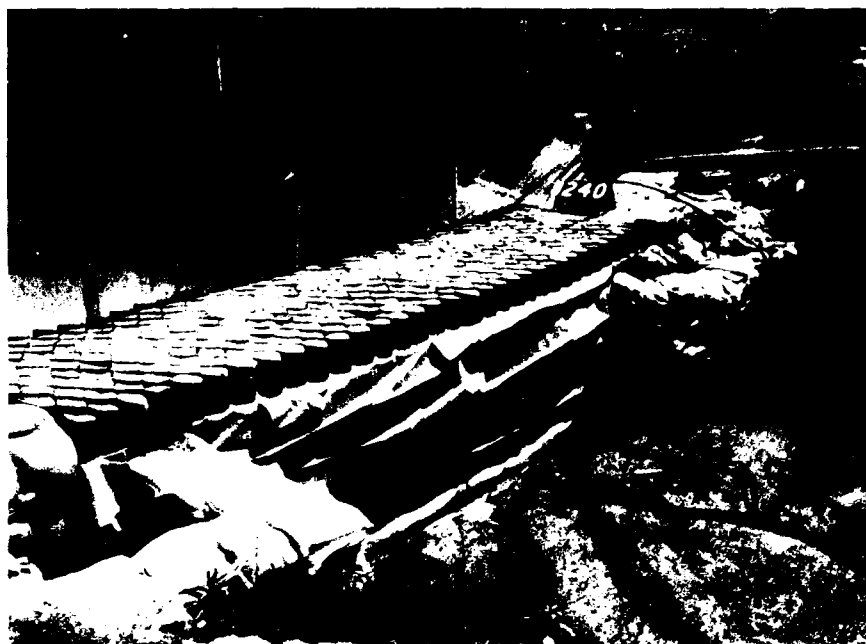
Photo 247. Landside view of Section 6-1 after 18 hr of wave action at the 3.0-ft water level

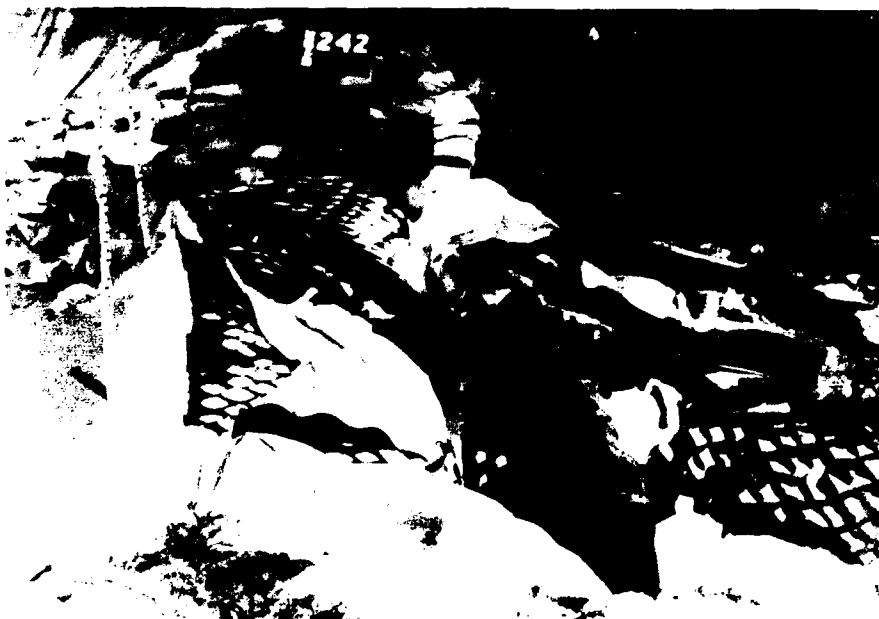
71. During flooding of the basin to carry out wave action at the 5.0-ft water level, the structure failed. When the water had reached 4.9 ft, the structure was displaced landward by a combination of overturning and sliding (Photo 252). Sliding occurred along the top surface of the second lift of cells. Photos 253 and 254 show Section 6-1 after failure.

Photo 254. End view of Section 6-1 at end of test

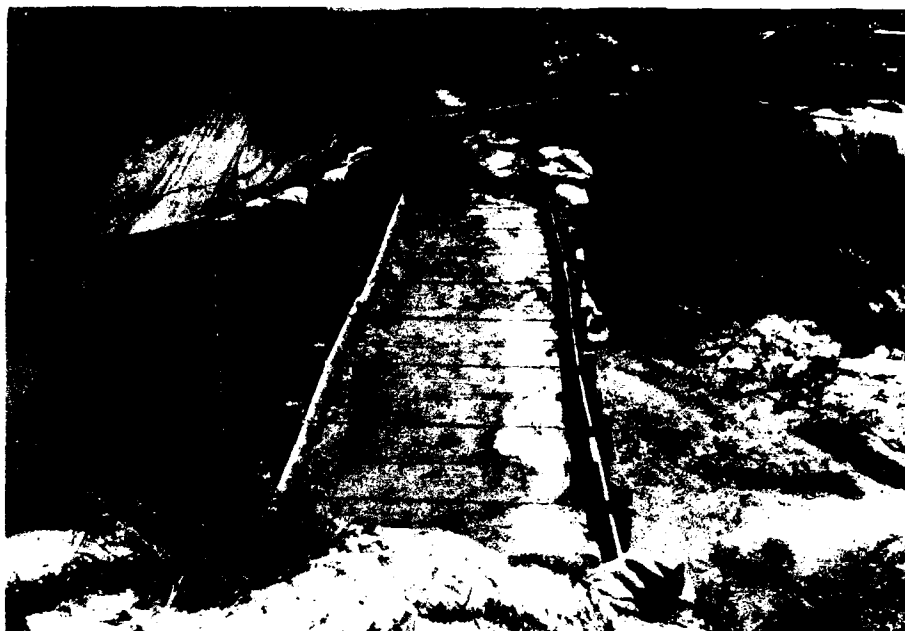
Photo 263. End view of Section 6-2 at the end of the static differential head tests

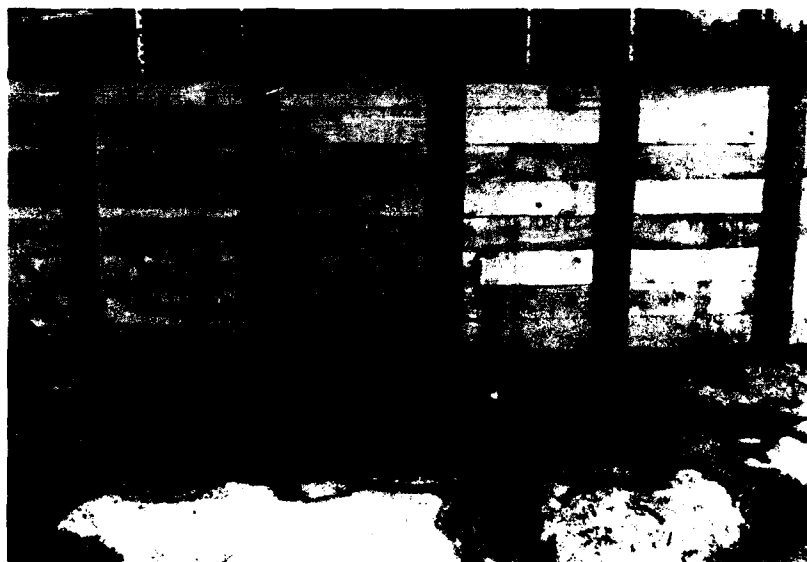
Photo 266. Landside view of water flowing around  
center support posts during wave action at the  
4.0-ft water level
