MISCELLANEOUS PAPER NO. 2

# CONDITION SURVEY OF LOCK NO. 2 MONONGAHELA RIVER

August 1968

Approved by DEPARTMENT OF THE ARMY  
US Army Engineer District, Pittsburgh  
Pittsburgh, Pennsylvania 15222-4136

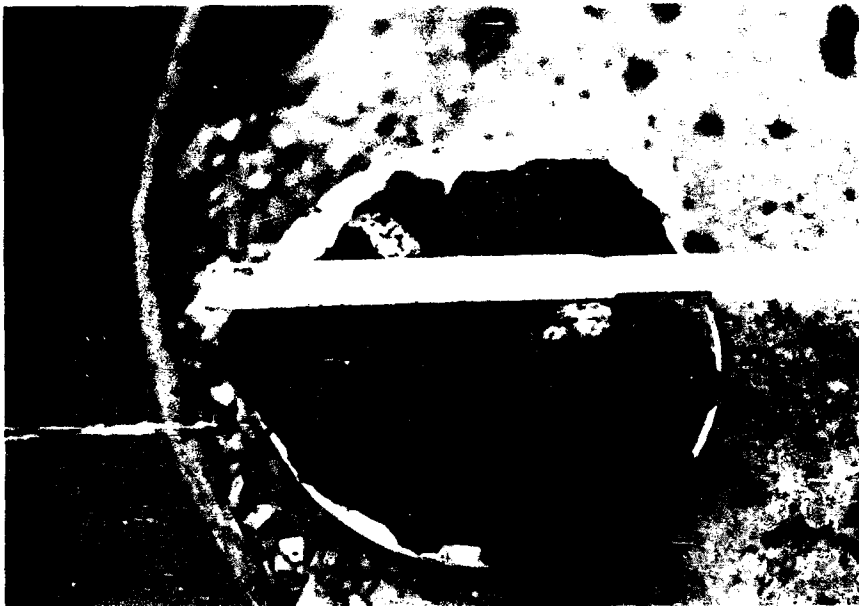
Figure 7.

35. Samples of backfill material were taken every 5 feet. The material ranged from loosely consolidated slag particles to zones of clay silt material (Figures 7 and 8). Approximately 115 ft of backfill was drilled and sampled, much of it required casing to prevent sloughing of adjacent material. A total of 328.8 ft of concrete core and 185.95 ft of foundation rock was cored.

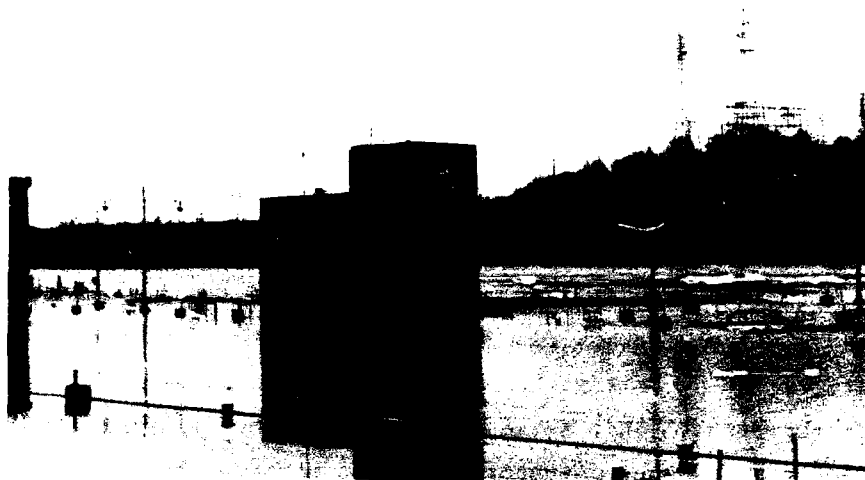
Figure 9.

36. The drilling program was completed 18 February 1986. During this field operation several days were lost due to subfreezing temperatures in which the wind chill factor went as low as -40°F. Other delays included two work stoppages due to flooding of the lock structure (Figure 9), once from 27 November through 29 November 1985 and once from 5 February through 7 February 1986.

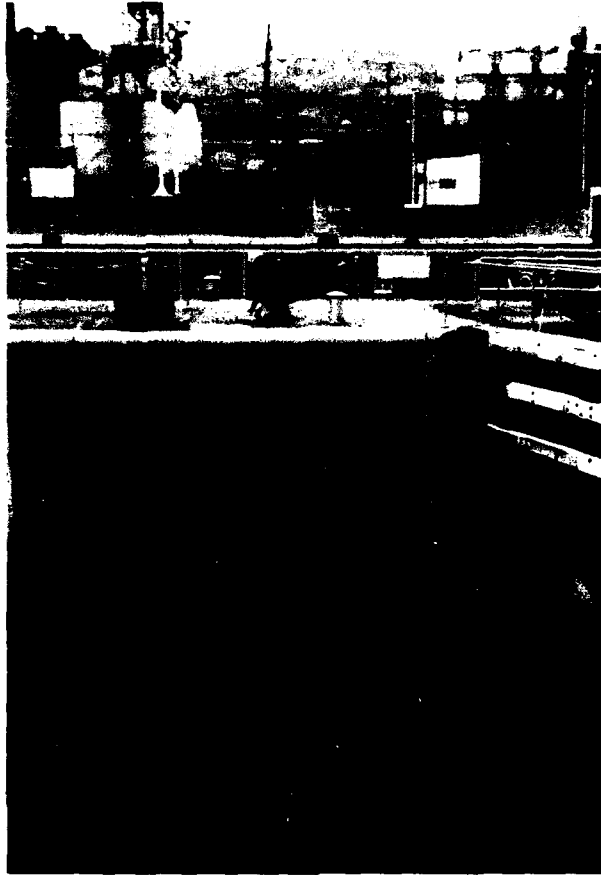
Photograph A5. Downstream of upper gate middle wall in  
small lock chamber

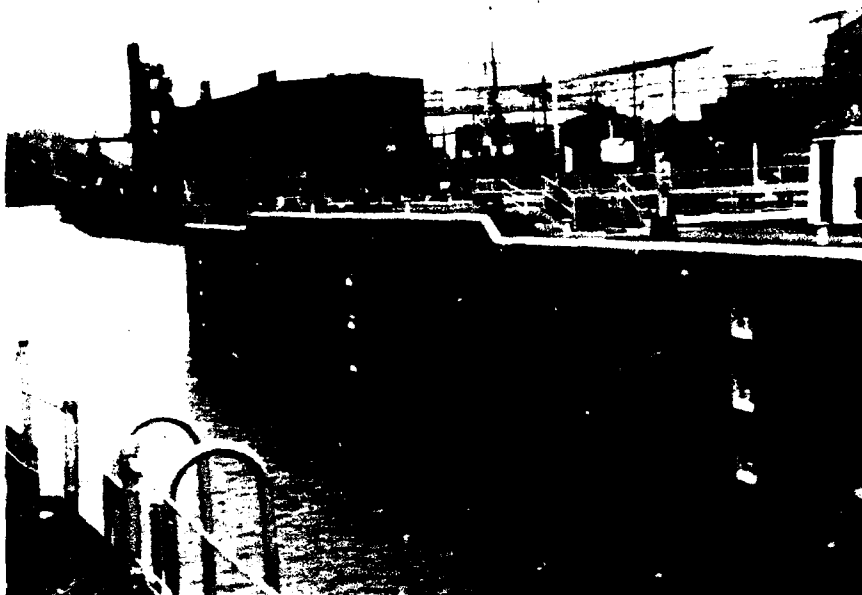
Photograph A10. Downstream of lower gates small lock chamber  
middle wall

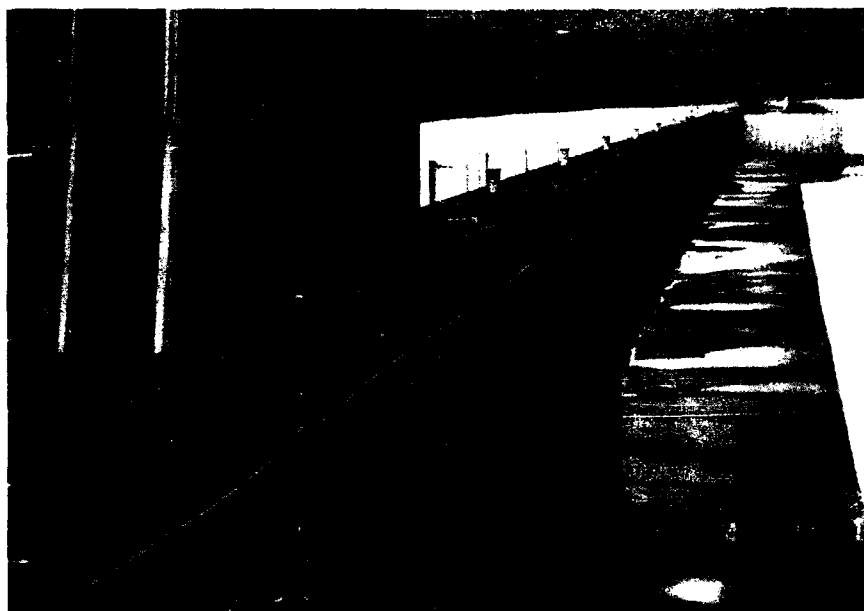
Photograph A15. River side upper guard wall
