## Richard B. Russell Dam and Lake

Savannah River, Georgia And South Carolina

# Final Foundation Report Volume 2 of 2

RICHARD B. RUSSELL PROJECT  
SAVANNAH RIVER, GEORGIA AND SOUTH CAROLINA  
FINAL FOUNDATION REPORT  
CONCRETE DAM, EMBANKMENTS, AND POWERHOUSE

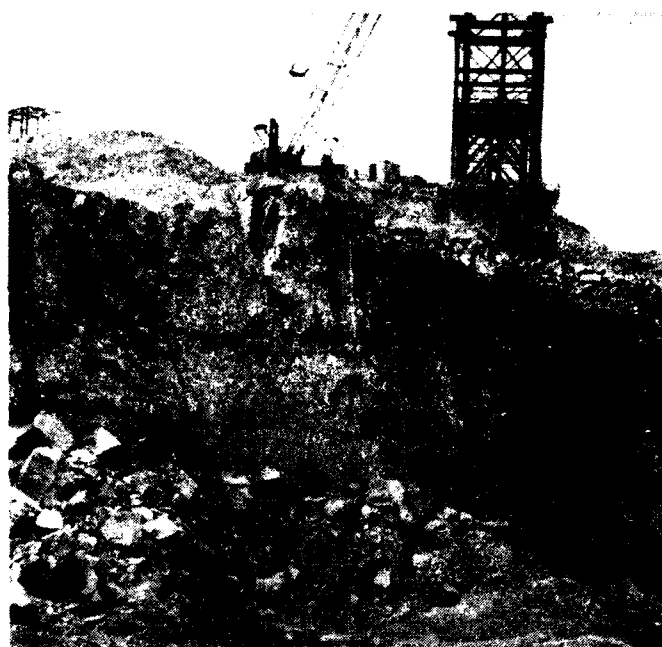
Photo 19 - Looking west into west retaining wall foundation area - near horizontal wall seam is at El. 307 (September 1978)

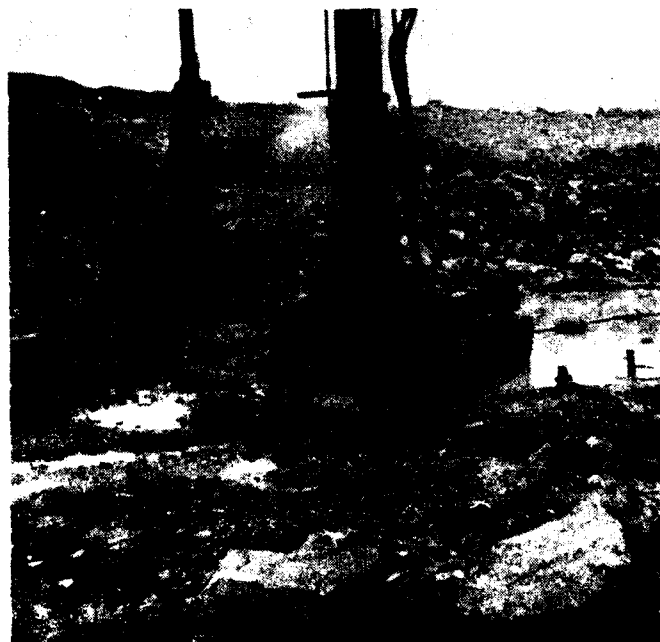
Photo 22 - Lane drillers on production shot downstream of draft tubes. Foreman (Frank Poes) reported difficulty with seam at about elevation 258' (October 1978)

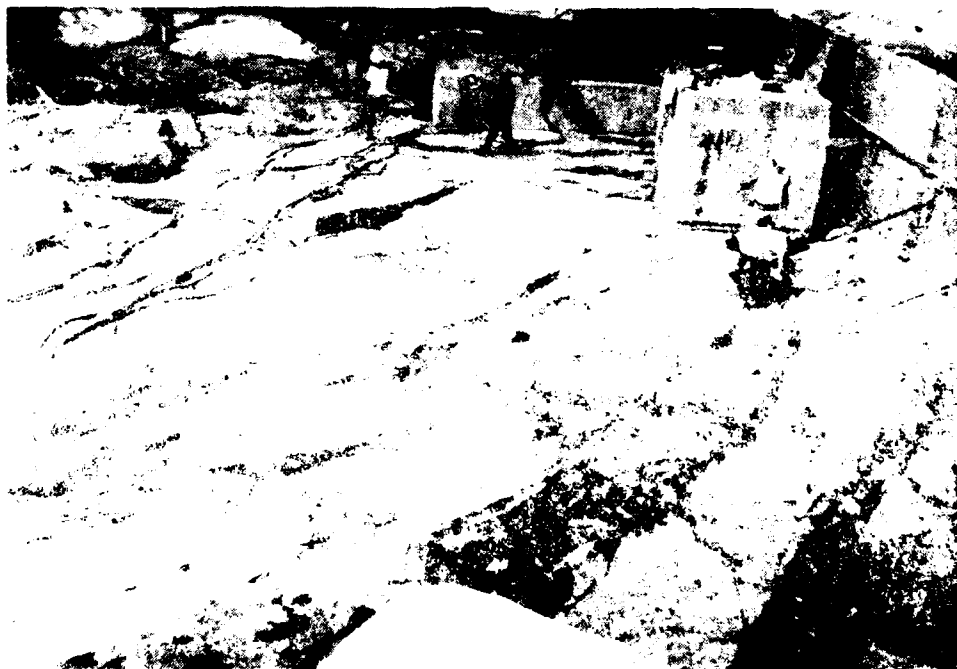
Photo 78 - Monolith 19 foundation (August 1979)

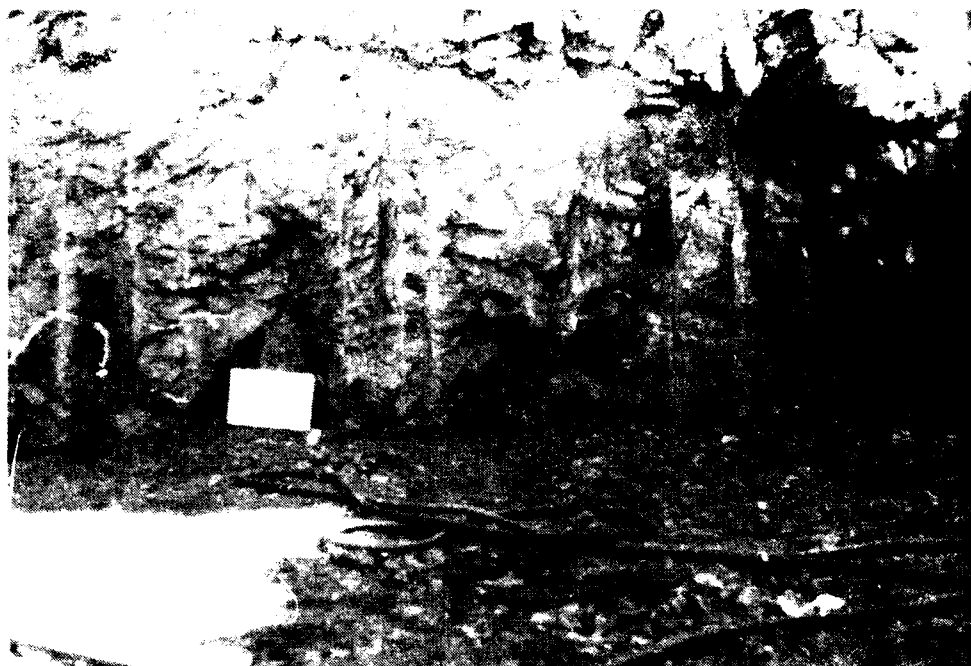
Photo 93 - Monoliths 28/29 Step-up face (February 1980)

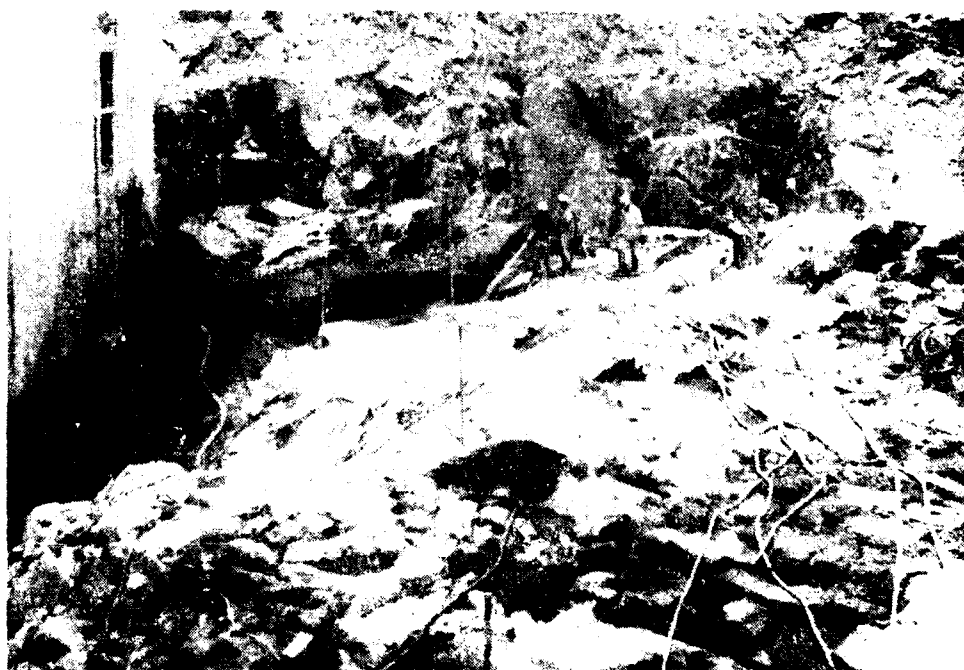
| <u>Photograph</u> | <u>Description</u> | <u>Page</u> |
|---|---|---|
| 94 | Monolith 29 foundation. | K-70 |

Photo 94 - Monolith 29 foundation

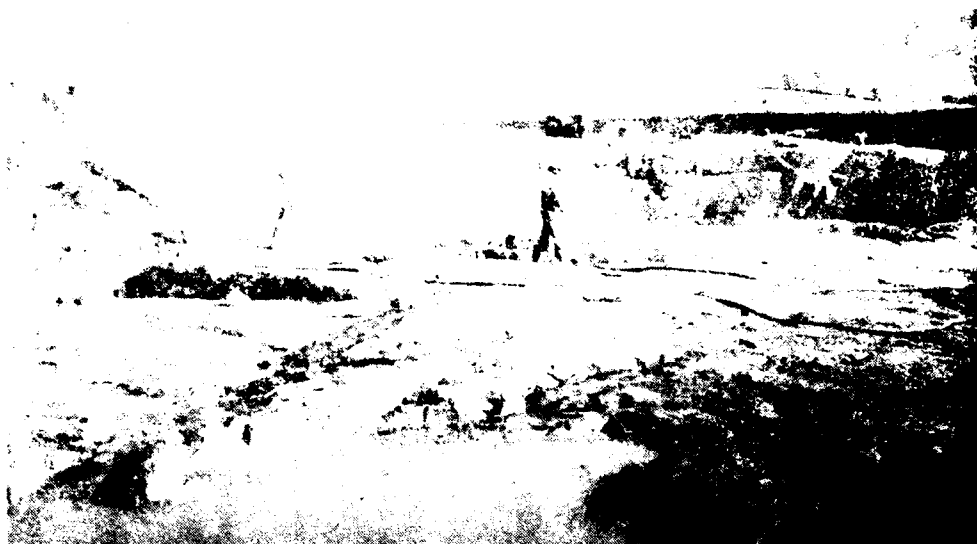
Photo 160 - Georgia east embankment cleanup. Note quarry operation in background.

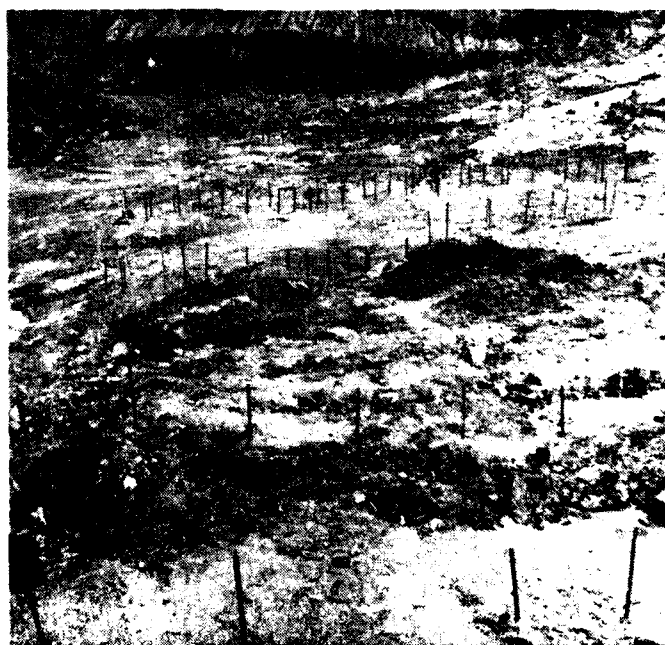
Photo 161 - Georgia east embankment cleanup. Note quarry operation in background.

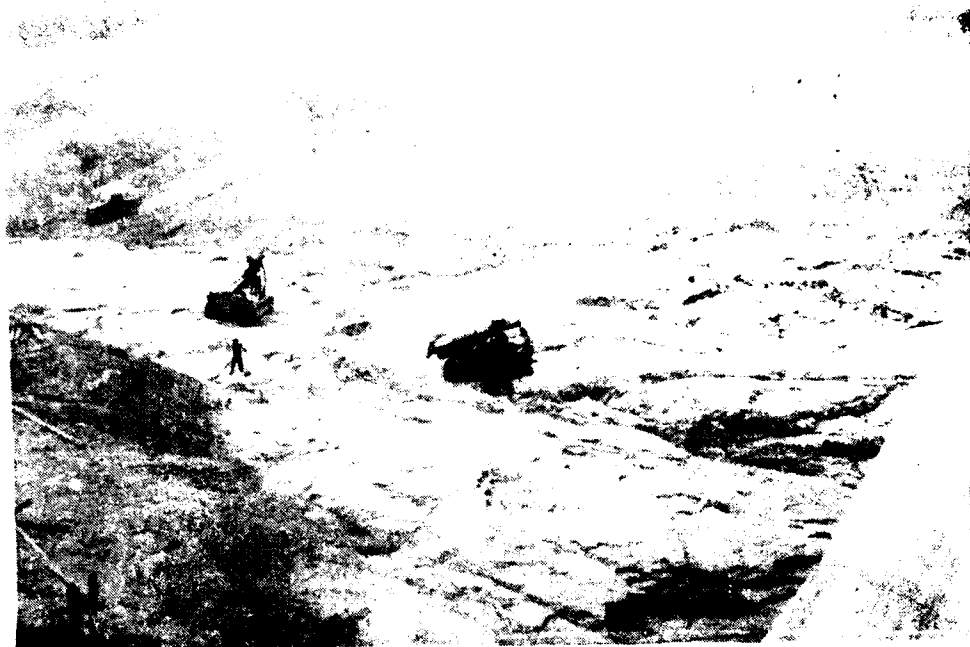
Figure 10 - Georgia coast - dune - note Monolith at right  
(Station 2 + 00 - 21 + 00)

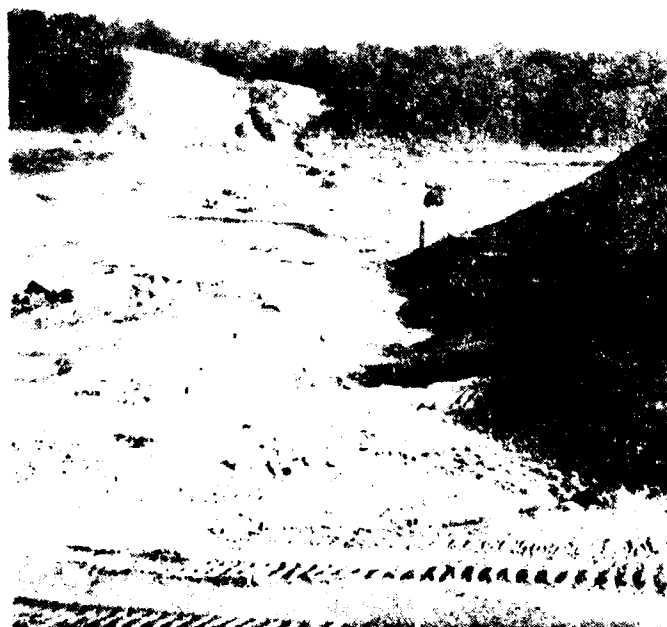
Figure 11 - Georgia coast - after storm - note  
200 ft. post markers at right  
(X 100 ft. 1950)

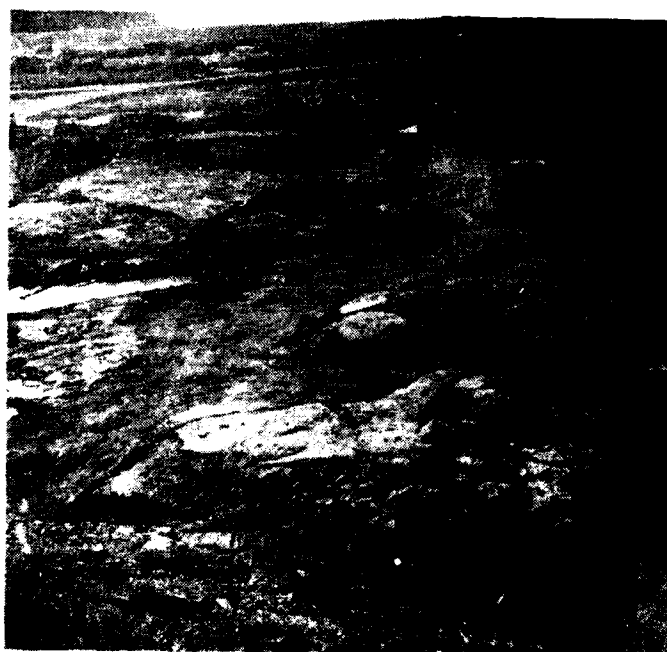
Photo 167 - Georgia abutment Monoliths 3-7 after cleaning by machines. (October 1978)

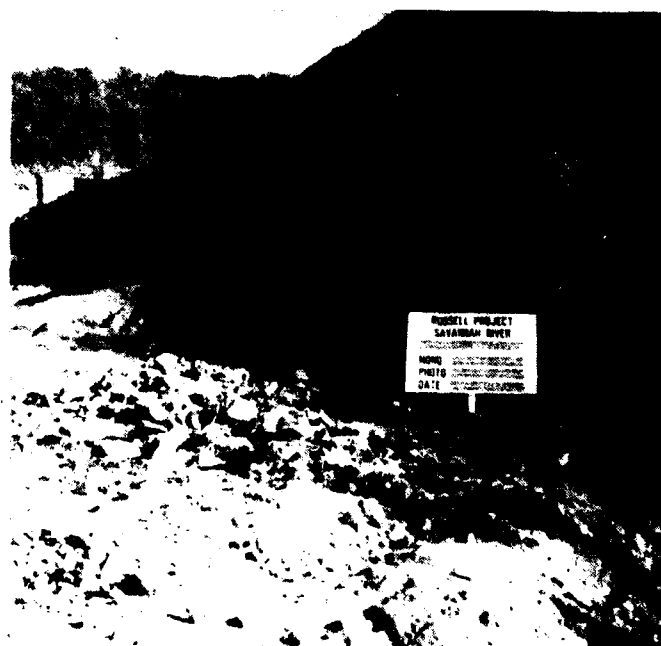
Photo 169 - Georgia east embankment downstream Monolith 2
